TNO-report  
98-CMC-R0328

## IMPACT ON A STEEL SONAR DOME

TNO Building and Construction  
Research

Date  
20 March 1998

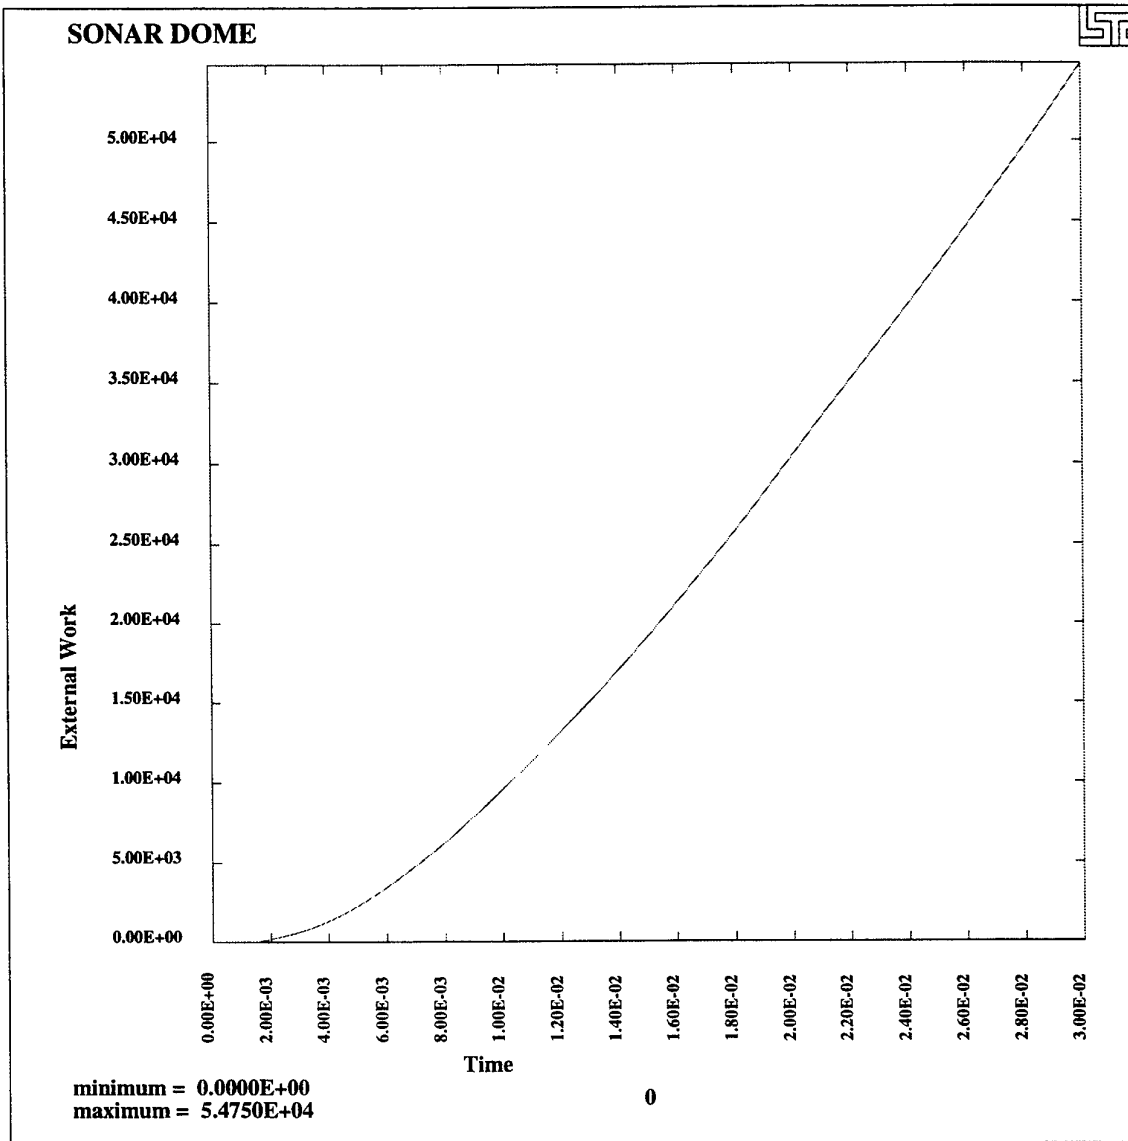
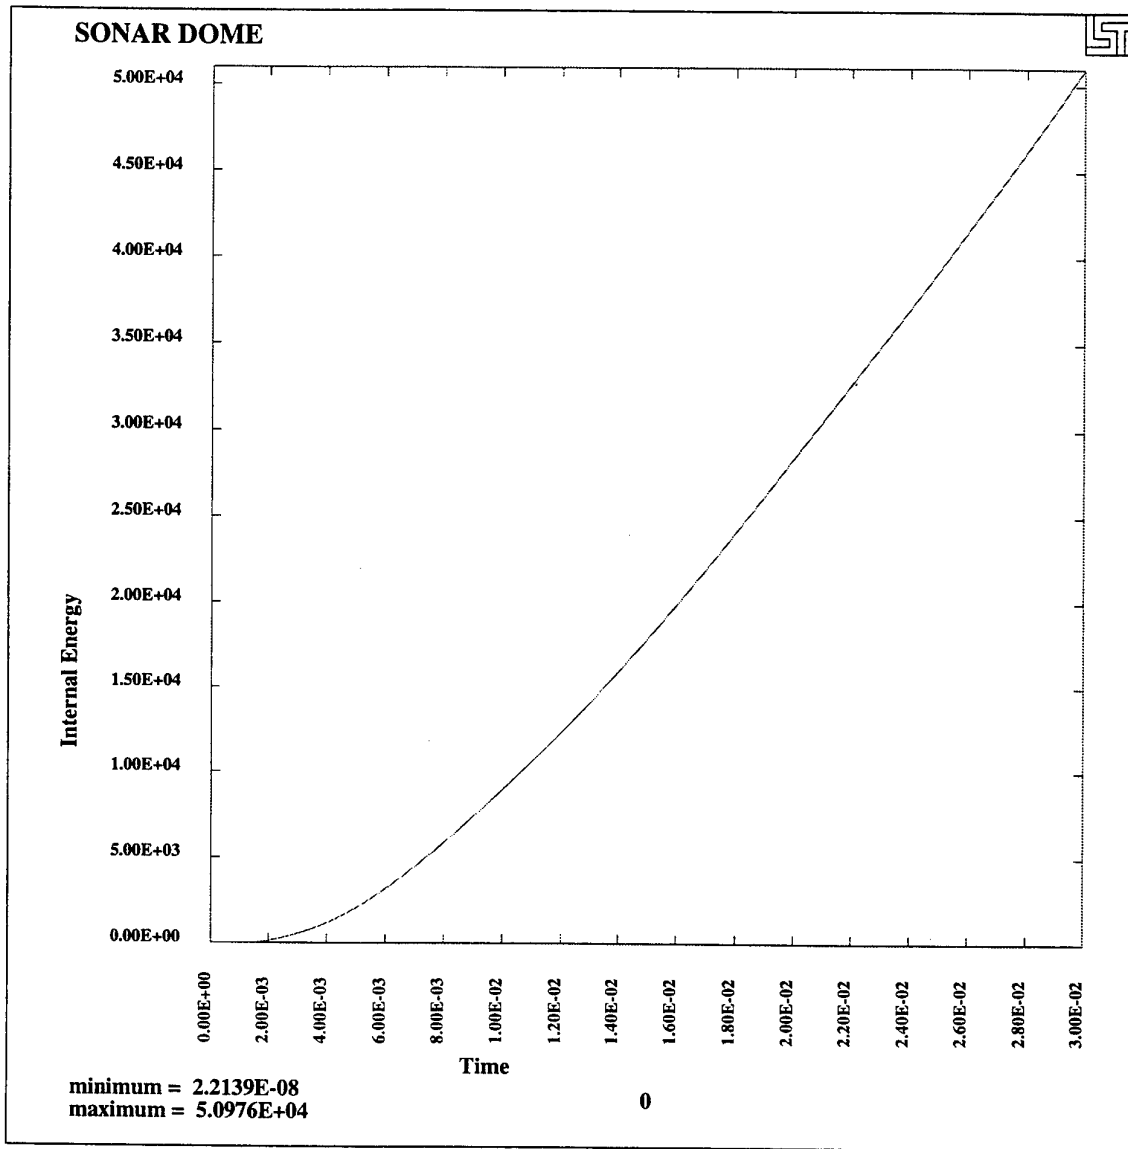
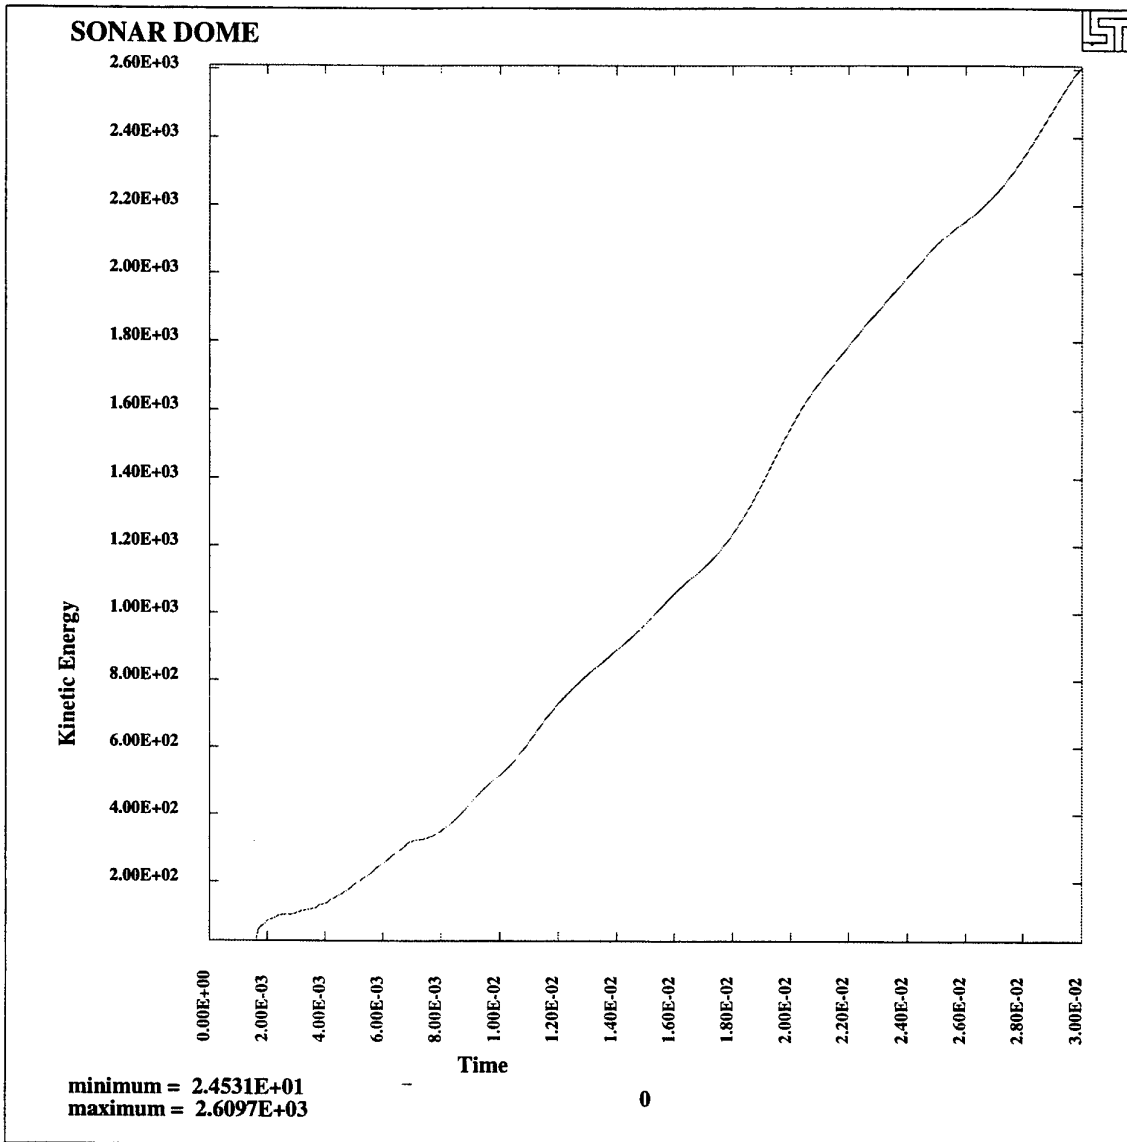
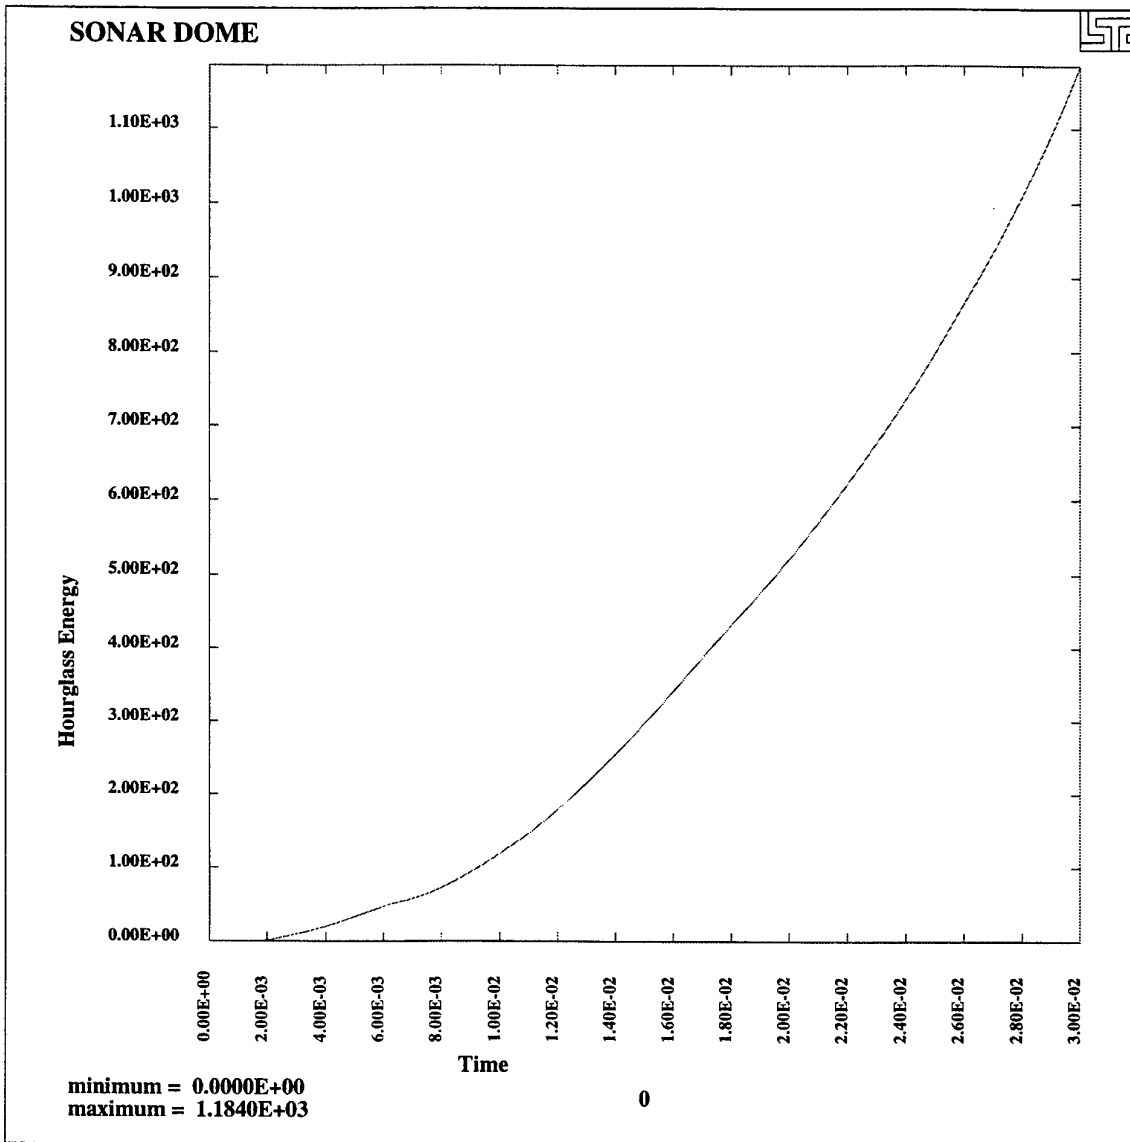
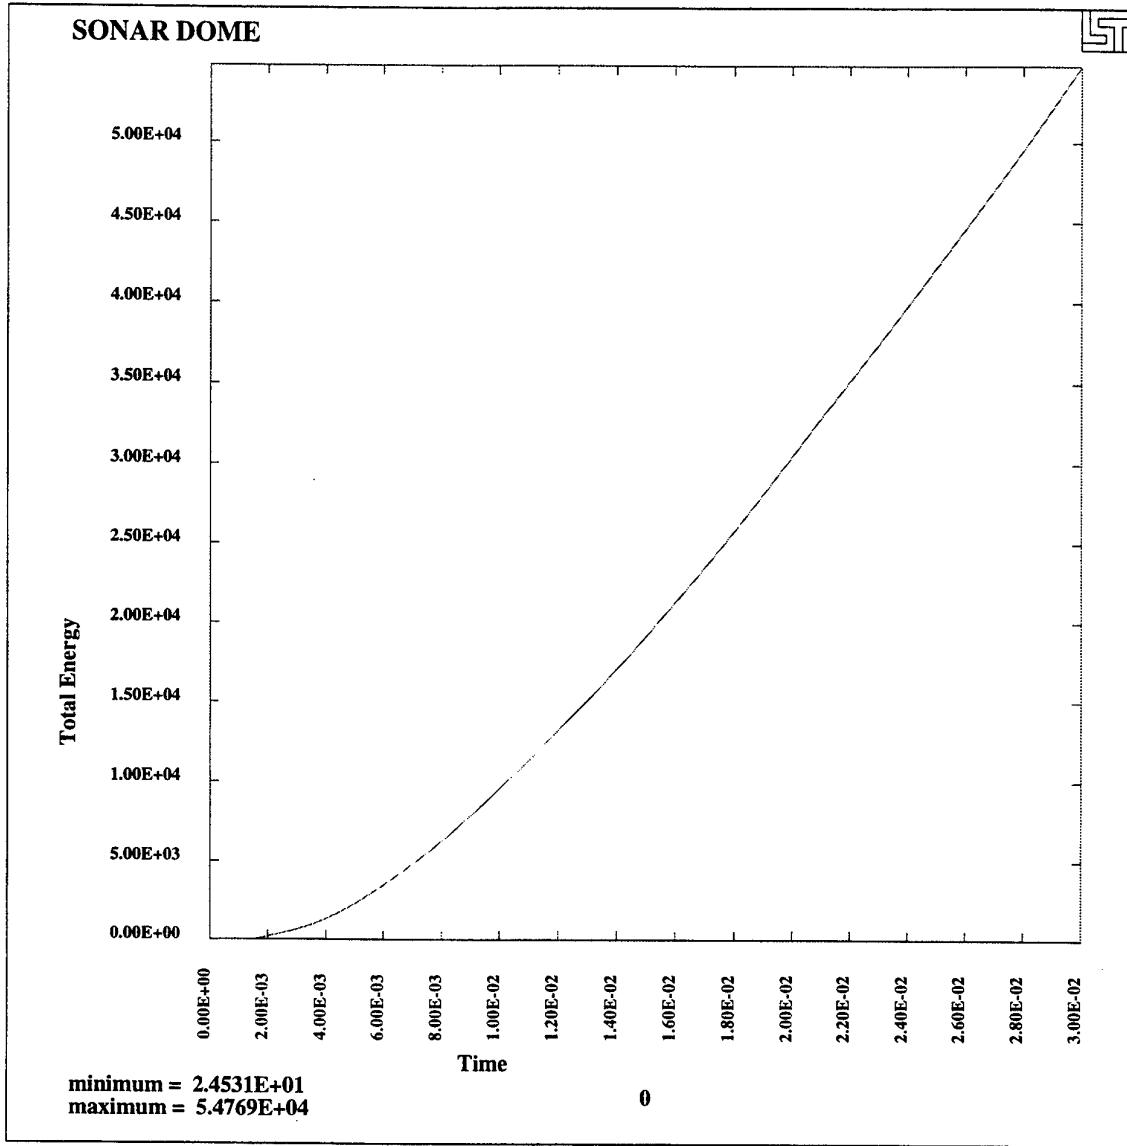
Figure 29-Figure 33 respectively show the external work, the internal energy, the kinetic energy, the hourglass energy and the total energy of the dome as a function of time. The total energy is equal to the sum of the internal energy, the kinetic energy and the hourglass energy. Note that the external work should be equal to and in fact equals the total energy. Note further that at  $t=0.03\text{s}$  the kinetic energy is about 5% of the total energy and the hourglass energy is about 2% of the total energy. This means that 93% of the external work is transformed in deformation (internal) energy (=summation of elastic and plastic energy). The deformation energy is 32.5 kJ for  $t = 0.02 \text{ s}$  and 51 kJ for  $t = 0.03 \text{ s}$ . At this point we remind the reader that the approach we used to calculate the tangential stiffness is conservative: the actual tangential stiffness could be considerably higher (see page 6). In the latter case the deformation energy will also be higher, maybe even up to 25%.

At  $t = 0.03 \text{ s}$  the internal energy seems to increase almost linearly.

Figure 29 External work [J] versus time [s]

Figure 30 Internal energy [J] versus time [s]

Figure 31 Kinetic energy [J] versus time [s]

Figure 32 Hourglass energy [J] versus time [s]

Figure 33 Total energy [J] versus time [s]
