# Three-Dimensional Breakwater Stability Tests at Vale de Cavaleiros, Cape Verde

Technical Report CHL-98-22  
July 1998

Final report

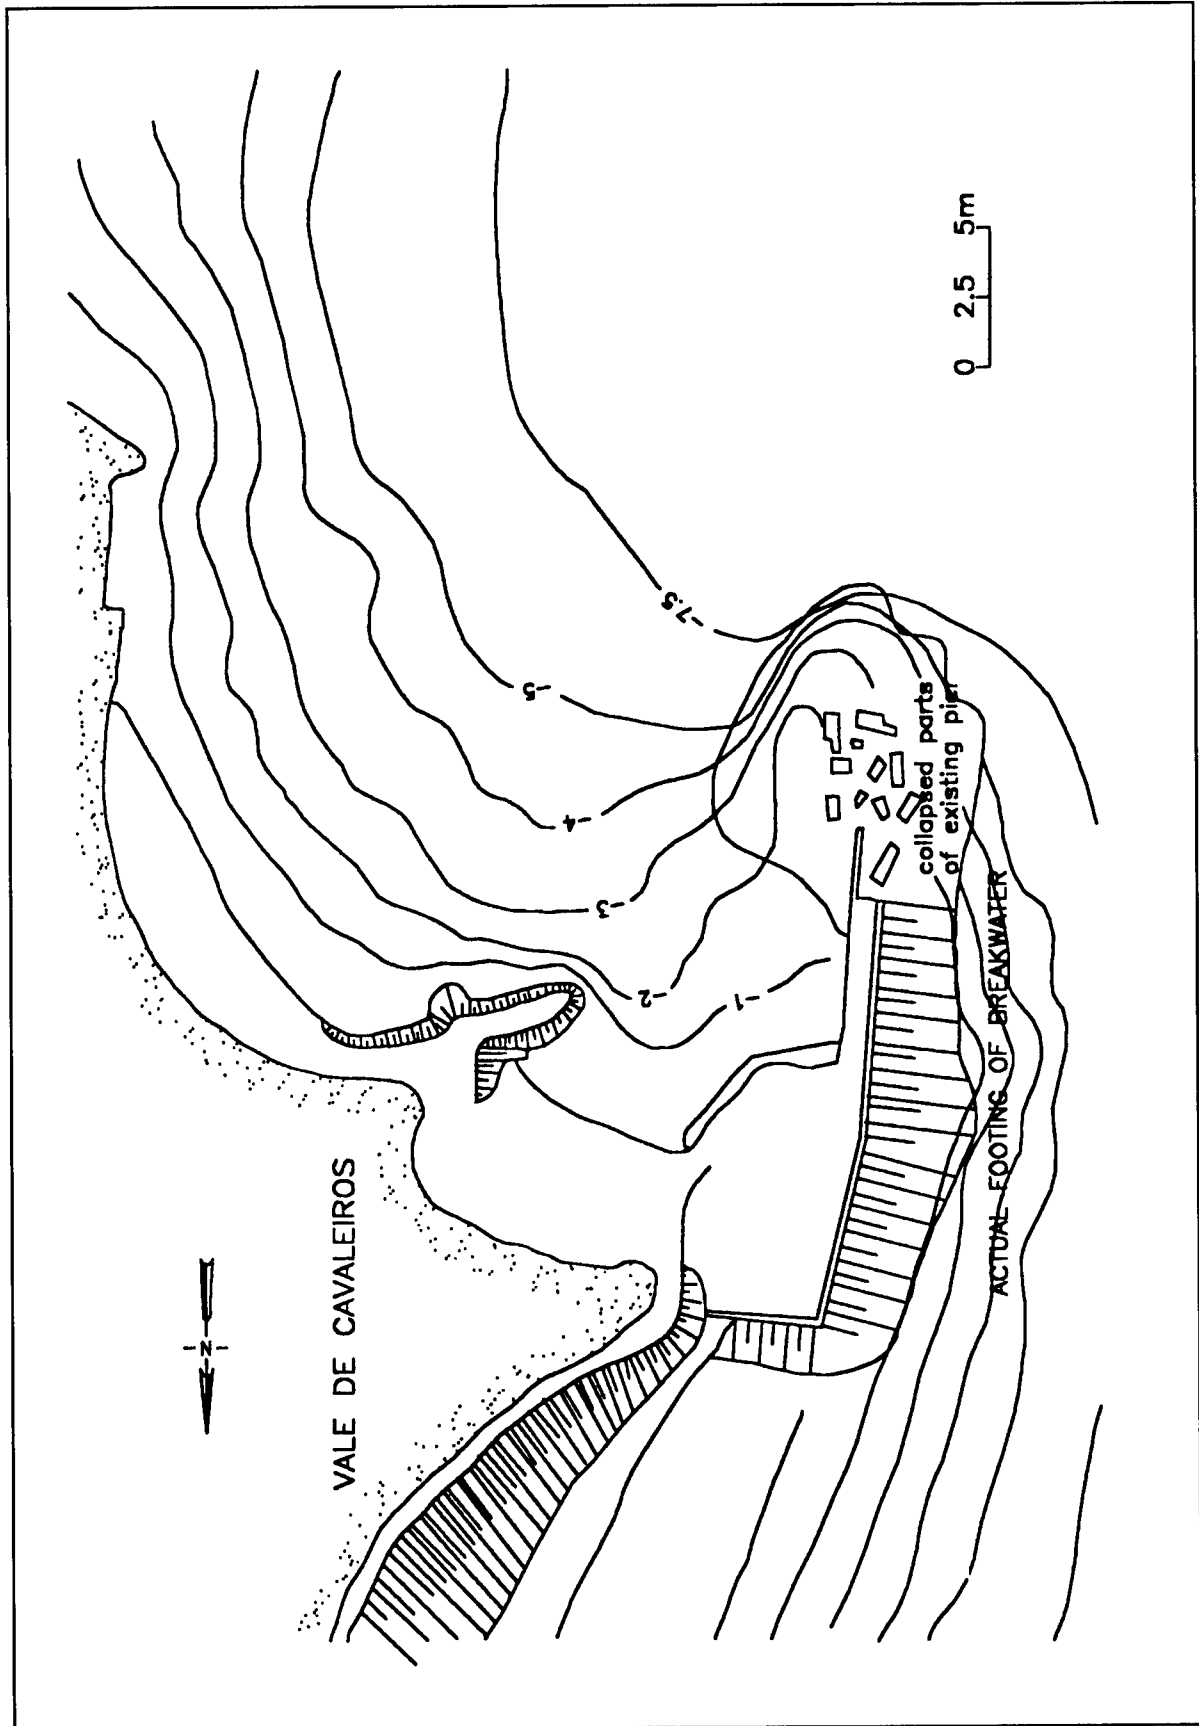
Figure 3. Existing site location map

The existing main breakwater is shown in Figures 3 and 4, with the layout view in Figure 4 dividing the breakwater into seven profiles. The porous breakwater consists of a traditional rubble mound fronting a recurved seawall. The crest elevation of the seawall is +8.15 m CD (CD refers to the lowest theoretical chart datum) while the crest elevation of the 6.25-tonne-tetrapod armor layer is approximately +7 m CD. The head of the breakwater was virtually destroyed by storms over 25 years and its remnants are completely submerged. The remaining tetrapod-armored trunk section extends south for approximately 180 m from Profile 1 (Figure 4). The existing tetrapod section extends down to approximately 0 m CD.

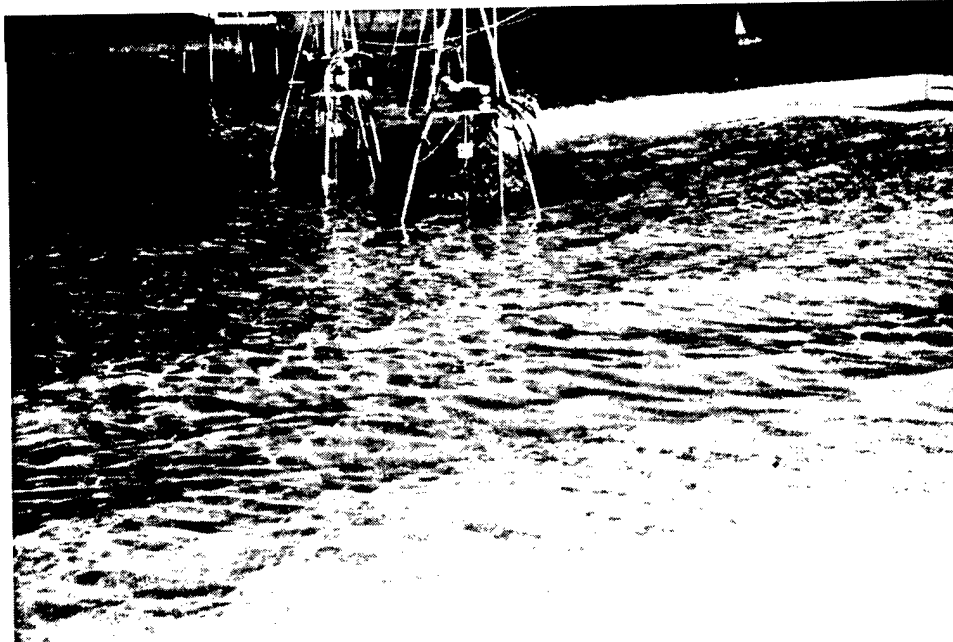
Figure 5. Three-dimensional stability model

Experiments were conducted in a 29.3-m-long, 29.6-m-wide, 1.5-m-deep wave basin. The model was constructed and molded of concrete to represent approximately 825 m of shoreline encompassing the harbor and breakwater location. Contours were molded to -20 m CD, and a 1V on 5H transition slope was molded from the -20-m contour to the model floor elevation of -21.3 m CD. Wave absorber was placed around the perimeter of the basin to minimize the effects of reflection. A photograph of the model is shown in Figure 5.

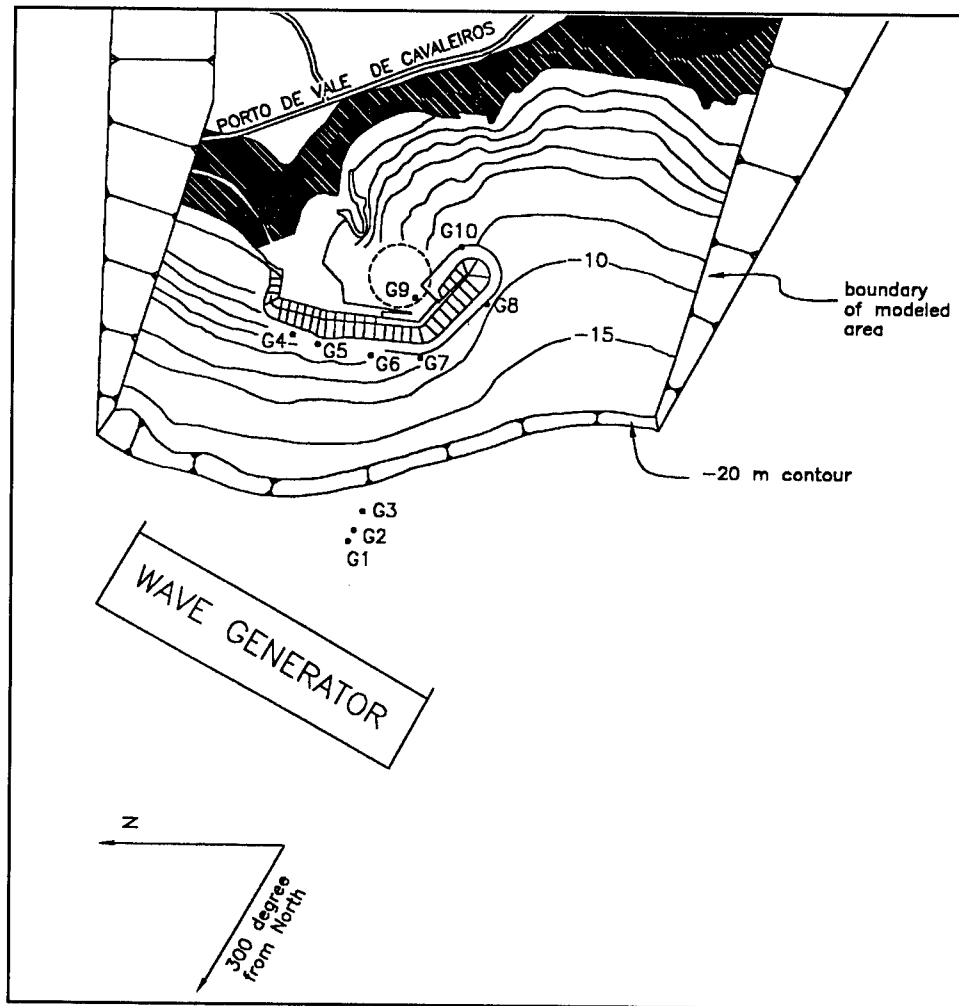
Figure 6. Three-dimensional model boundaries and wave gauge locations

calculation of incident and reflected wave heights by Goda and Suzuki (1976). The remaining gauges were placed at locations around the breakwater shown in Figure 6. Data obtained from the gauges were analyzed using the Time Series Analysis (TSA) computer program of Long and Ward (1987). Operations performed on wave data from individual gauges were mean down-crossing analysis to obtain significant wave height  $H_s$ , maximum and average wave heights, significant and average wave periods, and mean water levels at each gauge. Operations performed on the wave gauge array were unidirectional spectral density incident/reflection analysis to determine peak wave period  $T_p$ , and incident and reflected wave heights at the gauge array. Following calibration of the basin, Gauges 4 and 5 were removed and used in locations 9 and 10 during stability tests.

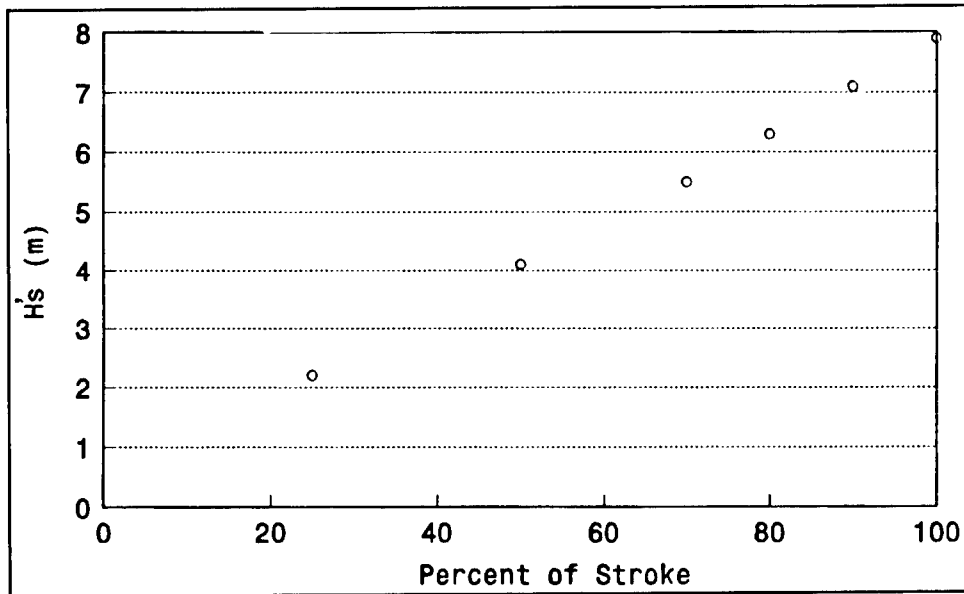
Figure 7.  $H_s'$  at -21.3 m CD versus generator stroke, 13-sec waves

Incident significant wave height  $H_s$ , obtained from Gauges 1 through 3 during calibration is plotted versus percent of generator stroke in Figures 7 through 9.

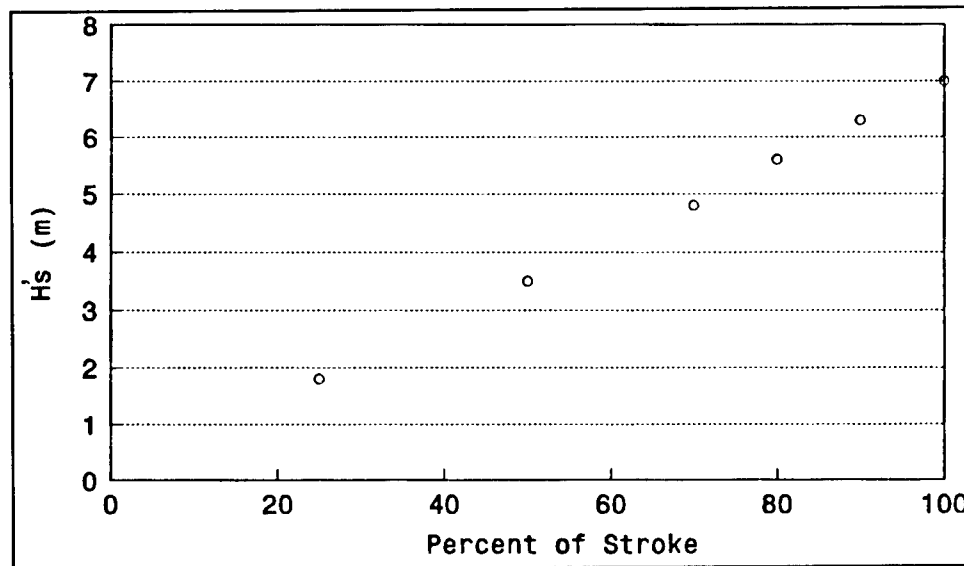
Figure 8.  $H_s'$  at -21.3 m CD versus generator stroke, 16-sec waves

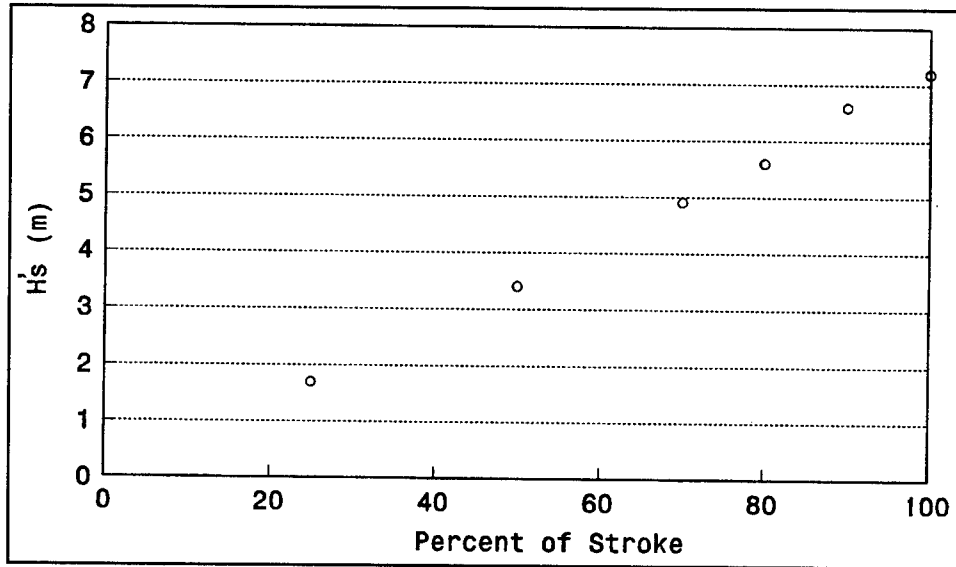
Figure 9.  $H_s'$  at -21.3 m CD versus generator stroke, 19-sec waves

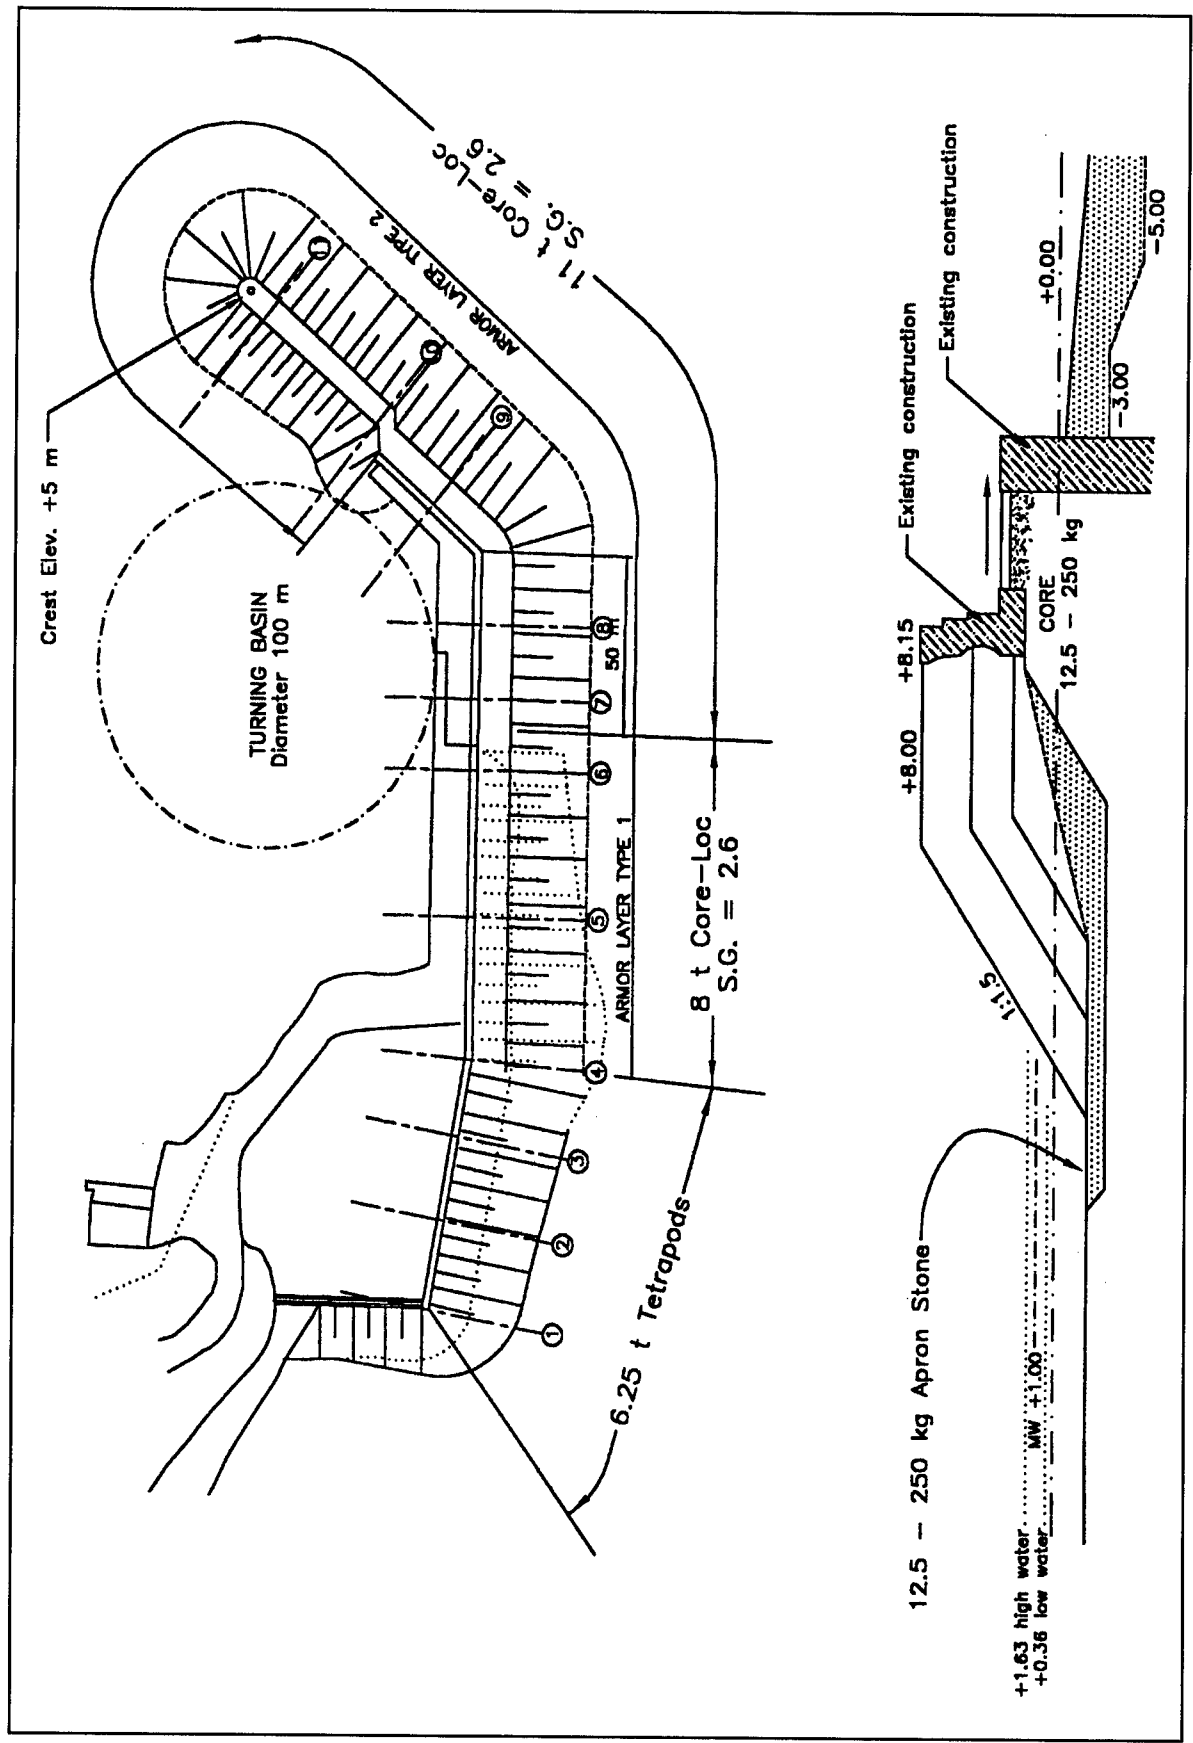
15 Figure 10. Elements of plan 1

Plan 1, the initial plan (Figure 10, Photos A1 through A3), consisted of 6.25-tonne tetrapods from the shoreward end of the breakwater to Profile 4; 8-tonne Core-Locs from Profile 4 to a point between Profiles 6 and 7 (a total reach of approximately 92 m); and 11-tonne Core-Locs on the remainder of the seaward trunk, around the head and terminating at the quay wall on the leeward side of the structure. For this plan, packing densities of the 8- and 11-tonne Core-Loc reaches were 0.55 and 0.59, respectively. The crest elevation of the head section was +5 m CD. Plan 1 was subjected to “shakedown” waves (13 sec, 3 m) to settle and nestle the armor units. During the wave series, apron material was displaced between Profiles 4 and 9, and Core-Locs were displaced at the toe near Profile 4 (Photos A4 through A6). The structure was subjected to 3.7-m waves for 13- and 16-sec periods, which caused additional toe unit displacement at Profile 4 and at the elbow near Profile 8.

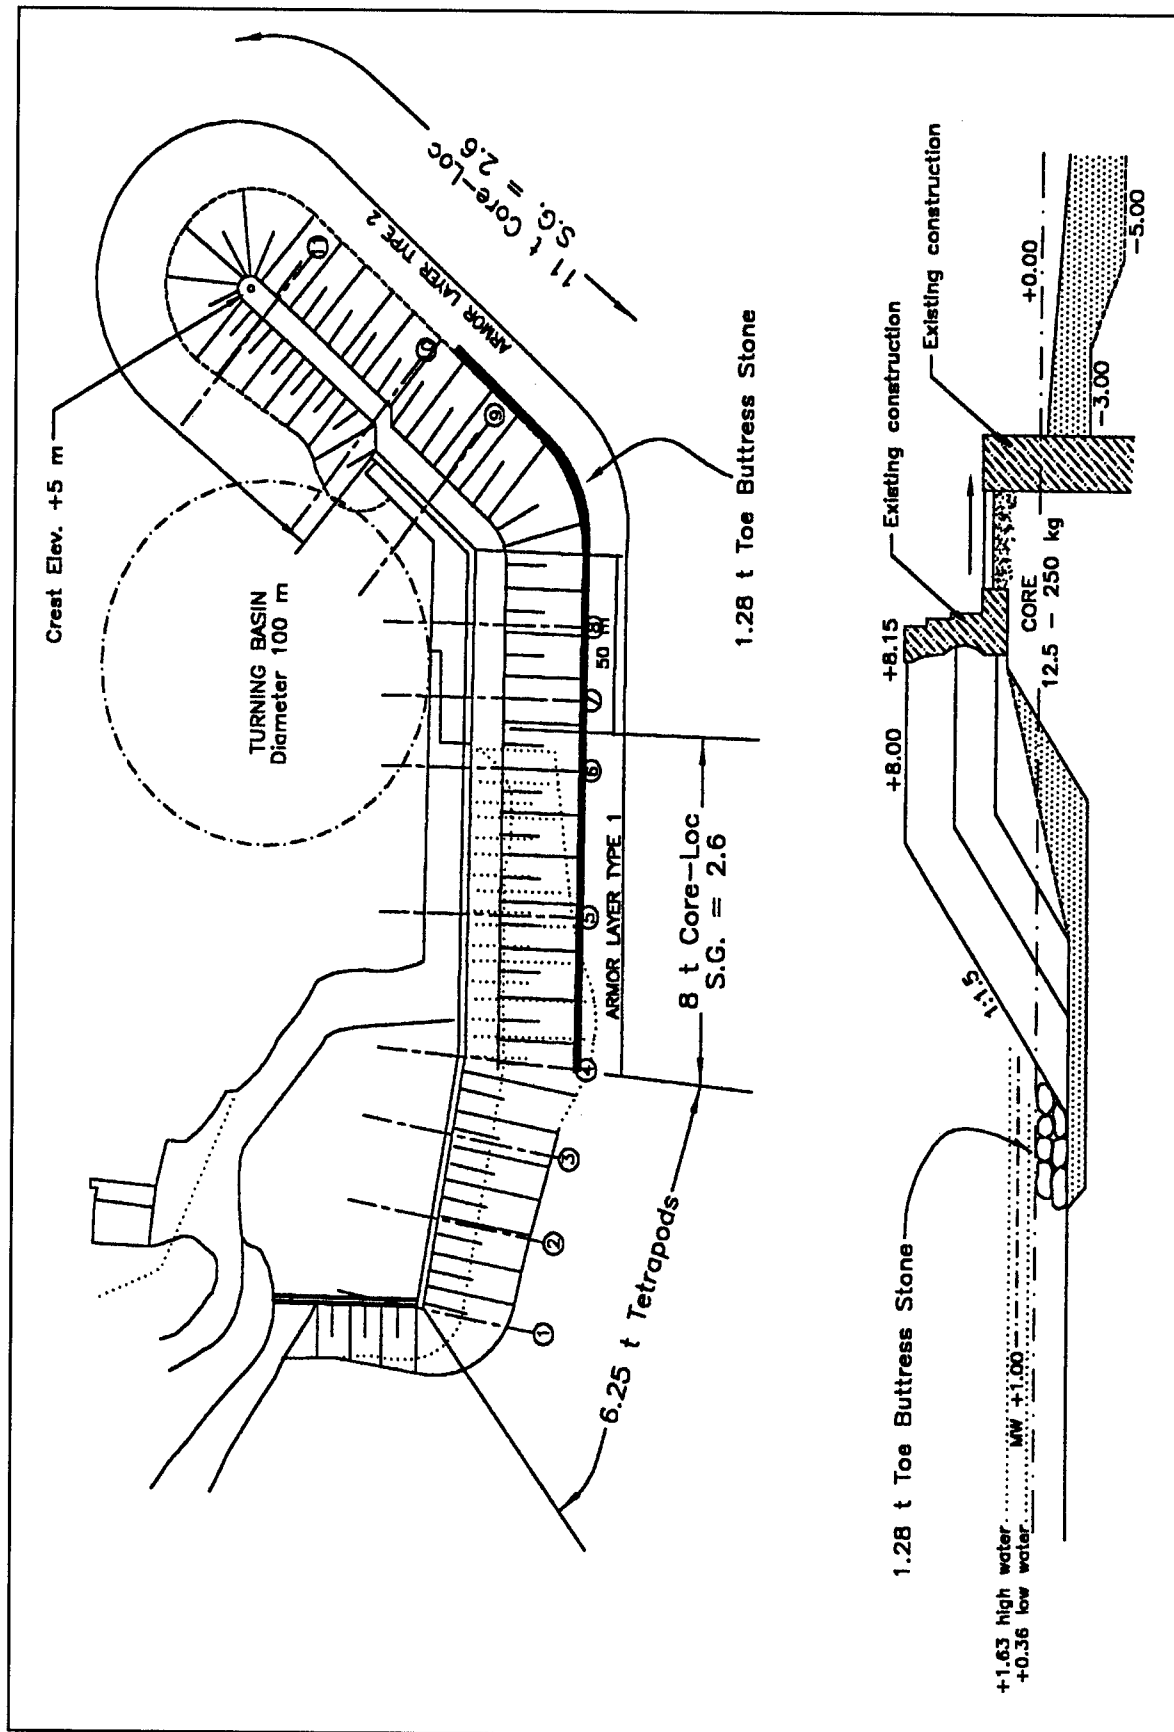
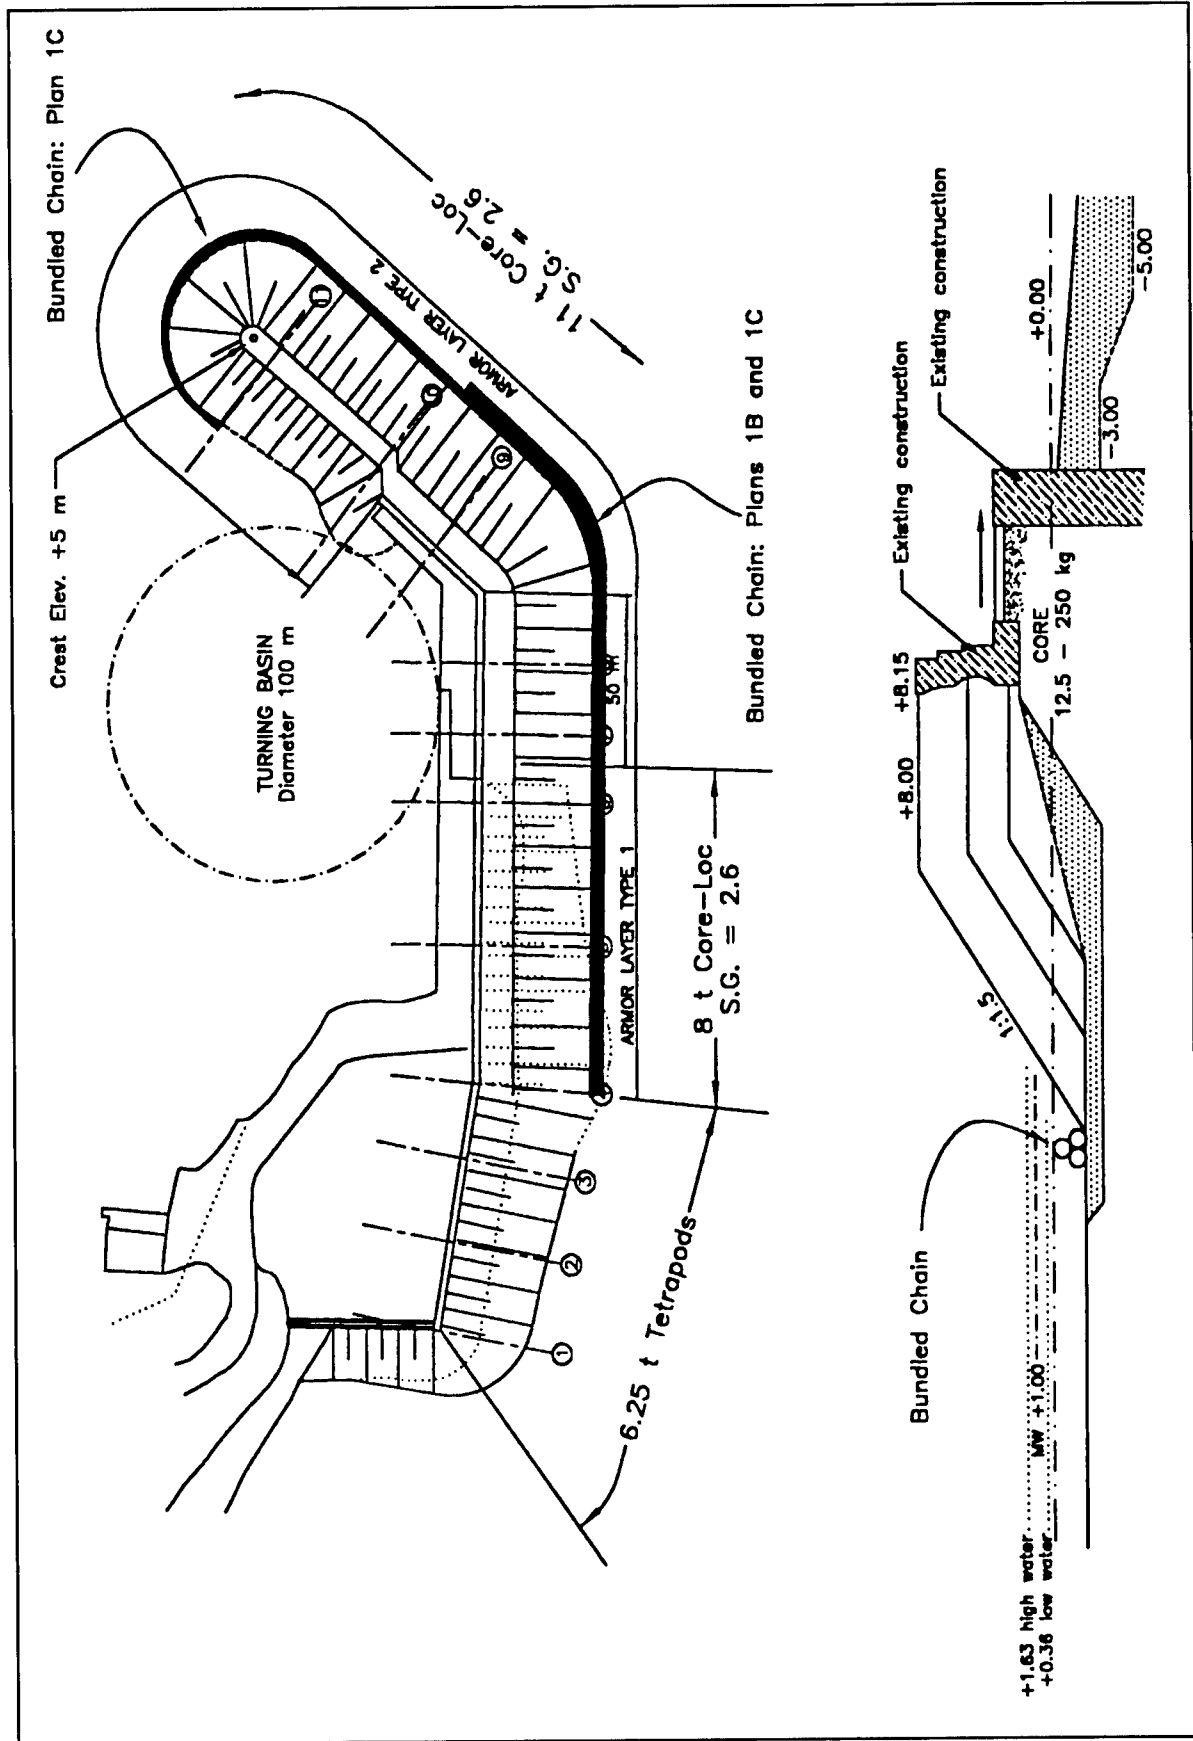
Figure 12. Elements of plans 1B and 1C

Plan 1B was identical to Plan 1 except three widths of bundled steel chain were placed along the toe from Profile 4 to the elbow (Figure 12). A single chain was placed at the toe at the elbow to the terminus of the quay wall. Additionally, a single chain was placed around the toe of the tetrapod section. The purpose of the chain was to stabilize the toe to observe the stability of upslope units. Rebuilding of the 8-tonne Core-Loc section resulted in  $\phi = 0.60$ . The addition of the chain stabilized the Core-Locs at the toe; however, wave energy also displaced the chain and it was necessary to reposition the chain between wave series. The armor layer loosened between Profiles 4 and 5, and apron material was displaced for wave conditions up to 17-sec, 5.2-m, but the section remained stable (Photo A13). During the 17-sec, 5.2-m condition, 11-tonne units at the toe near Profile 10, which was unprotected by the chain, were removed by waves, causing the upper units in this area to be displaced. A hole developed in the armor layer near the crown at Profile 10, which increased in size and migrated “north” along the structure (Photos A14 through A16). Additionally, green water overtopping was observed over the +5-m CD breakwater section for waves 3.7 m in height and greater. The severe breaking condition migrated to deeper water as peak period and/or wave height increased.

Plan 1C was the same as Plan 1B except three widths of steel chain were included along the toe from Profile 4 to the leeward side of Profile 11 for Plan 1C (Figure 12). In addition, the chain was anchored to the breakwater at approximately 8-m (prototype) intervals using pins inserted under the structure. The breakwater was rebuilt prior to experiments and the resulting packing densities for the 8- and 11-tonne Core-Locs were 0.62 and 0.59, respectively. The structure was stable for waves up to 6.7 m, but it was observed that the armor layer loosened in areas between chain anchors. During 16-sec, 6.7-m waves, one

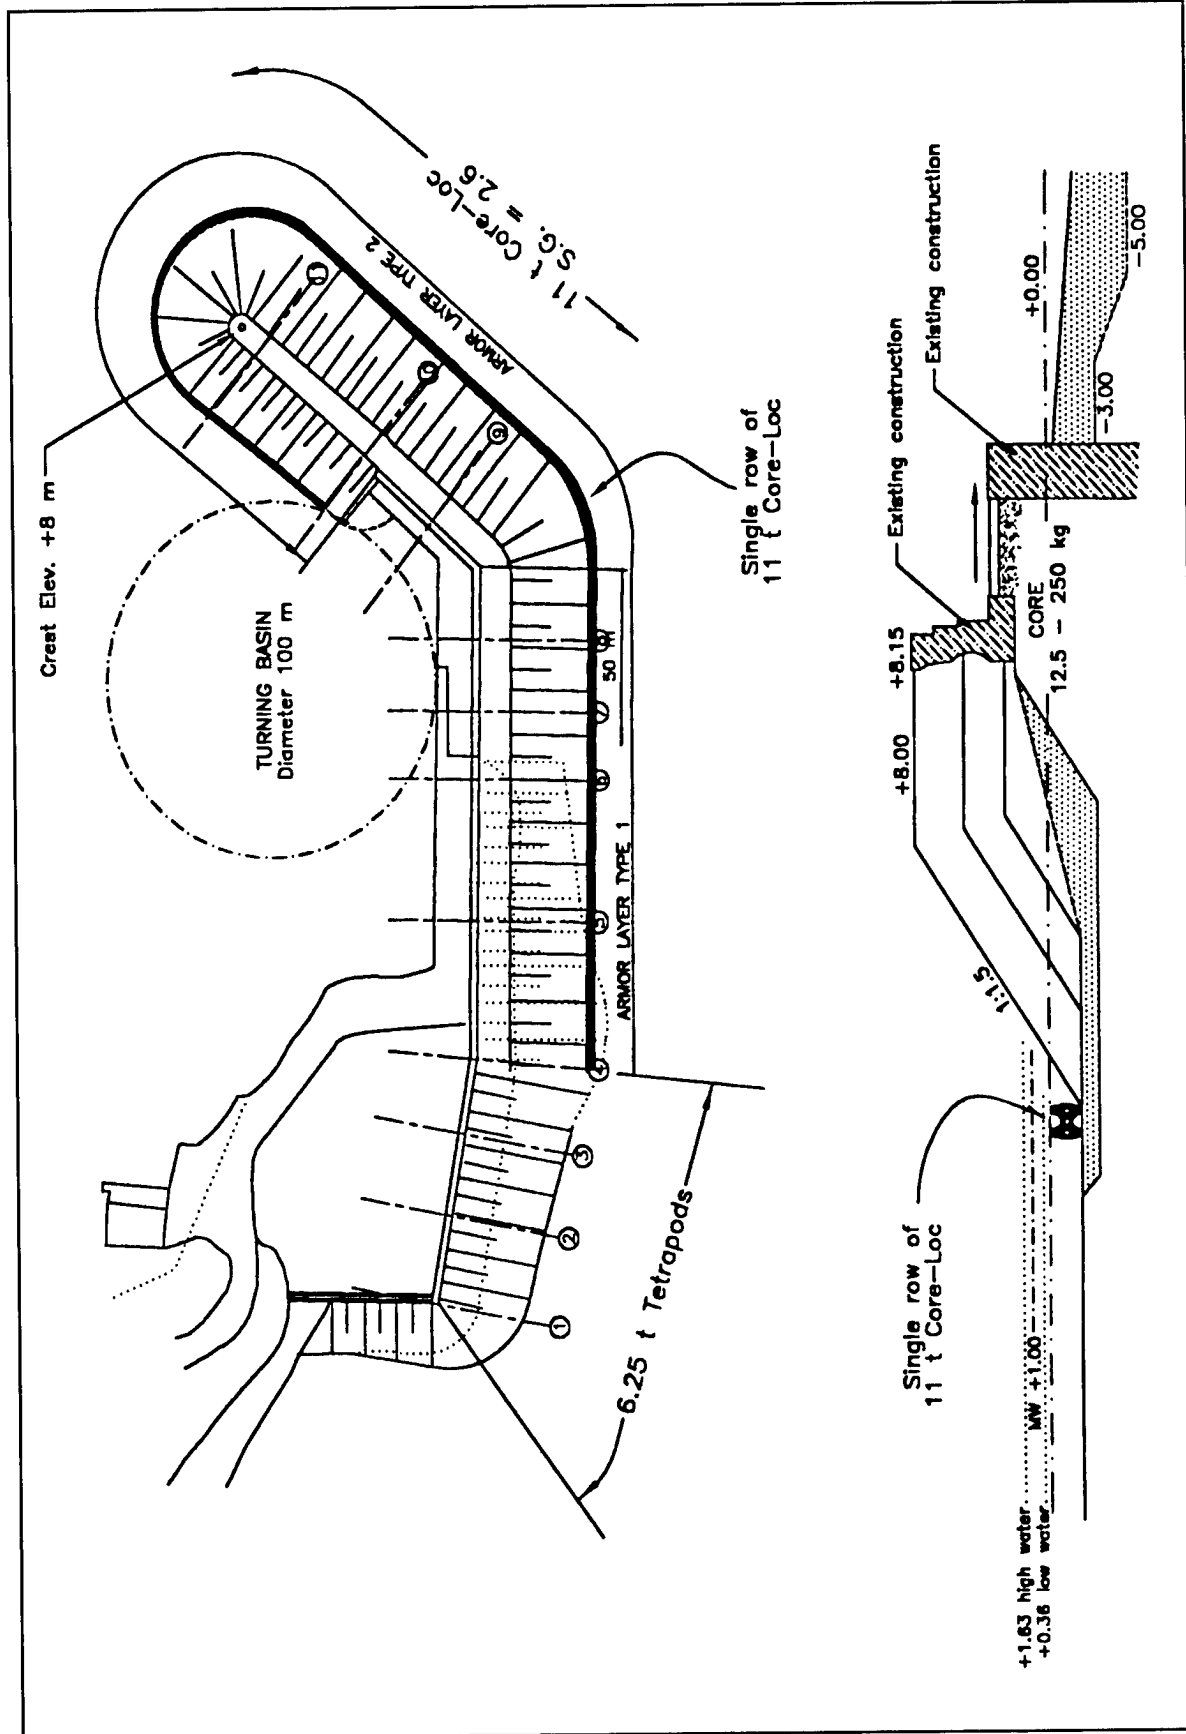
Figure 13. Elements of plan 2

Based on observations of the model and conversations with JV RRI-BCEOM personnel Messrs. A. Merrien and L. Fischer, Plan 2 consisted of raising the +5-m head portion of the breakwater to bring the entire structure to +8 m to reduce overtopping. The 8-tonne units were replaced with 11-tonne Core-Locs and the toe was reinforced with additional 11-tonne units placed in a single row (Figure 13). The packing density of the 11-tonne Core-Locs was 0.62. Toe protection units were placed 90 deg to the toe units of the structure in a manner in which adjacent units interlocked (Photos A23 through A25). The 11-tonne Core-Locs used for toe protection were displaced during 13- and 16-sec, 3.7-m waves, and the armor layer failed due to toe instability (Photos A26 and A27).

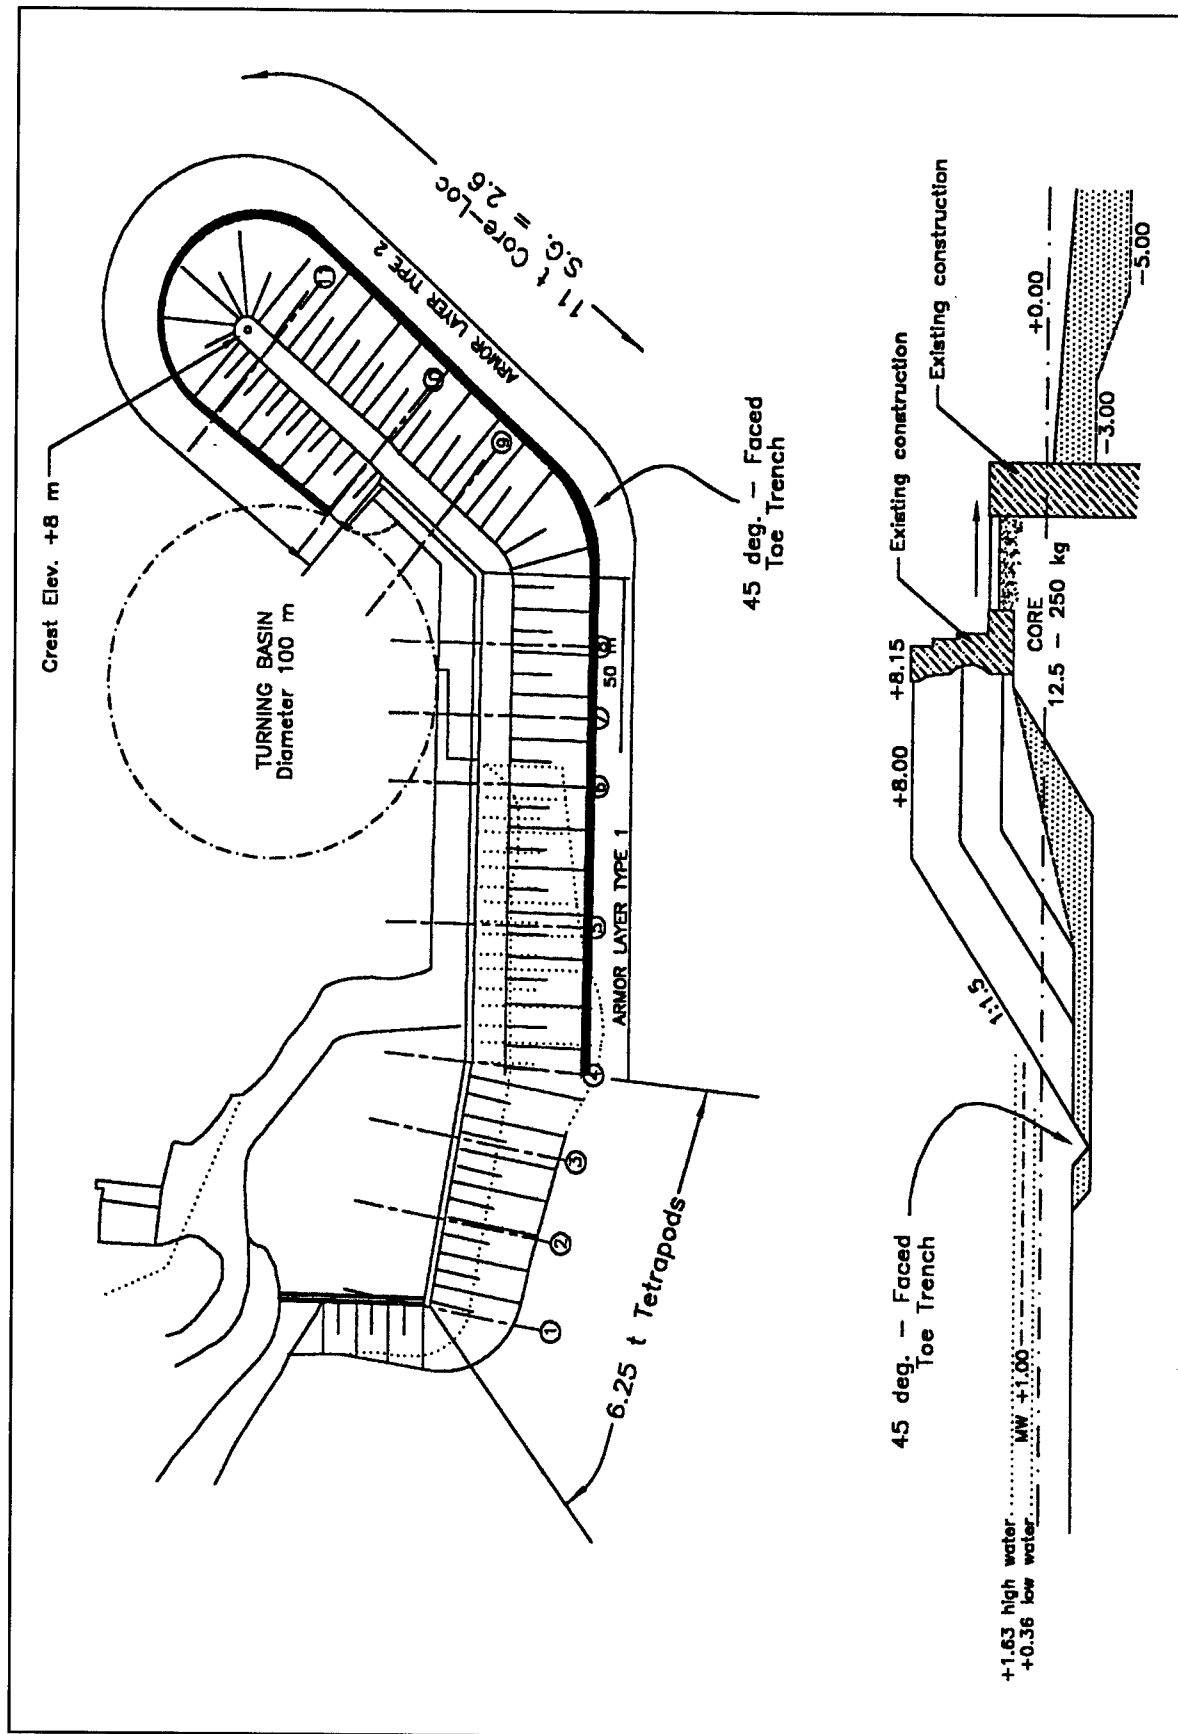
21 Figure 14. Elements of plan 2A

Plan 2A was the same as Plan 2 except the single row of 11-tonne Core-Locs was replaced with a wood board anchored to the floor around the entire Core-Loc armor layer to act as an immovable toe restraint. The board simulated a toe trench 1 m deep and included a 45-deg bevel adjacent to the toe unit (Figure 14). The plan consisted entirely of 11-tonne Core-Locs ( $\phi = 0.61$ ) beginning at Profile 4 with a crest elevation of +8 m CD throughout the structure (Photos A28 through A30). One toe unit was displaced during 16-sec, 3.7-m waves near Profile 5, but the structure was stable for waves up to 16-sec, 5.2-m waves. During the 16-sec, 5.2-m condition, one toe unit was displaced near Profile 6, one toe unit was displaced from Profile 9, and three toe units were displaced near Profile 10. No further displacement of Core-Locs was observed for 19-sec, 5.2-m or 13-sec, 6.7-m waves; however, underlayer stone was observed to be displaced between Profiles 4 and 6 in areas of toe displacement. Additionally, the armor layer began to loosen in this area. During 16-sec, 6.7-m waves, 16 additional toe units were displaced, producing noticeable damage to the structure. Most of the armor was displaced off the structure at the elbow between Profiles 8 and 9 during 19-sec, 6.7-m waves (Photos A31 through A33).

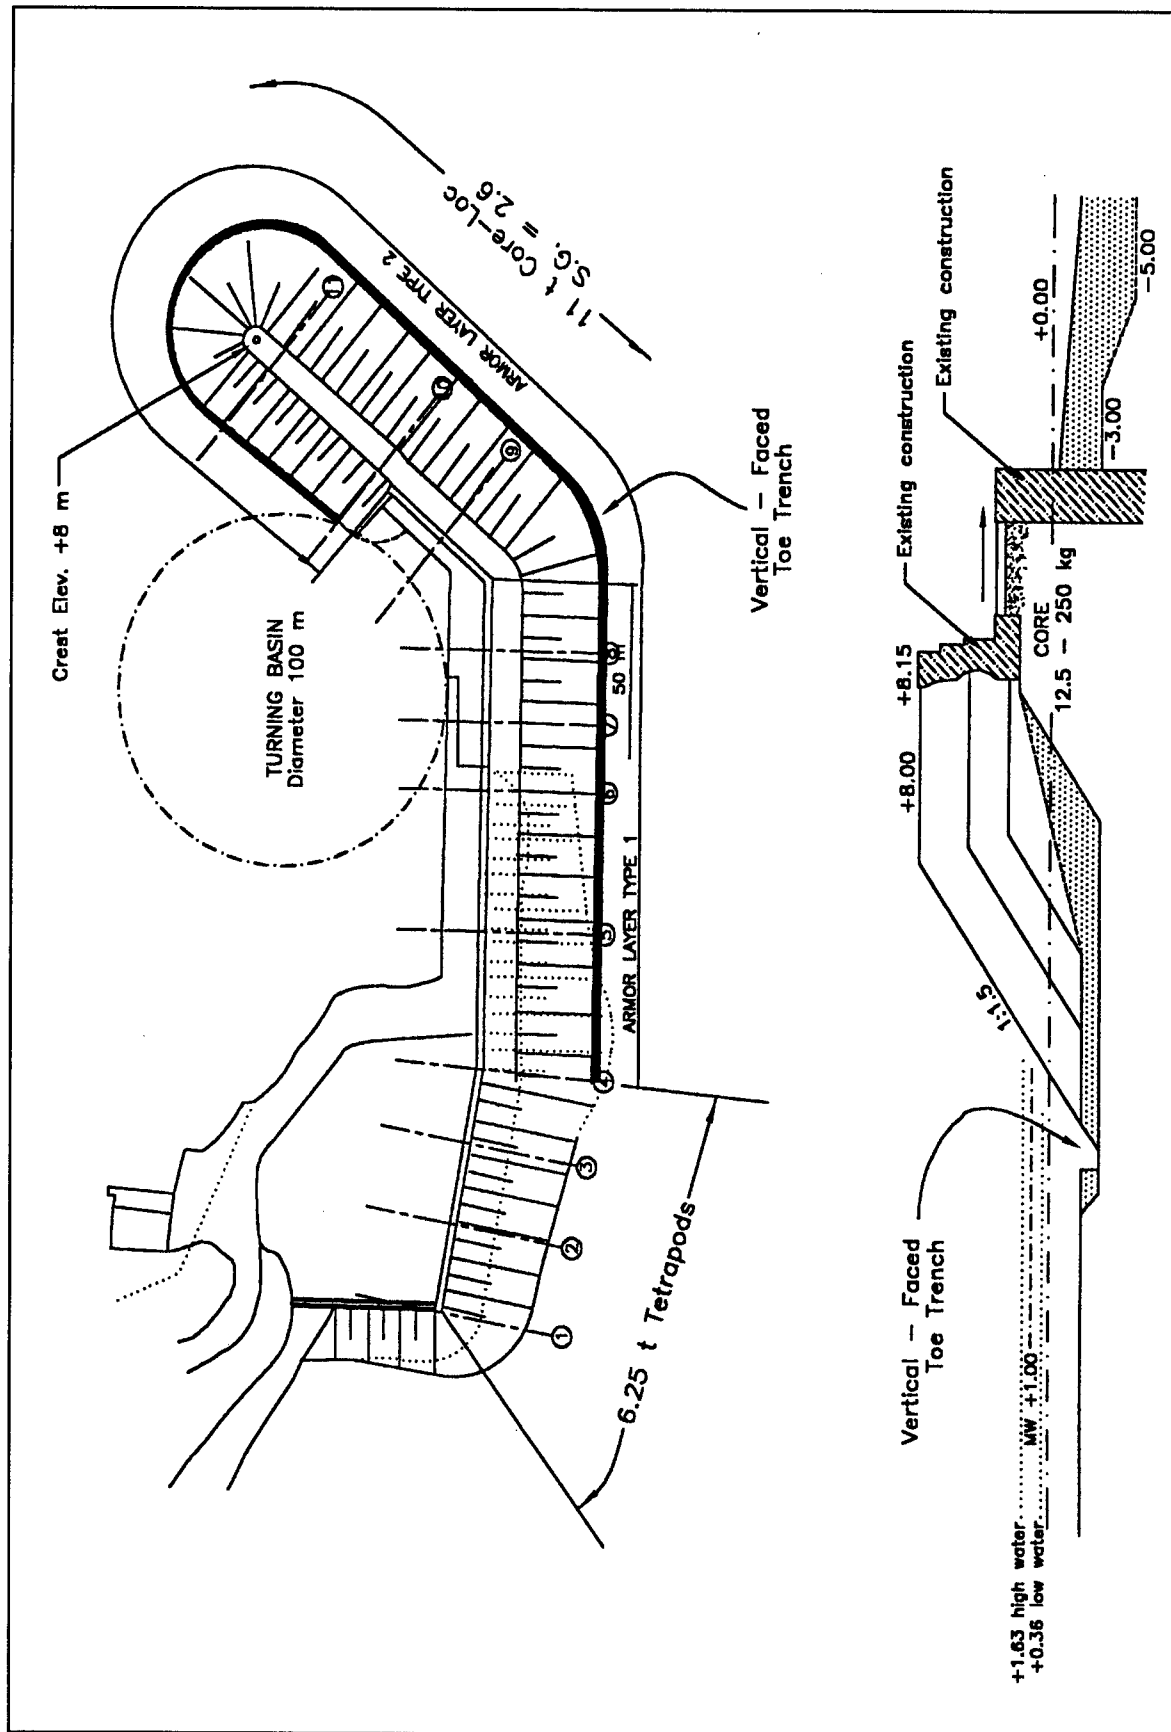
23 Figure 15. Elements of plan 2B

Plan 2B was identical to plan 2A except the toe reinforcement was constructed using a board anchored to the floor to represent a toe trench 1.5 m high with vertical sides (Figure 15). The breakwater armor was rebuilt and the packing density for the 11-tonne Core-Locs was 0.63. To expedite the study, all 3.7-m waves and the 13-sec, 5.2-m condition were omitted for this test series. From previous experiments with plans which included a restrained toe, the omitted wave conditions caused no or only minor damage to the breakwater. No units were displaced during this series (Photos A34 through A36). Plan 2B was rebuilt with the same packing density and the experiment was repeated. One Core-Loc was displaced off the head midway through 19-sec, 6.7-m waves, but the structure remained stable throughout the rest of the wave condition.

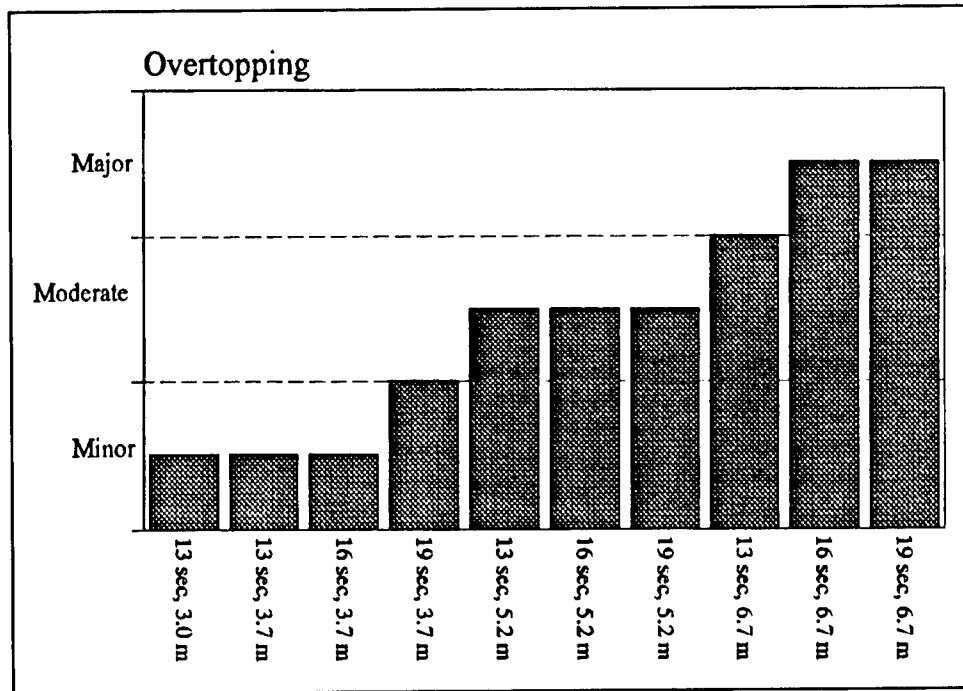
Figure 17. Wave overtopping at trunk, all plans

Overtopping was classified as minor, moderate, or major. Minor overtopping was defined for the present study as occasional or no overtopping. Moderate overtopping was defined as regular overtopping with occasional green water. Conditions that produced frequent overtopping and green water were classified as major.

The classification of overtopping (minor, moderate, or major) is plotted versus wave condition in Figures 17 through 19. The wave conditions in the figures are labeled from left to right by the sequence in which they were generated during the experiment, i.e., 13-sec, 3.0-m waves were generated first and 19-sec, 6.7-m waves were generated last. Figure 17 shows the amount of overtopping that occurred at the trunk for all plans. Major overtopping occurred at the trunk for 16-sec, 6.7-m waves, but was minor or moderate for all other conditions. Figures 18 and 19 show overtopping classifications for Plan 1 and Plan 2 series experiments at the head, respectively. The figures illustrate the reduction of overtopping by raising the crest elevation to +8 m CD (Plan 2 series) from +5 m CD (Plan 1 series).

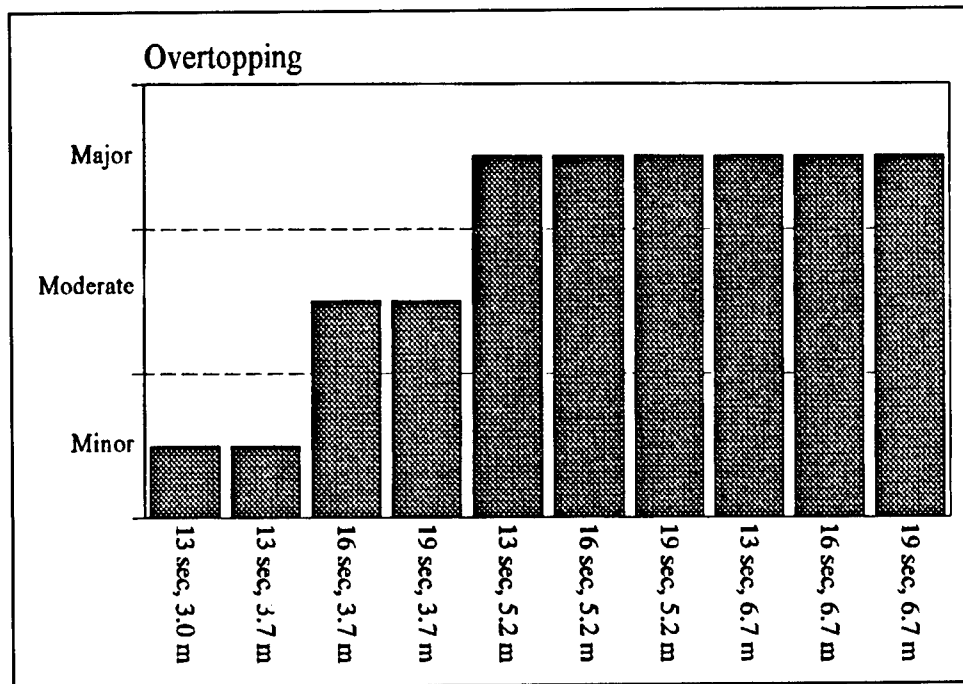
Figure 18. Wave overtopping at breakwater head, plan 1 series waves

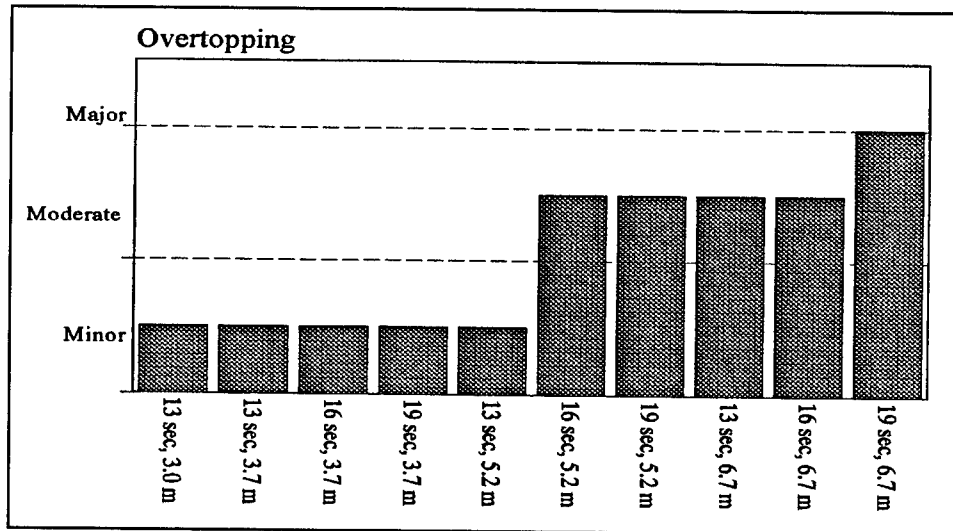
Figure 19. Wave overtopping at breakwater head, plan 2 series waves
