# Three-Dimensional Breakwater Stability Tests at Vale de Cavaleiros, Cape Verde

Technical Report CHL-98-22  
July 1998

Final report

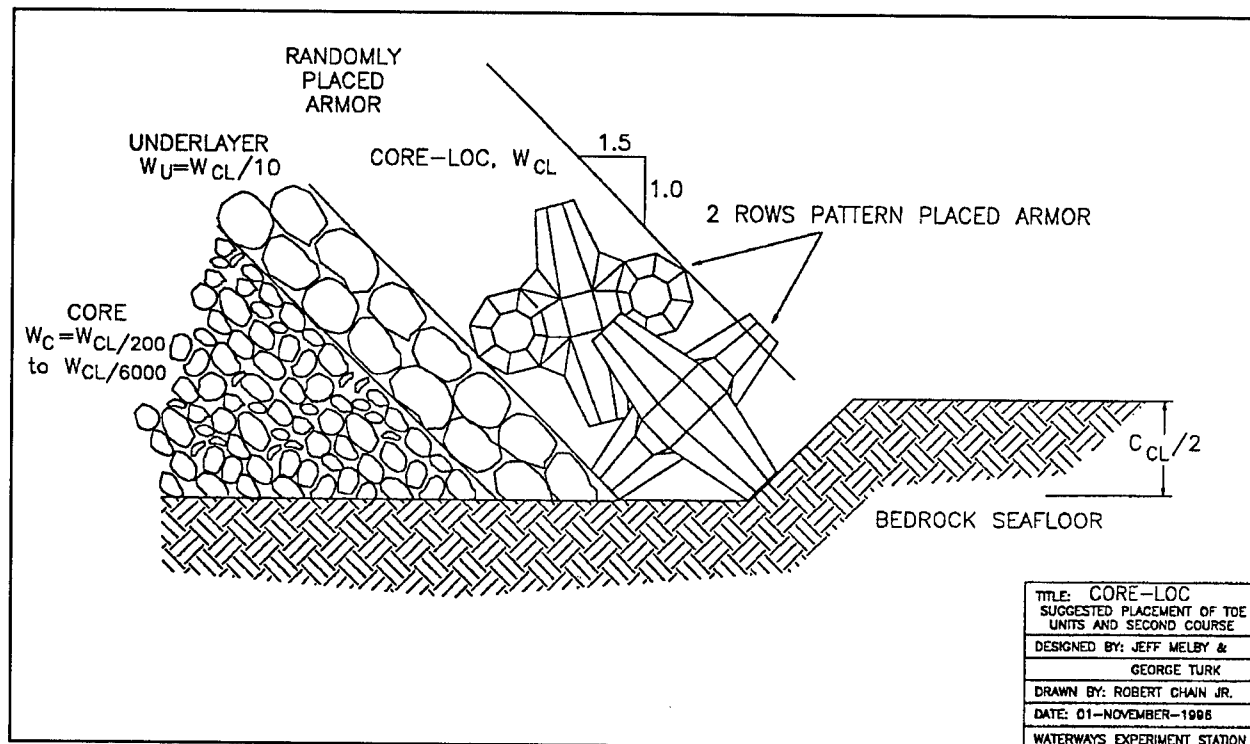
Figure 20. Example of toe trench constructed on rocky bottom

For the conditions tested in the model, the breakwater was not damaged if a stable toe trench, 1.5 m deep and near vertical, was installed. The model tests were conducted on a fixed bottom, which in nature would be analogous to a smooth rocky bottom in the prototype. An example of a prototype toe trench constructed in a rocky bottom is shown in Figure 20. The seaward face of the trench should be as near vertical as possible.

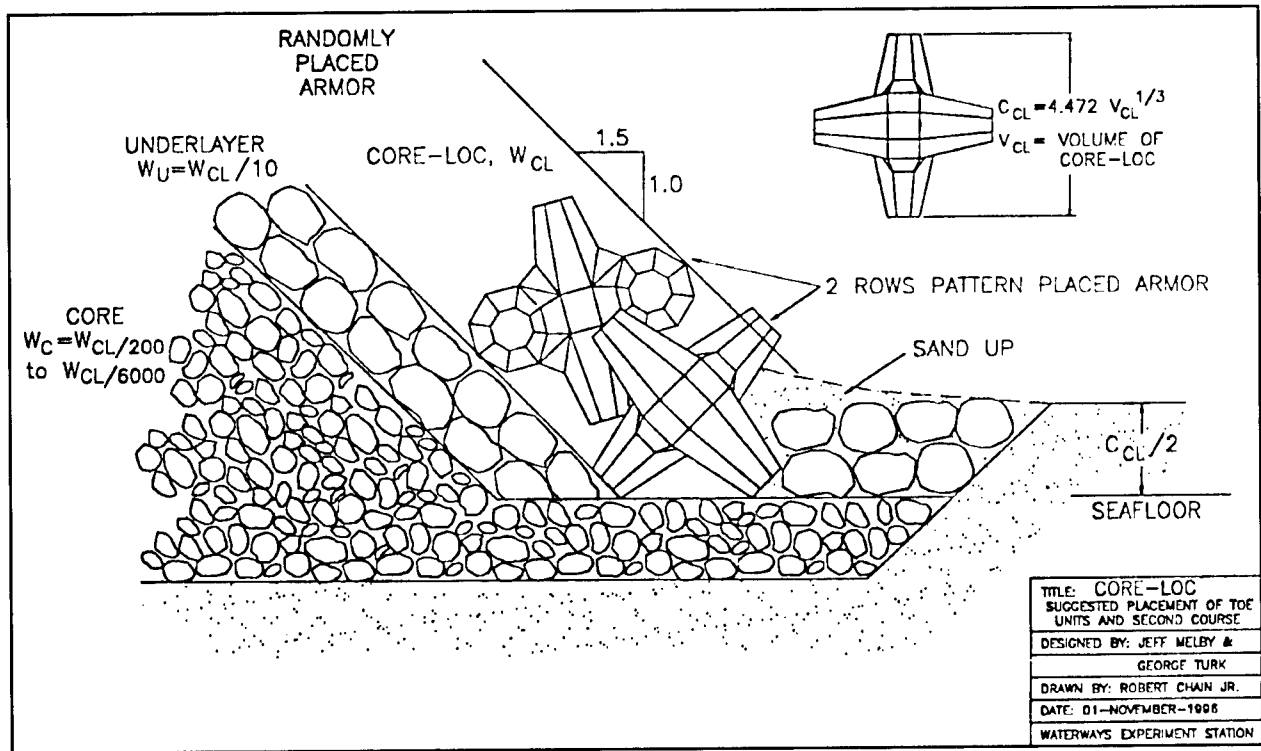
Figure 21. Example of toe trench constructed on sandy bottom

No model tests were conducted on stability with a movable bed; therefore, it was not possible to quantify the effects of a sandy bottom on the stability of the toe trench because the model floor was fixed. For structures placed in shallow water the *Shore Protection Manual* (1984) recommends a toe protection scheme similar to Figure 21, in which a wide trench is constructed and replaced with armor. The *Shore Protection Manual* suggests constructing the trench horizontally 2 times the water depth or 2 to 3 times the design wave height for the most severe scour.

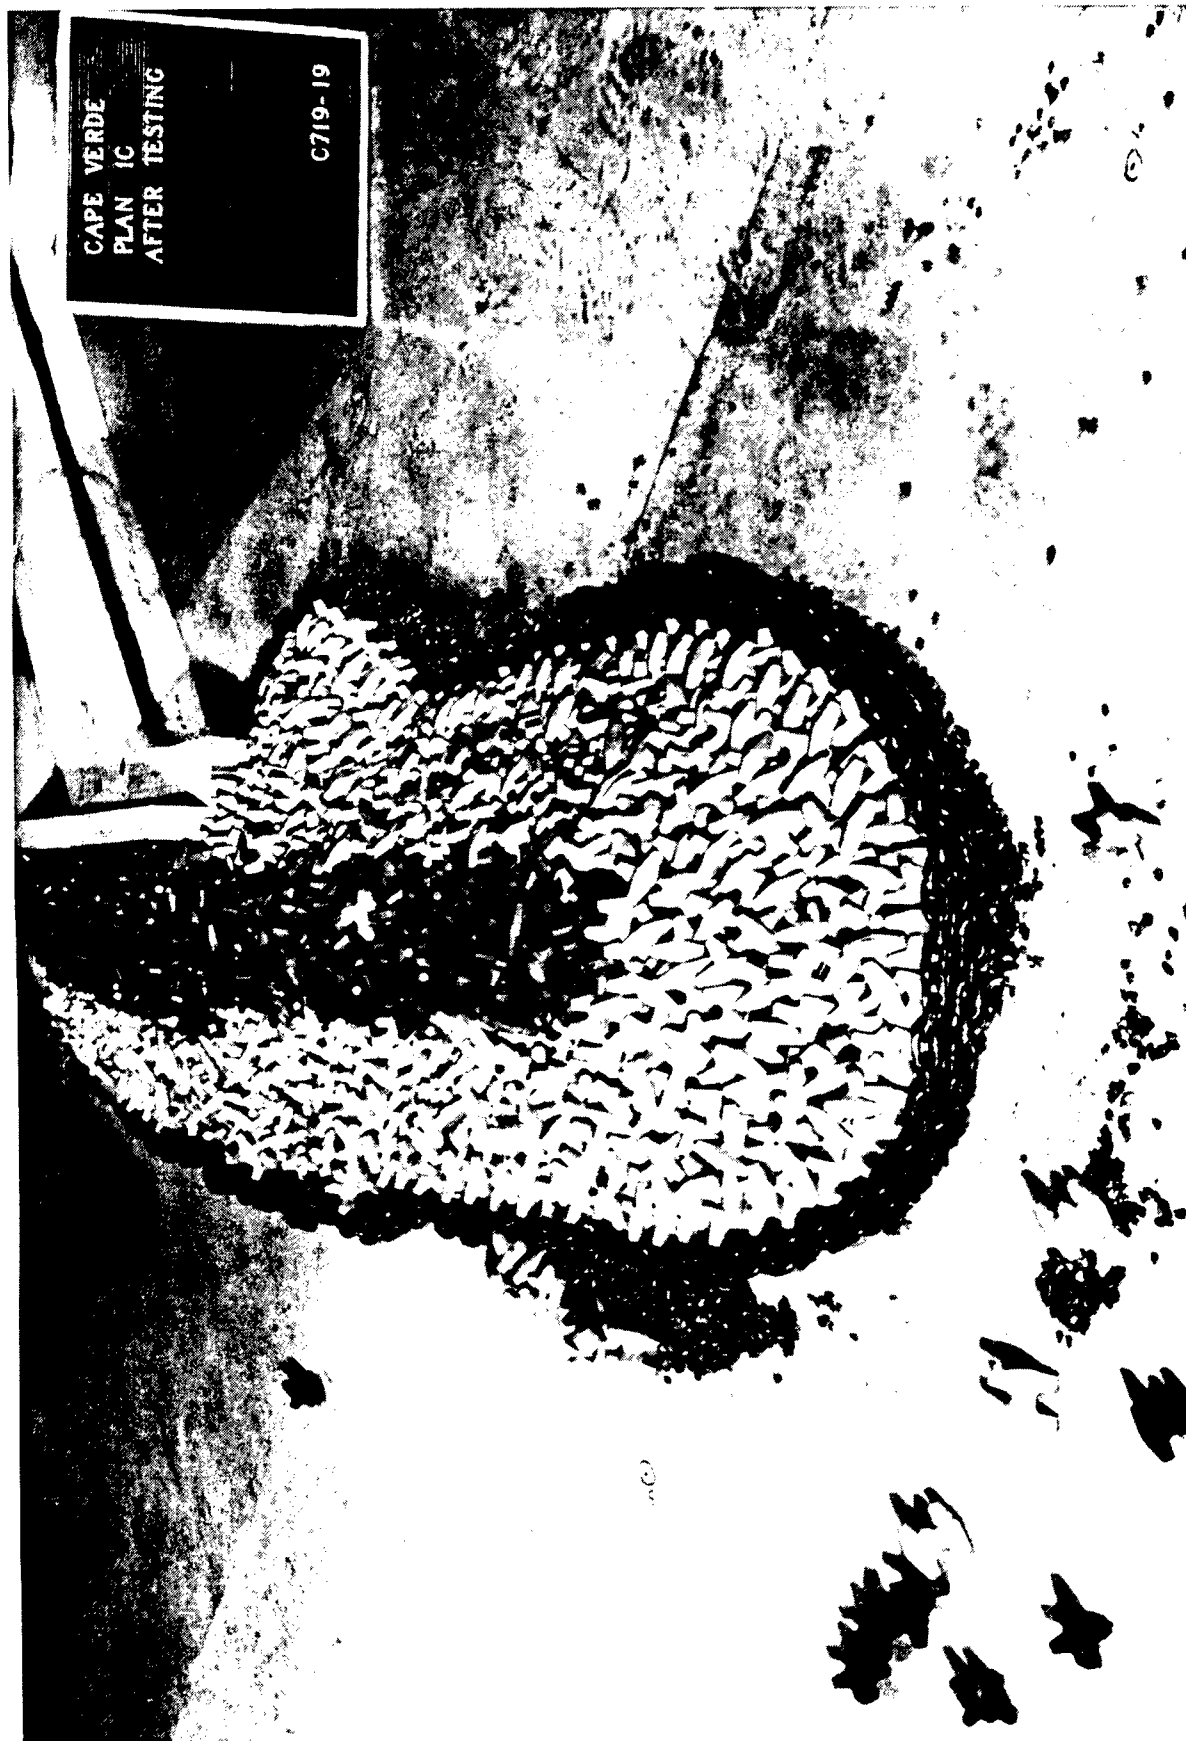
Photo A19. View of plan 1C breakwater head after testing with 19-sec, 6.7-m waves

11-tonne and three 8-tonne toe units were displaced. The toe failed near Profile 10 during 19-sec, 6.7-m waves at a location where the chain was forced seaward between anchors (Photos A17 through A19).

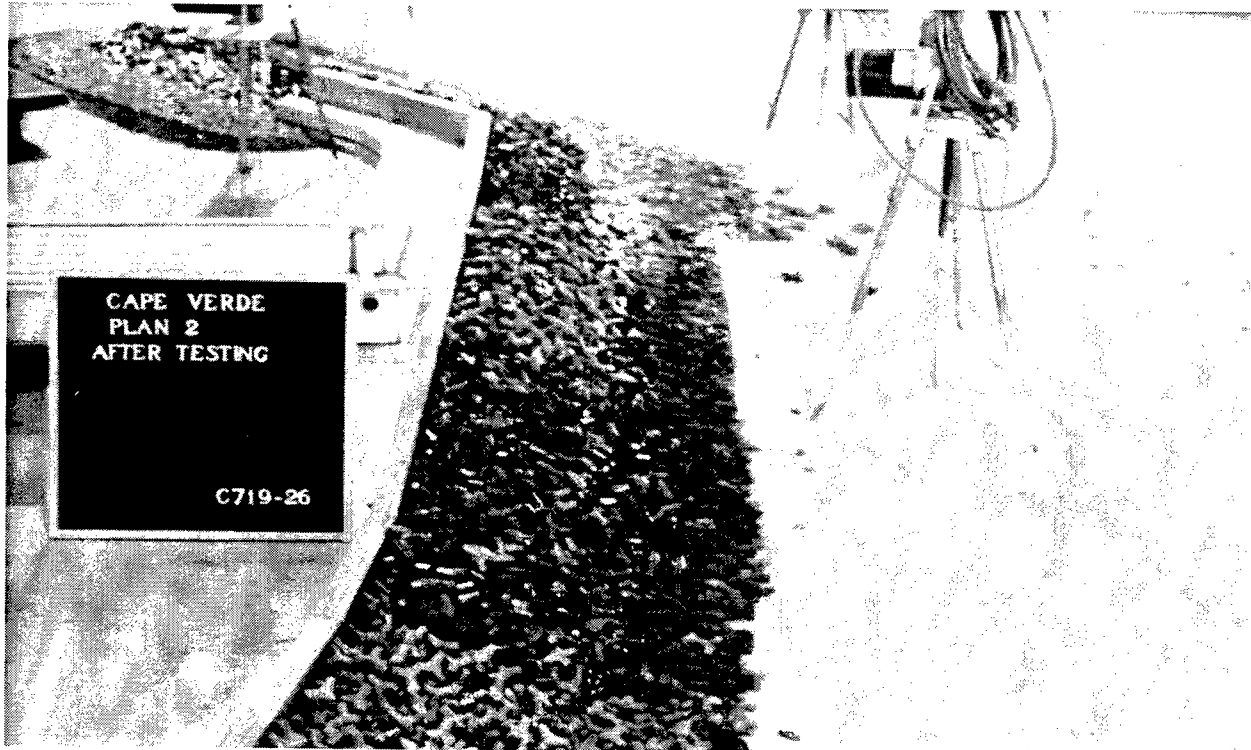
Photo A26. View from north of plan 2 breakwater trunk after testing with 13- and 16-sec, 3.7-m waves

Based on observations of the model and conversations with JV RRI-BCEOM personnel Messrs. A. Merrien and L. Fischer, Plan 2 consisted of raising the +5-m head portion of the breakwater to bring the entire structure to +8 m to reduce overtopping. The 8-tonne units were replaced with 11-tonne Core-Locs and the toe was reinforced with additional 11-tonne units placed in a single row (Figure 13). The packing density of the 11-tonne Core-Locs was 0.62. Toe protection units were placed 90 deg to the toe units of the structure in a manner in which adjacent units interlocked (Photos A23 through A25). The 11-tonne Core-Locs used for toe protection were displaced during 13- and 16-sec, 3.7-m waves, and the armor layer failed due to toe instability (Photos A26 and A27).

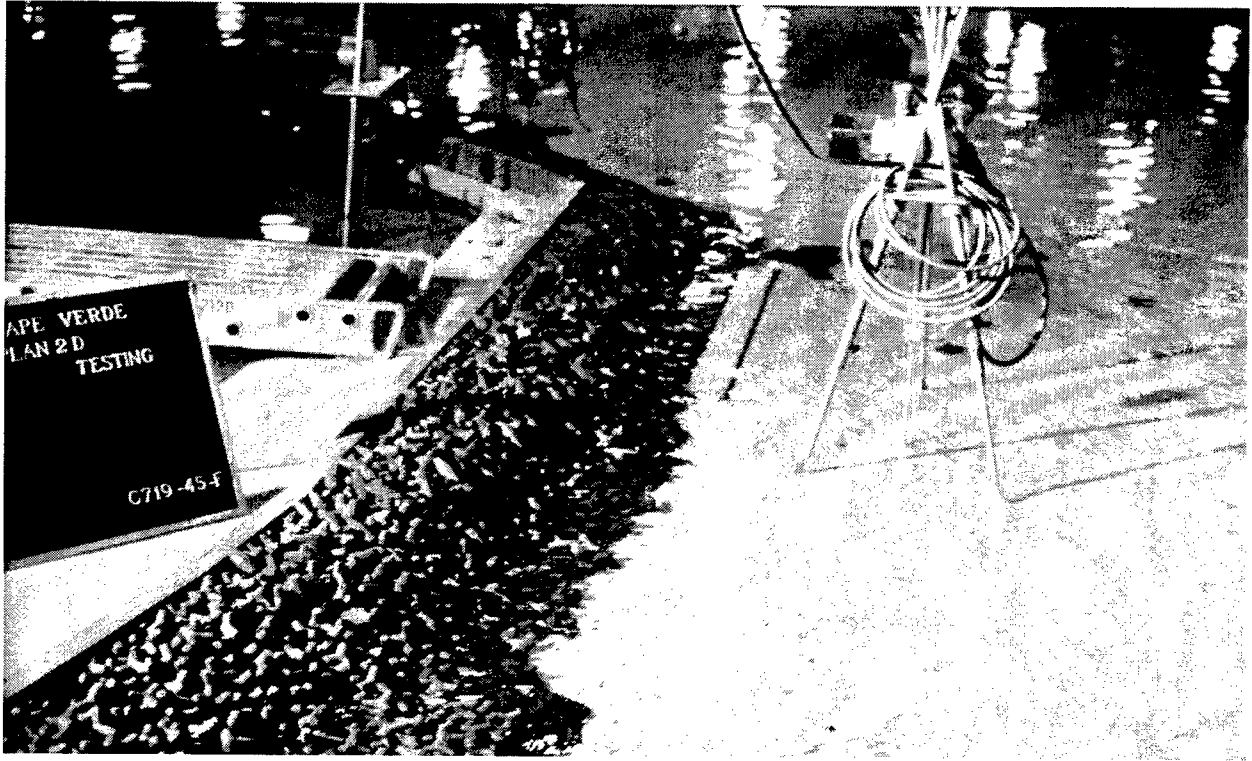
Photo A45. View from north of plan 2D breakwater trunk after testing with total sequence

Plan 2D was identical to Plan 2C except the cargo containers were placed end to end along the Core-Loc toe (Figure 16, Photos A43 and A44). The armor layer was rebuilt with a packing density of 0.62. Results were similar to experiments with Plan 2C; the containers began to displace during 13-sec, 3.0-m waves and movement continued with higher waves. Eventually, all containers were displaced from their original position and moved southward along the breakwater. Without toe protection, Core-Loc toe units were displaced and upslope

units settled causing exposure of underlayer stone between Profiles 4 and 5 (Photos A45 and A46).

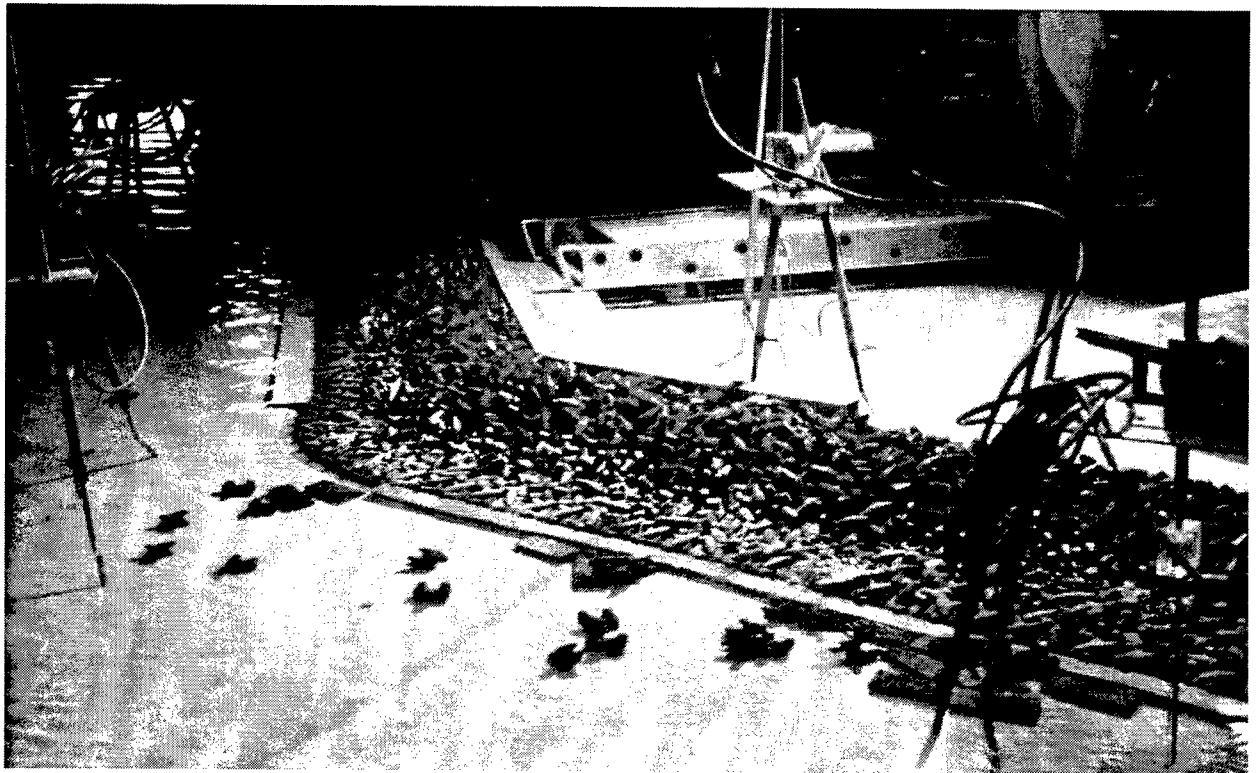
Photo A46. Sea-side view of plan 2D breakwater head after testing with total storm sequence
