CRREL Report 98-5

# **Dredging as Remediation for White Phosphorus Contamination at Eagle River Flats, Alaska**

Michael R. Walsh and Charles M. Collins

August 1998

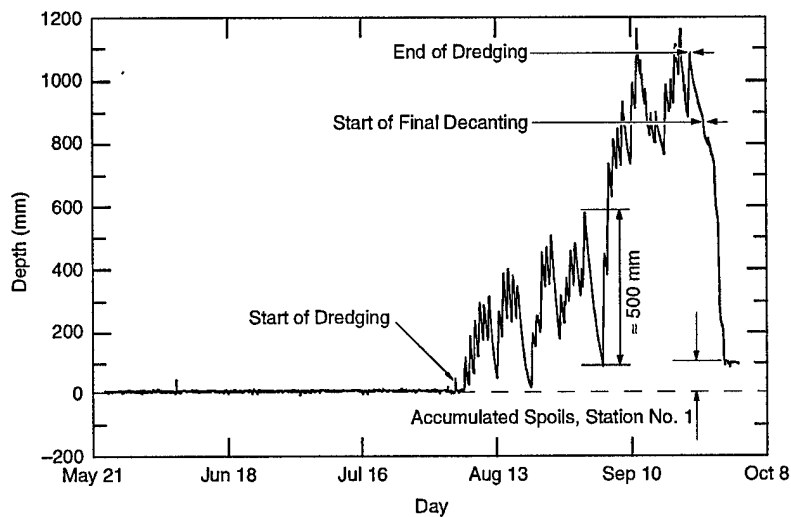
Figure 11. Basin supernatant levels (1996).

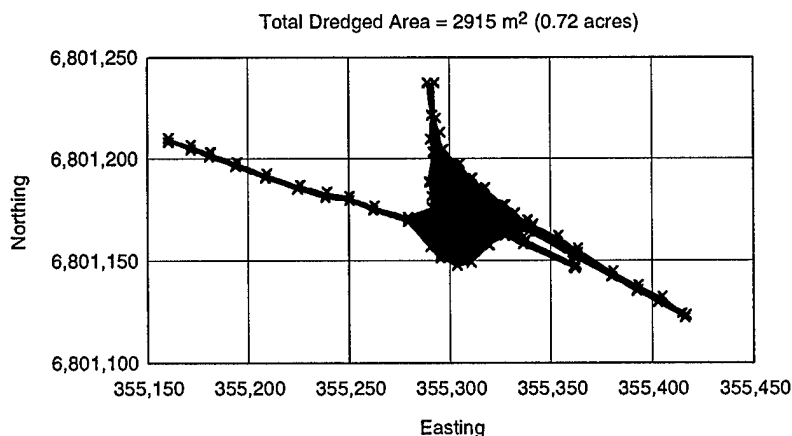
Figure 14. Area dredged in 1996 (x denotes surveyed point).
