TECHNICAL MEMORANDUM 98/202  
January 1998

**DEFECT CONDEMNATION  
FOR  
SUBMARINE PRESSURE HULL WELDS**

J.R. Matthews — J.F. Porter — T. MacAdam

Defence  
Research  
Establishment  
Atlantic

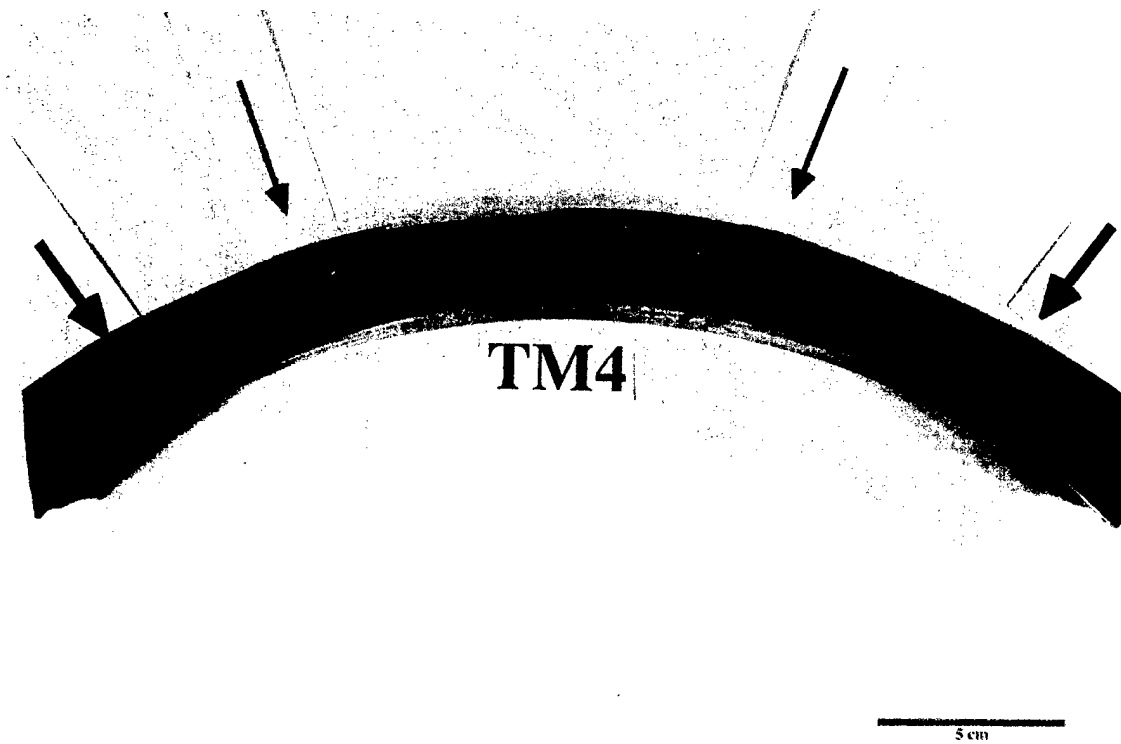
Figure 6.1.1: Fracture surface of panel TM-4 containing root flaws. The arrows indicate extremes of initial and final flaws.

Figure 6.1.1 indicates a typical fracture resulting from the presence of root flaws. The thinner arrows indicate the length of the initial flaw while the thicker arrows show the extent of the final flaw.

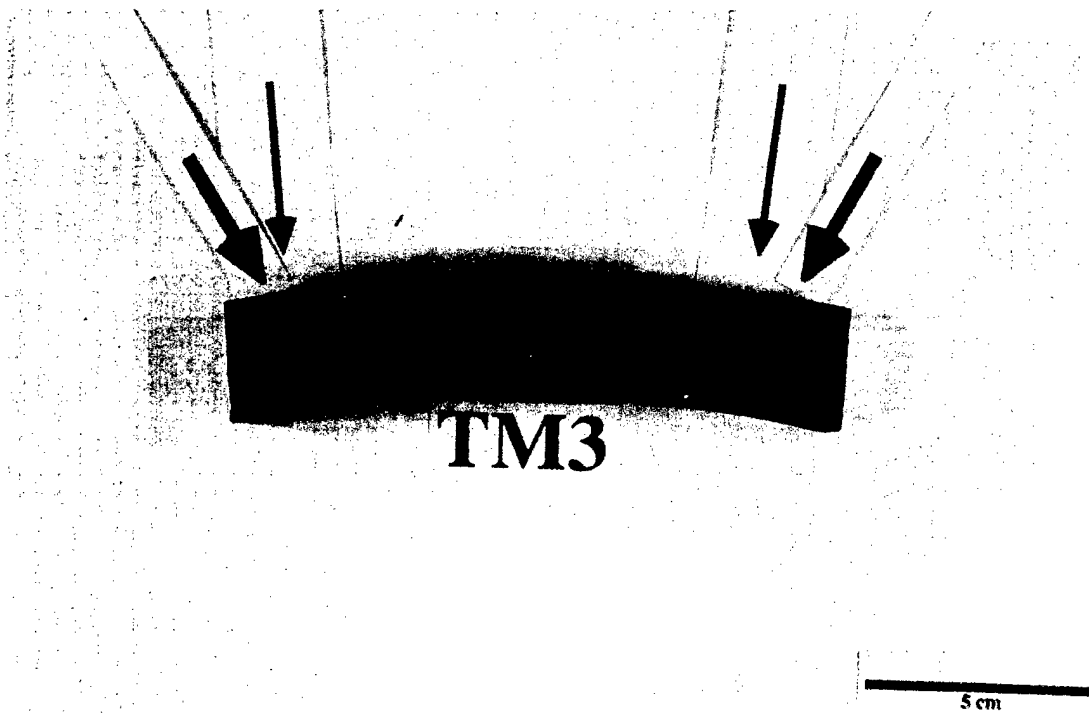
Figure 6.1.2: Fracture surface of panel TM-3 containing cap flaws. The arrows indicate extremes of initial and final flaws on the convex side.

Compared to the through-thickness flaw propagation in panel TM-4, the cap defects display a relatively small extension during explosion bulge testing because they were subjected to fewer shots and thus less deformation. Further, the fracture exposed the initial flaw and propagation only for what appeared to be a portion of its entire length.

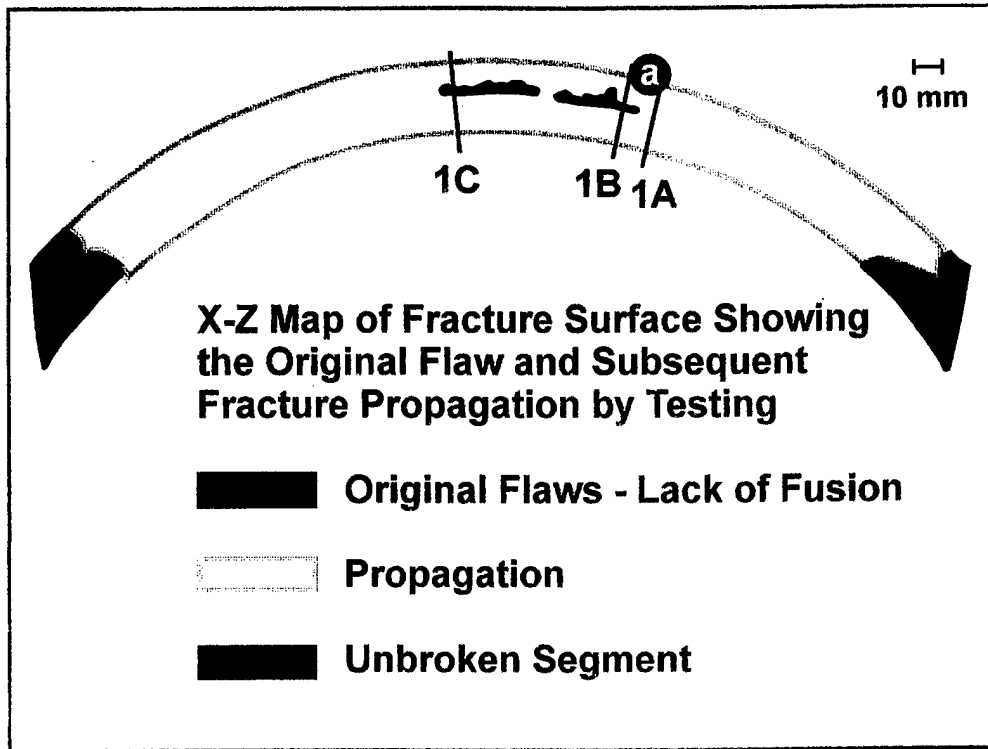
Figure 6.1.3(a): X-Z map for panel TM-1

Table 6.1.1 indicates the lengths, approximate location in relation to the nearest surface, and the depths of the initial flaws as observed on the fracture surfaces. Figures 6.1.3(a) to 6.1.3(f) show the schematics of these results.

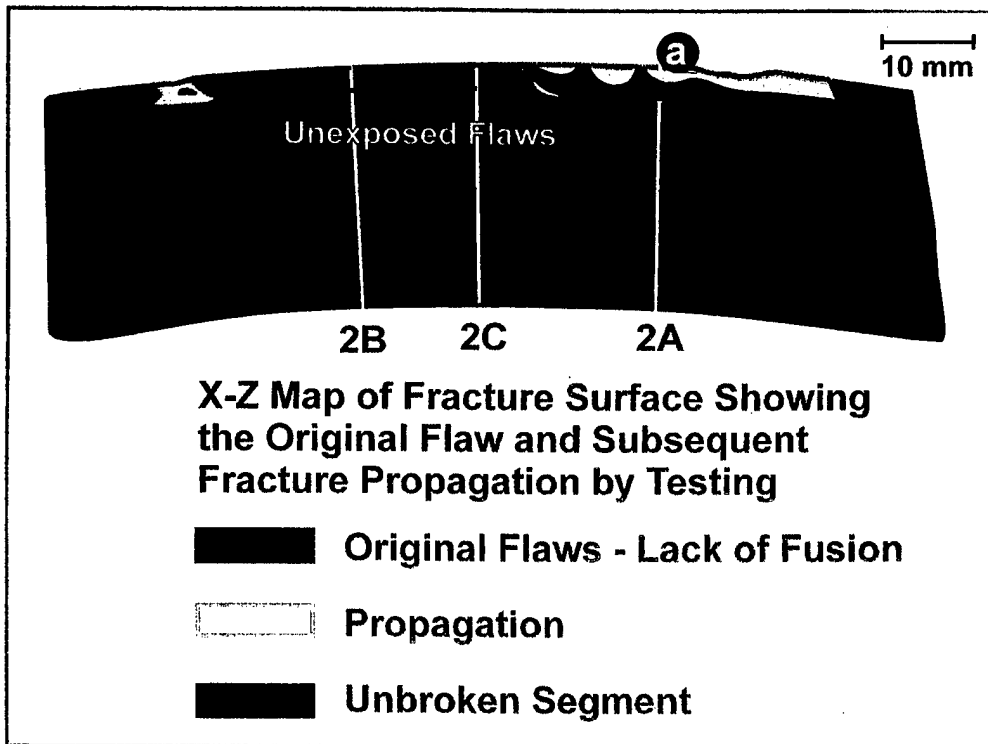
Figure 6.1.3(b): X-Z map for panel TM-2

Two cross-sections were also taken in panel TM-2 from the fracture surface portion that did not expose the flaw on the fracture surface but within the two exposed flaws. These cross-sections displayed cap flaws that did not propagate but were aligned with the flaw that propagated to the convex surface. Compared to the other three panels that indicated the cap flaws to be non-continuous, TM-2 on the other hand, had a continuing cap flaw on the convex side that was not exposed to the fracture surface at least at the two locations where macrographs were prepared (Figure 6.3.5). These flaws are presented as a broken line at these locations in the X-Z map.

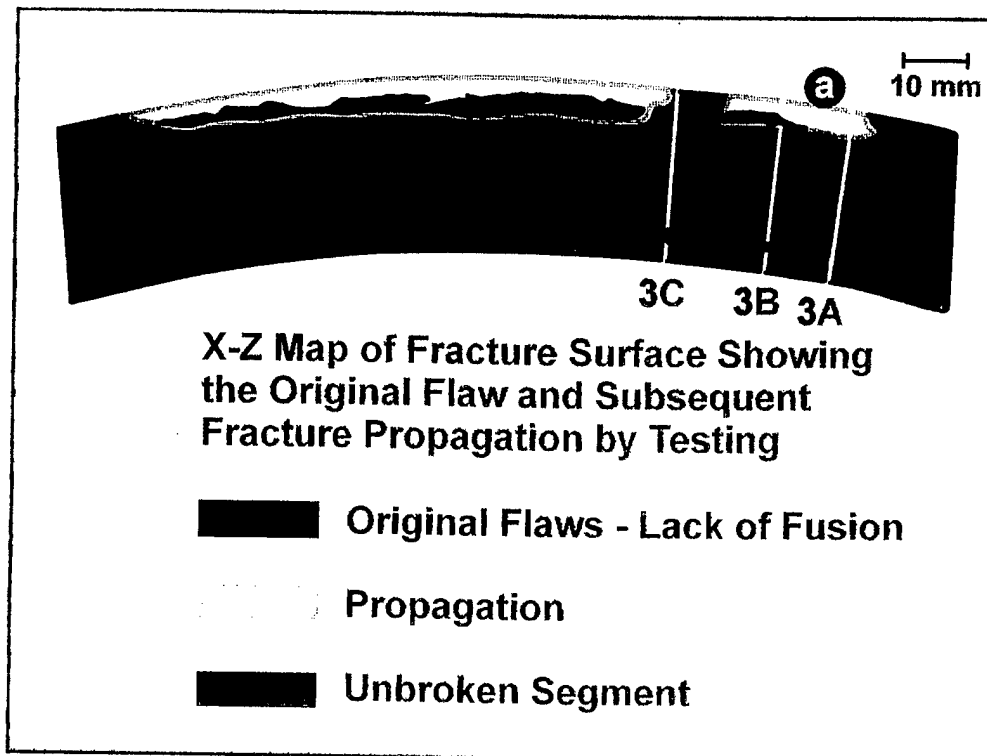
Figure 6.1.3(c): X-Z map for panel TM-3

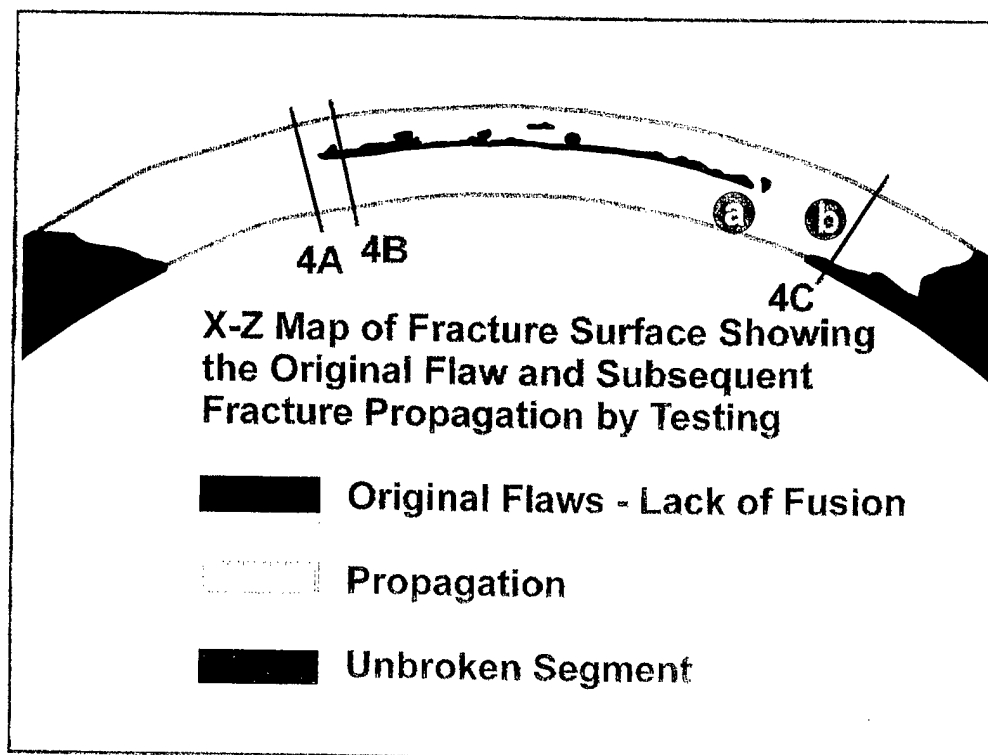
Figure 6.1.3(d): X-Z map for panel TM-4

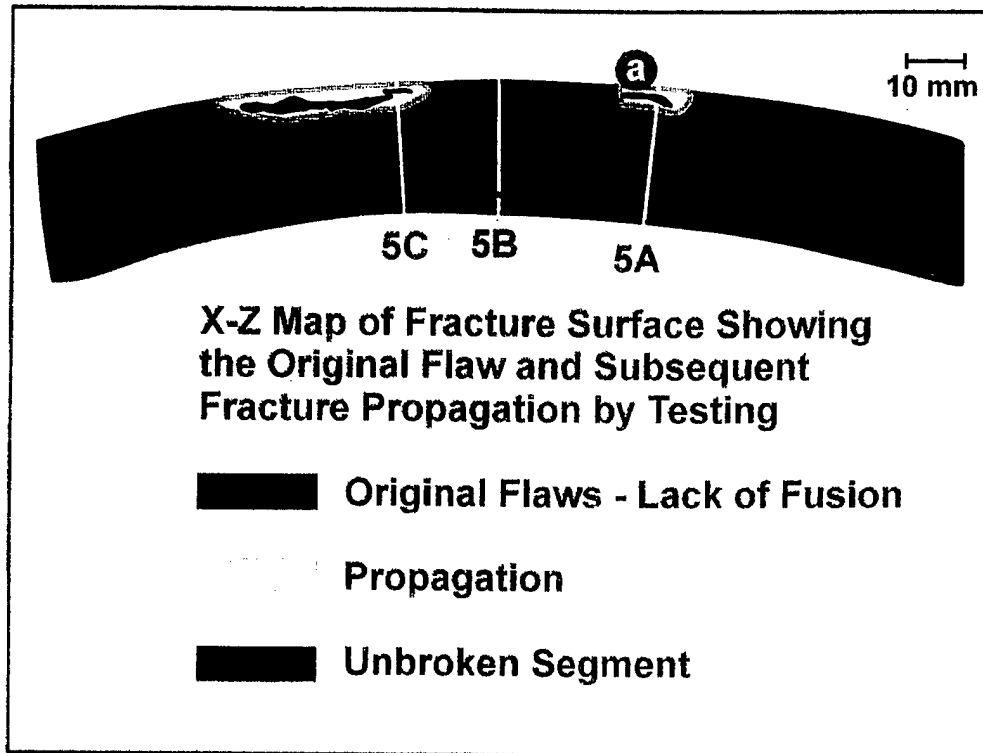
Figure 6.1.3(e): X-Z map for panel TM-5

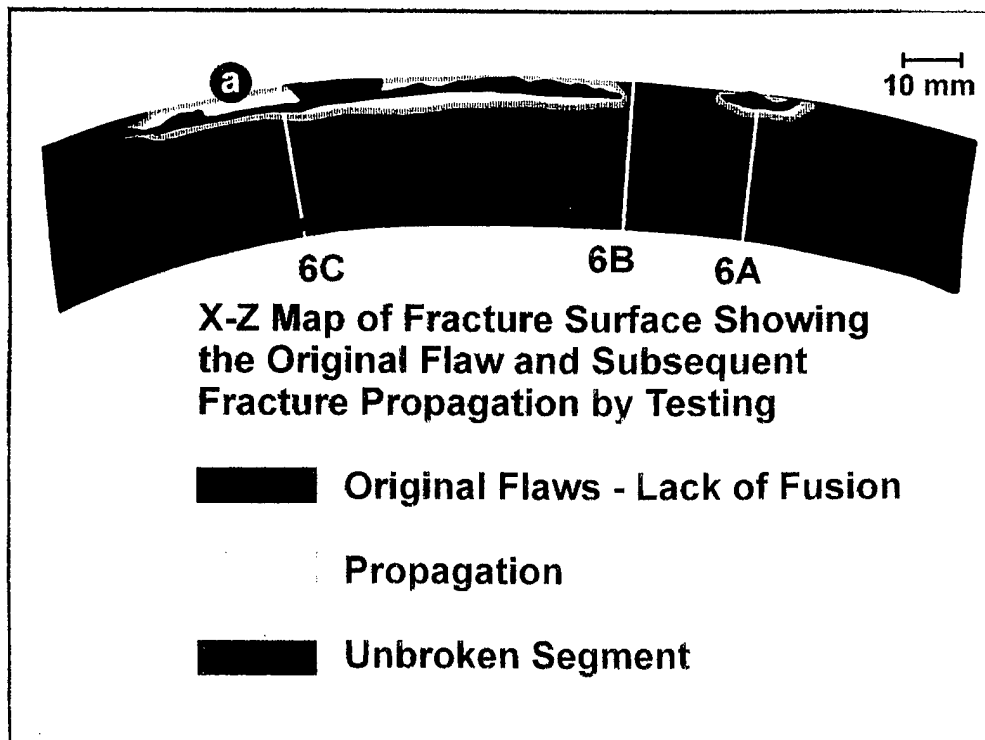
Figure 6.1.3(f): X-Z map for panel TM-6

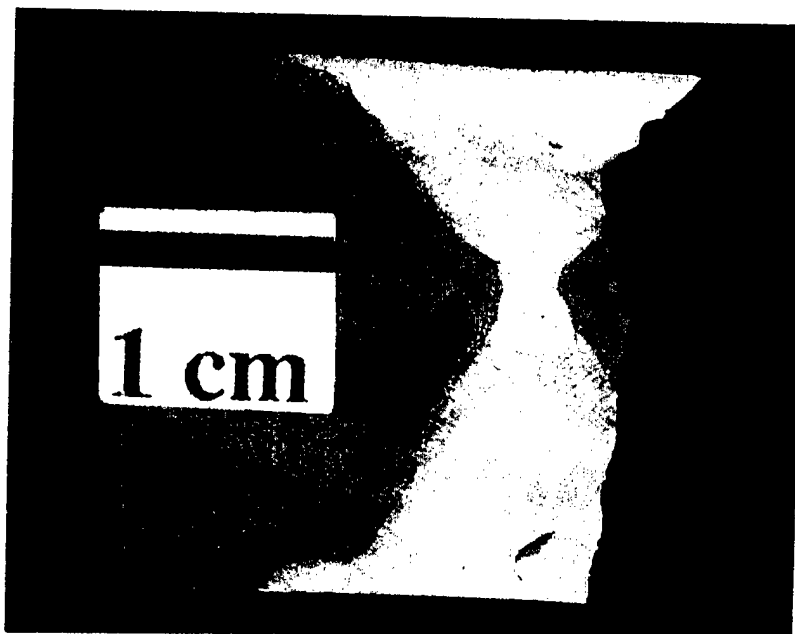
Figure 6.3.4: Macrograph of cross-section (from TM-5) at location that exposes the initial flaw at the convex side of the fracture face. (Top side is the convex surface).

The cross-sectional metallographs of panels with cap flaws indicate that the initial flaws delineated in the fracture face with a featureless appearance were indeed in the cap passes of the weld and that the propagation occurred in the weld metal on both sides of the initial flaw in the radial direction (see Figure 6.3.4). These fractures did not expose a continuous initial flaw on the fracture surfaces (see Table 6.6.1). Cross-sections were therefore extracted in all of these fractures at positions that do not show the propagation of the flaw. Using these an attempt was made to establish if the flaw was indeed continuous on the convex side of the panel. They showed that these defects are at different interpass locations. Therefore, compared to root defects which are associated with the single root pass, the cap defects are associated with one or more of the cap passes.

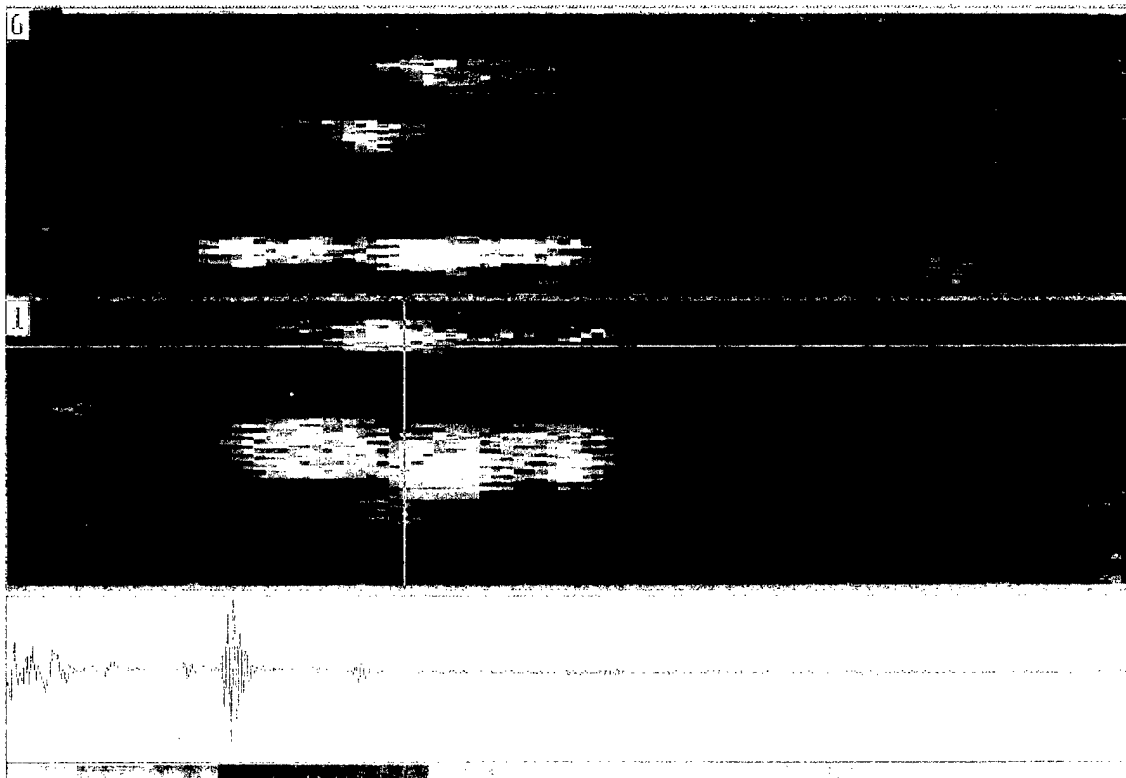
Figure A-1: Computer-aided ultrasonic scan for plate TM-1.

A top view printout of the APHIUS results from each of the six plates is found in Annex A.

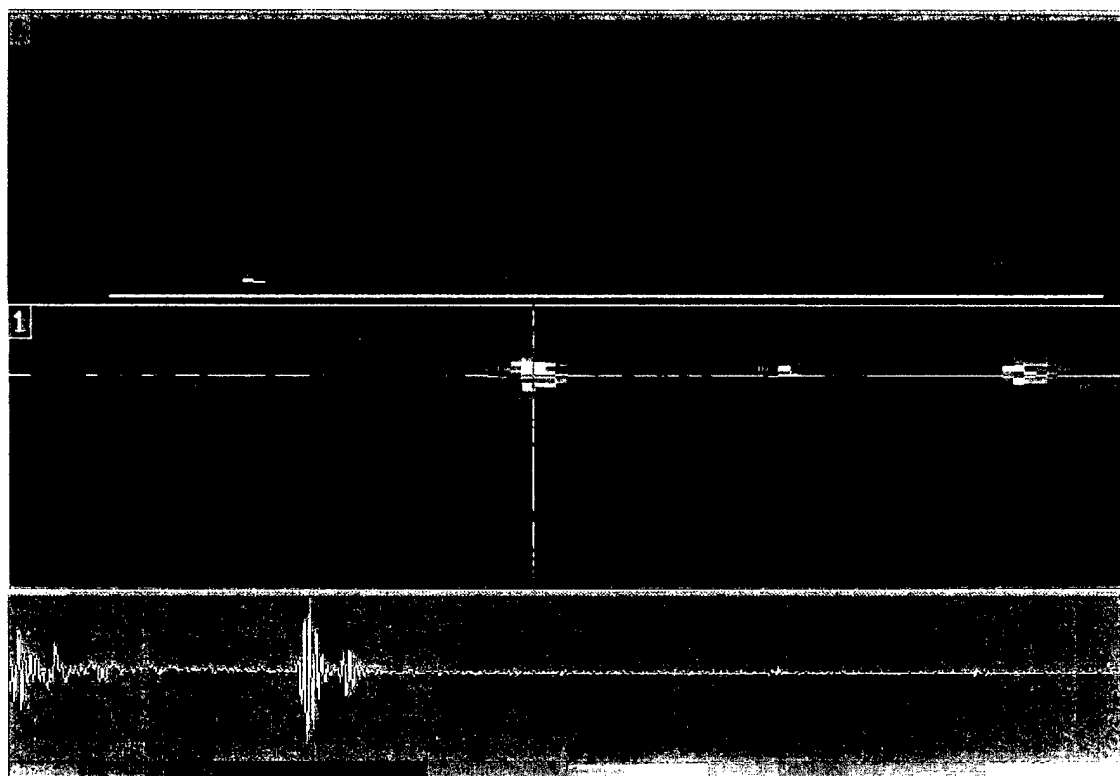
Figure A-2: Computer-aided ultrasonic scan for plate TM-2.

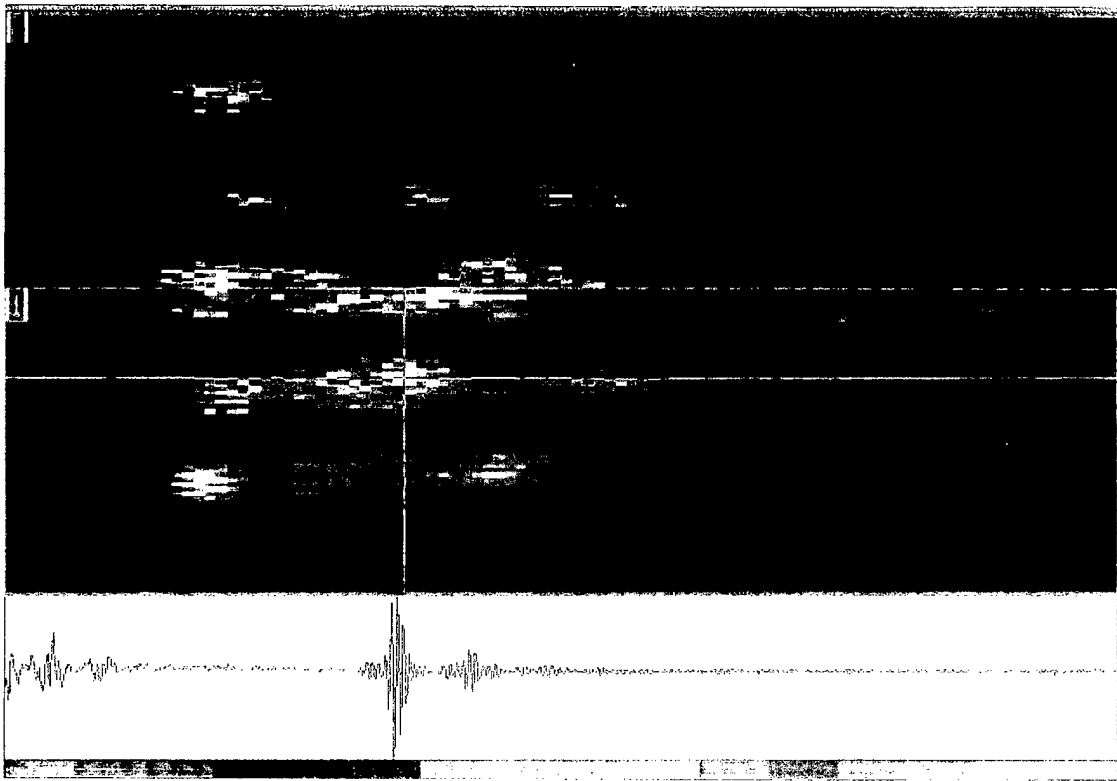
Figure A-3: Computer-aided ultrasonic scan for plate TM-3.

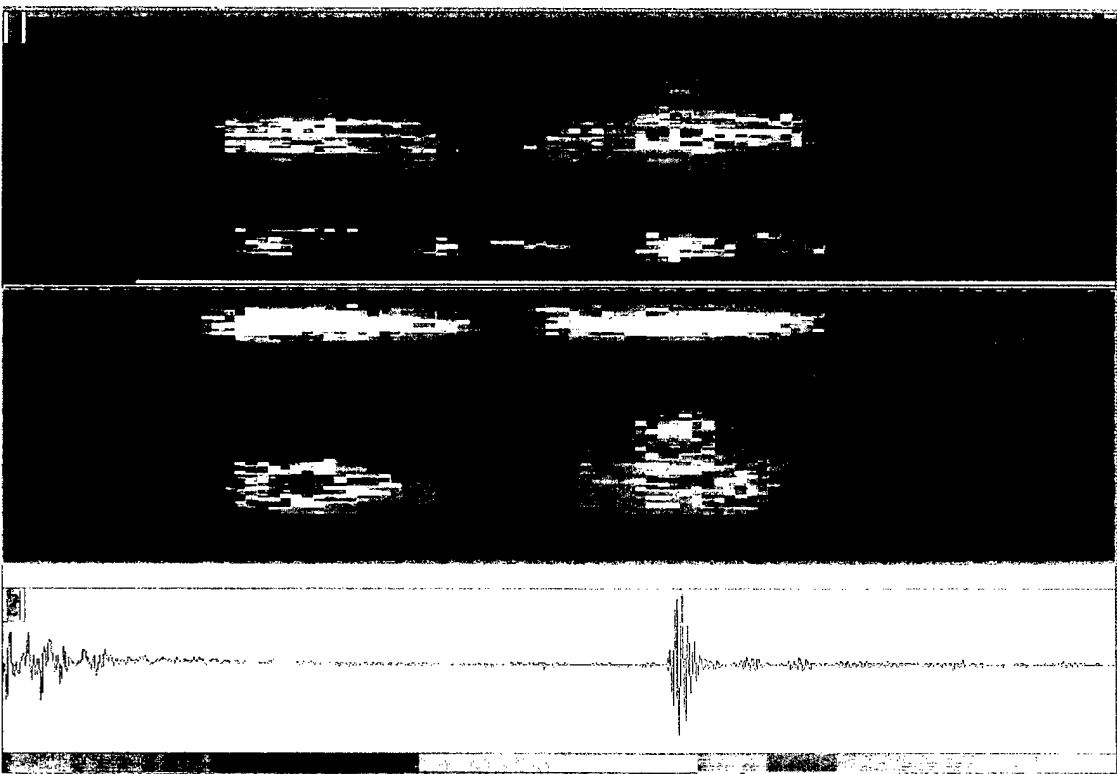
Figure A-4: Computer-aided ultrasonic scan for plate TM-4.

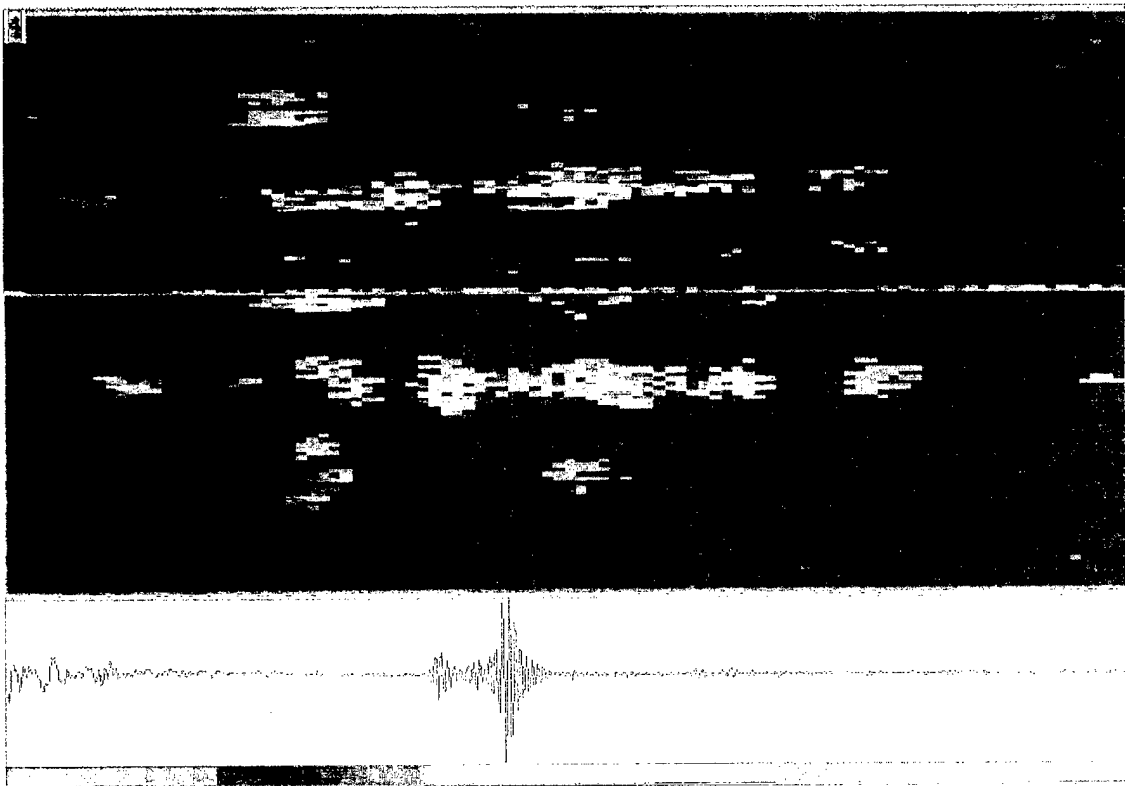
Figure A-5: Computer-aided ultrasonic scan for plate TM-5.

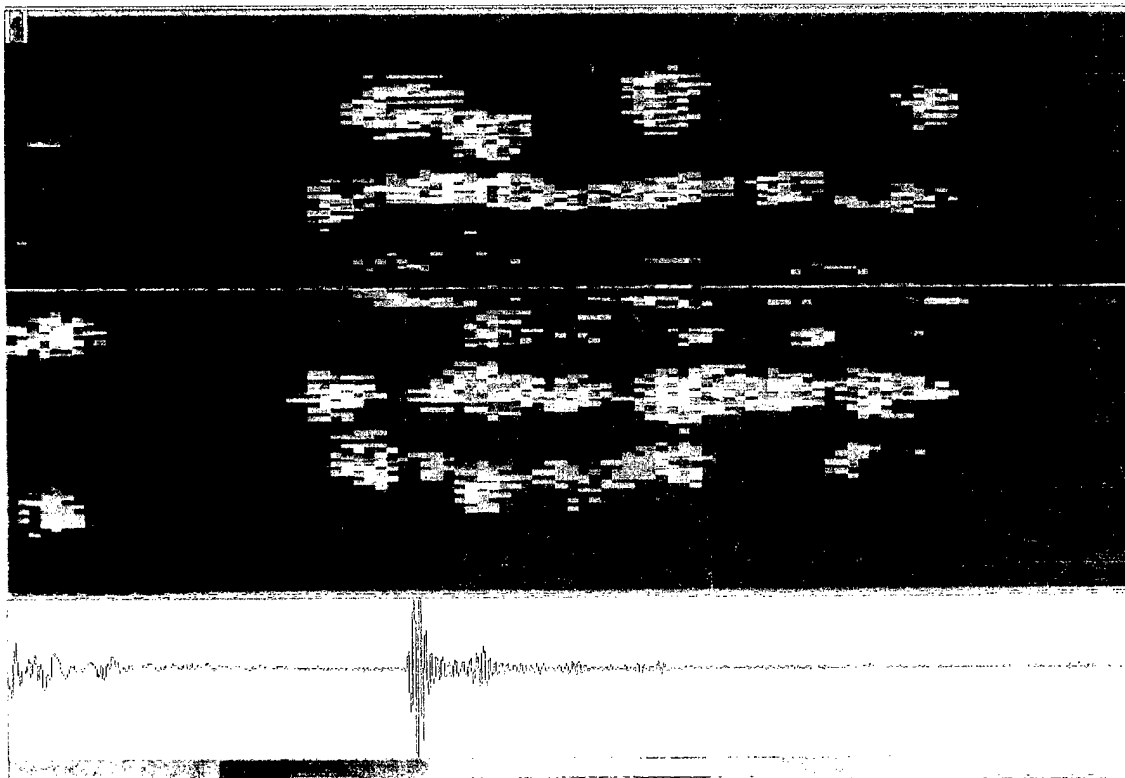
Figure A-6: Computer-aided ultrasonic scan for plate TM-6.
