| REPORT DOCUMENTATION PAGE | | | Form Approved<br>OMB No. 0704-0188 | |
|---|---|---|---|--|
| 1. AGENCY USE ONLY (Leave blank) | 2. REPORT DATE<br>September 1998 | 3. REPORT TYPE AND DATES COVERED<br>Final Report | | |
| 4. TITLE AND SUBTITLE<br><br>Waste Water Treatment Plant and Incinerator Complex, Sites 5EP2447 and 5EP2446, Fort Carson, Colorado | | 5. FUNDING NUMBERS<br><br>PR FC96147 | | |
| 7. PERFORMING ORGANIZATION NAME(S) AND ADDRESS(ES)<br><br>National Park Service<br>Midwest Archeological Center<br>100 Centennial Mall North, Room 474<br>Lincoln, Nebraska 68508-3873 | | 8. PERFORMING ORGANIZATION<br>REPORT NUMBER<br><br>N/A | | |

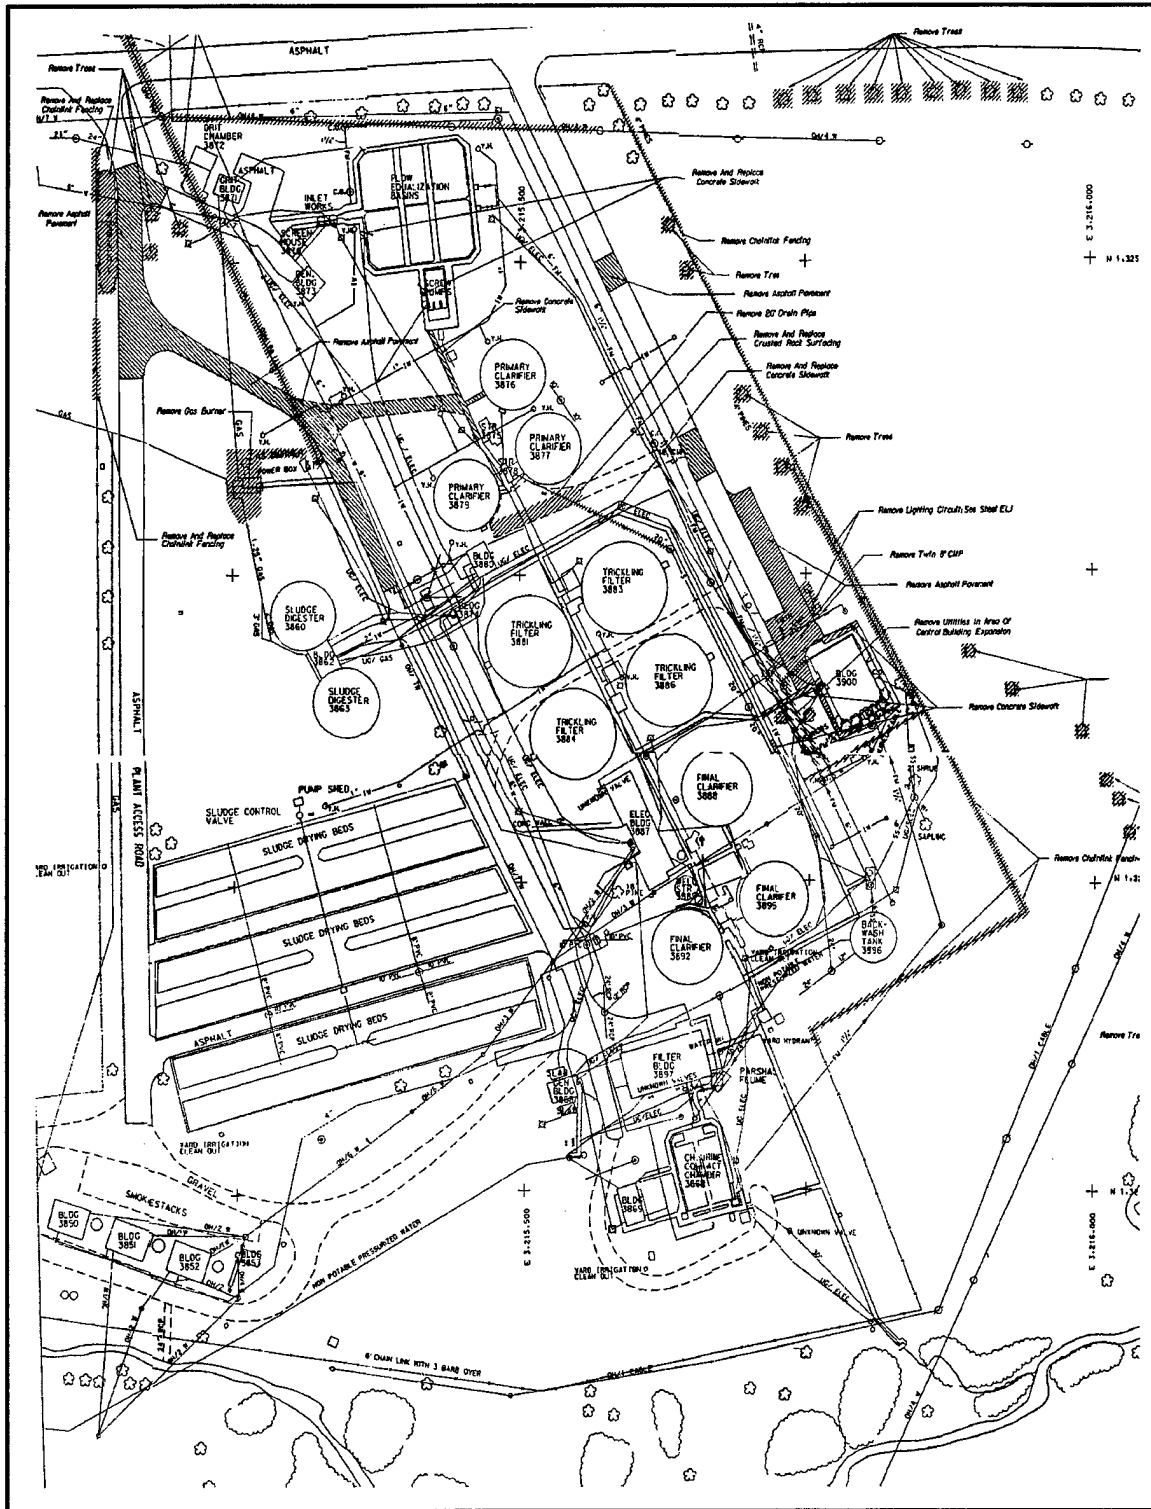
Figure II-9. 1995 Site Plan. Removal Plan - Waste Water Treatment Plant (WWTP) Upgrade. Plan 871-75-05, Sheets P2.1 and P2.2, Areas A and B.

Incinerator Lavatory 3853 originally housed a shower and lavatory for incinerator workers. The building later housed a generator before being demolished in 1995 (Figure II-9). All that remains today is a concrete floor and foundation.

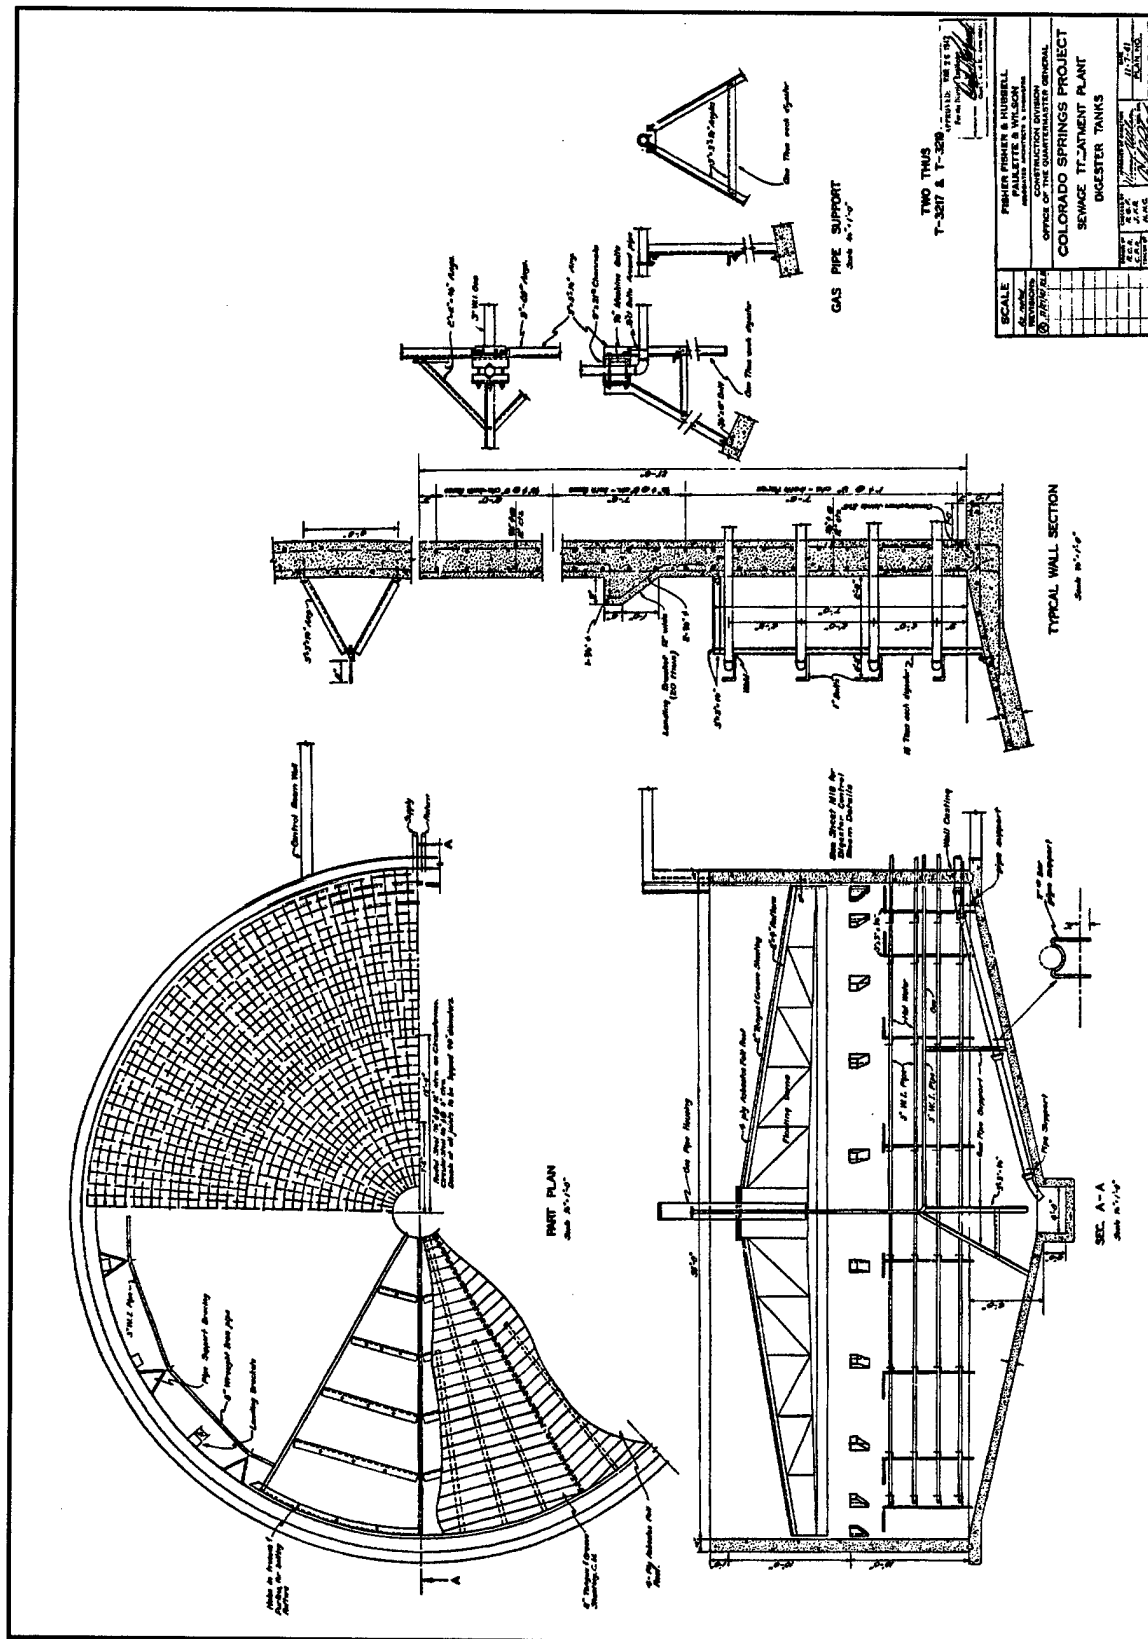
Figure II-11. Plans and sections for Primary and Secondary Digesters 3860 and 3863. Sewage Treatment Plant Digester Tanks. Plan 7131-15-M17 2G.

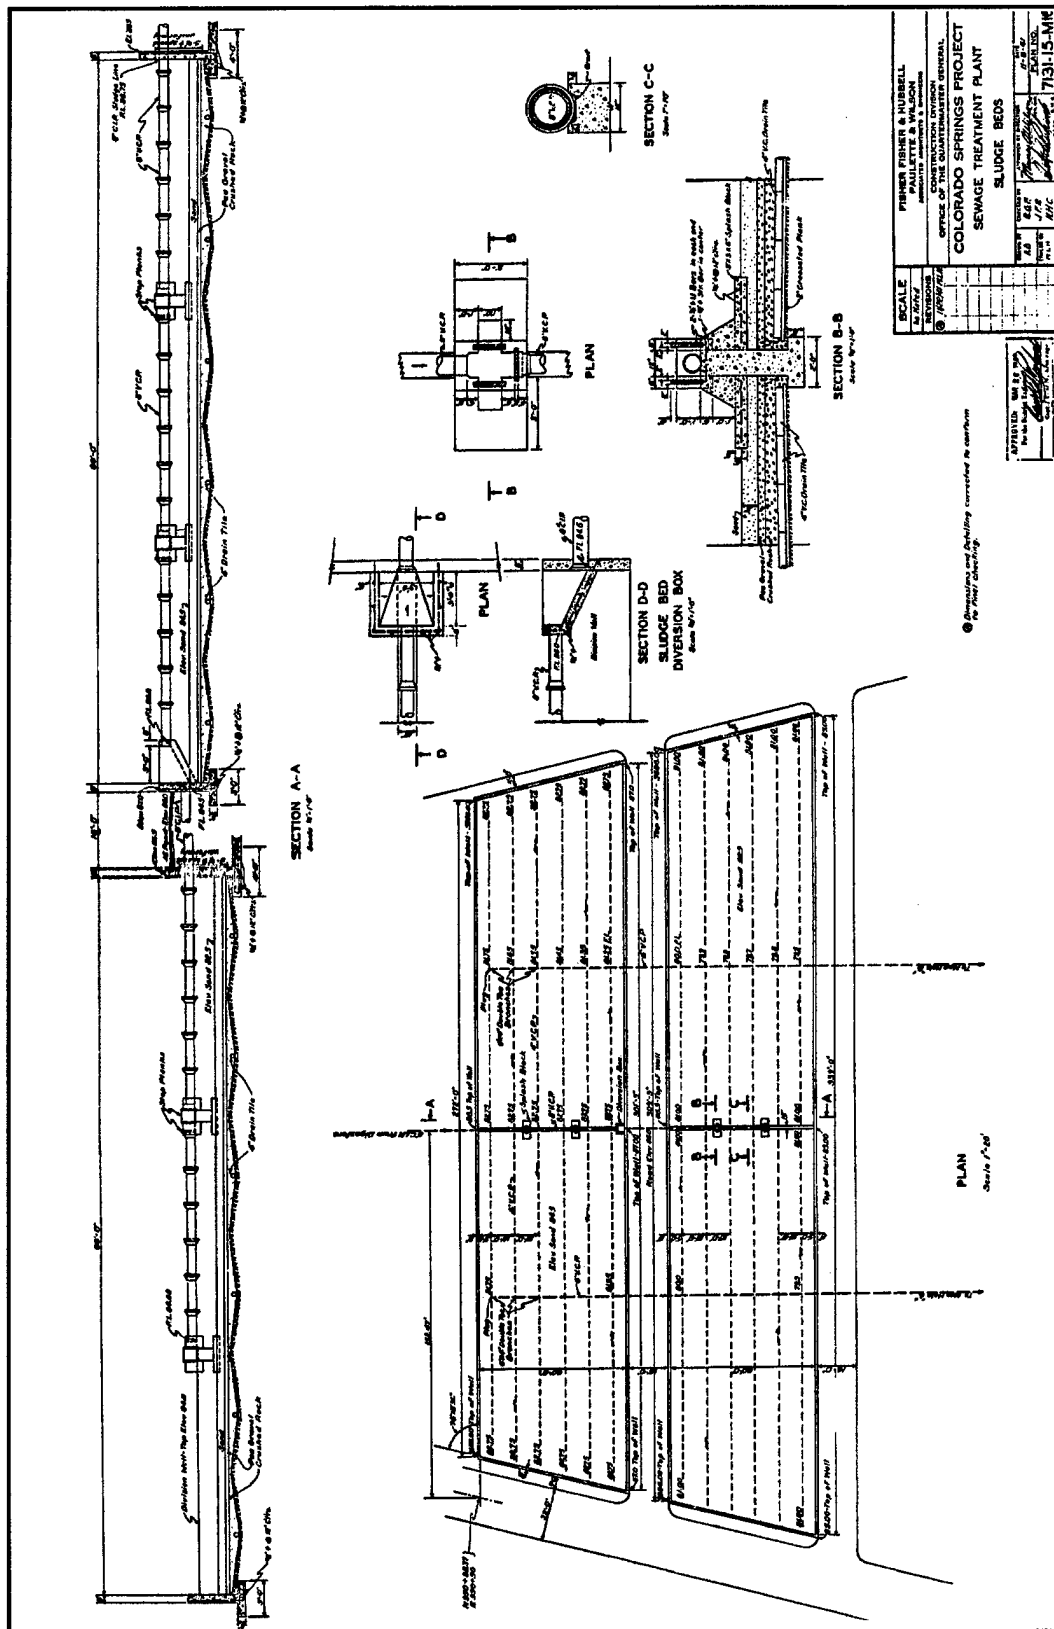
Figure II-14. Plans, sections, and details for Sludge Beds 3864 and 3865. Plan 7131-15-M16 2G.

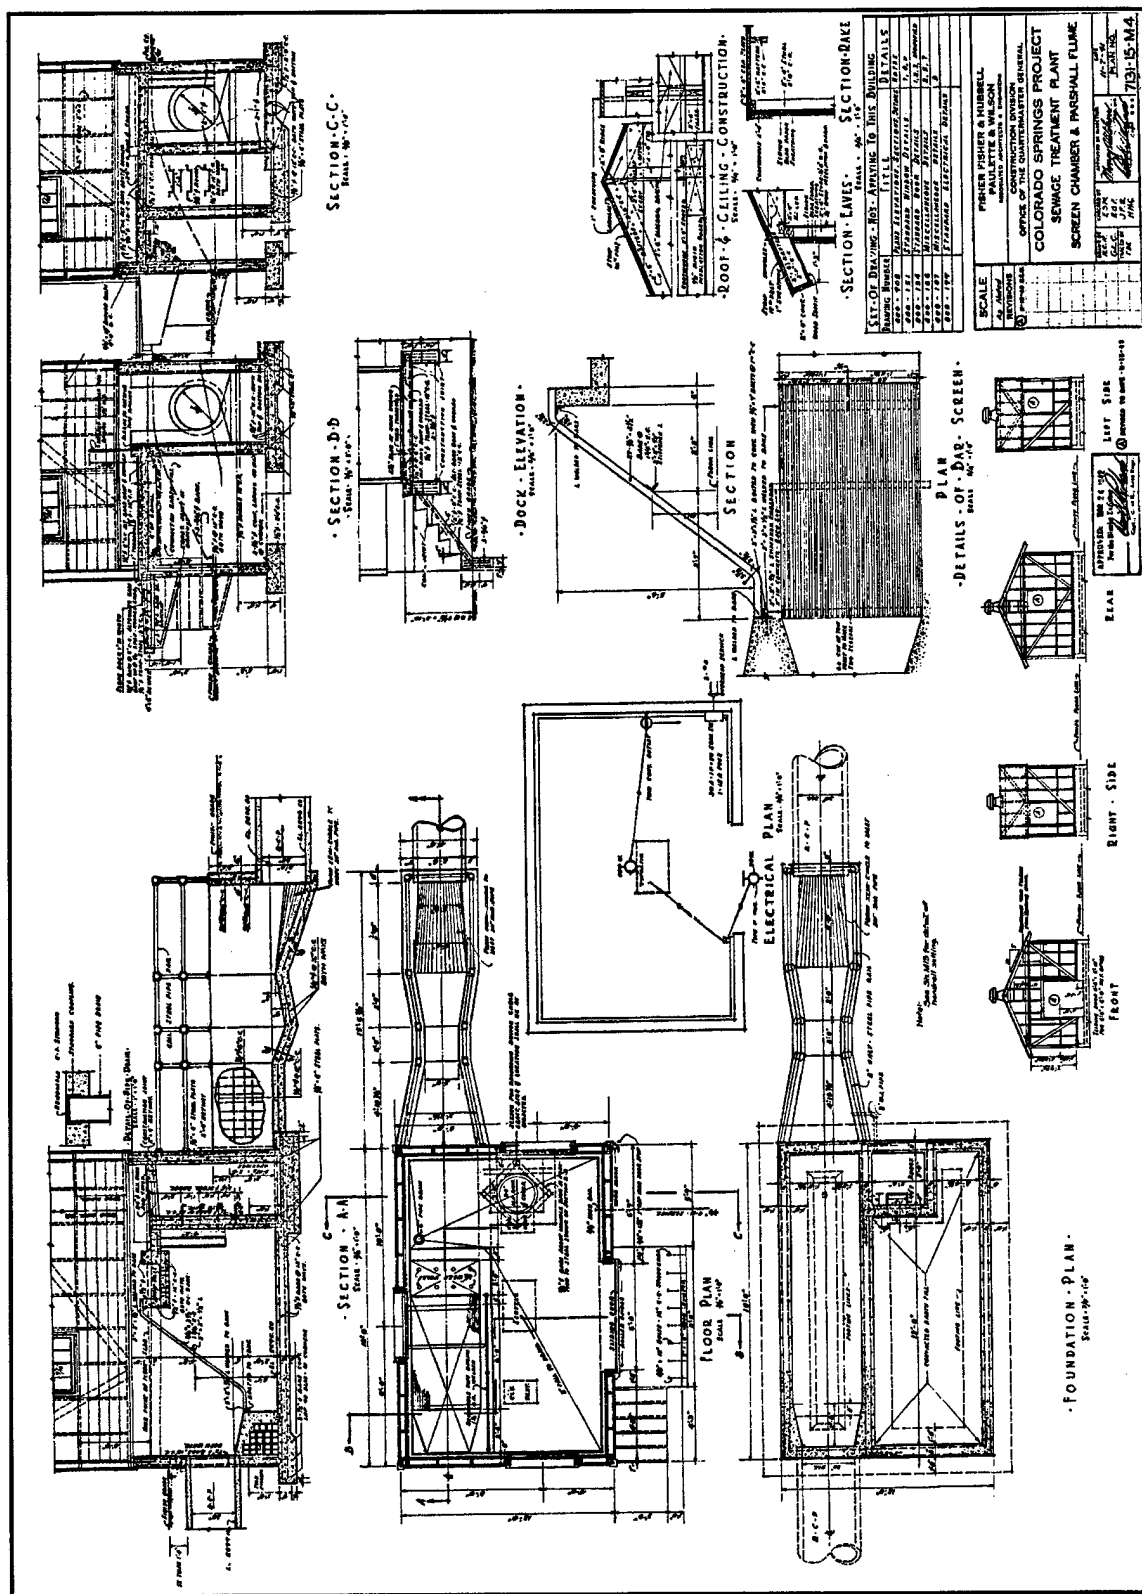
Figure II-16. Plans, sections, and details for Screen House 3870. Screen Chamber and Parshall Flume. Note that Parshall Flume in plan demolished in 1985. Plan 7131-15-M4 2G.

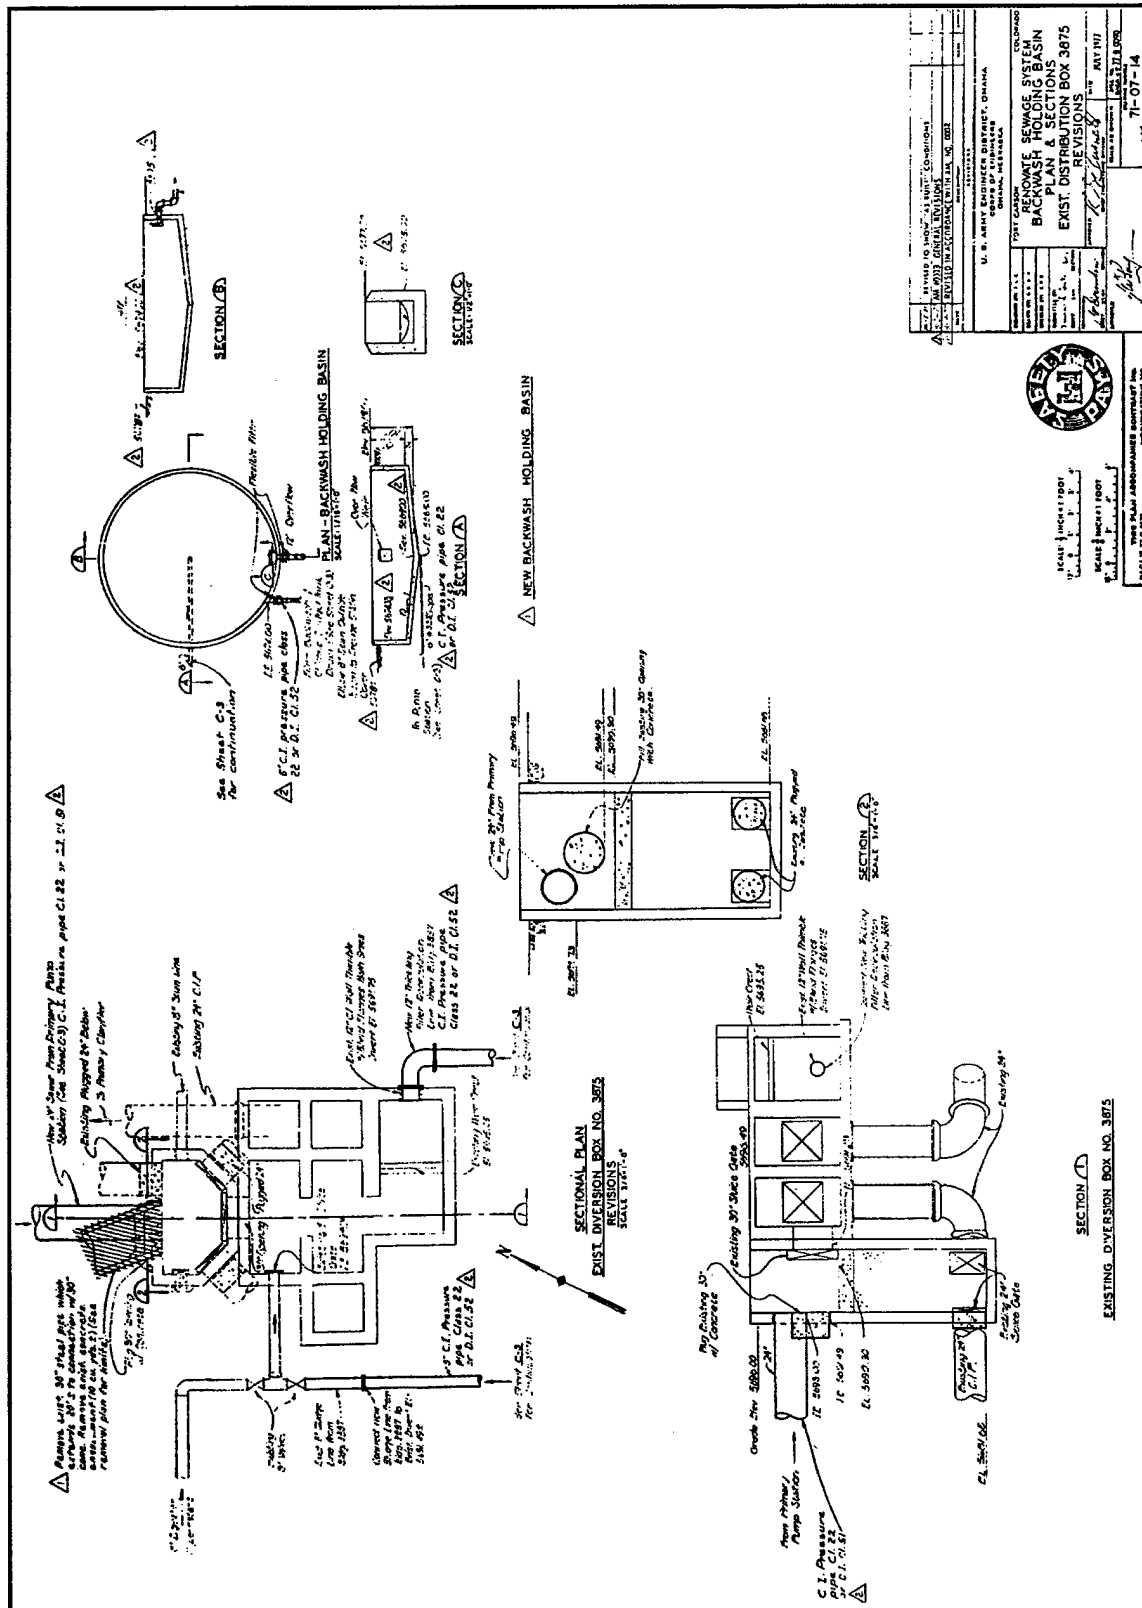
Figure II-18. Plans and sections for Diversion Box 3875. Backwash Holding Basin Plan and Sections - Existing Distribution Box 3875 Revisions. Plan 71-07-14, Sheet C29. Note six-bay addition on downstream side.

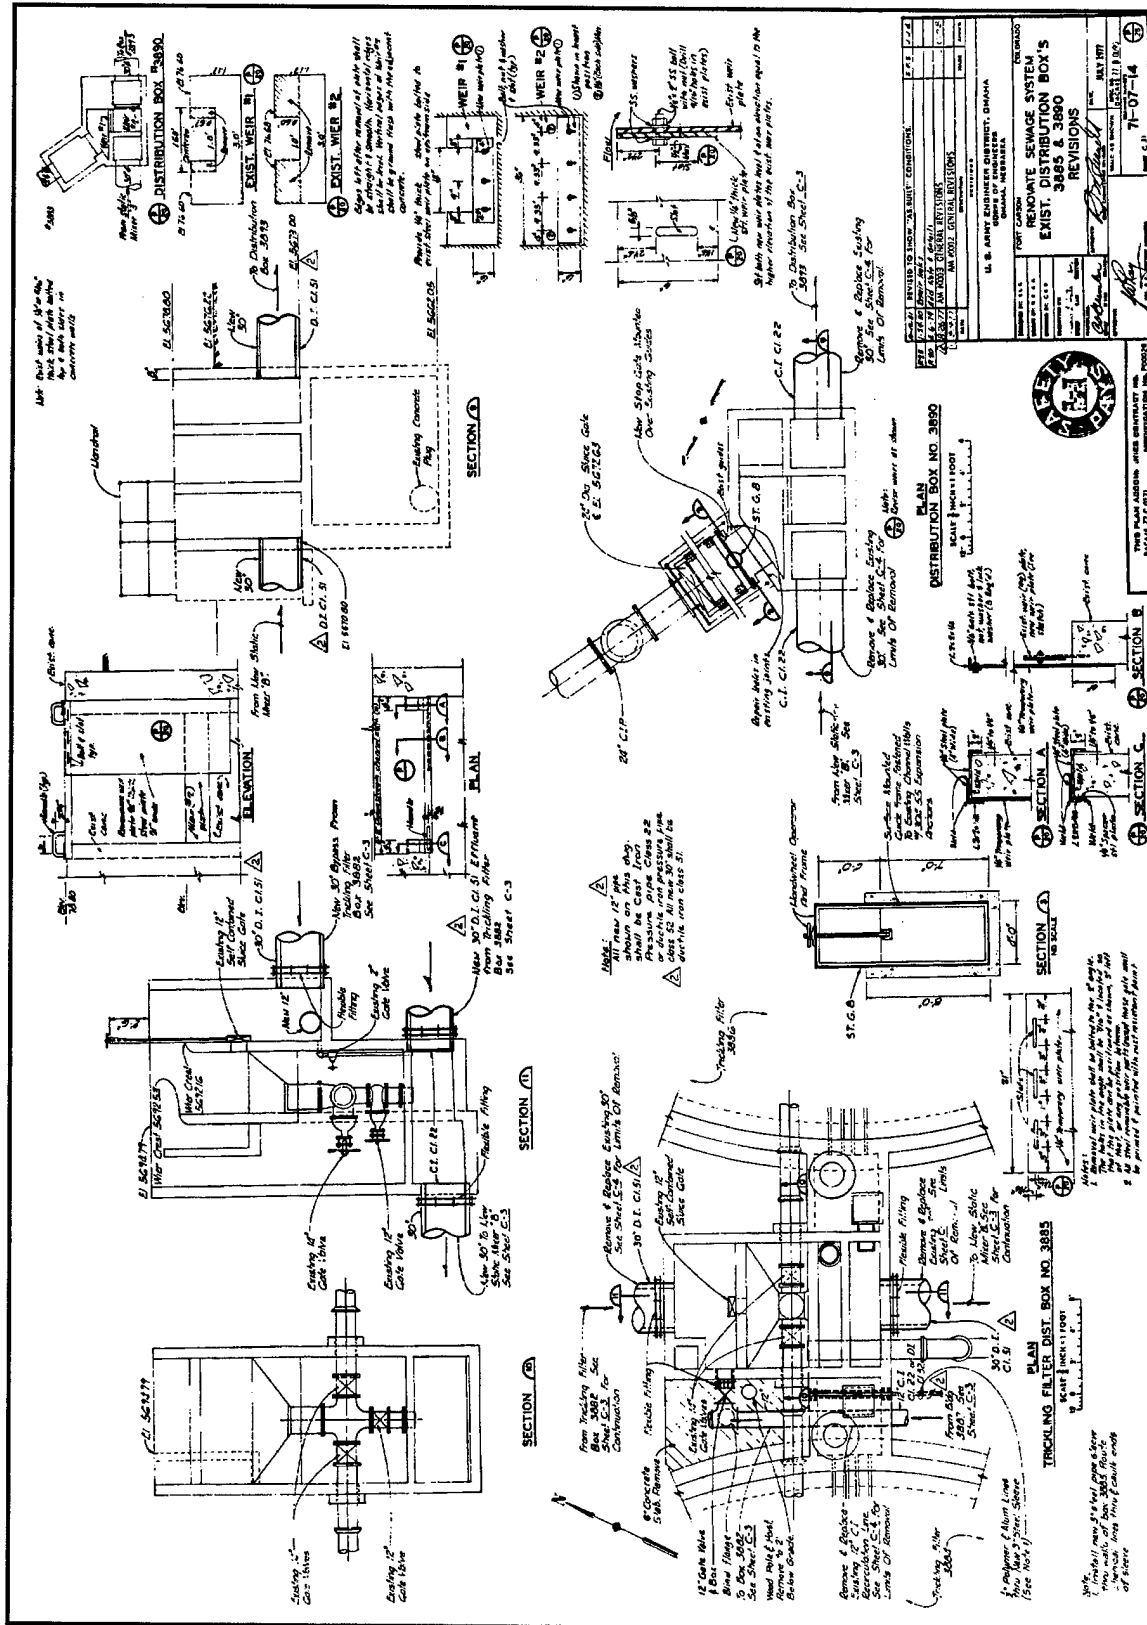
Figure II-23. Plan, sections, and equipment layout for Filter Head Box 3885; plan and section for Diversion Box 3890. Existing Distribution Boxes 3885 and 3890 - Revisions. Plan 71-07-14, Sheet C31. Note that angled leg at 3890 is addition.

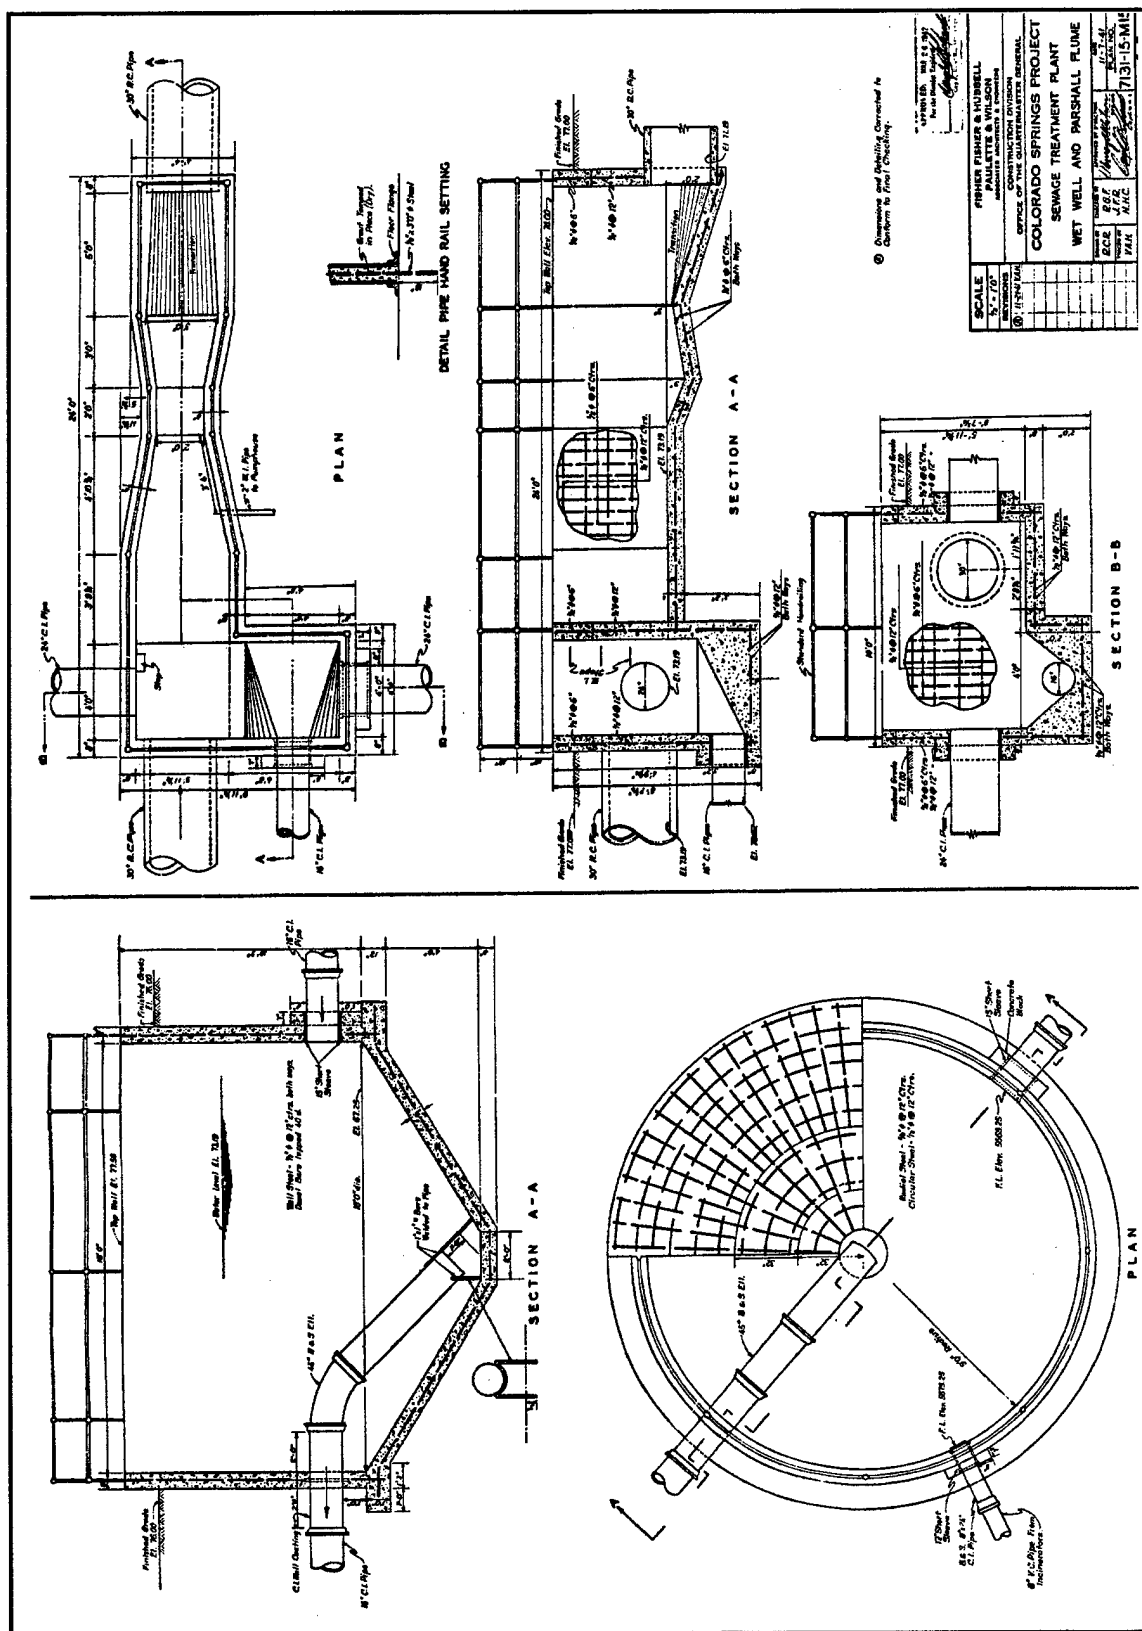
Figure II-28. Plan and section for Recirculation Well 3889; plan and sections for Diversion Box/Parshall Flume 3893. Wet Well and Parshall Flume. Plan 7131-15-M15 2G.

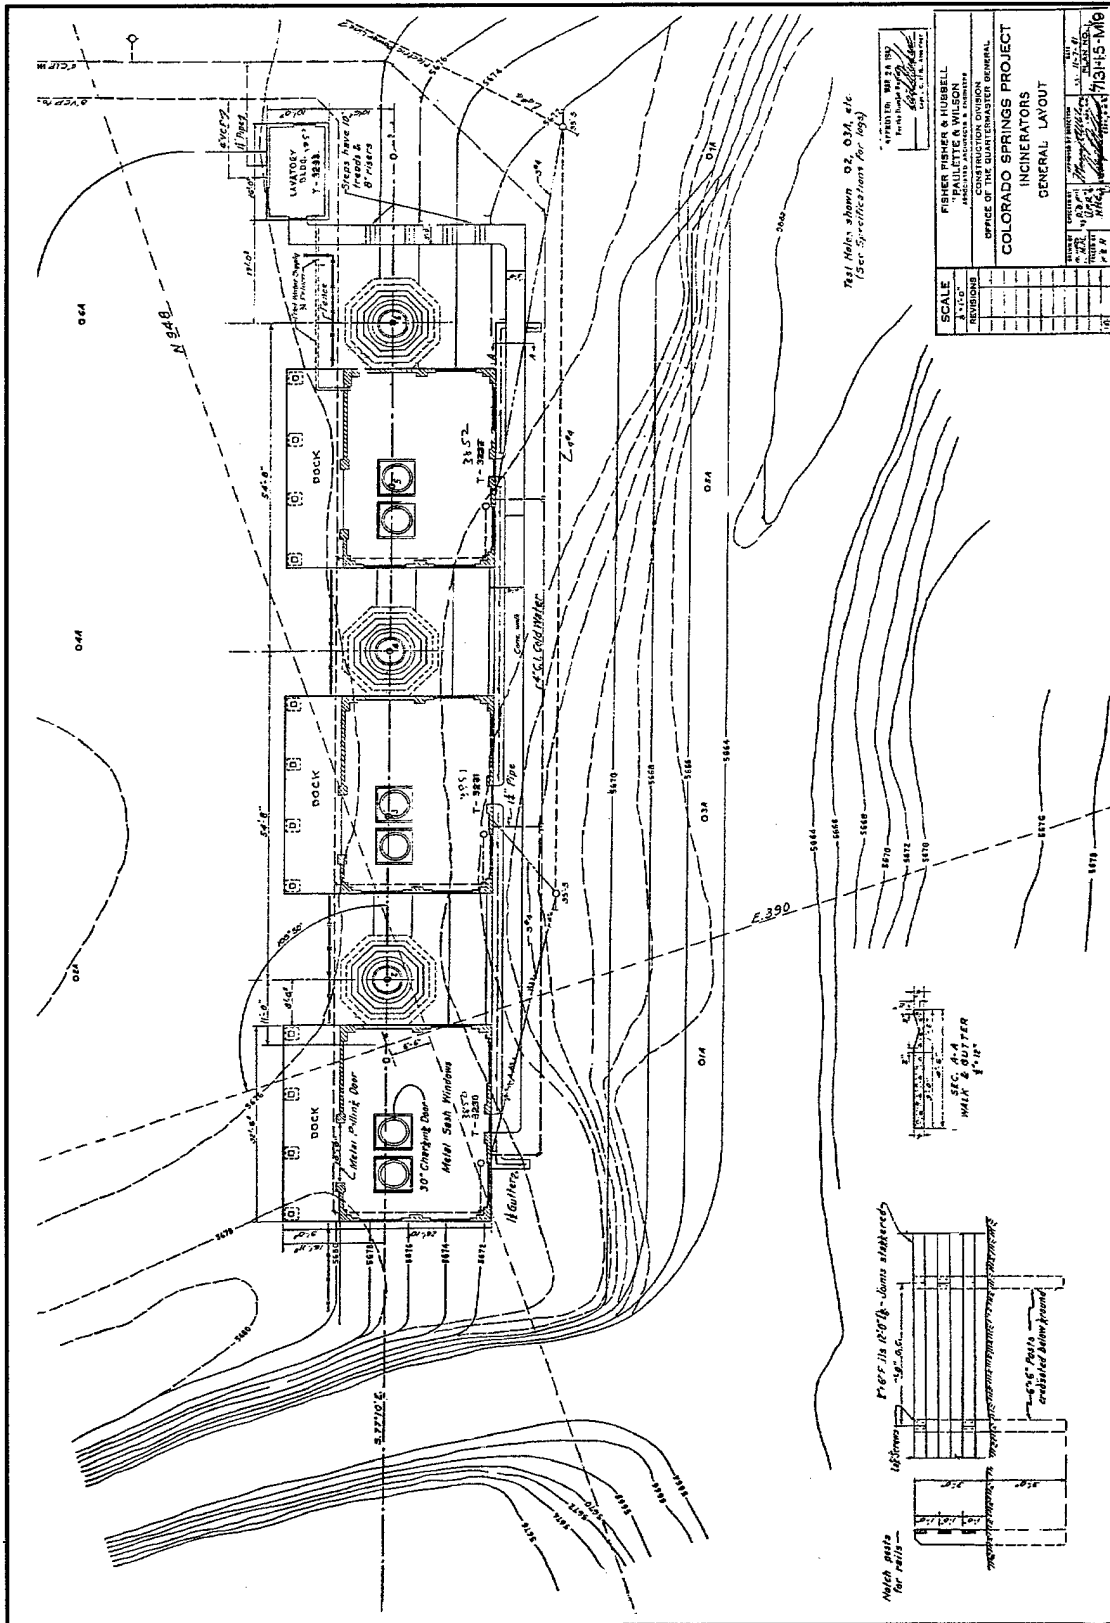
Figure II-30. Plans for Buildings 3850, 3851, and 3852, Incinerators, Plan 7131-15-M19.

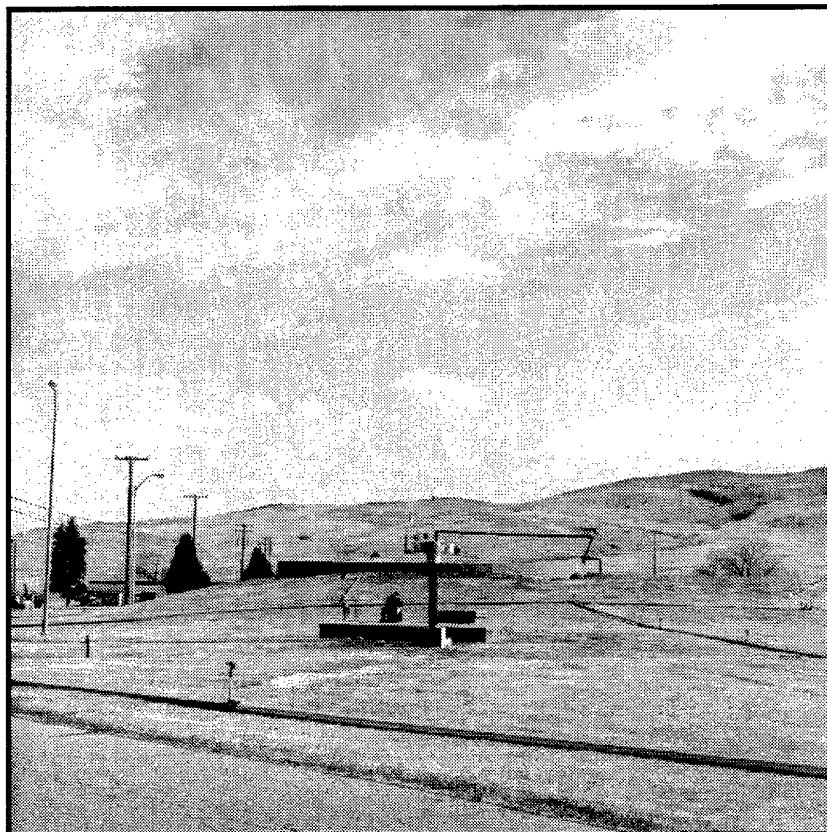
Figure II-34. Side View of Primary Digester 3860. Natural Gas Valve Box and PRV 30 in Foreground. These Process and Burn Methane from Digesters. Roll HH11, Exposure 6.

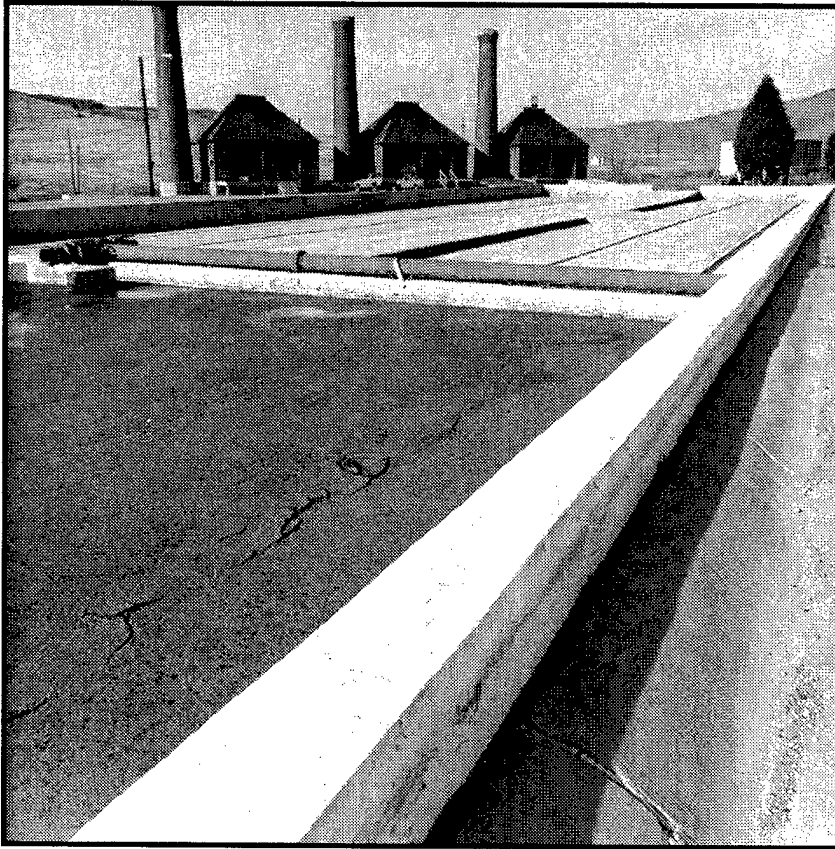
Figure II-41. View of Typical Sludge Drying Operation at Sludge Bed 3866. Note Concrete Floor and Drainage Cuts in Far, Empty Half. Fill Pipe Separates Halves. Roll HH14, Exposure 9.

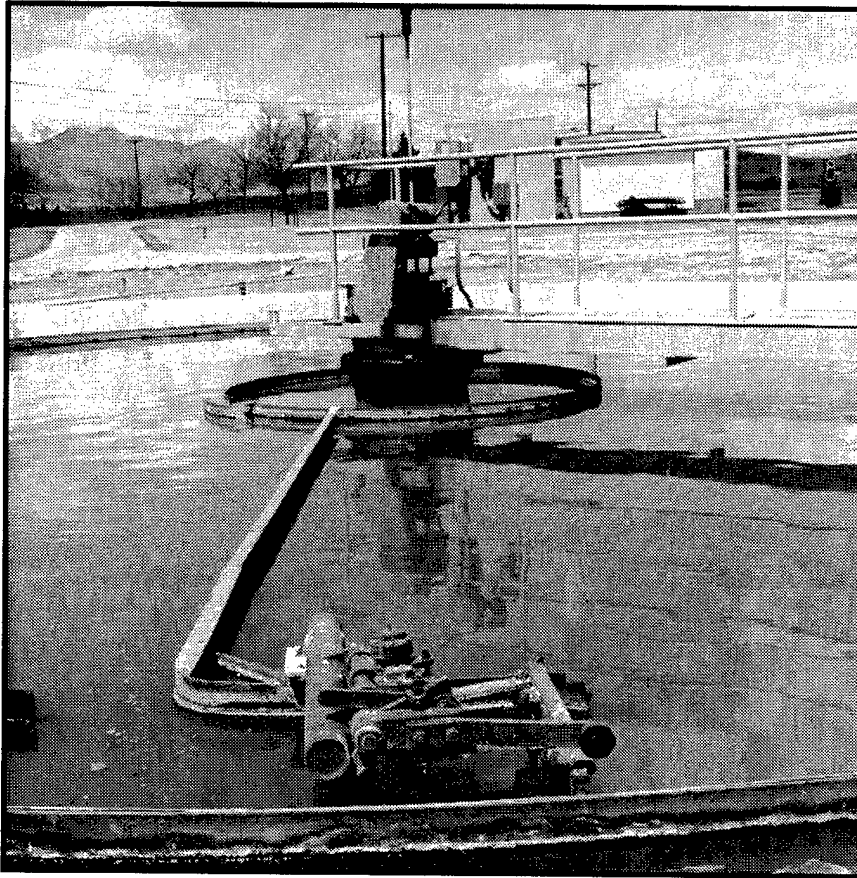
Figure II-49. Detail View of Typical Primary Clarifier Skimmer at Primary Clarifier 3877. Roll HH26, Exposure 2.

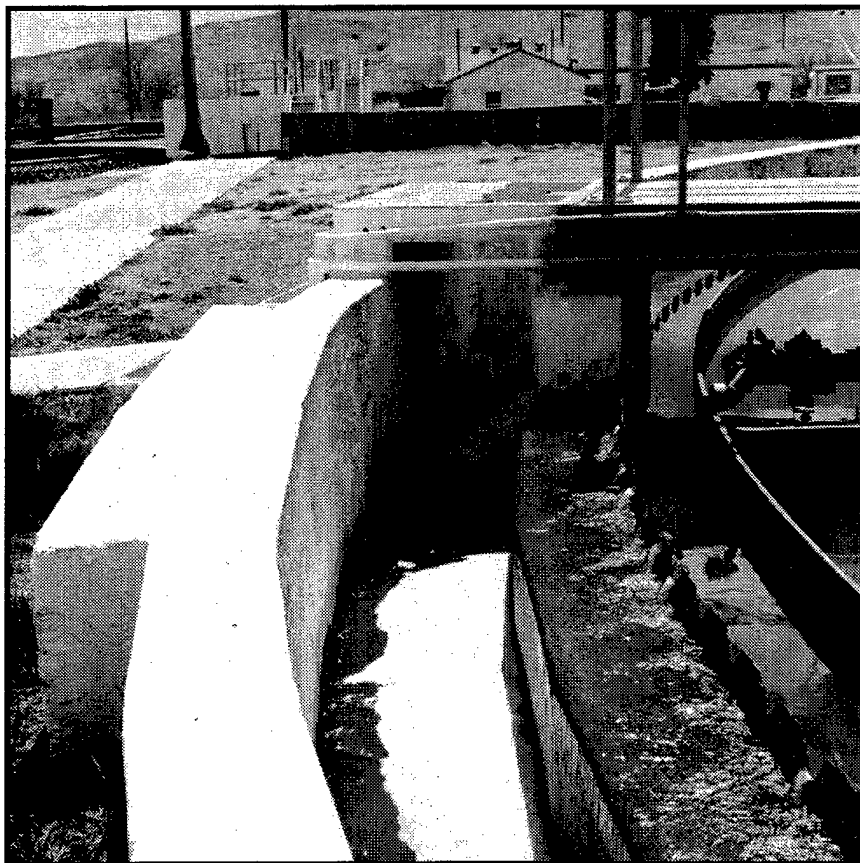
Figure II-50. Detail View of Typical Primary Clarifier Effluent Drain, Weir Plate, Skimmer Rail, and Skimmer Mechanism. View from Primary Clarifier 3877. Roll HH26, Exposure 11.

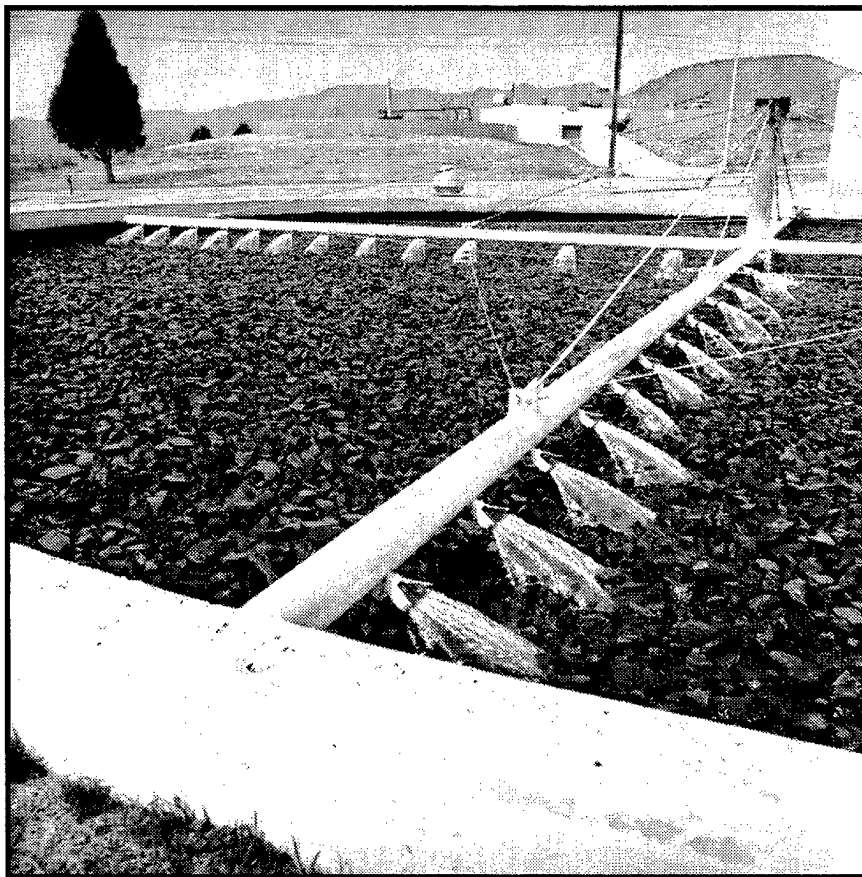
Figure II-55. Detail View of 1981-era Distributor Boom at Trickling Filter 3881. Roll HH16, Exposure 6.

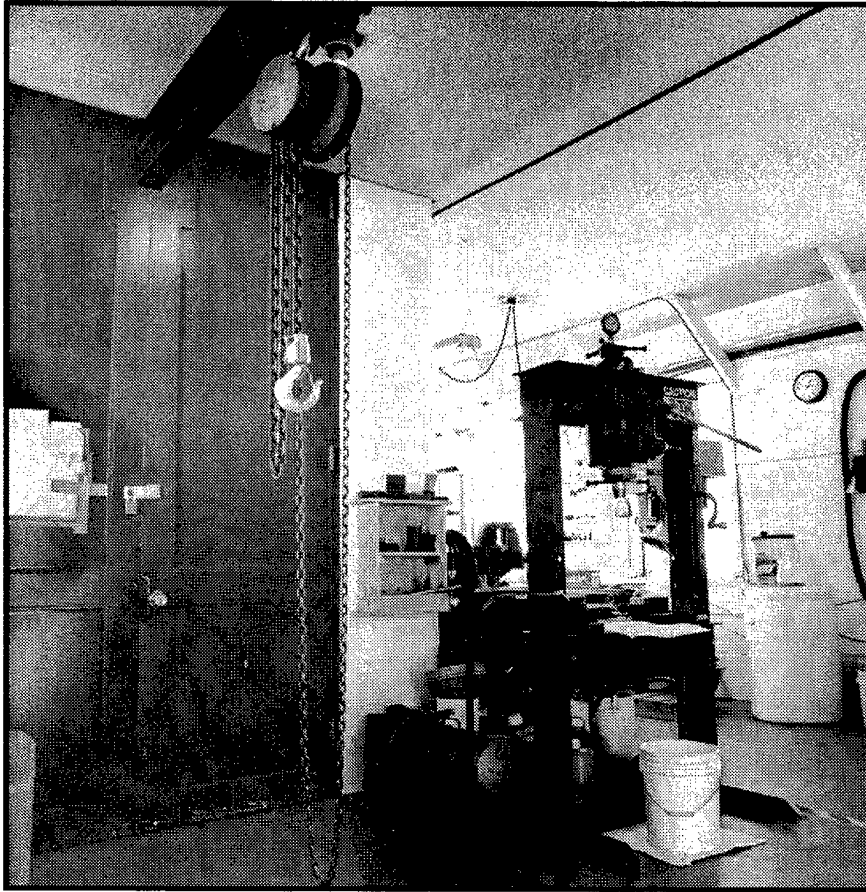
Figure II-65. Interior view of Laboratory and Control 3887. Original Chlorine Storage Room on Main Floor of North Wing (Now Storage Area and Shop). Room to Left is 1961-era Modification. Overhead Traveling Crane Moved Chlorine Tanks. Roll HH27, Exposure 10.

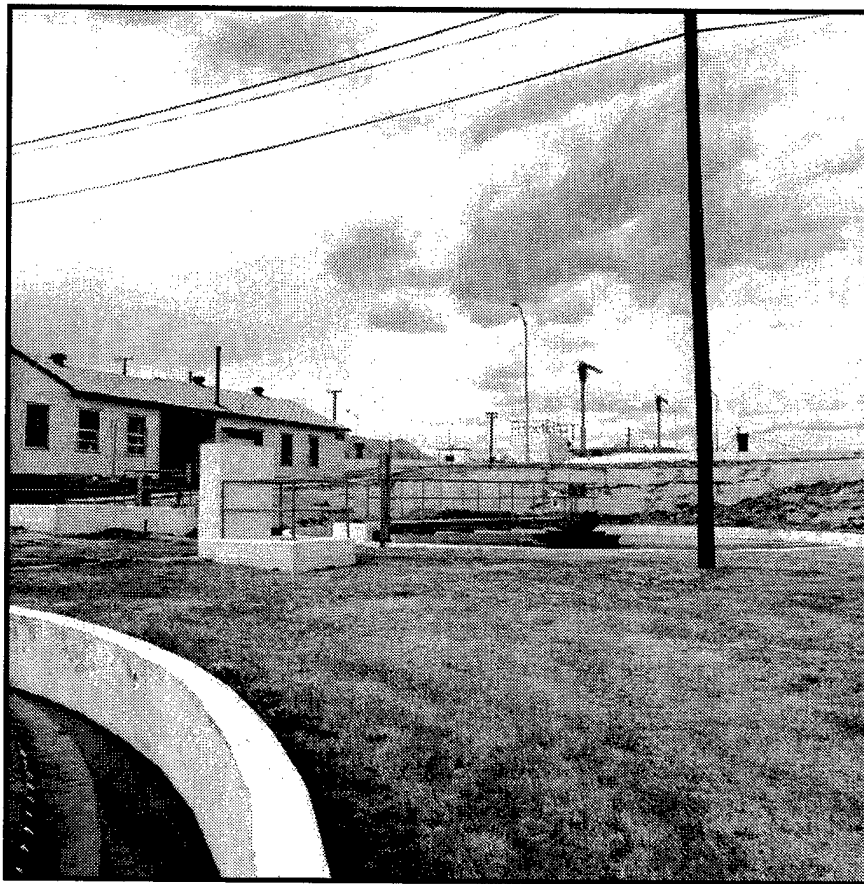
Figure II-67. View of Unnamed Abandoned Flow Box. This Open Structure Sits Over the Exposed Channel Carrying Effluent From Secondary Clarifier 3888 to Diversion Box 3891. Roll HH19, Exposure 8.

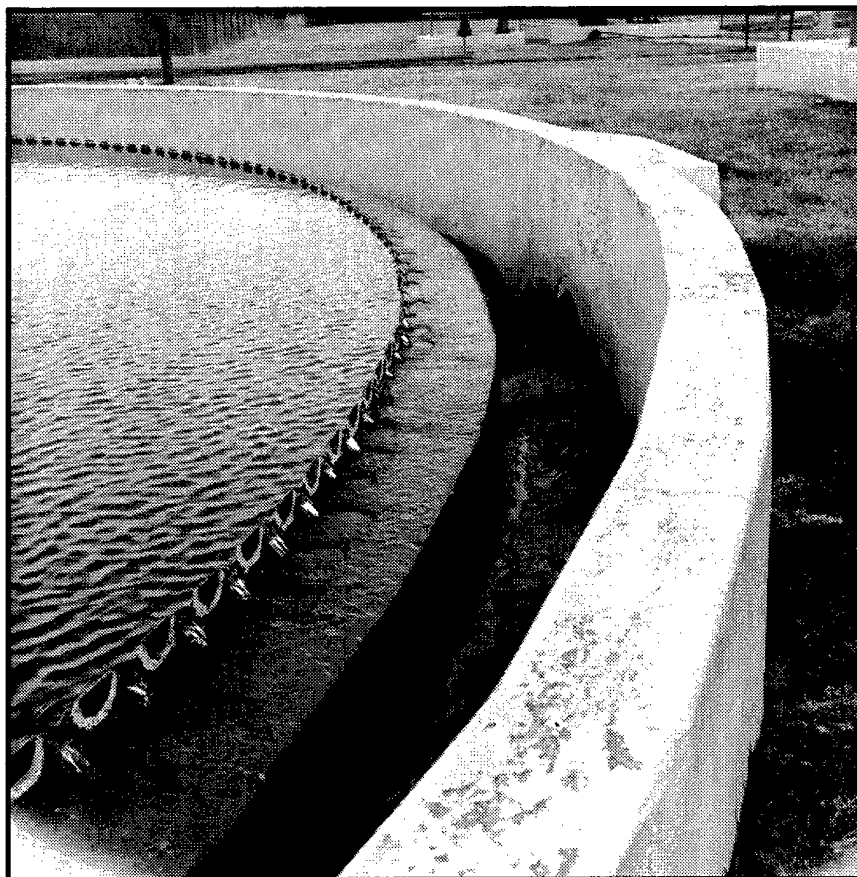
Figure II-76. Detail View of Typical Secondary Clarifier Weir Plate and Effluent Drain. View of Secondary Clarifier 3895. Roll HH22, Exposure 5.
