Damage Behavior of Composite
Structures and Joints
at Room and Elevated Temperatures

Final Report: Phase I

Contract No: DAAE07-96-C-X-121

March 1998

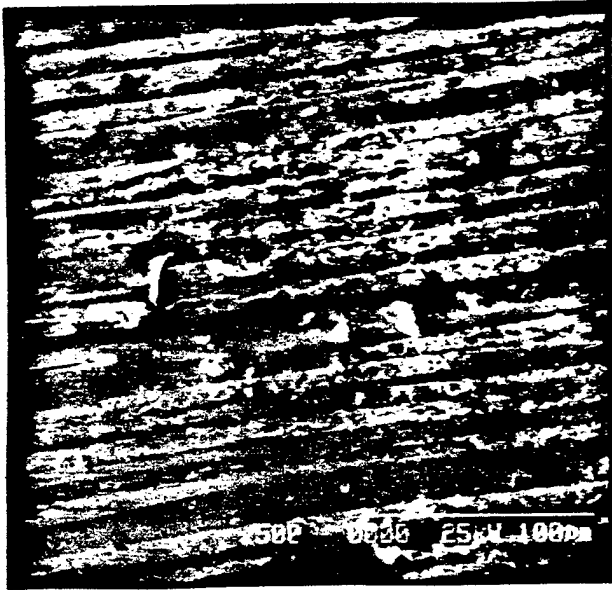
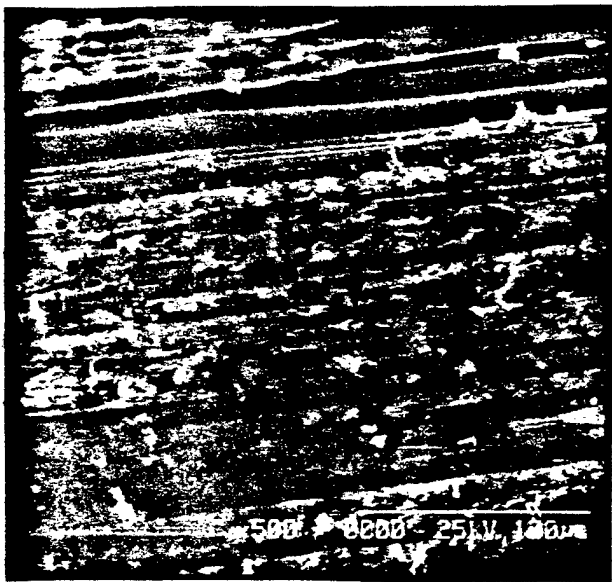
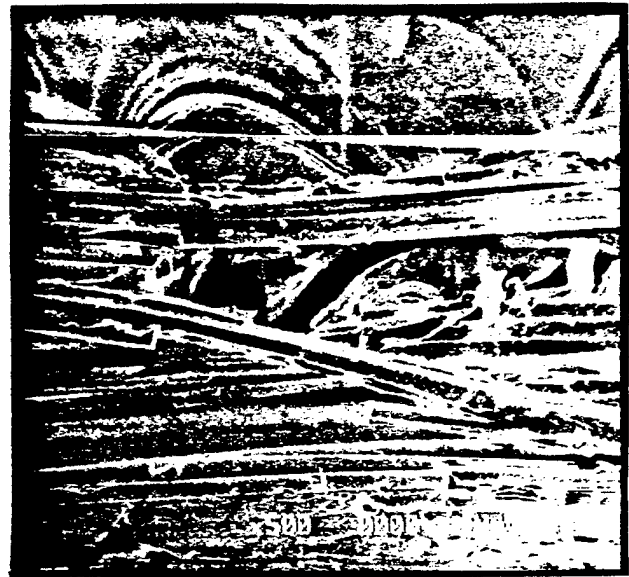
(a) No Load

(b) at 930 MPa

(c) At 1300 MPa

(d) at 1480 MPa
Fiber breakage

Fig.6 Microphotographs showing fiber breakage and interfacial debonding.

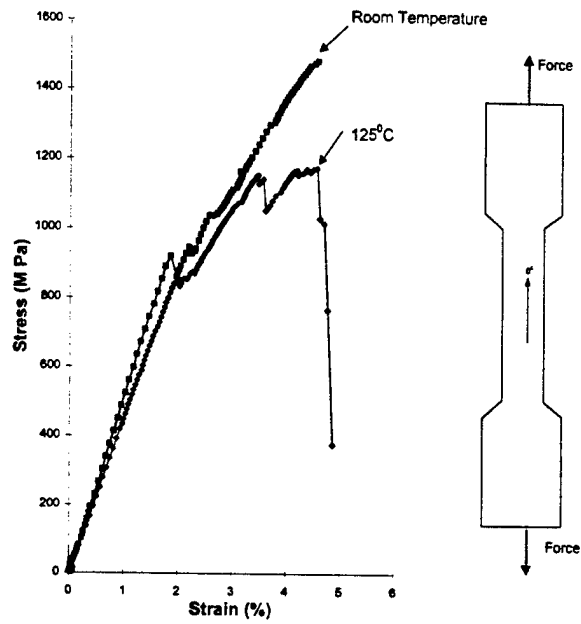
Fig.8 Comparison of room temperature and 125°C results for $[0^0]_8$ -ply specimens.

The tensile testing in SEM has provided us extremely important information about the mechanical behavior of the composite at room and elevated temperatures. The results are summarized in Fig. 5, 8 and 9. Fig. 5 shows the effect of various lay-up configurations. It is noted that the strength, stiffness and failure strain are greatly affected. Using the rule of mixtures, transformation formulas and classical lamination theory, one can predict the stiffness of the composite for the various configurations. Comparison of the predicted values with experimental data is given in Table 3. It must be noted the agreement between theoretical and experimental values is very good. The failure strength also is affected by the lay-up configuration. In this case the simulation of experimental results is done through the Finite Element model which is discussed later.

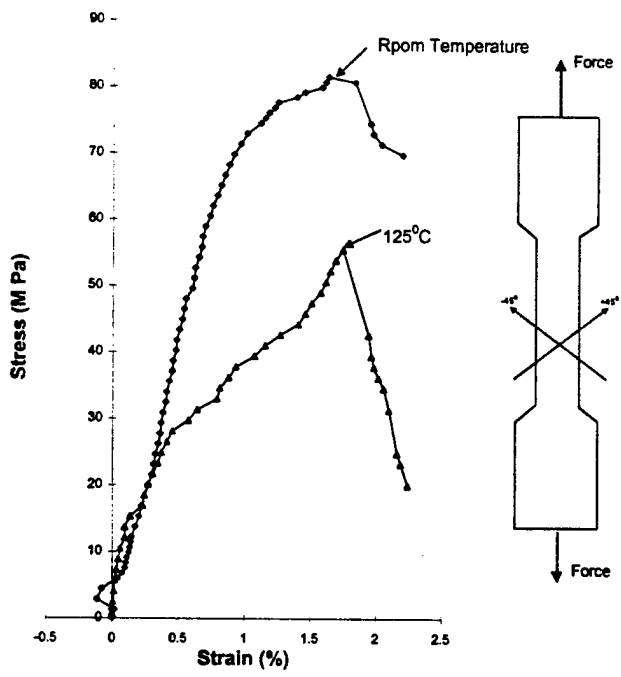
Fig.9 Comparison of room temperature and 125°C results for $[+45^0/-45^0/+45^0/-45^0]_s$ specimens.

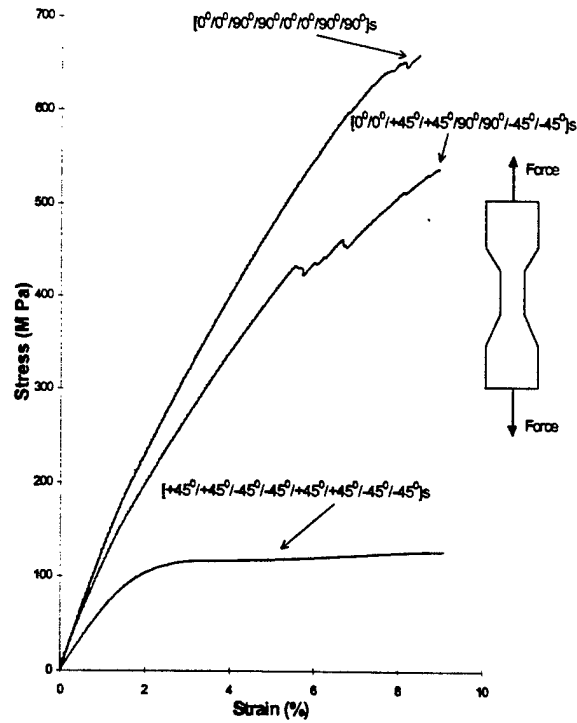
Fig.17 Effect of lay-up configuration at room temperature (Short specimens)

The main reason of conducting these tests was to ascertain whether the size of the specimens had any effect on the behavior of the composite. The results at room temperature, 75^0C and 125^0C are shown in Figs.17-19, and basically conform with those obtained for longer specimens. It must be noted that, the same configuration and temperature effects on the failure strength, stiffness and strain at failure are observed here also. The effects of configuration on strength, stiffness and failure strain of the composite at various temperatures were shown in Figs. 17-19. Figs. 20-22 depict the effect of temperature for three different lay-up configurations.

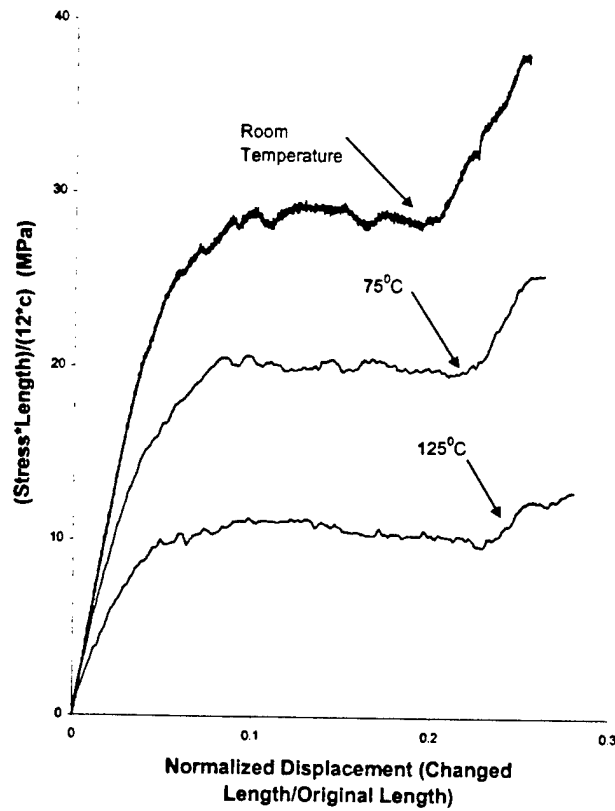
Fig.30 Effect of Temperature for $[+45^{\circ}_3/-45^{\circ}_3]_{2s, type2}$ (Three Point Bending)

The room and elevated temperature results are presented in Figs. 24-30. In Figs. 24-27 the mid-span normalized stresses are plotted vs. the mid-span normalized displacements at room temperature, 75°C and 125°C to show the effect of lay-up configurations on the behavior of the composite. The three-point bending behavior of this composite is mostly linear, followed by a sudden drop in the stress indicating failure of at least one ply or delamination. Ply failure is usually associated with broken fibers and severe

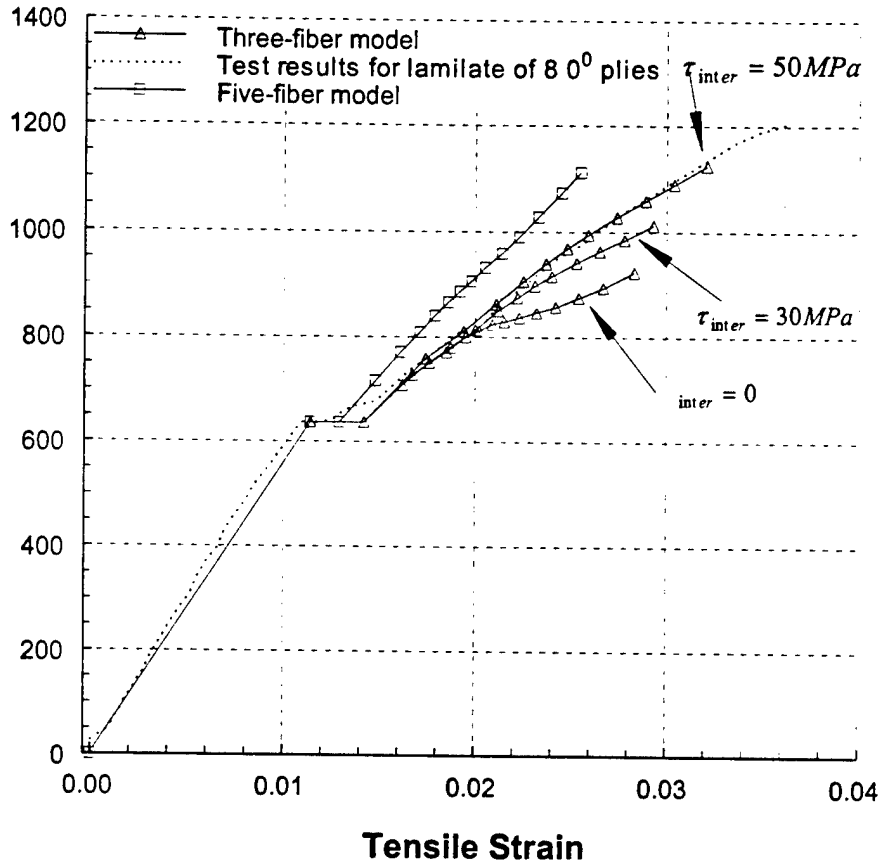
Fig.39 Comparison between simulated FE and experimental stress-strain curves for S2 glass toughened epoxy $[0^{\circ}]_{8-ply}$

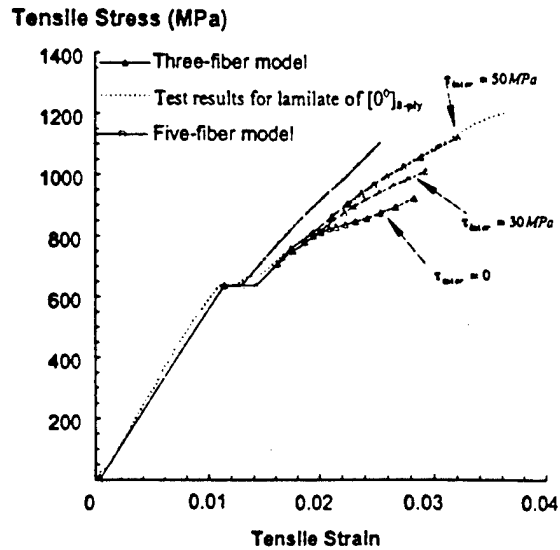
An analytical model to simulate the observed behavior and based on micromechanics was developed. It was observed that the model based on finite element calculations and incorporating the elastic properties of matrix and fiber, and interfacial shear can simulate the observed behavior quite well (Fig.2.)

Fig. 2. Comparison between simulated FE and experimental stress-strain curves for S2 glass toughened epoxy ($[0^0]_8-ply$)
