Case Study: Structural Evaluation of Heavy Wood Trusses at Corpus Christi Army Depot, Texas

by Ghassan K. Al-Chaar, Dexter S. Yoon, and Pramod Desai

REFERENCE: USACERL Technical Report 99/26, *Case Study: Structural Evaluation of Heavy Wood Trusses at Corpus Christi Army Depot, Texas*

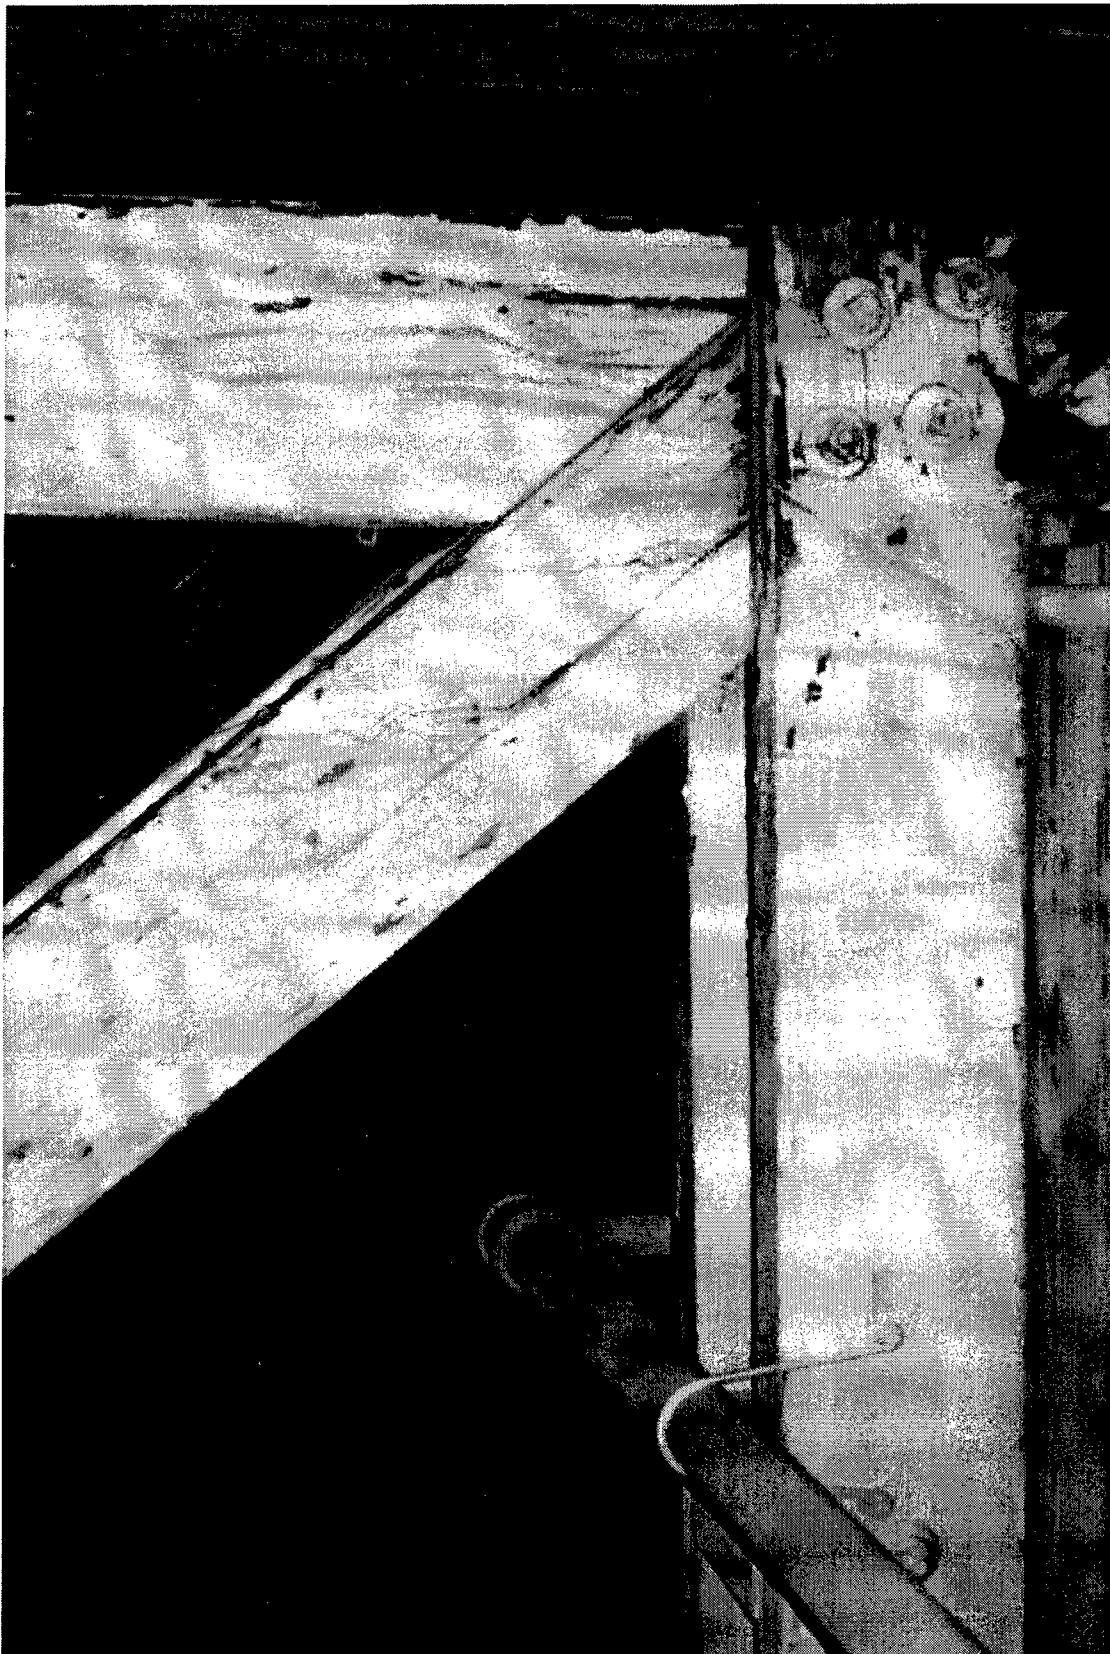
6. Decay was found in joint B, Truss 24.5. See Photo 9. The bolts are loose, and repairs are recommended in Chapter 6.
7. Eight diagonal members were found to be fractured, as shown in Photos 10 through 17. These members are: BZ and QM in Truss 27, CY in Truss 29.5, BZ and CY in Truss 34, DX in Truss 36, QM in Truss 36.5, and PN in Truss 38. See Chapter 6 for repair recommendations.

Photo 9. Major damage due to decay in a joint in Area A.

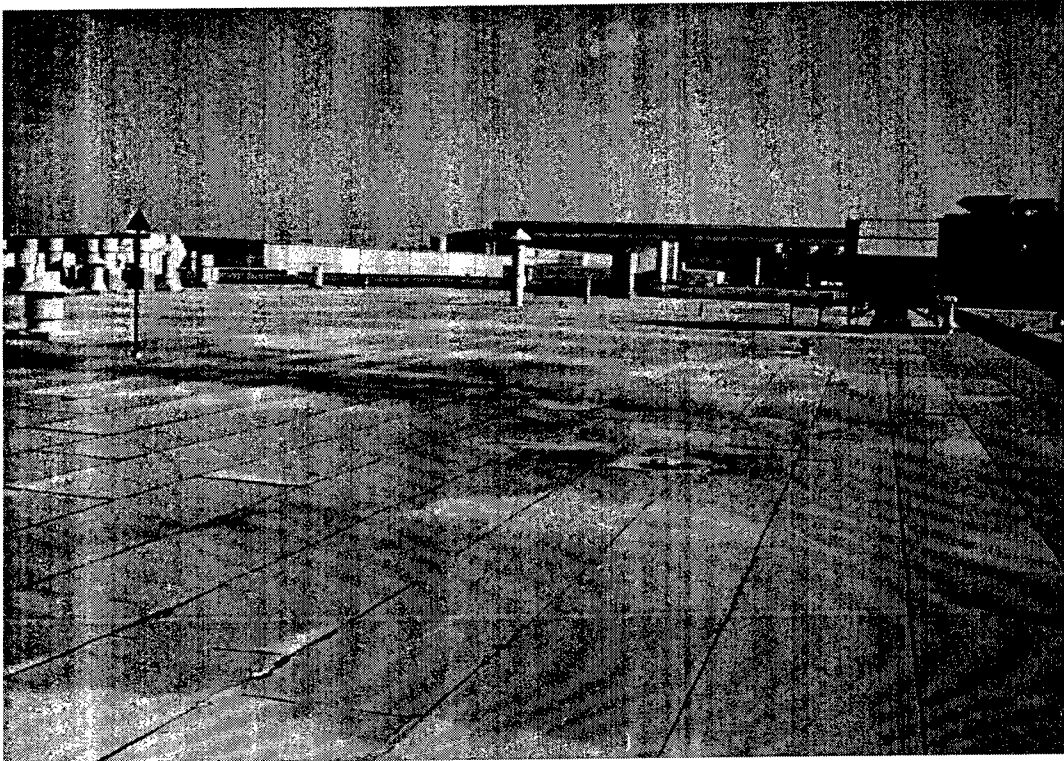
2. Major signs of roof leaks were observed in several areas. Some of the leaking areas of the roof may have been repaired, but surfaces on the roof are still collecting water and may be actively leaking, as shown in Photos 19 and 20. All traces of leaks observed from the inside of the structure and from the surfaces on the roof that are still collecting water are shown in Figures 5 and 6. Roof repair is recommended. Also, the roof should be inspected during heavy rain to ensure the protection of the wood members supporting the roof.

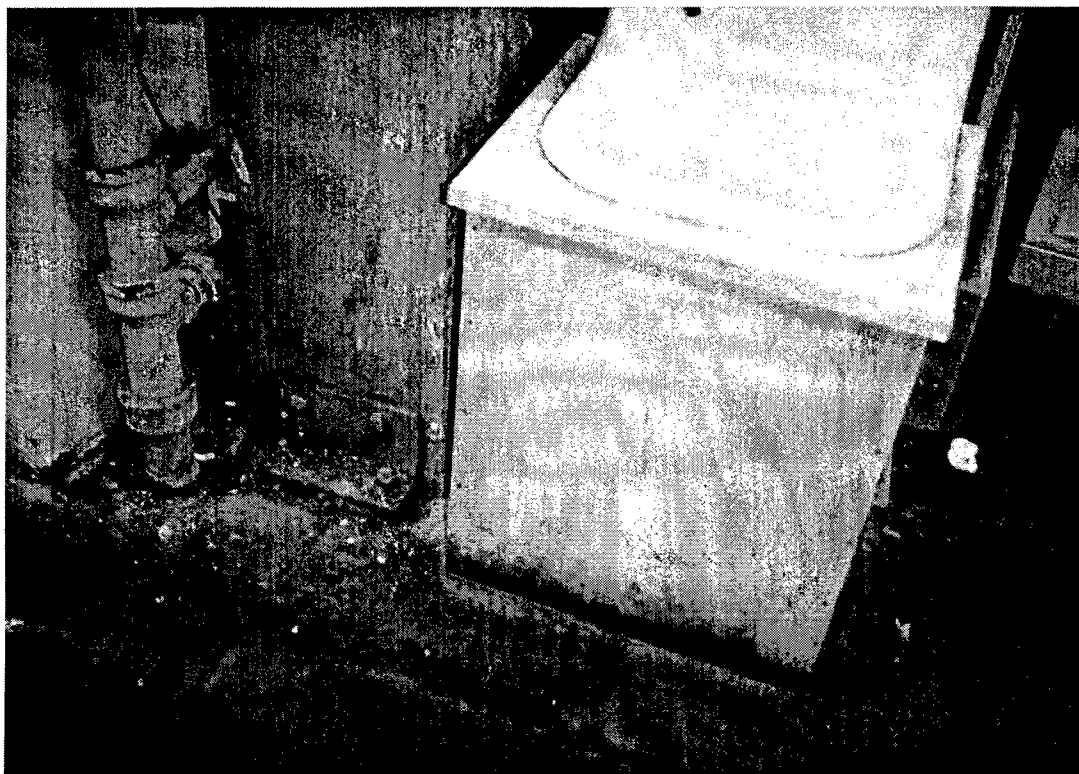
9. A sink in Area C, column line 53, will cause damage to the adjacent column, as shown in Photo 25. Isolating the sink from the column is recommended.
Moisture content from 18% to 23% is a potential start for termites.
10. The truss in column line 40, between column line I and G, has a fracture in the top chord between joints J and K, as shown in Photo 26. See Chapter 6 for recommended repair.
11. There is a fractured member in a truss on column line 56, Area D, located on the lower chord of the truss, between Joints R and T, as shown in Photo 27. See Chapter 6 for recommended repair.
12. Diagonal member CT in Truss 63 of Area B was found fractured, as shown in Photo 28. See Chapter 6 for recommended repair.

Photo 25. Leakage from a sink that will damage a column.

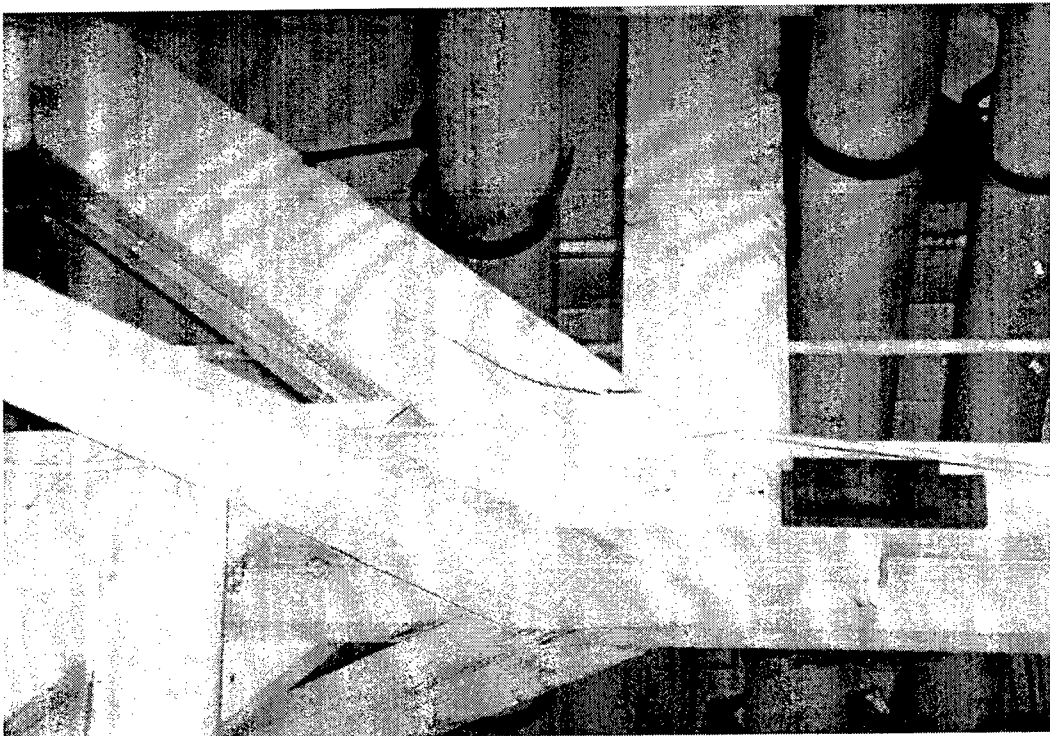
Photo 28. Fracture on member CT of column line 63.

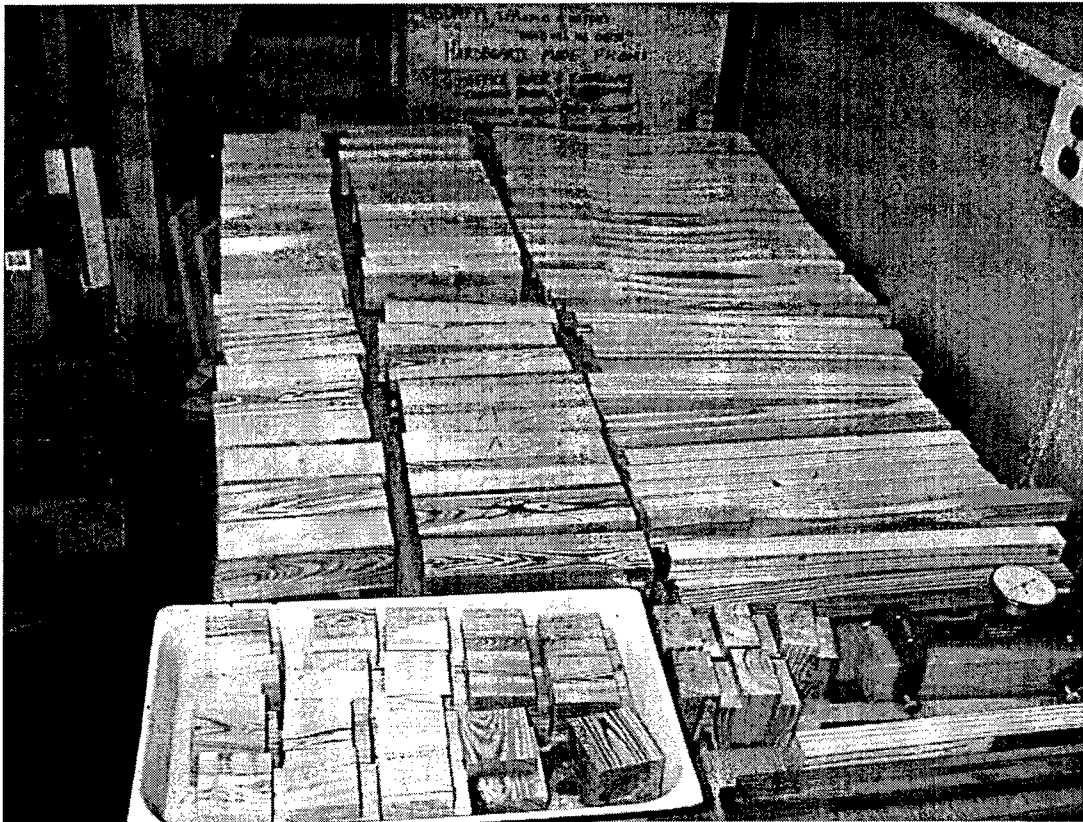
Table 8 shows the dimensions and specific gravities of the tested samples. Table 9 and Photo 29 show five different kinds of test specimens that were cut from the two sample sets, A and D. First, the specimens were conditioned at a relative humidity of 65% and a temperature of 68 °F for a period of at least 72 hours. They were then subjected to five mechanical tests using a universal testing machine, following standard ASTM D-143 test procedures (Reference 3). Both the average moisture content and specific gravity value for each specimen also were determined.

Photo 29. Specimens cut and conditioned in a chamber at 68 percent humidity and 67 °F.
