HAZARD DIVISION 1.2 TESTING IN A MINIATURE MAGAZINE

Michael M. Swisdak, Jr.

6. AUTHOR(S) Michael M. Swisdak, Jr.			
7. PERFORMING ORGANIZATIONS NAME(S) AND ADDRESS(ES) Indian Head Division Naval Surface Warfare Center Indian Head, MD 20640-5035			8. PERFORMING ORGANIZATION REPORT NUMBER IHTR 2158

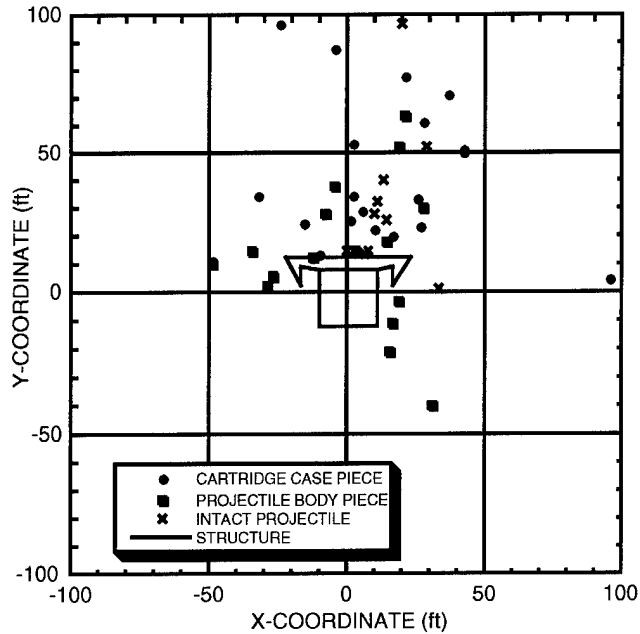
Figure 4-3. Debris Recovery—Narrow View

There was no concrete debris ejected from the structure. The farthest fragment throw was 204.2 m (670 ft); this item was a piece of projectile body. Its final position was in line with the opening on the side of the barricade. Two fragments had a range of about 91 m (300 ft), 9 fragments had a range of about 61 m (200 ft), 9 fragments had a range of about 30 m (100 ft), and 50 fragments had ranges of less than 30 m (100 ft). Figures 4-2 and 4-3 are plots of the recovered debris locations. Figure 4-2 presents a wide field and shows the locations of all of the recovered items; Figure 4-3 presents a more restricted view and concentrates on the region around the structure. Appendix B is a catalog that gives the location and description of each debris piece.
