**DOT/FAA/AR-99/34**

# **Characterization of Early Stages of Corrosion Fatigue in Aircraft Skin**

## **Phase II: Interpretation of Corrosion-Fatigue Fracture Surfaces in Alclad 2024-T3 Aluminum Alloy Sheet**

Phase II Report

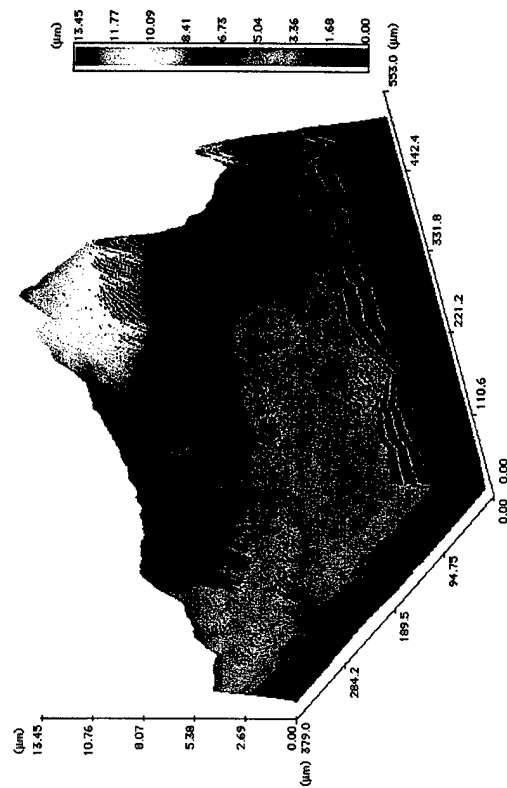
(a) Left SEM Photograph

(b) Right SEM Photograph

(c) Grayscale Topography Image

(d) Perspective View of Fracture Surface

In summary, an SEM-based stereoanalysis program has been developed that can be used to study details of fracture surface topography at higher magnifications than is possible with a confocal optics scanning laser microscope. Further improvements are necessary to shorten computational time and to reduce the local noise in the elevation data.
