Dredging Research Technical Notes

Stability Evaluation of the Octapod Sensor Mount

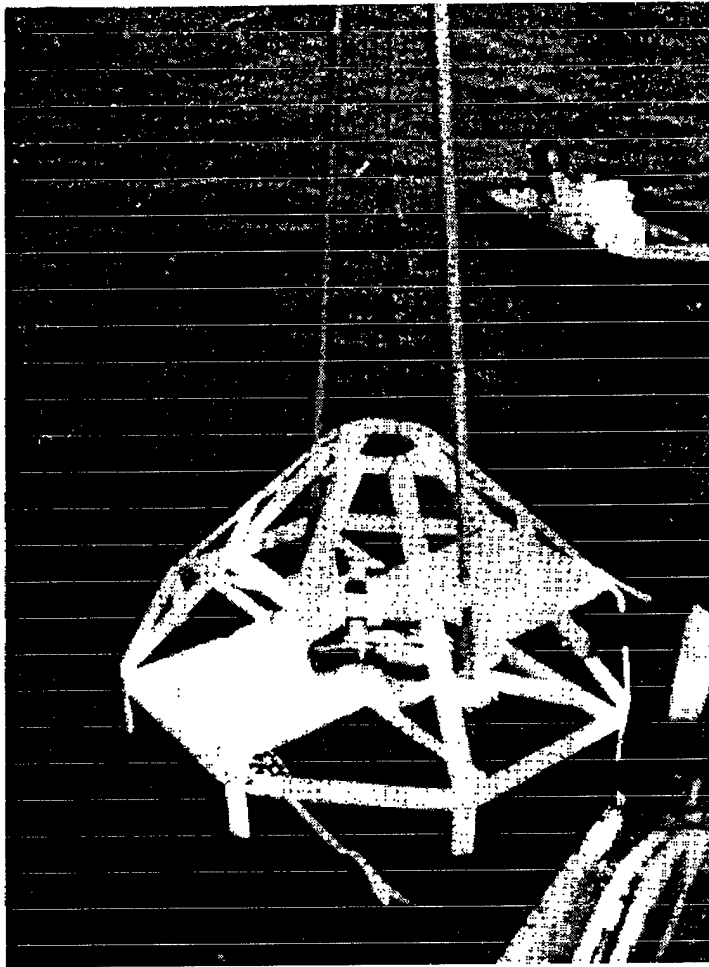
Figure 1. OCTAPOD being deployed

The Octapod (Figure 1) is a 4-ft-tall, eight-sided, heavy steel instrument mount designed by CERC's Prototype Measurement and Analysis Branch (PMAB) to support and protect a variety of oceanographic sensors. The 1-ft-long leg extensions located at each of the eight corners were designed to bury into the bottom to prevent trawler nets from snagging the base plate and entangling the Octapod. Although the design of the Octapod used in this field evaluation has recently been extensively modified to make it more trawler-resistant, the stability results presented herein are still valid.

The modified design is six-sided and 2 to 3 ft tall, depending on application, with 2-ft-long leg extensions.

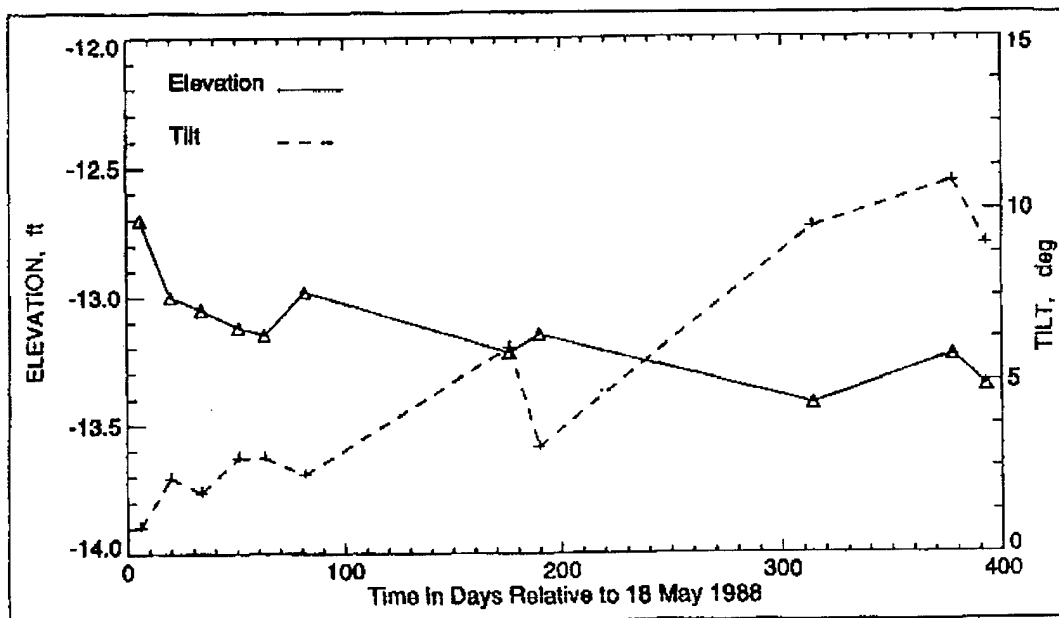
Figure 2. Octapod elevation and tilt

Eleven measurements were made starting on 24 May 1988 (day 6 on the abscissa of Figure 2) and ending on 15 June 1989 (day 394). The measurements were not uniformly distributed through time; over half were taken during the first three months of the study when the greatest amount of settling was expected. Some additional measurements were attempted but could not be made because of high seas. In addition to the measurements of the Octapod, 24 surveys were conducted of profile line 188 located 80 ft to the south. Five of these surveys are shown in Figure 3. Table 2 lists interpolated depths at the position of the Octapod (1,570 ft) and at other nearby locations. Periodic diver inspections were made to observe the Octapod and note any scour or filling that took place.

Table 1 summarizes each of the Octapod measurements. Elevations computed based on each of the prisms compared favorably. Note that the adjusted X and Y coordinates given in Table 1 are for the location of the prisms, not of the Octapod itself. A detailed analysis of the 10 repetitions from each measurement session indicated that by using 10 measurements the tilt of the Octapod could be resolved to 1 deg and the elevation could be resolved to 0.1 ft. The variation in Octapod elevation and tilt are shown in Figure 2. Figure 2 clearly shows the rapid decrease in depth (0.3 ft) which occurred immediately following the first survey, an apparent response to the installation. It also shows the relative stability during

most of the period and the points that indicate upward movement of the Octapod.

The most significant of these upward movements occurred during August when it "rose" 0.2 ft. This occurred during a survey that also shows a general upward movement of the entire profile of about 0.2 ft. Since there were no storm events, this apparently is an error which probably resulted from a slight tilt of the Elta 2S (0.0044 deg). The first survey in November is also suspect. It is 0.1 ft below the 24 November 1988 survey (day 191), and the 20 July (day 64) survey; the value for the tilt is much greater than for those other surveys.

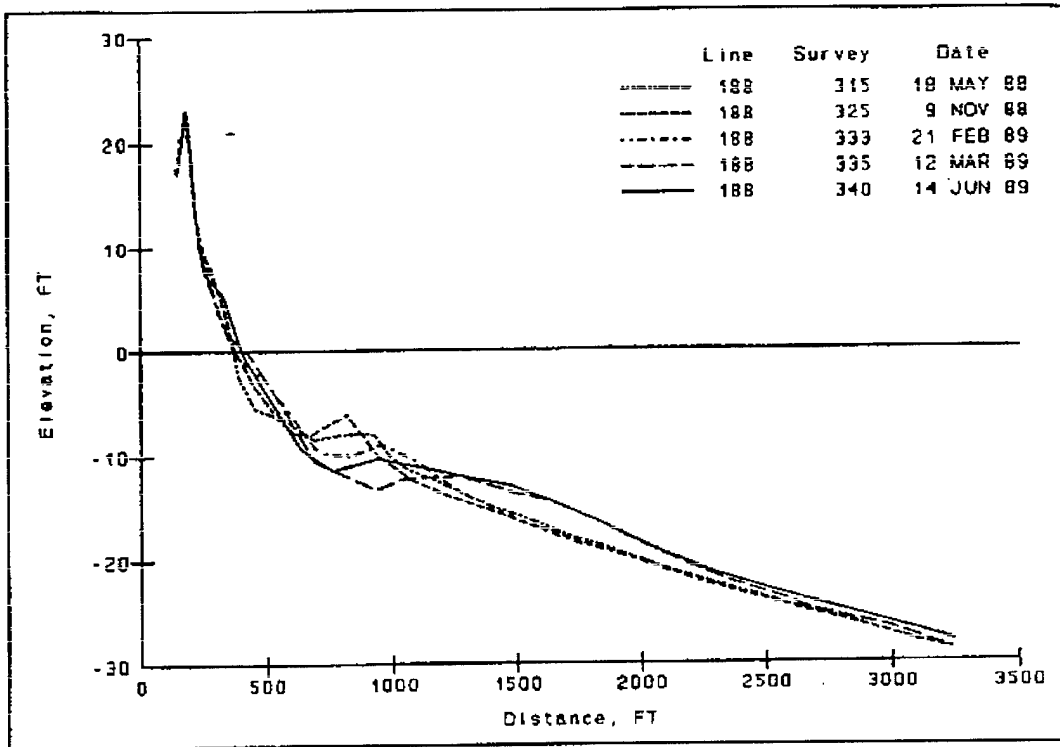
Figure 3. Representative surveys of Profile Line 188 during the study

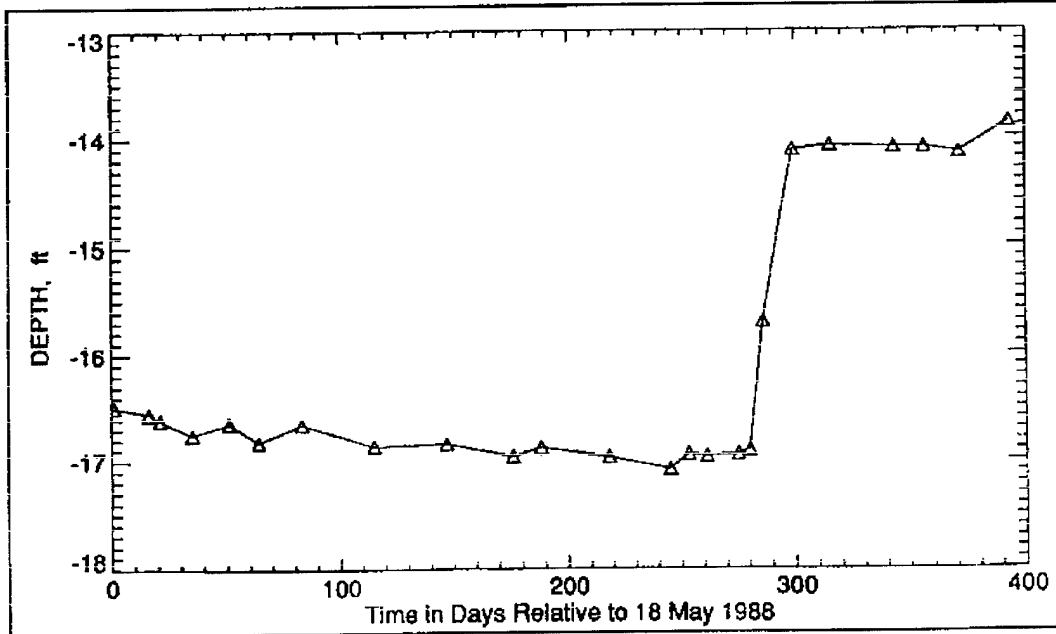
Figure 4. Variation in depth at the Octapod site

The variations in sea-floor depth at the Octapod are clearly seen in Figure 4 which plots the data in Table 2. The figure shows that at the location of the Octapod the bottom was extremely stable until a sequence of

two storms occurred, the first on 24 February 1989 (day 282) and the second two weeks later on 7 March (day 296). Each of these storms moved significant amounts of material offshore, ultimately covering the Octapod with 2.7 ft of sediment.
