**RESEARCH ON ADVANCED NONDESTRUCTIVE  
EVALUATION (NDE) METHODS FOR AEROSPACE STRUCTURES**

**UNIVERSITY OF DAYTON RESEARCH INSTITUTE**

**REPORT DATE: October 1998**

**FINAL REPORT FOR 9 SEP 94 THROUGH 30 SEP 98**

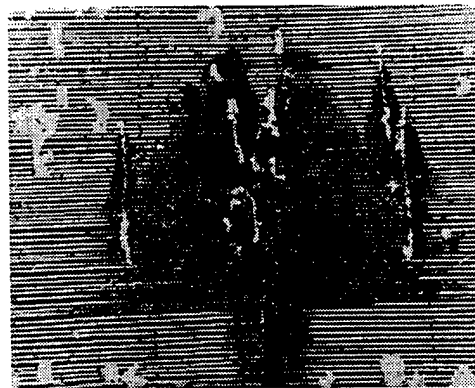
Figure 6. Metallographic result of sample from Fig. 5.
