Water Quality

WOTS Reservoir Erosion Control and Revegetation Workshop and Demonstration

Smithville Lake, Smithville, Missouri

by Hollis H. Allen, Michael A. Watkins, and Bruce K. Clark

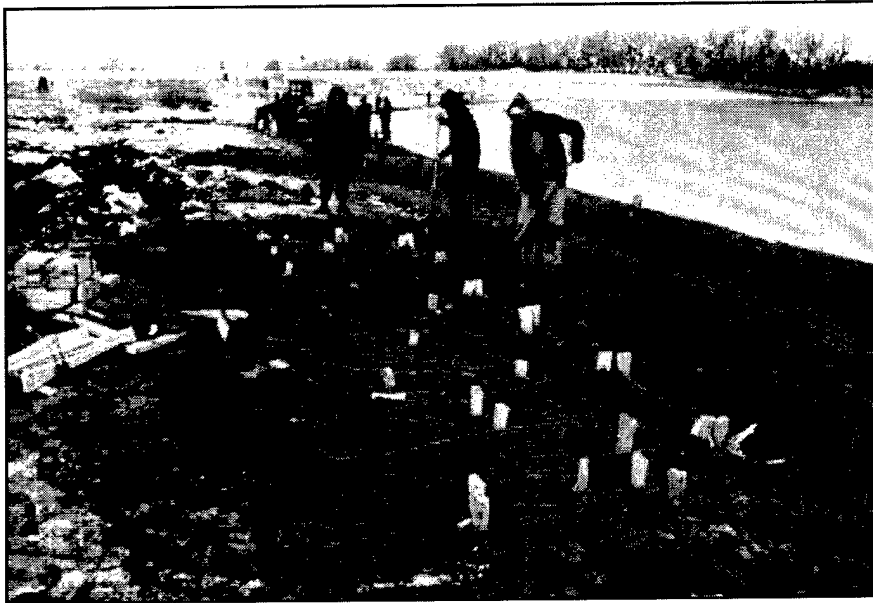
Figure 2. Breakwater made from a coir geotextile roll with workshop participants installing a brush mattress made from willow

The second breakwater treatment consisted of a coir geotextile breakwater that covered 130 ft of shoreline. The breakwater, like the one above, was designed to be temporary. It will diminish wave energy and will allow plants to be planted both behind and in it. The breakwater was constructed of nonwoven coir fiber made from coconut husks and bound by either a choice of woven coir rope or polyethylene rope. The demonstration breakwater was 20 in. in diameter and was bound by polyethylene rope for durability in a wave environment. The shoreward side of the breakwater was planted with emergent aquatic vegetation immediately adjacent to the breakwater, with live willow whips laid down and secured as a brush mattress, in accordance with methods described in Allen and Leech (1997). The coir breakwater with an incom-

plete brush mattress is shown during installation in Figure 2.

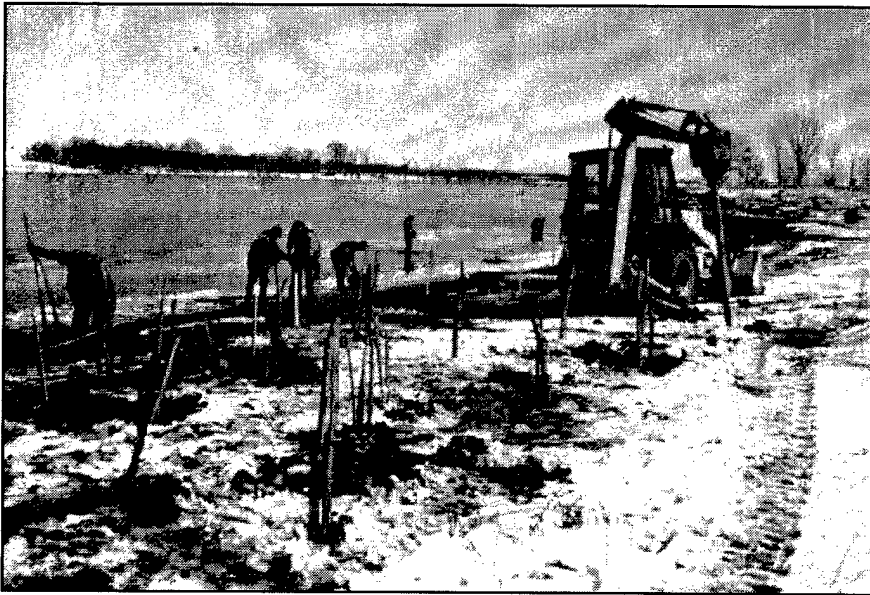
Figure 4. Dormant willow posts being installed with the aid of a backhoe mounted with a "stinger"

to geese and carp. Figure 3 shows one of these patches with the fence around it. Landward of the 4- by 4-ft patches of emergent aquatic plants, both dormant willow poles and willow cuttings were planted. A backhoe with an attached "stinger," as described by Hoag (1994), facilitated the use of 8- to 10-ft long willow poles (Figure 4).

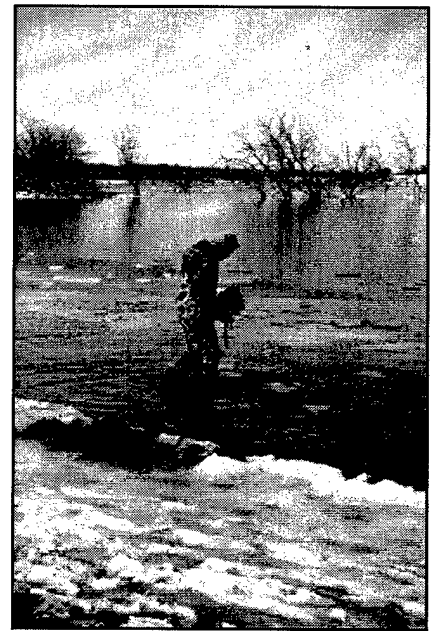
Figure 5. Submersed aquatic vegetation, such as coontail, being deposited in shallow water

vegetation, such as coontail (*Ceratophyllum demersum*) were simply deposited in about 1 to 2 ft of water (Figure 5).
