OPTICAL FIBER-BASED CORROSION SENSORS FOR AGING AIRCRAFT

The Second Joint NASA/FAA/DoD
Conference on Aging Aircraft
Williamsburg VA
Aug 31 - Sep 3

LPG-Based Corrosion Sensor F&S

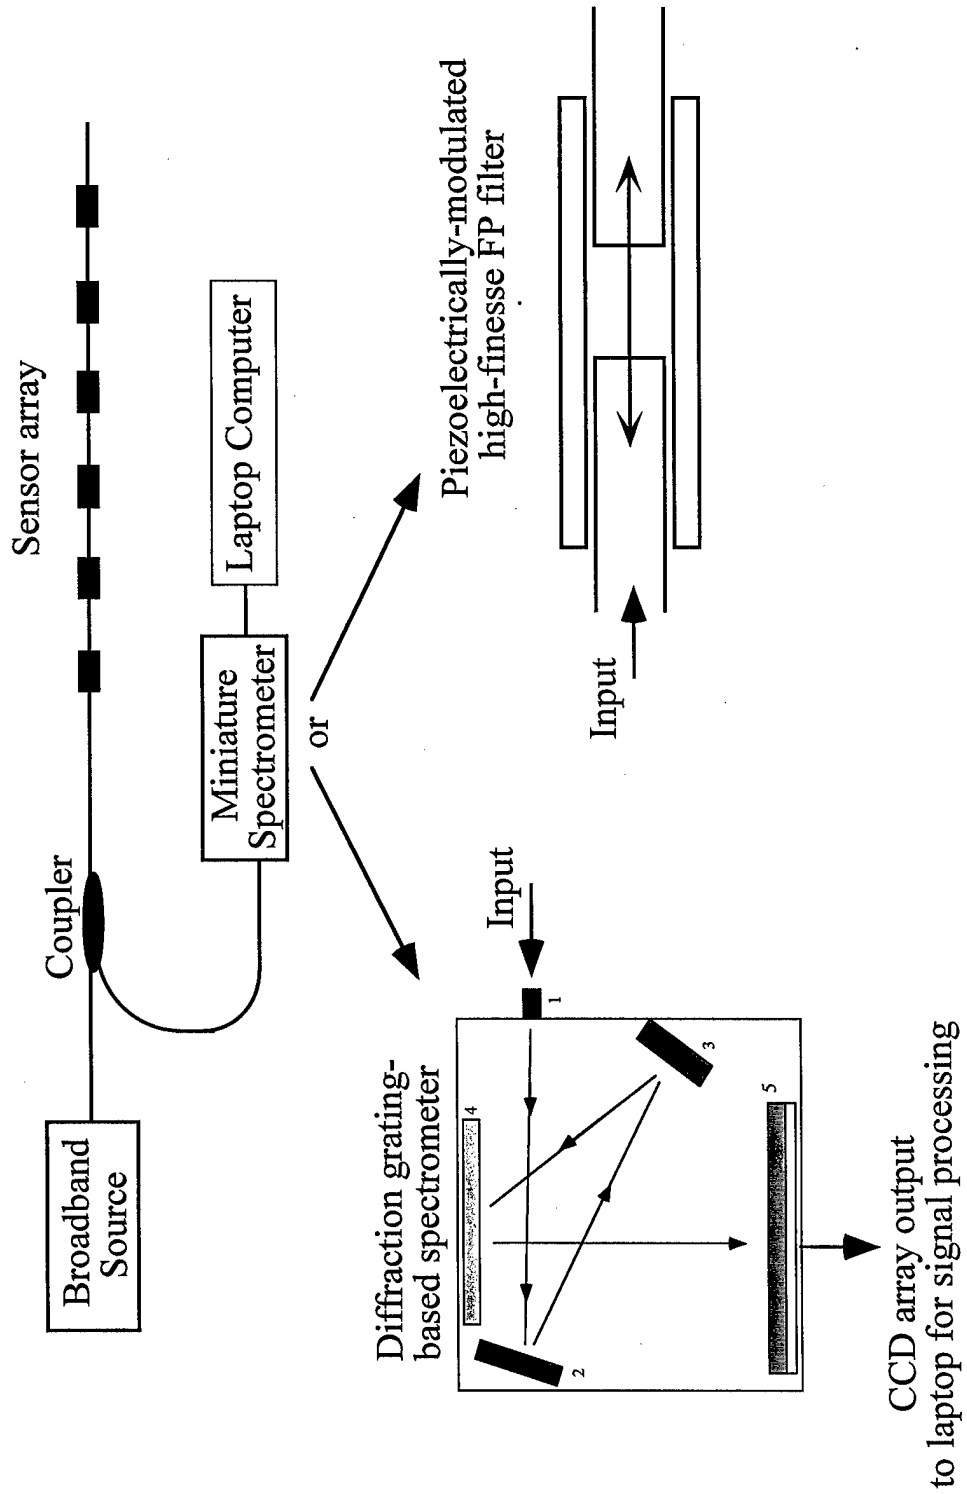
Multiplexing Corrosion Sensors
