CARDIVNSWC-TR-61-99-18 September 1999

Survivability, Structures, and Materials Directorate
Technical Report

**ADVANCED MEASURES TO CONTROL GALVANIC
CORROSION IN PIPING SYSTEMS**

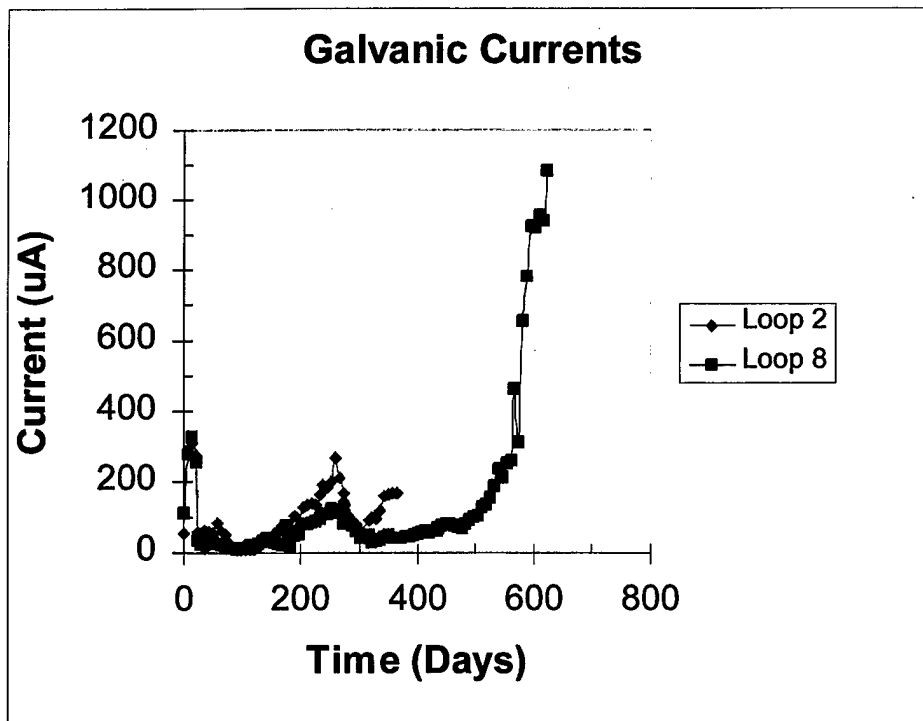
Figure 9 – Titanium with calcareous deposit coating/70:30 Copper-Nickel Piping Couples – measured galvanic currents as a function of exposure time.

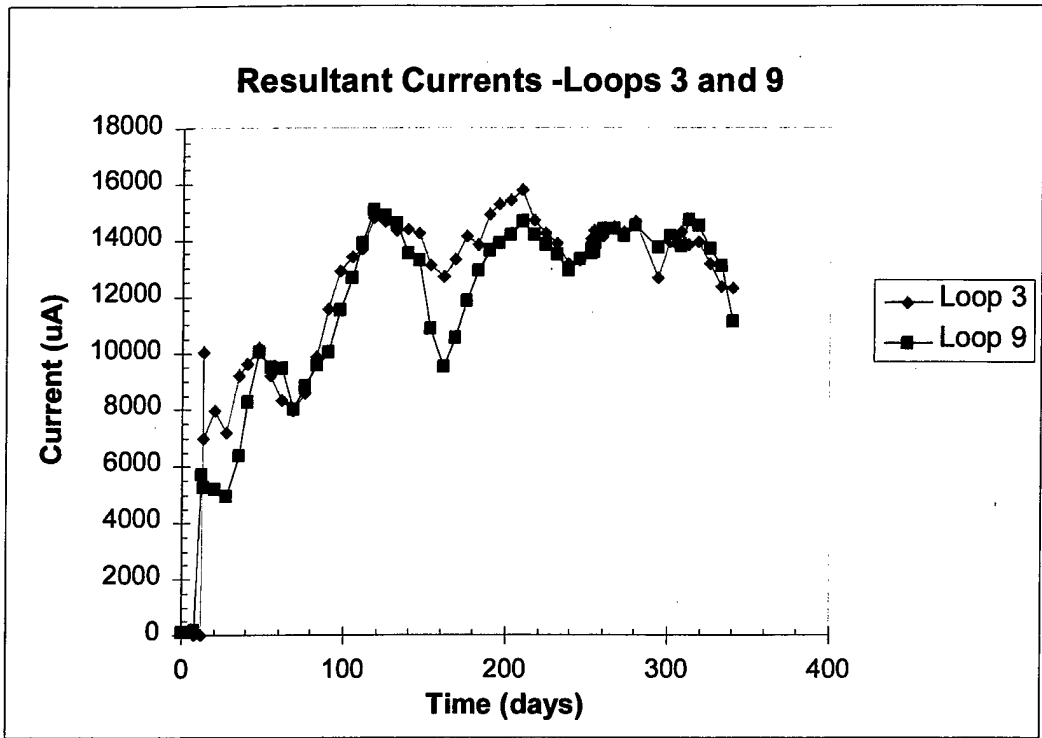
Figure 12 - Alloy 625/70:30 Copper-Nickel Piping Couple with bi-electrode used in the cathodic protection mode – measured resultant currents as a function of exposure

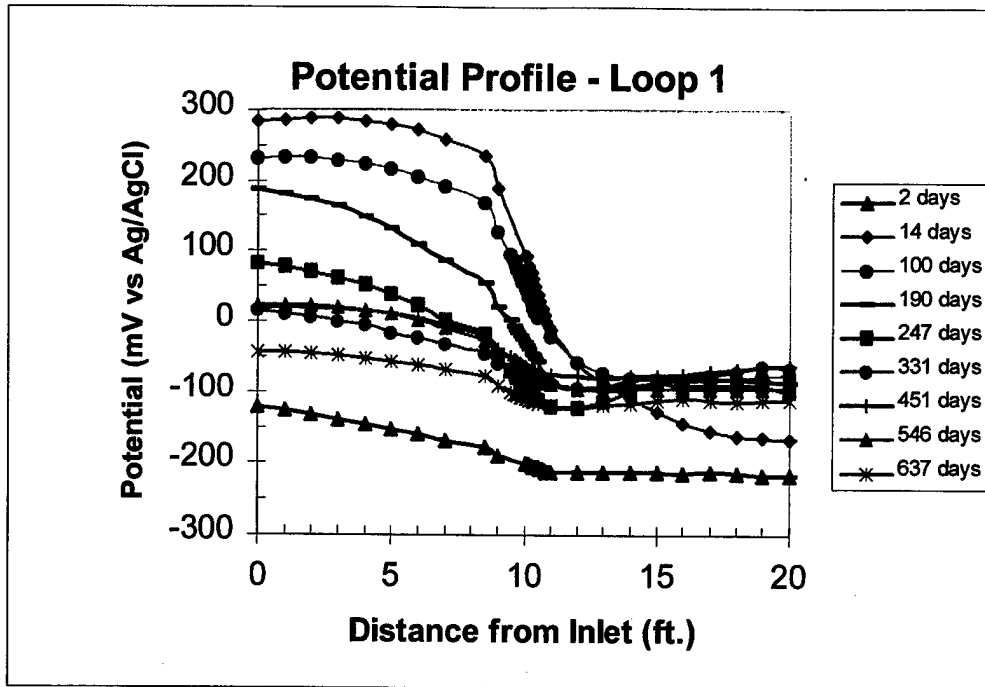
Figure 18 - Titanium/70:30 Copper-Nickel Piping Couple – potential profile of Loop No. 1 as a function of time and location along the pipe (Loop 1).

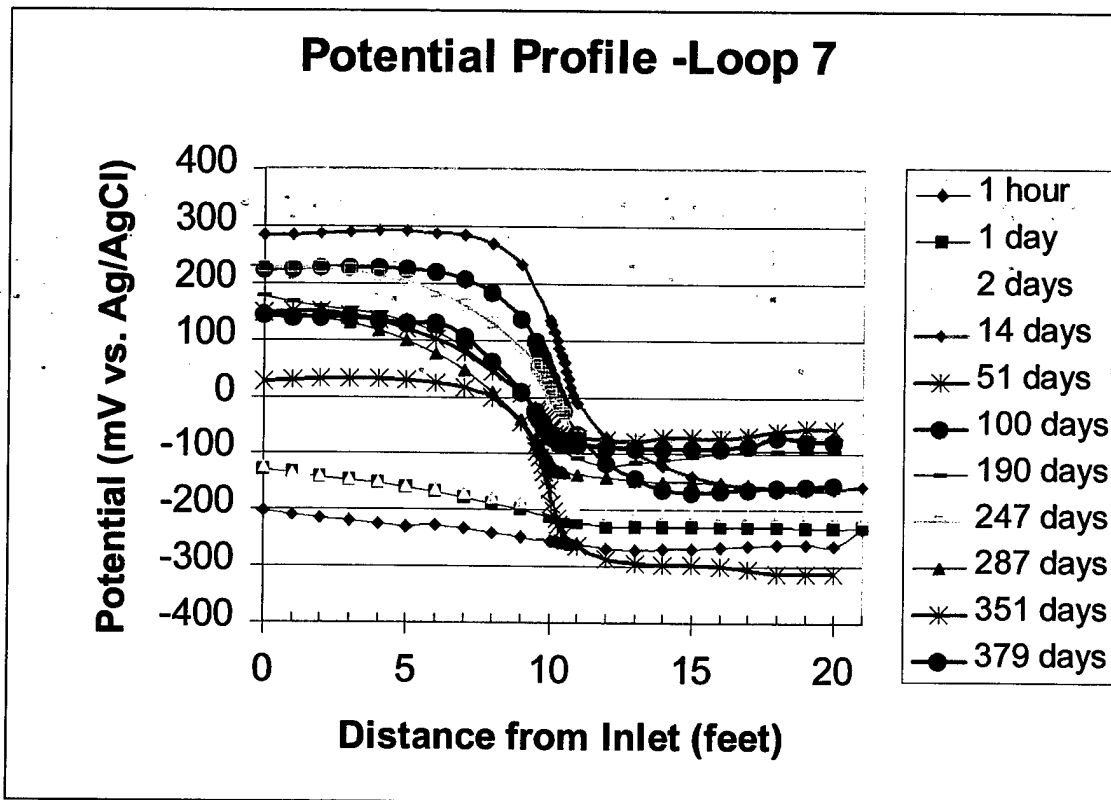
Figure 19 - Titanium/70:30 Copper-Nickel Piping Couple – potential profile as a function of time and location along the pipe (Loop 7).

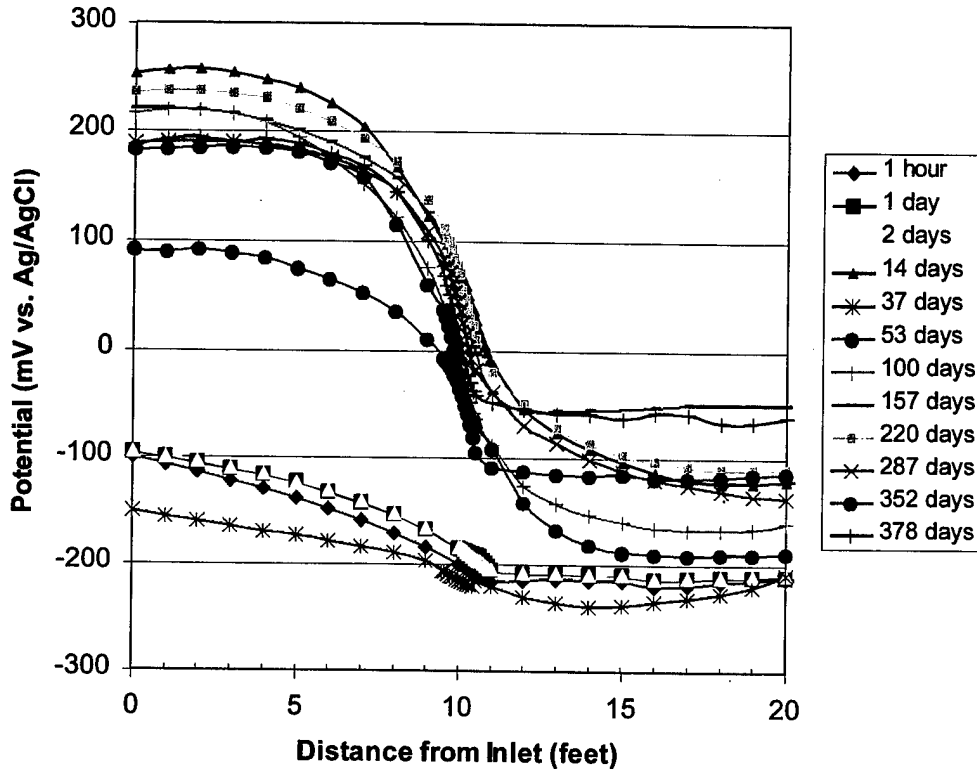
Potential Profile - Loop 12

Figure 23 - Alloy 625/70:30 Copper-Nickel Piping Couple – Loop 12. Potential profile shown as a function of time and location along the pipe.

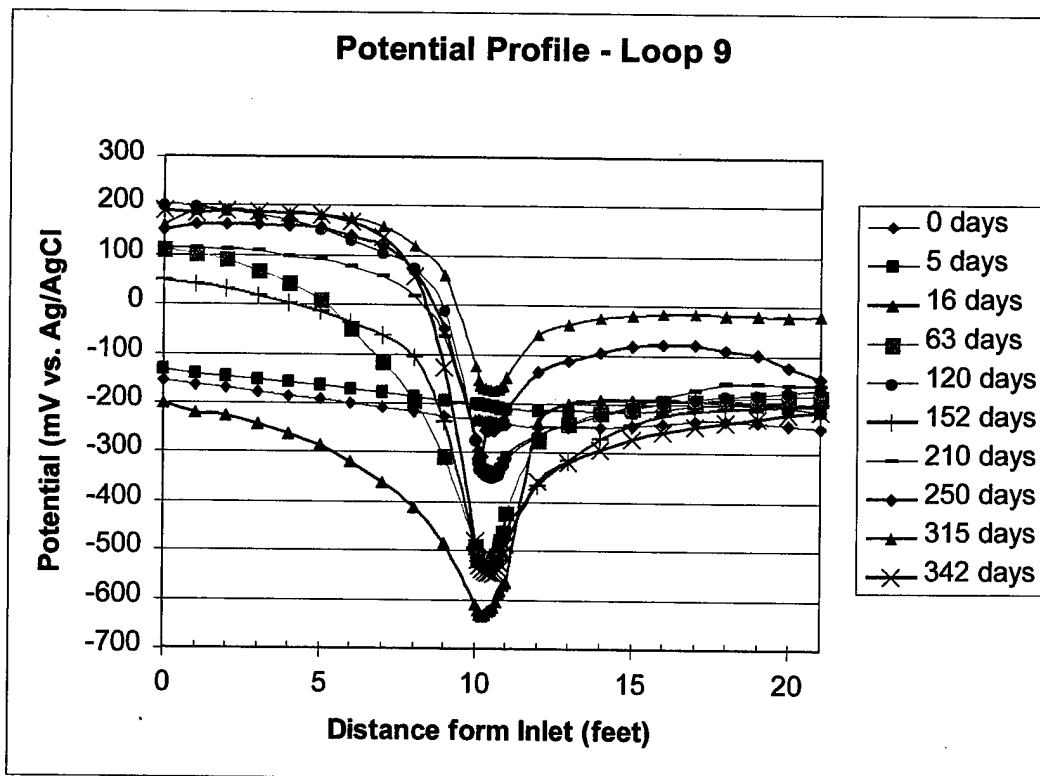
Figure 27 - Alloy 625/70:30 Copper-Nickel Piping Couple with bi-electrode in CP mode – Loop 9. Potential profile shown as a function of time and location.

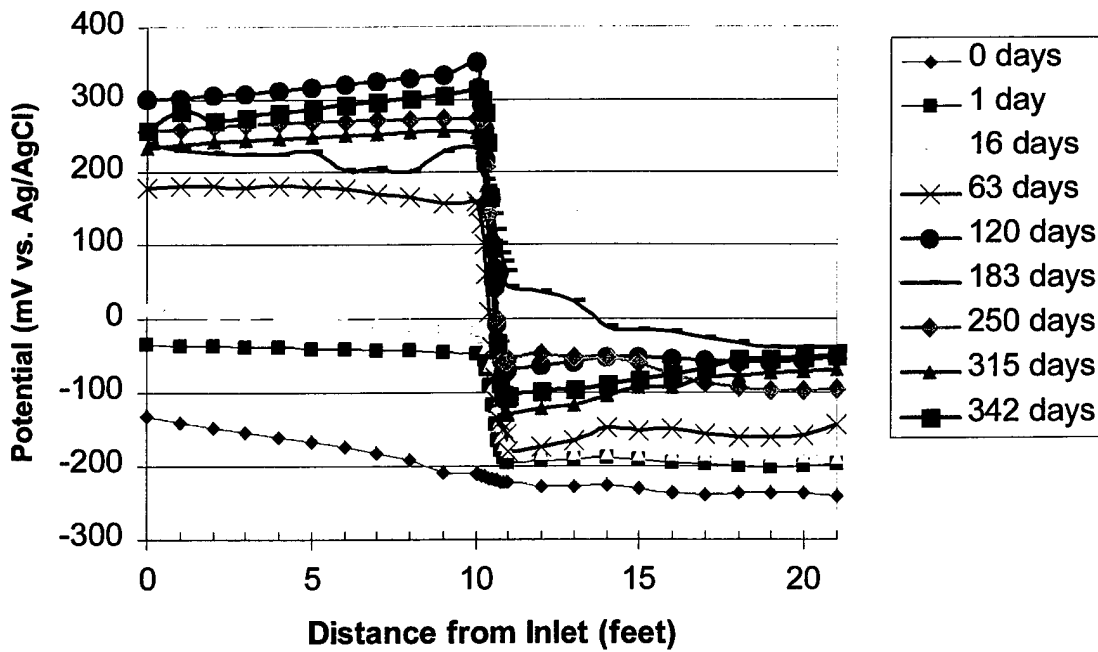
Figure 29 - Alloy 625/70:30 Copper-Nickel Piping Couple with bi-electrode – Loop 10. Potential profile shown as a function of time and location along the pipe

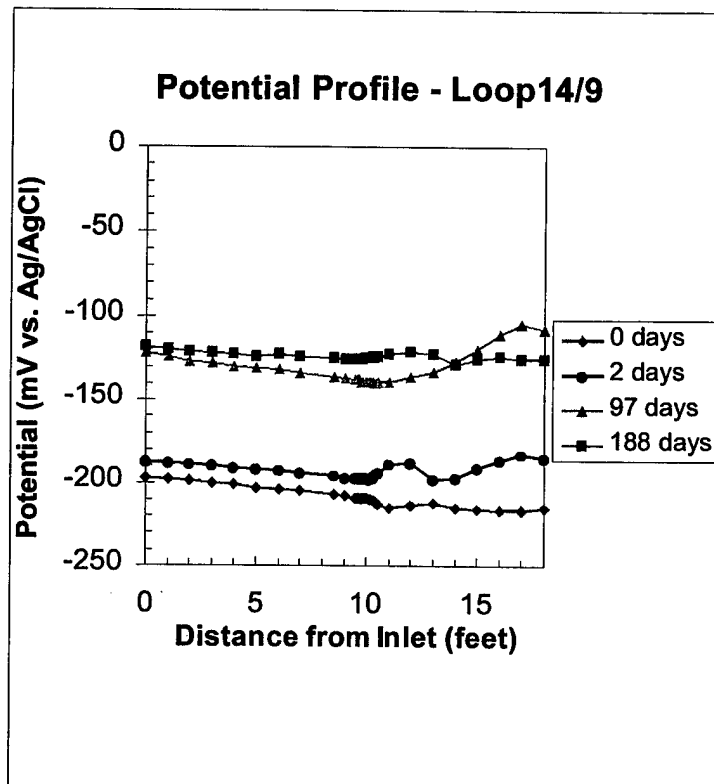
Figure 31 - Tiodize™ Type IV Titanium/70:30 copper-nickel piping couple - Loop 14/9. Potential profile shown as a function of time.

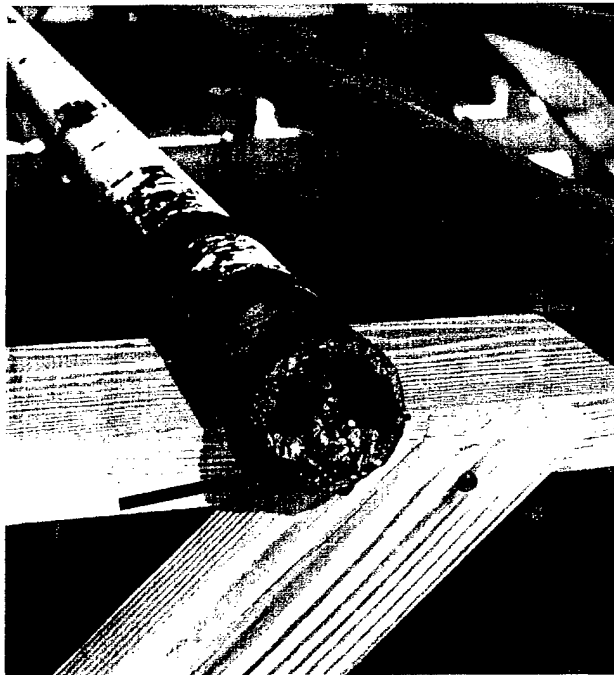
Figure 44 - Macrofouling of titanium piping viewed (at arrow) during one of the inspections during the one-year exposure using filtered natural seawater flowing at 1.8 m/s.

Macrofouling occurred in many of the Alloy 625 and titanium piping sections. Both cathodic alloys are not natural antifoulants or biocides to marine organisms. The recommended velocities for the use of either Alloy 625 or titanium in natural seawater is above 6 m/s (20 fps) which is also about 30% above the maximum recommended (15 fps) velocity of straight sections of 70:30 copper-nickel piping. Figure 44 shows the level of macrofouling at one end of the titanium piping after one-year exposure. Upon opening that titanium piping section, Figure 45 displays macrofouling along two feet at the inlet end. The macrofouling on the titanium piping, shown in Figure 46, is tightly adherent. The outlet end of a Alloy 625 piping section also displays biofouling (Figure 47). Most of the macrofouling settled along the bottom half of the

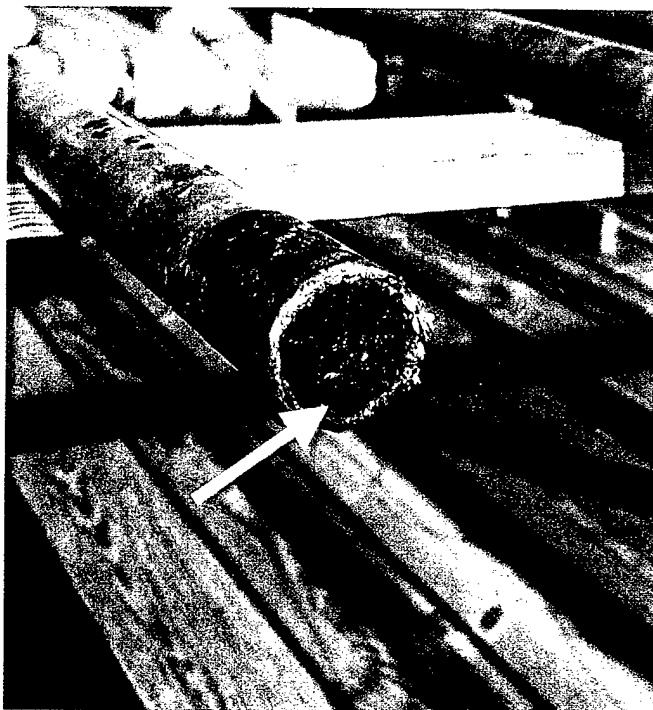
Figure 47 - Biofouling at the outlet of a Alloy 625 section viewed during one of the inspections during the one-year exposure in flowing, filtered natural seawater.

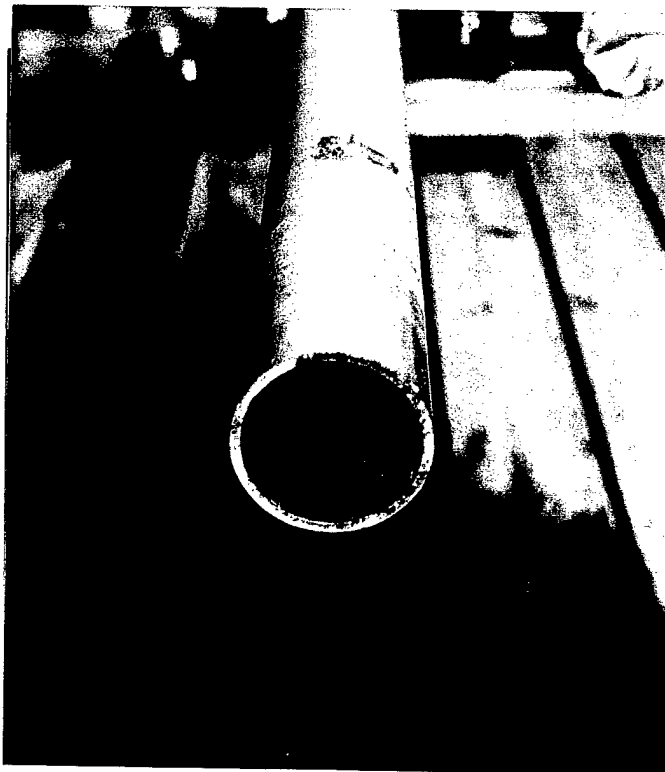
Figure 55 - TI-COMP™ 10 coated titanium pipe after 6 months exposure. Interior deposit and sludge during the exposure period could easily be removed.

As mentioned earlier, some titanium pipe sections were reused after thorough cleaning to apply either an organic or an anodized coating. Figure 54 shows the pre-exposure condition of the organic urethane-based TI-COMP™ 10 coating that had been applied on both inner and outer surfaces of titanium pipe 13/3 (Figure 54). After six months exposure, only some loose silt was found along the interior pipe surfaces (Figure 55). Figure 56 shows a different view of the loose deposit on the organic-coated titanium piping. These deposits were easily removed to reveal a smooth and intact coated pipe surface (Figure 57). The 70:30 copper-nickel section at the inlet end displayed a small site where biofouling had occurred, but exposed no visible signs of pitting

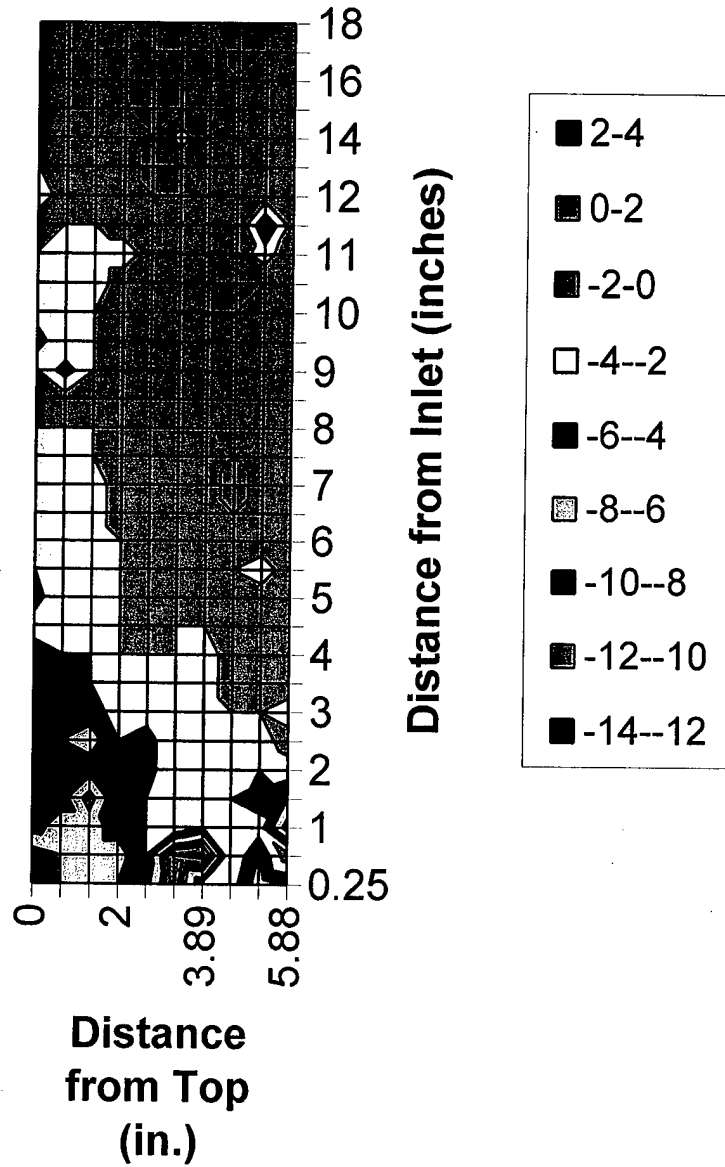
Figure 67 - Titanium/70:30 copper-nickel couple, mockup loop 7 after 379 days exposure. Surface topography of copper-nickel section as function of pipe clockwise orientation and distance from titanium. Legend denotes depth of corrosion/pitting in mils (0.001").

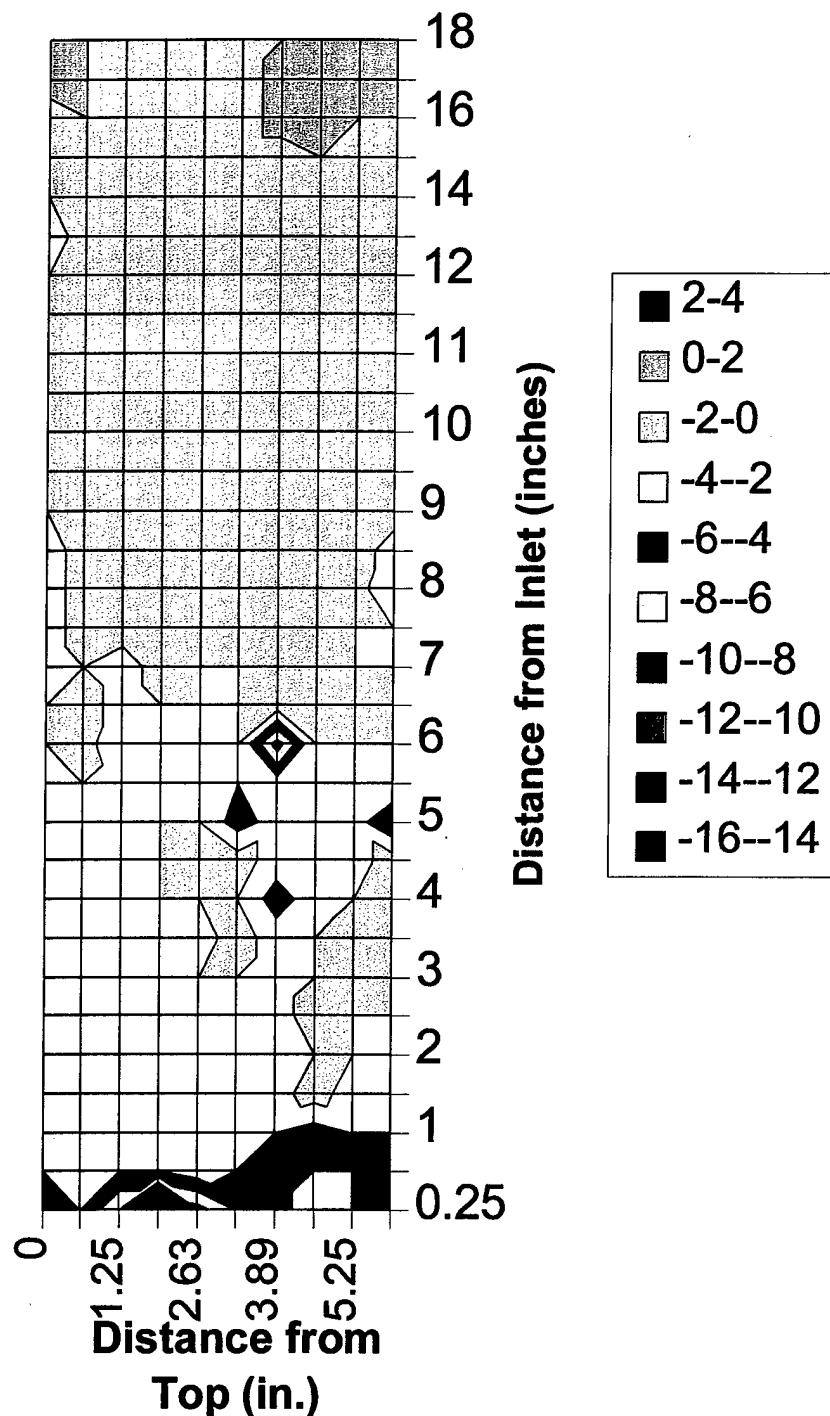
Figure 72 - Alloy 625/70:30 copper-nickel couple, mockup loop 5 after 379 days exposure with 10-in long PVC spacer between dissimilar alloy sections. Surface topography of copper-nickel section as function of pipe clockwise orientation and distance from titanium. Legend denotes depth of corrosion in mils (0.001").

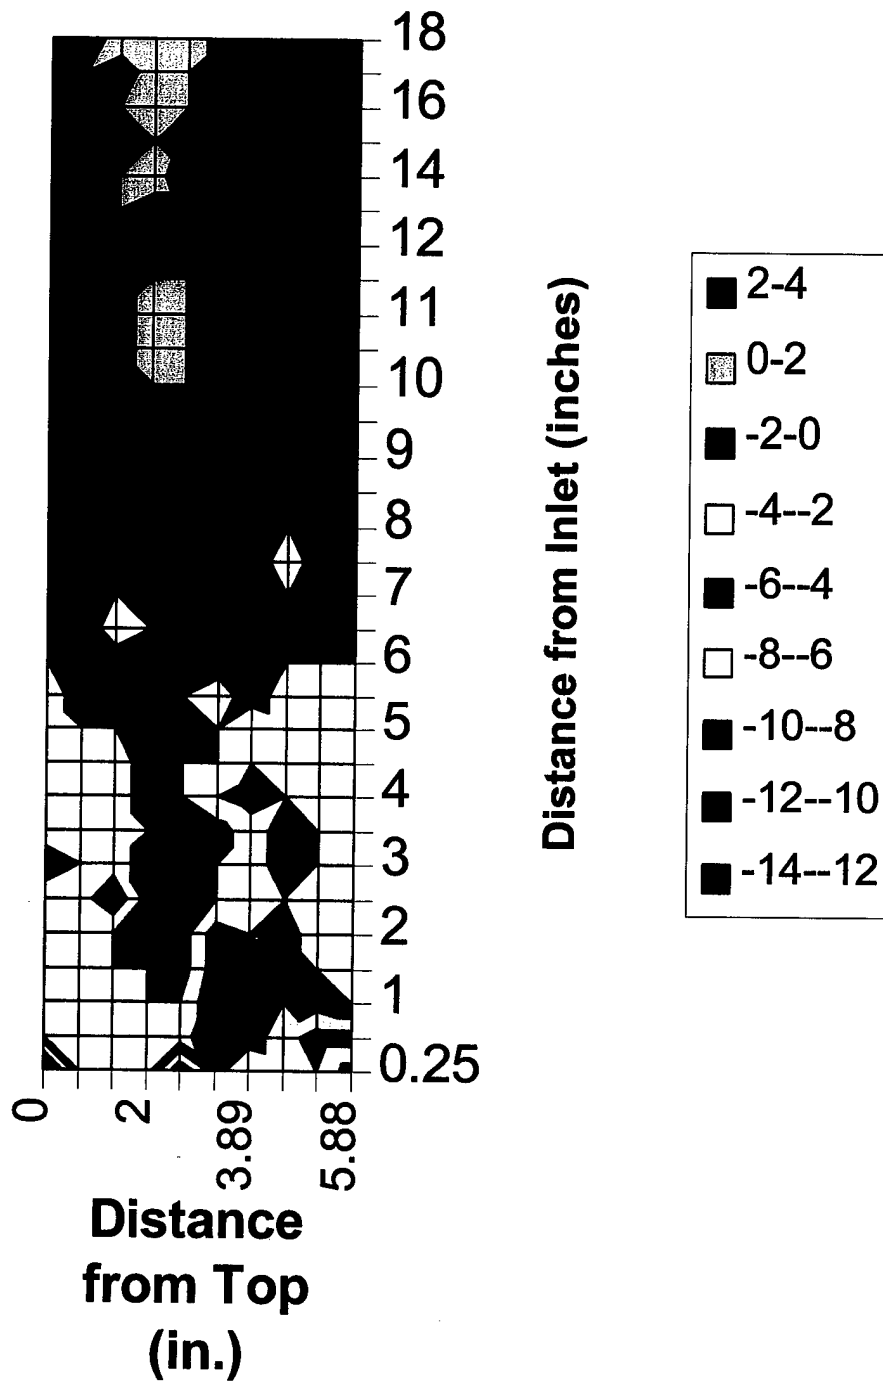
Figure 73 - Alloy 625/70:30 copper-nickel couple, mockup loop 11 after 379 days exposure with 10-in long PVC spacer between dissimilar alloy sections. Surface topography of copper-nickel section as function of pipe clockwise orientation and distance from titanium. Legend denotes depth of corrosion in mils (0.001").
