**DOT/FAA/AR-99/20, P1**

# **Development of a Supplemental Inspection Document for the Fairchild SA226 and SA227 Aircraft, Part 1**

September 1999

Technical Report

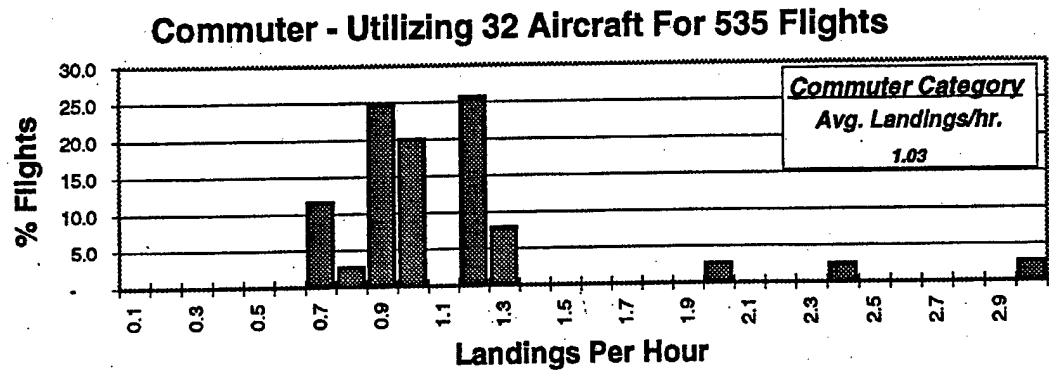
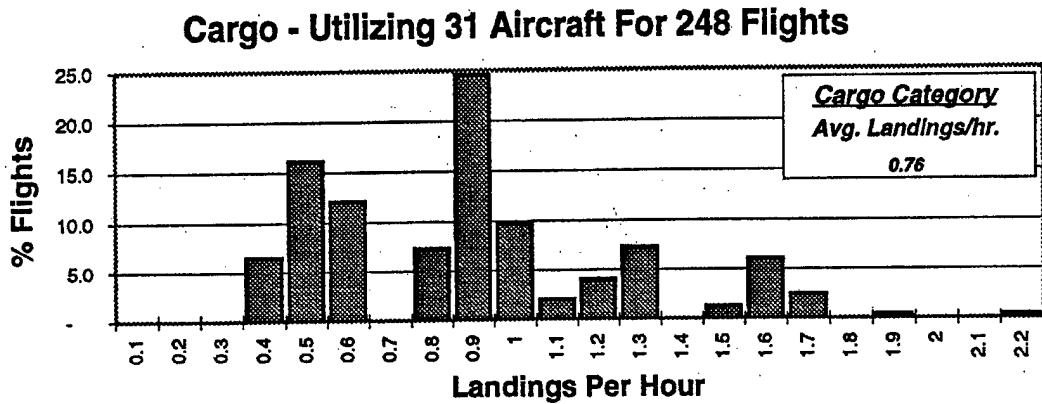
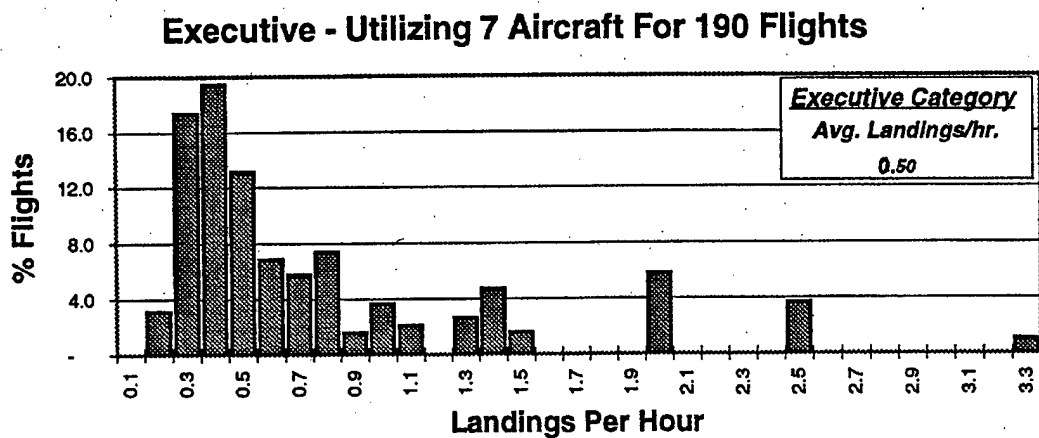
**FIGURE 2-1 LANDING FREQUENCY COMPARISON**

Figure 2-1 shows histograms of the three operation categories illustrating the number of flights vs. landings per hour.

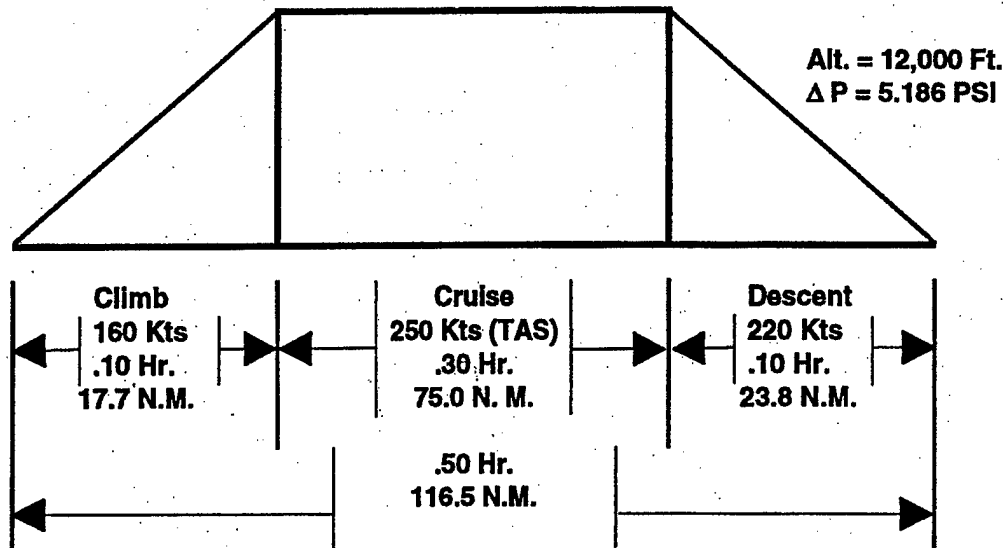
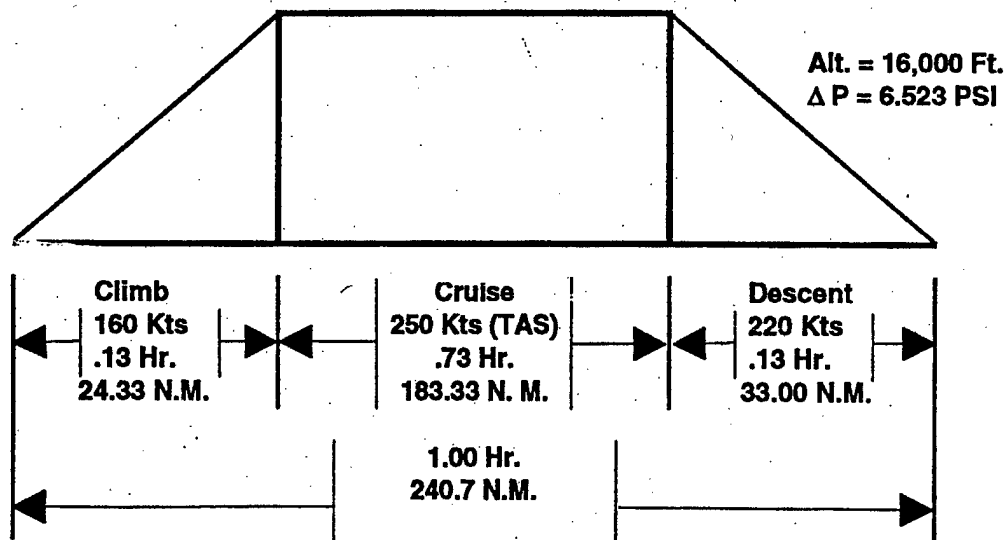
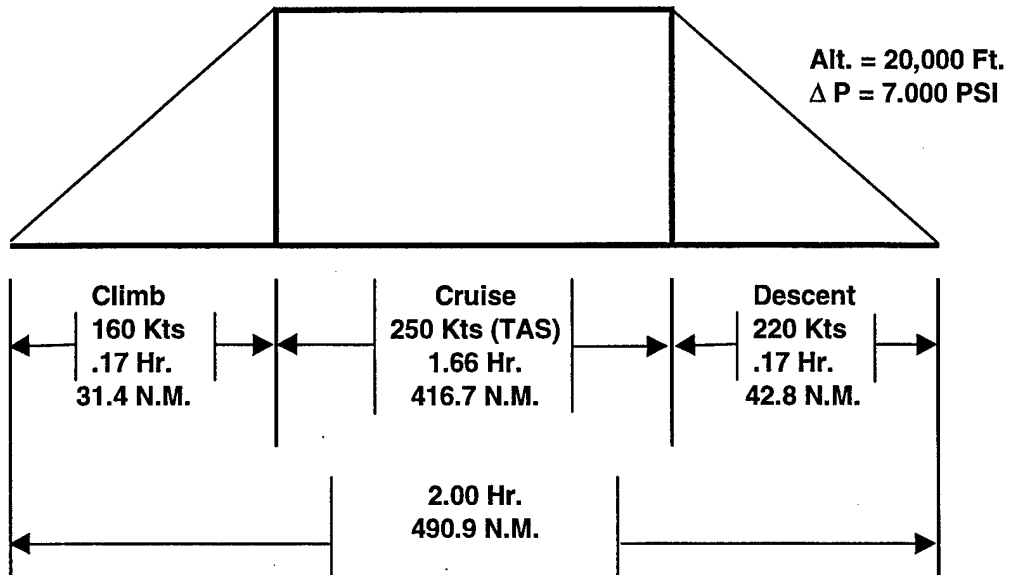
FIGURE 3-1 FLIGHT PROFILE ILLUSTRATION

Figure 3-1 FLIGHT PROFILE ILLUSTRATION (Continued)

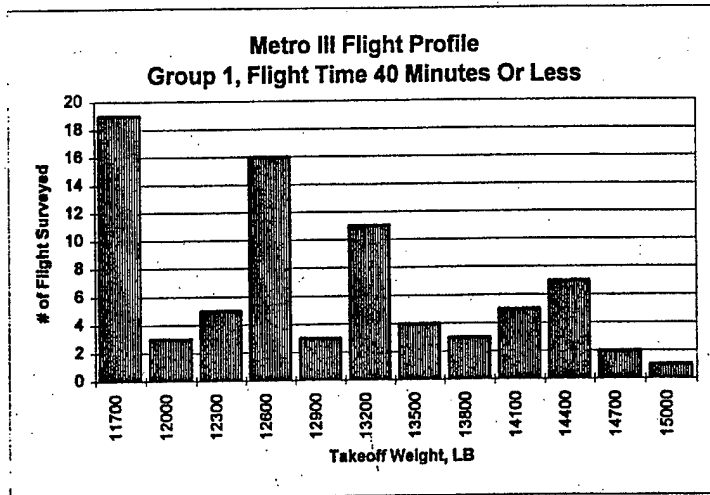
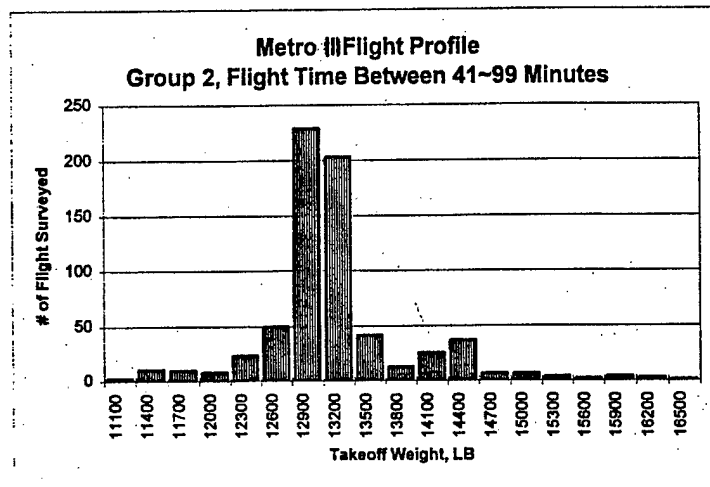
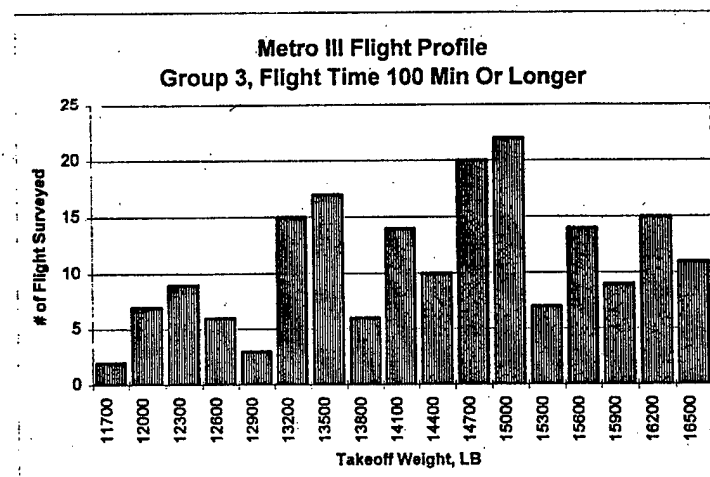
**FIGURE 3-2 FLIGHT PROFILE - FLIGHT LENGTH**

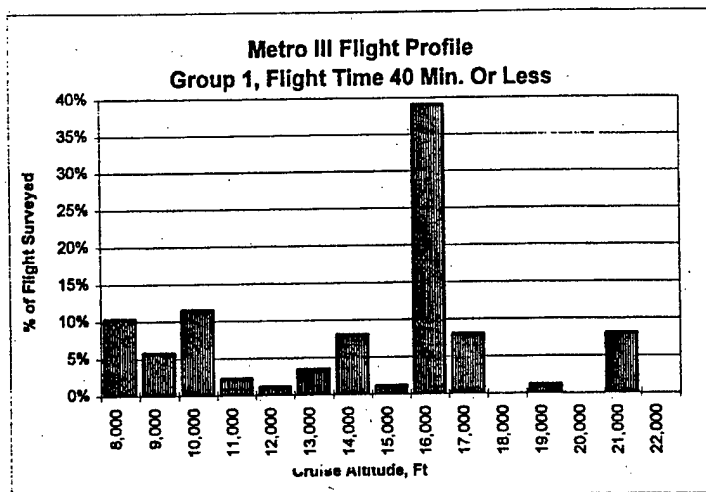
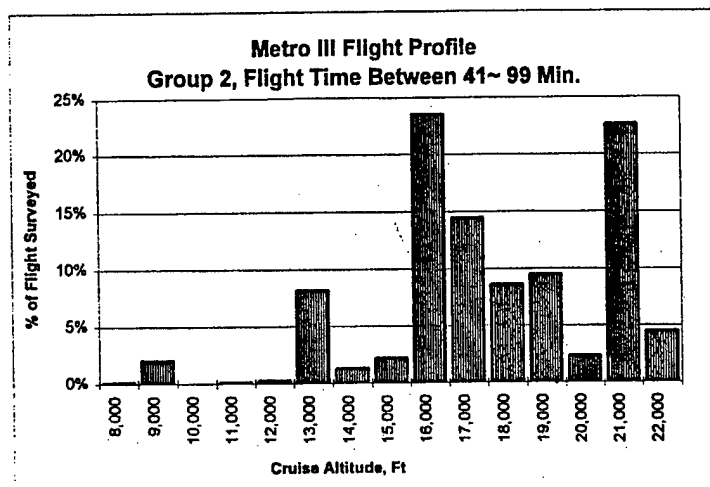
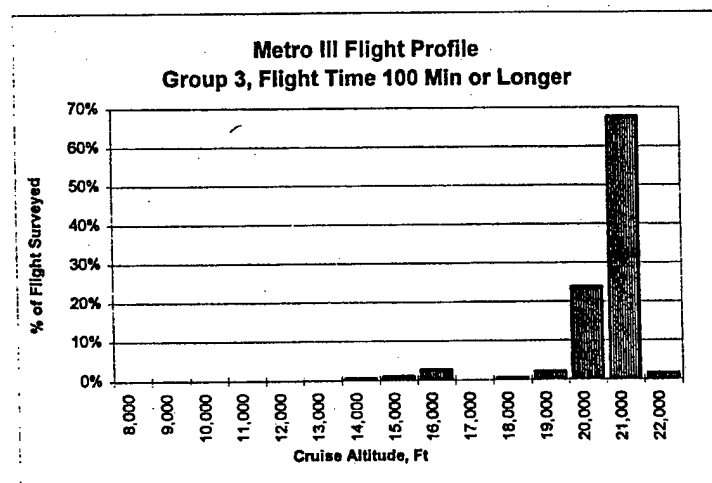
**FIGURE 3-3 FLIGHT PROFILE - CRUISE ALTITUDE**

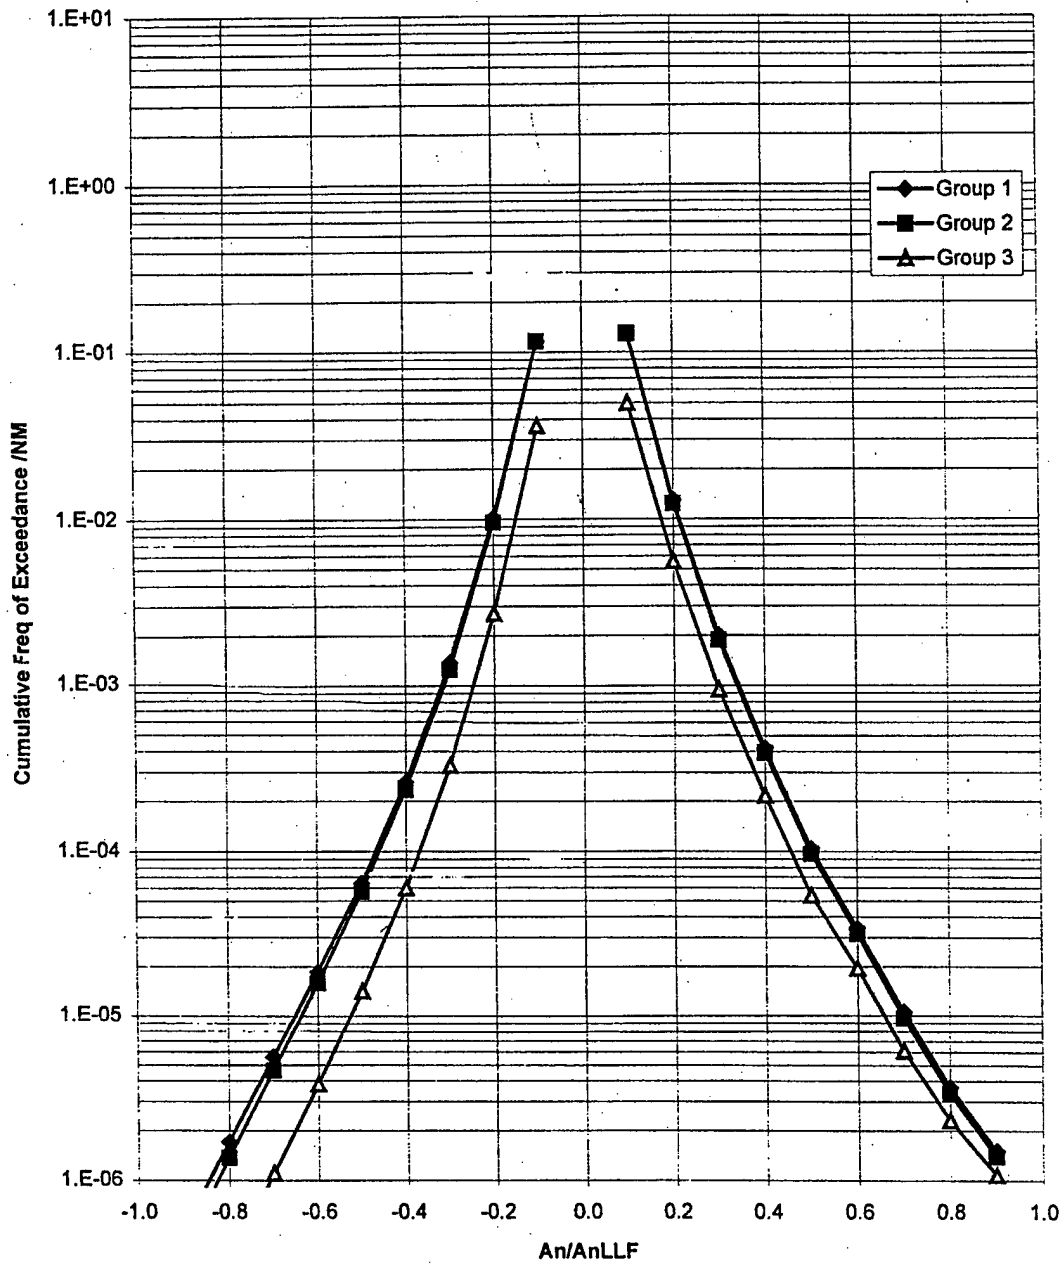
FIGURE 4-1 SA227 MANEUVER AND GUST SPECTRUM

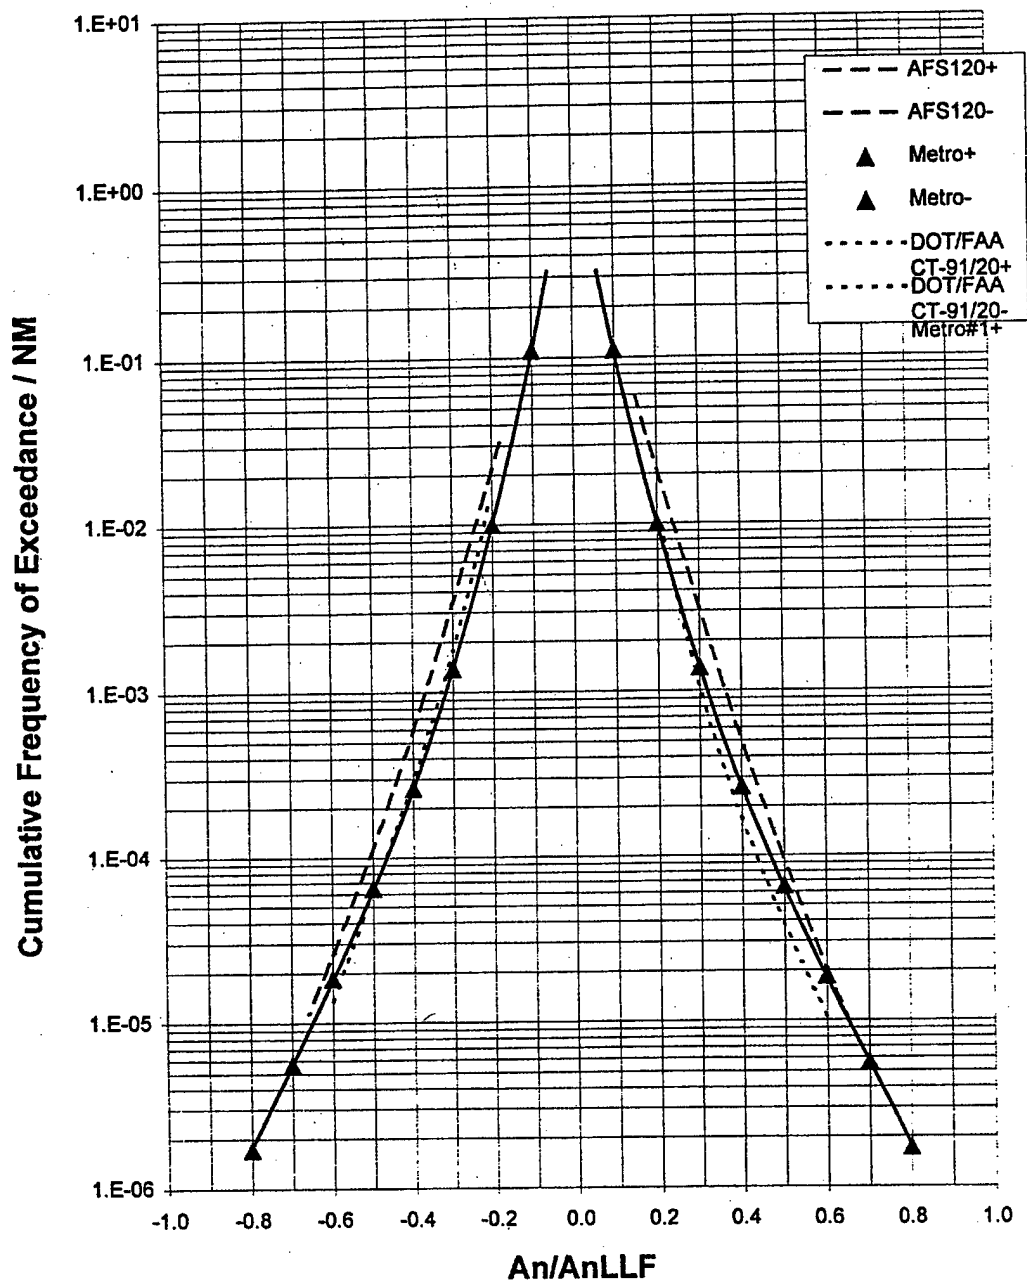
**Load Spectra Comparison Metro III**  
**Gust, Group 1, 30 Min, 12,000 FT, 12,800 LB TO Wt.**

**FIGURE 4-2 GROUP 1 FLIGHT PROFILE**  
**VERTICAL GUST LOADS EXCEEDANCE COMPARISON**

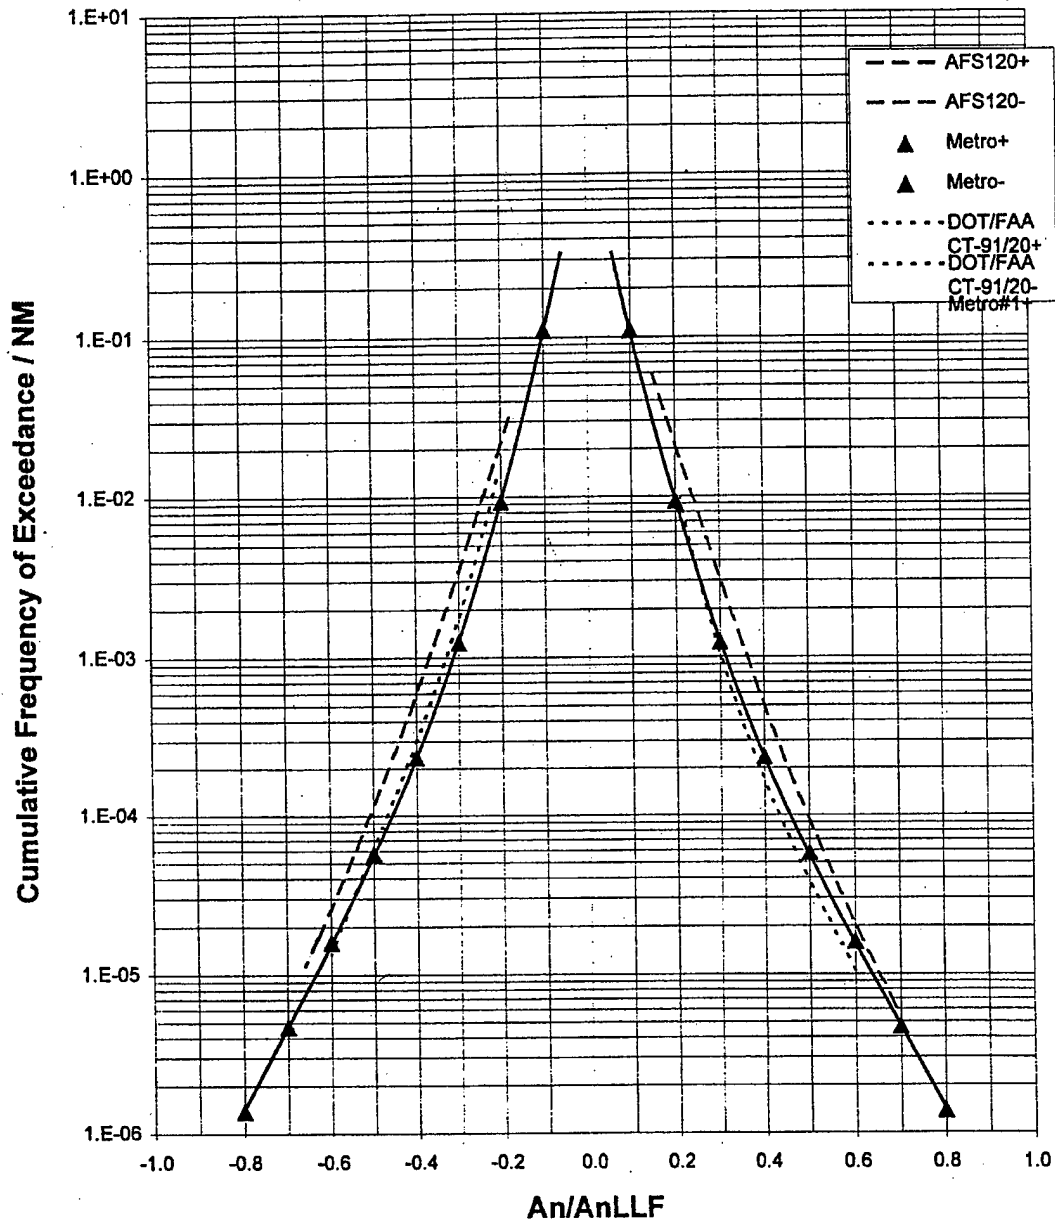
**Load Spectra Comparison for Metro III**  
**Gust, Group 2, 60 Min, 16,000 FT, 13,300 LB TO Wt.**

**FIGURE 4-3 GROUP 2 FLIGHT PROFILE  
 VERTICAL GUST LOADS EXCEEDANCE COMPARISON**

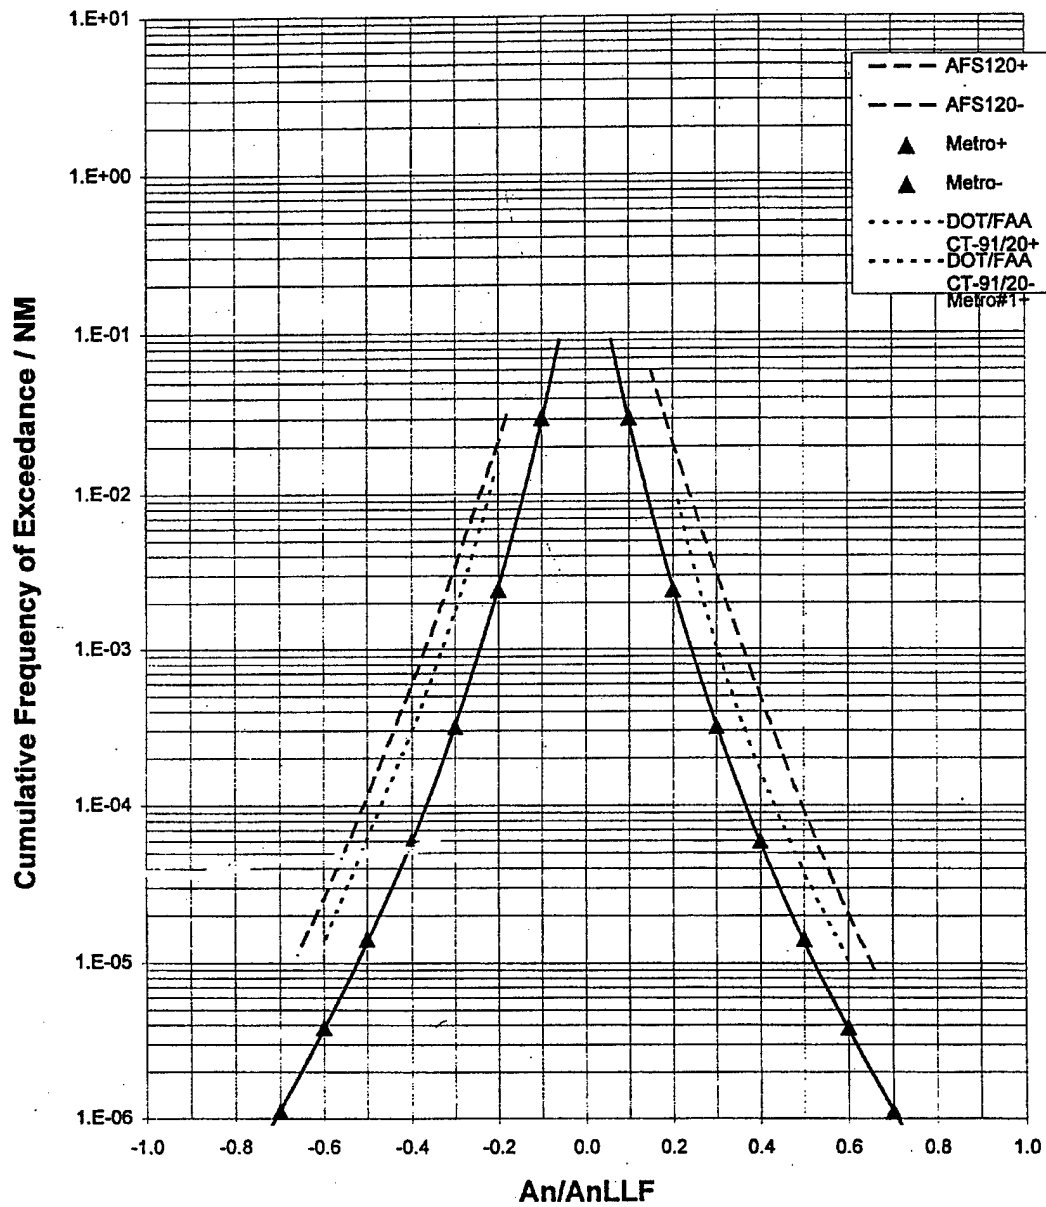
**Load Spectra Comparison for Metro III**  
**Gust, Group 3, 120 Min, 20,000 FT, 13,800 LB TO Wt.**

**FIGURE 4-4 GROUP 3 FLIGHT PROFILE  
 VERTICAL GUST LOADS EXCEEDANCE COMPARISON**

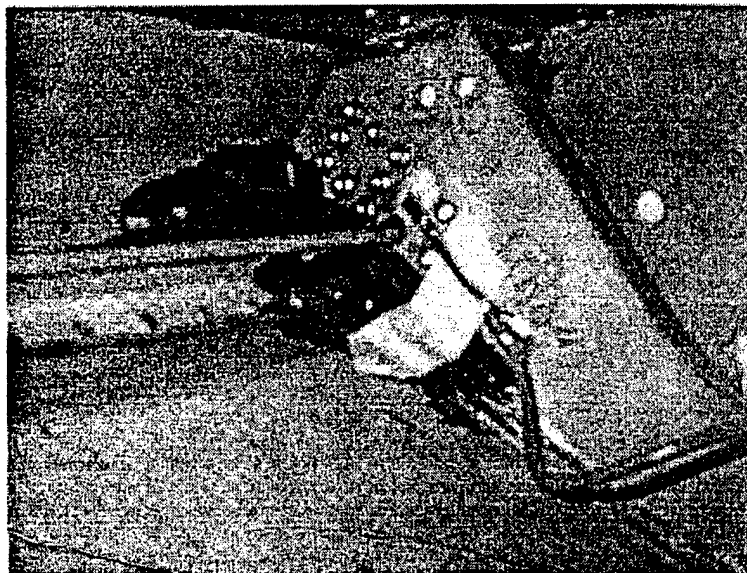
**FIGURE 5-2 STRAIN GAGE 34**

Four additional gages were mounted in the fuselage cargo door surround structure to measure stresses at the latches due to pressurization. The location of these gages is

shown in Figure 5-2 through Figure 5-4. The stresses measured by these gages are shown in Appendix D of reference 20.

The stress measured at gage 34 was in reasonable agreement with the calculated stress. The stress at gages 35 and 36 was unexpected and did not match the stresses which caused fatigue cracks at this location during the full-scale fatigue test. After the crack was discovered during the fatigue test, the frames at this location were increased in thickness from 0.040 to 0.071 inch the local lightening holes were removed, and the tooling holes were plugged. The new configuration is the one being used in the current test. These changes are not expected to change the sign of the local stresses. The compressive stresses now measured locally may be due to variations in the local engagement of the latches that would vary from aircraft to aircraft. For this reason any analysis must assume the maximum calculated stress in these frames.

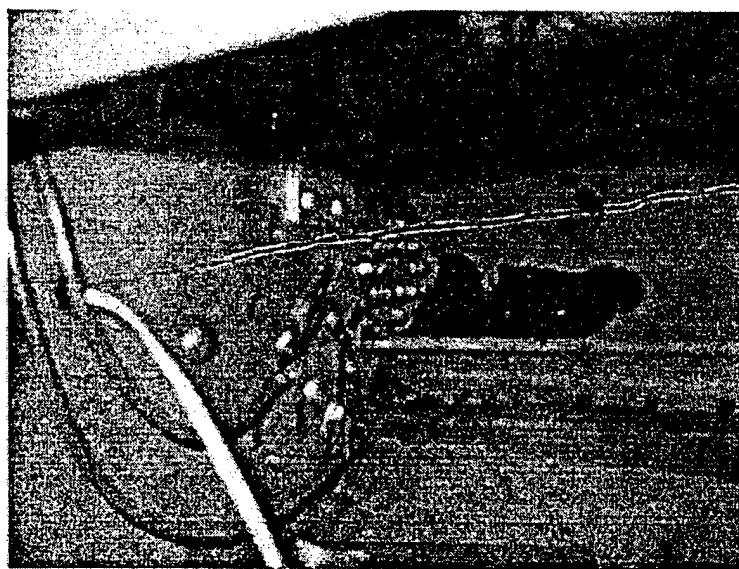
**FIGURE 5-3 STRAIN GAGE 35, 36**

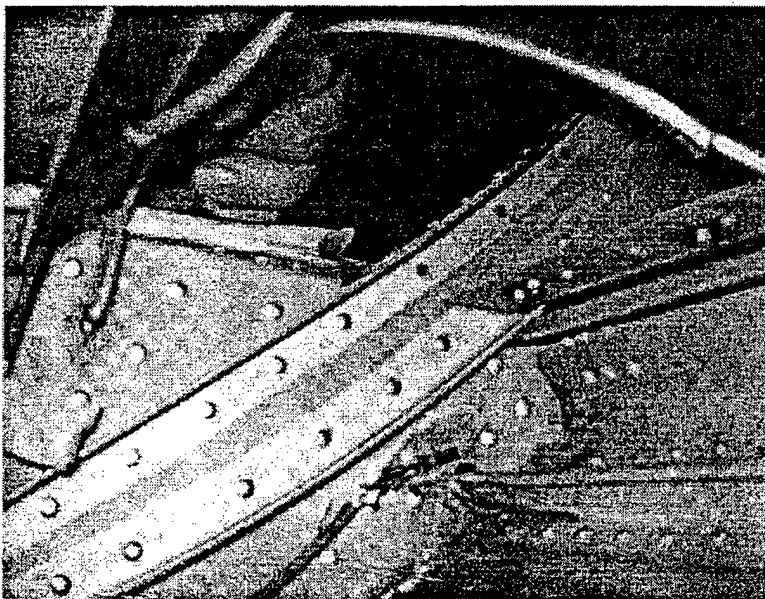
**FIGURE 5-4 STRAIN GAGE 37**

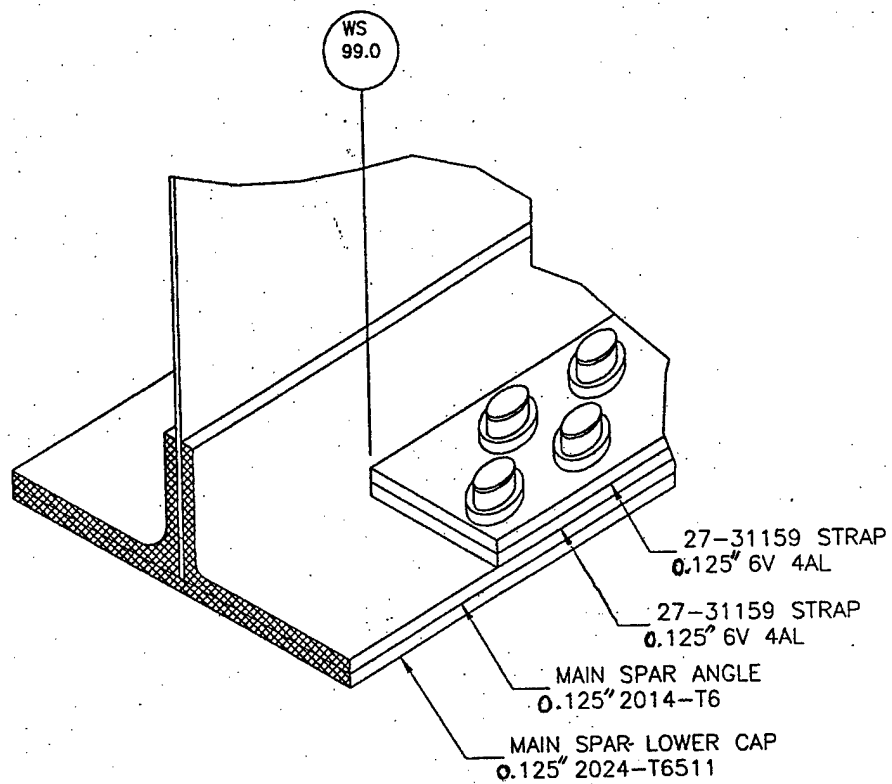
**FIGURE 6-1 W1 - SA226 MAIN SPAR LOWER CAP AT WING STATION 99.0**

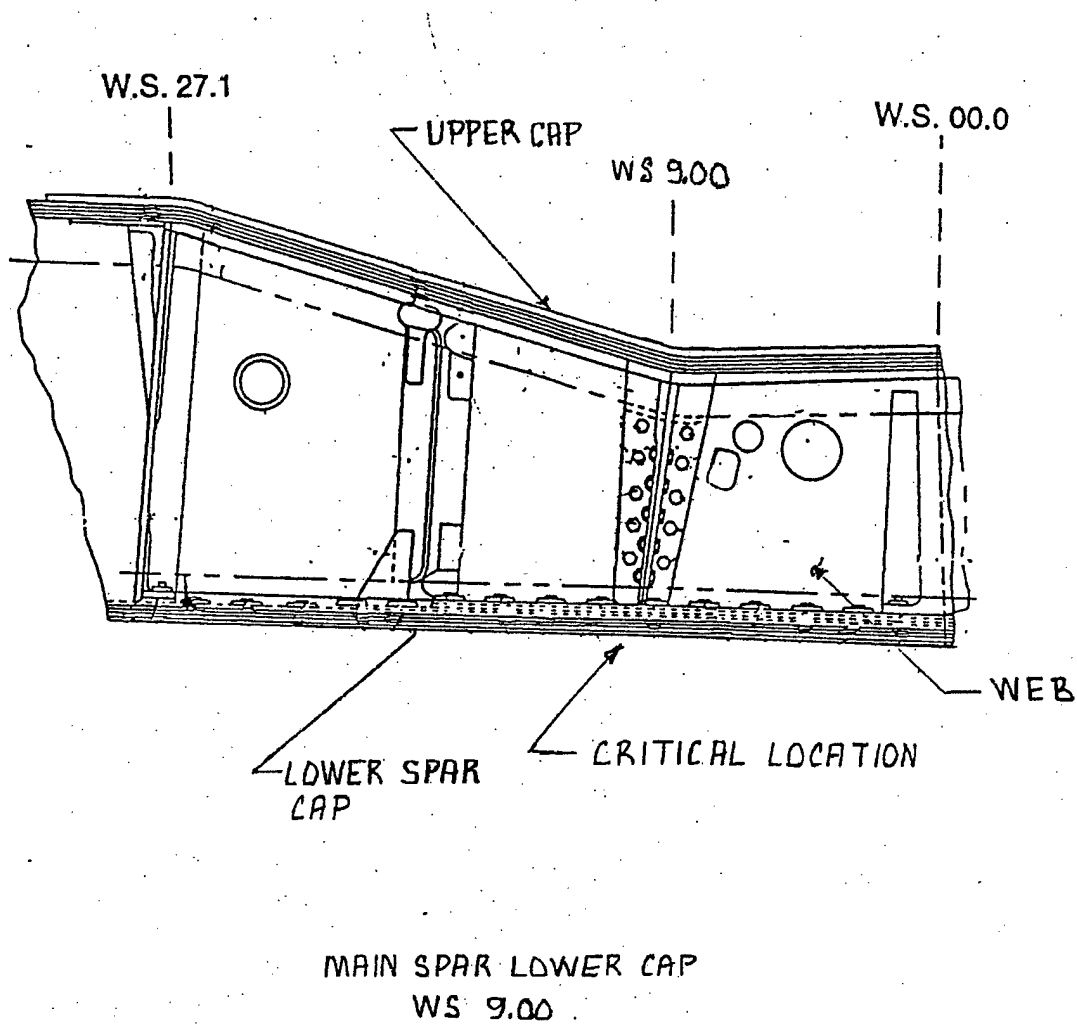
FIGURE 6-2 W2 - SA226 MAIN SPAR LOWER CAP AT WING STATION 9.0

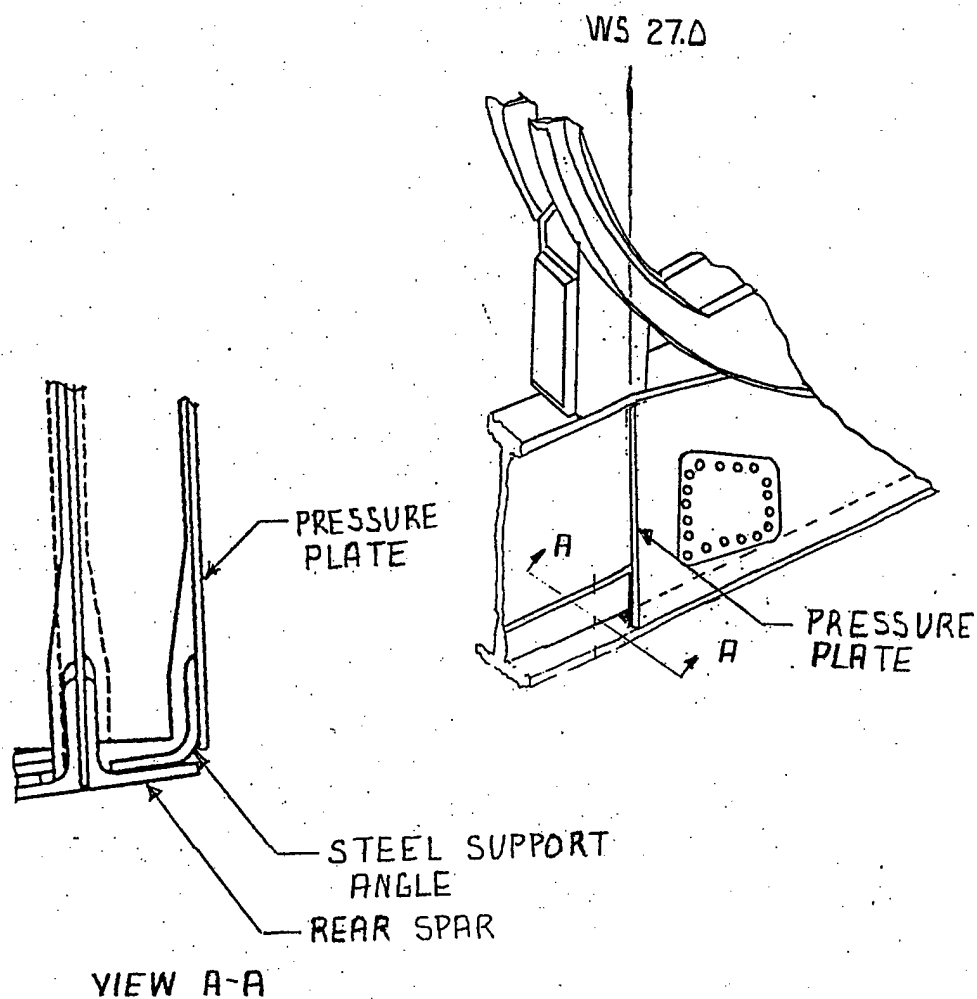
FIGURE 6-3 W3 - SA226 REAR SPAR LOWER CAP AT WING STATION 27.0

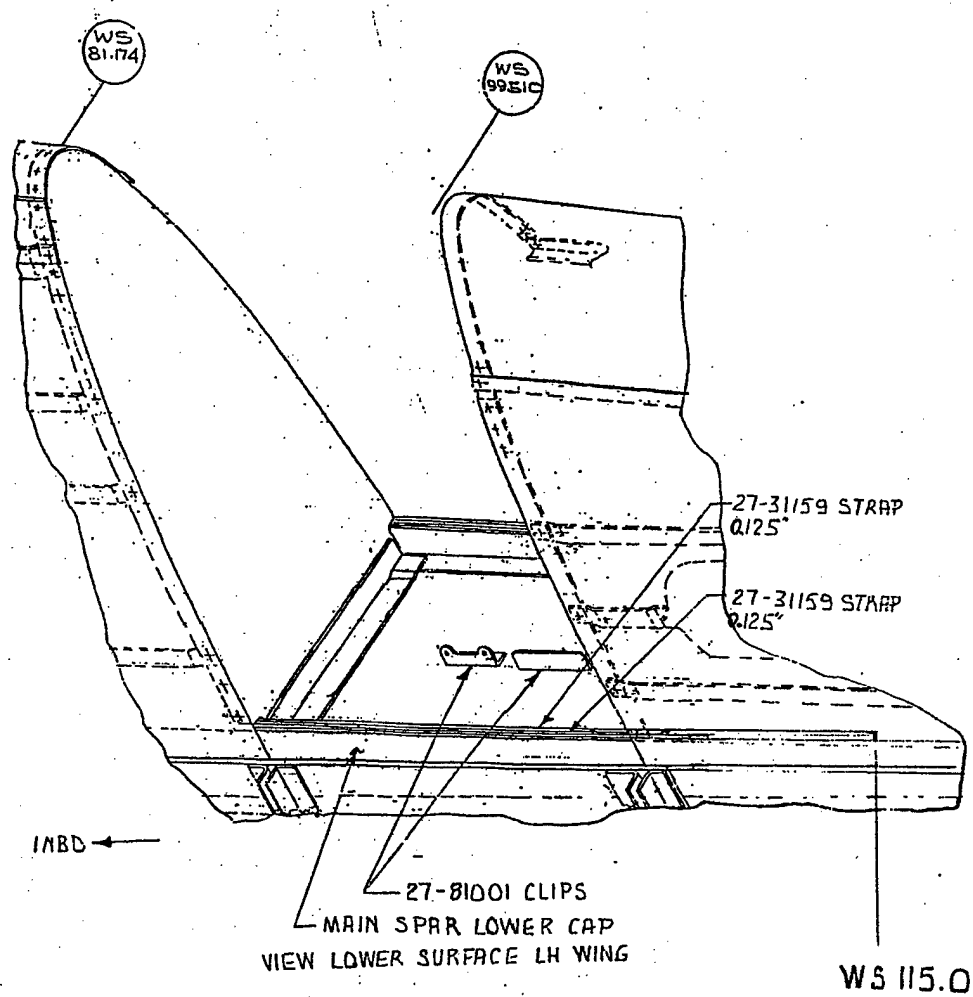
**FIGURE 6-4 W4 - SA227 MAIN SPAR LOWER CAP AT WING  
STATION 99.0**

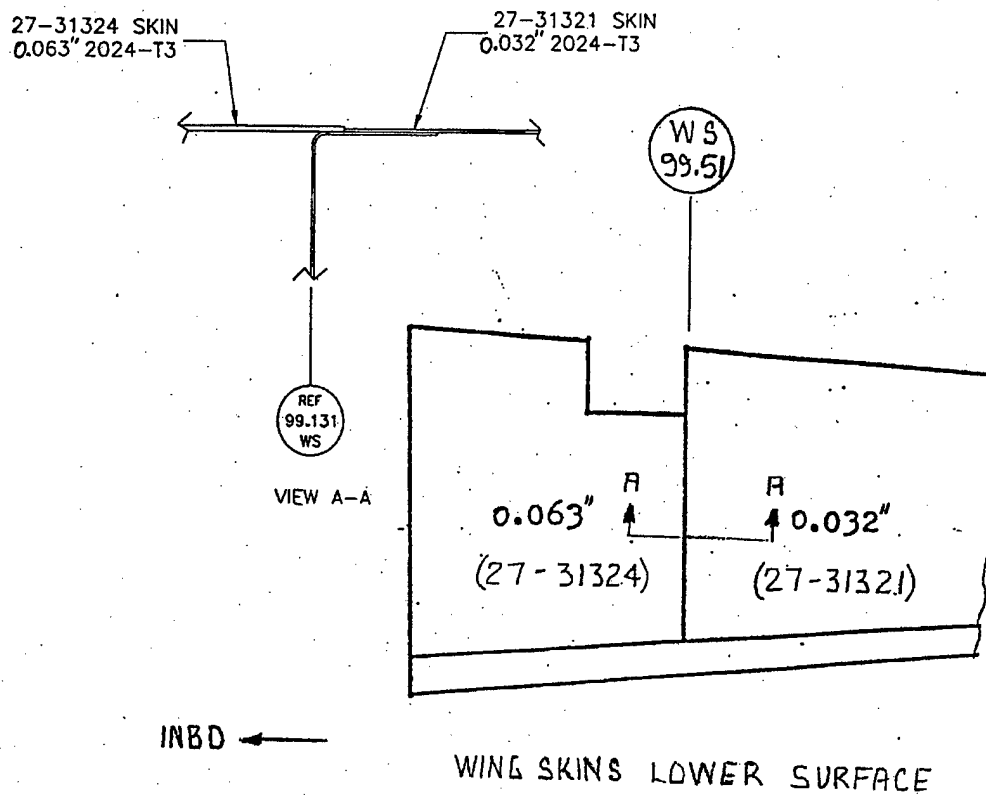
**FIGURE 6-5 W5 - SA227 SKIN SPLICE AT WING STATION  
99.51 LOWER SURFACE**

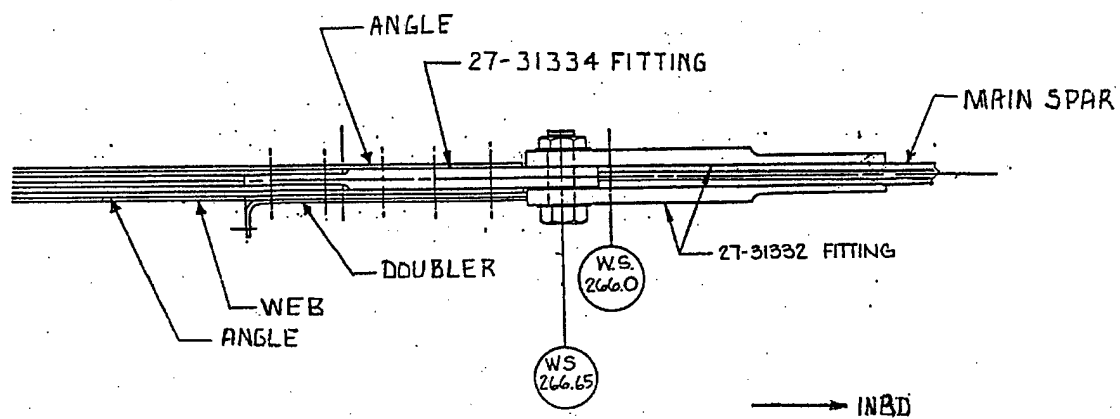
WING EXTENSION FITTING MAIN  
SPAR LOWER SURFACE  
VIEW LOOKING FWD

**FIGURE 6-6 W6 - SA227 WING EXTENSION FITTING MAIN  
SPAR LOWER SURFACE**

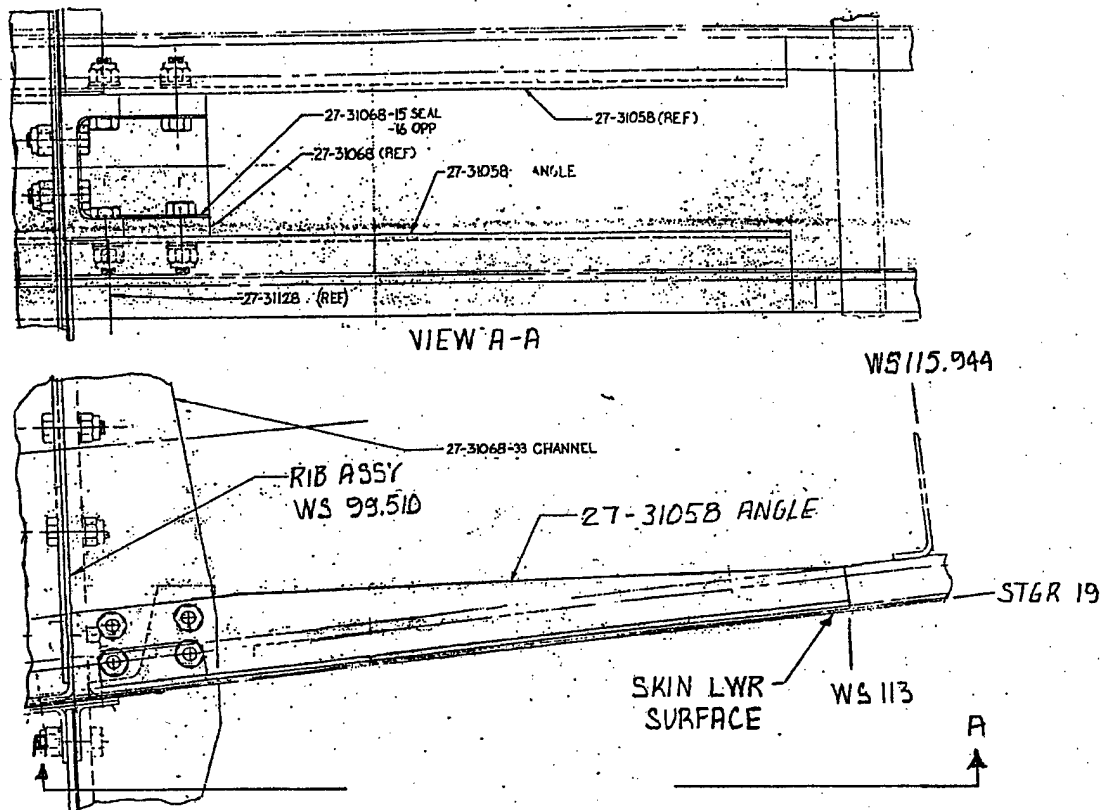
**FIGURE 6-7 W7 - SA227 LOWER WING SKIN ON FORWARD  
SIDE OF LANDING GEAR TRUNNION**

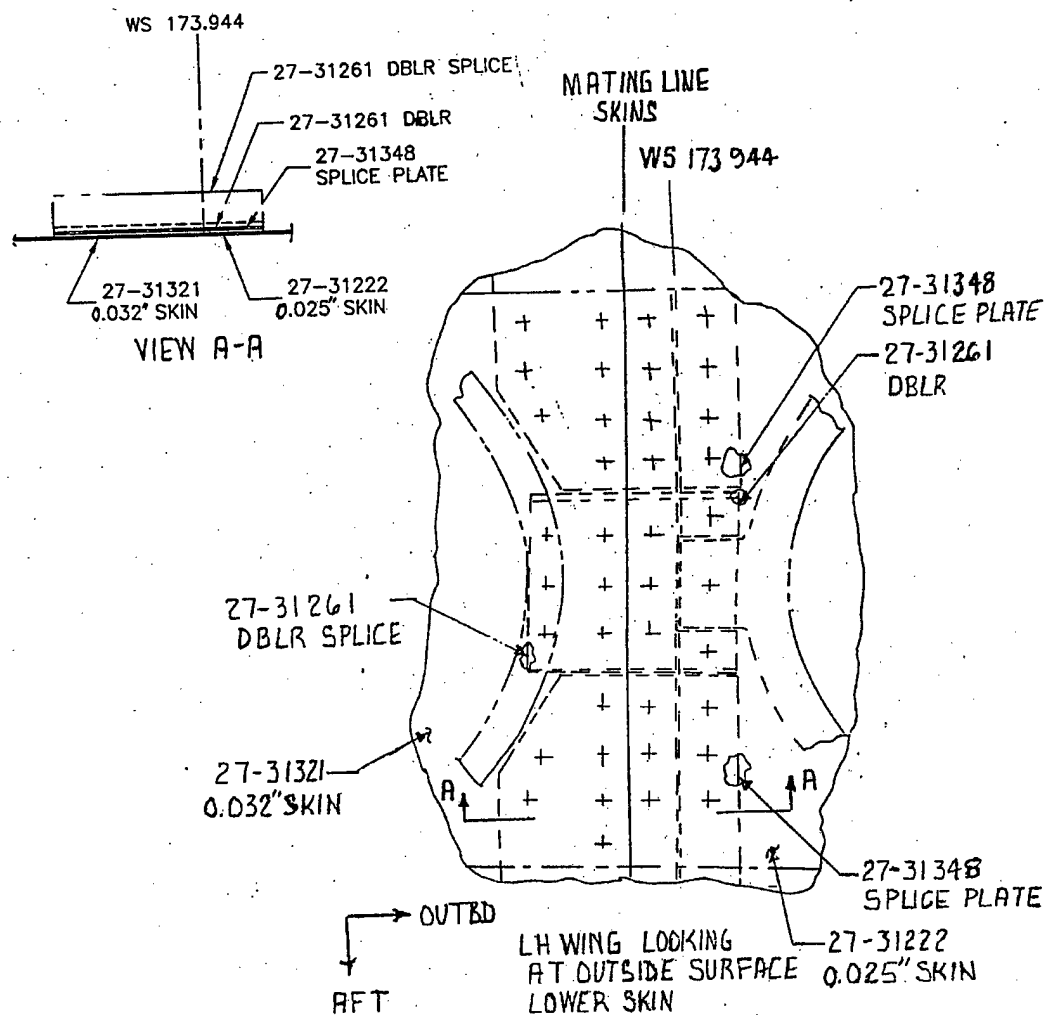
**FIGURE 6-8 W8 - CHORDWISE SKIN SPLICE AT W.S. 173.944  
LOWER SURFACE**

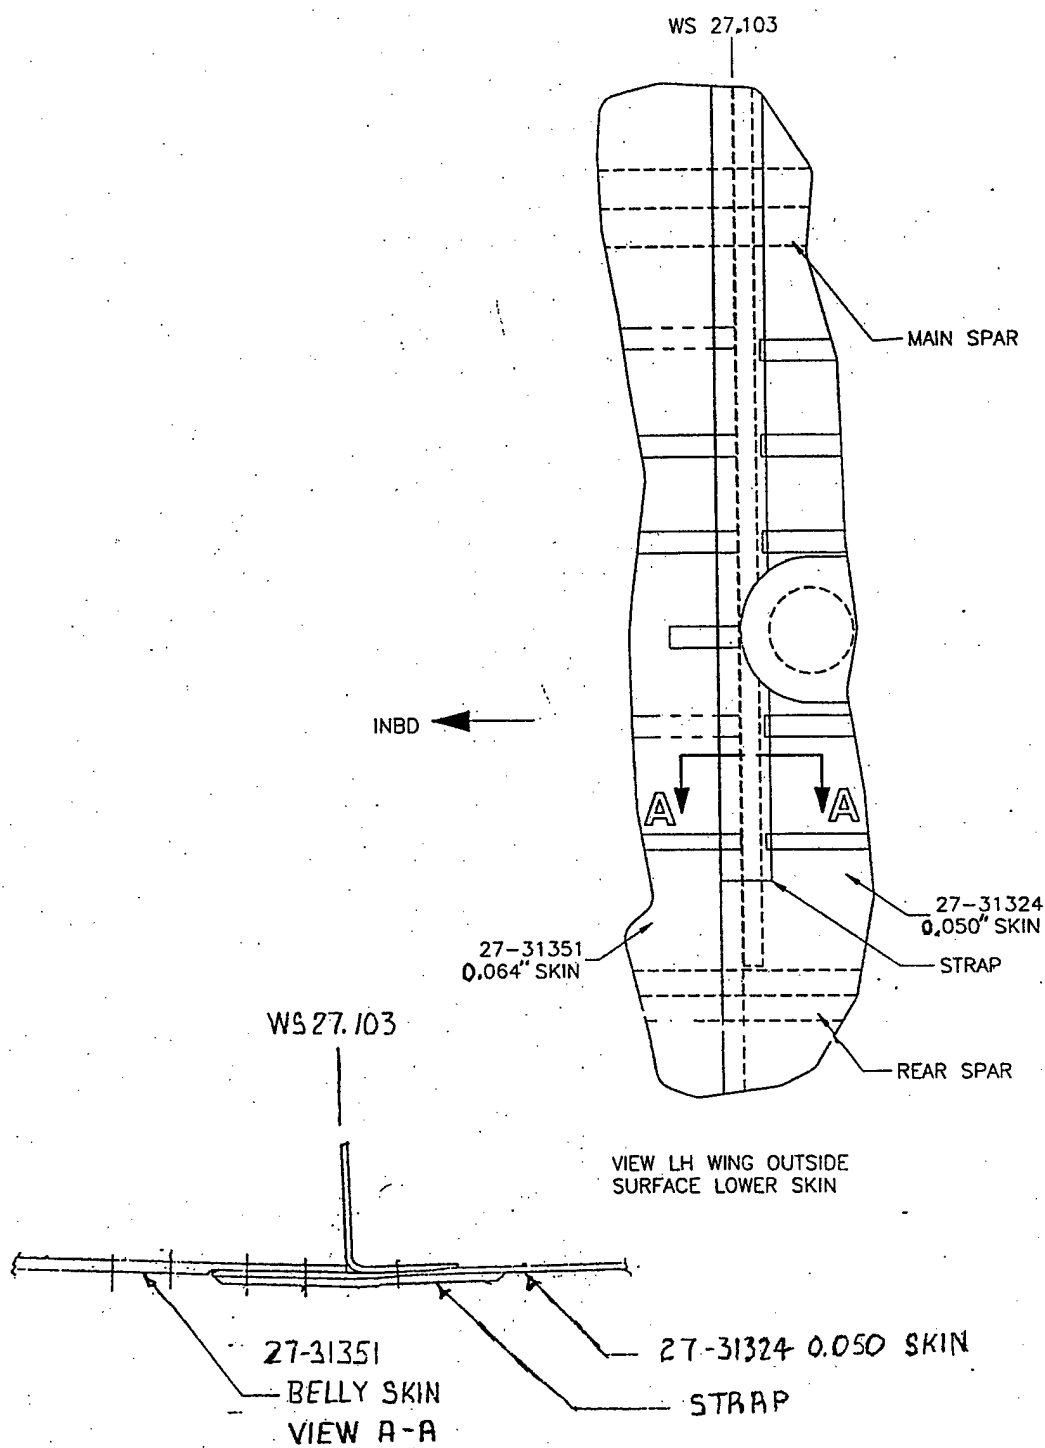
**FIGURE 6-9 W9 - SKIN SPLICE AT W.S. 27.103 LOWER  
SURFACE OUTBOARD OF THE RIB**

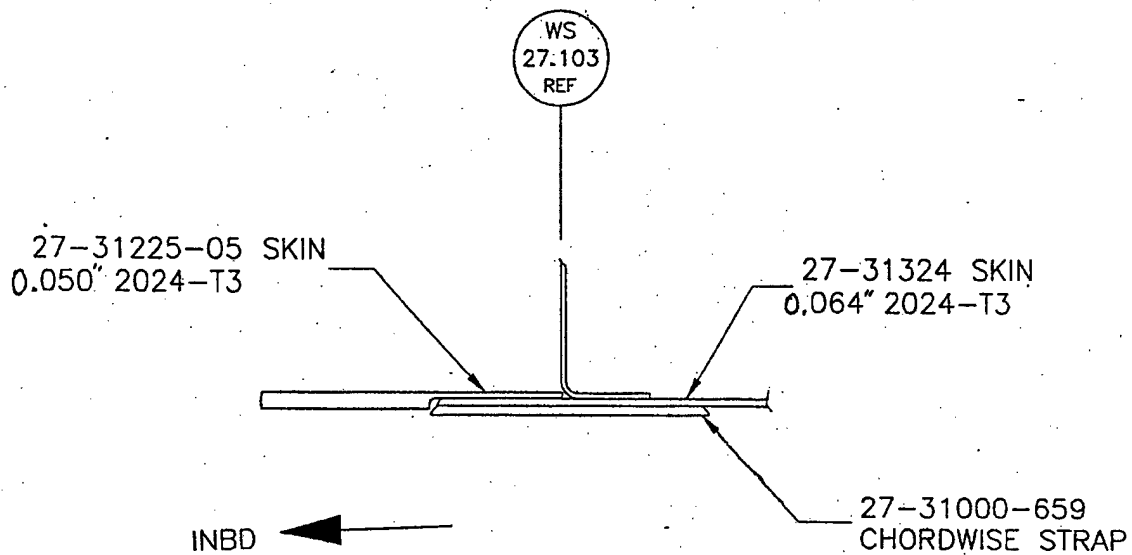
**FIGURE 6-10 W10 - SKIN SPLICE AT W.S. 27.103 LOWER  
SURFACE INBOARD OF SPLICE**

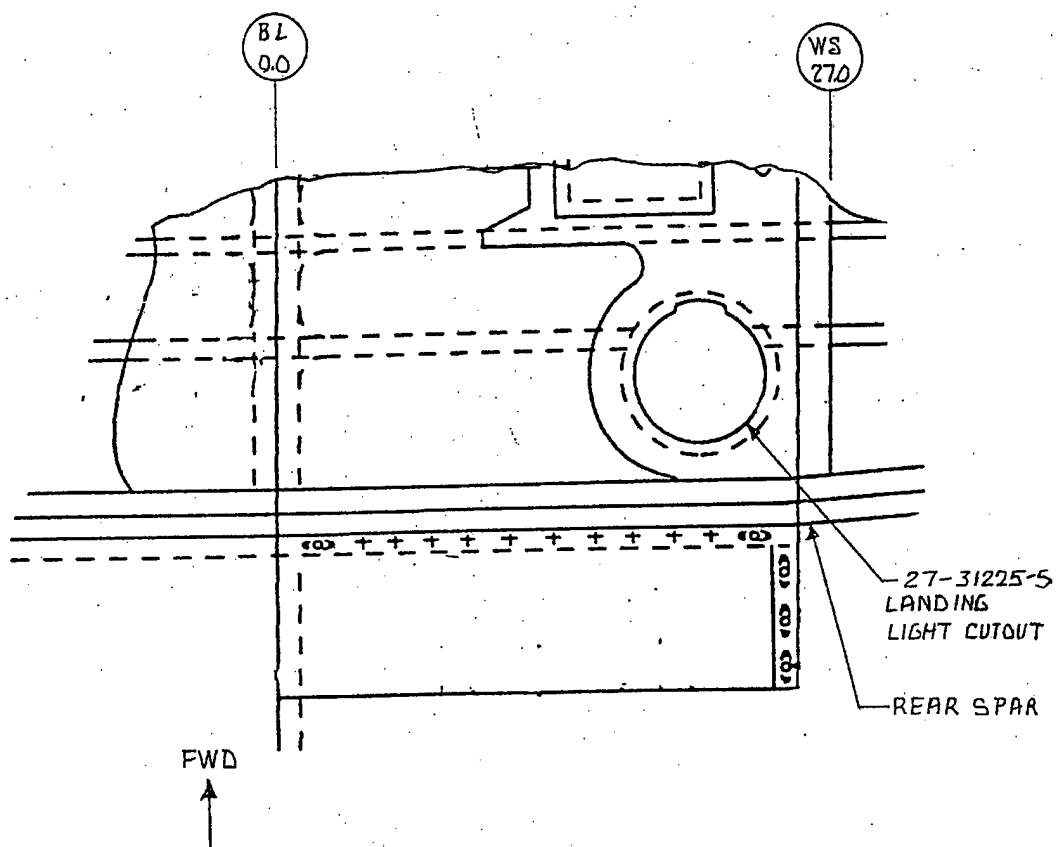
WING LOWER CENTER SECTION SKIN

**FIGURE 6-11 W11 - SA226 WING LOWER CENTER SECTION  
SKIN AT LANDING LIGHT CUTOUT**

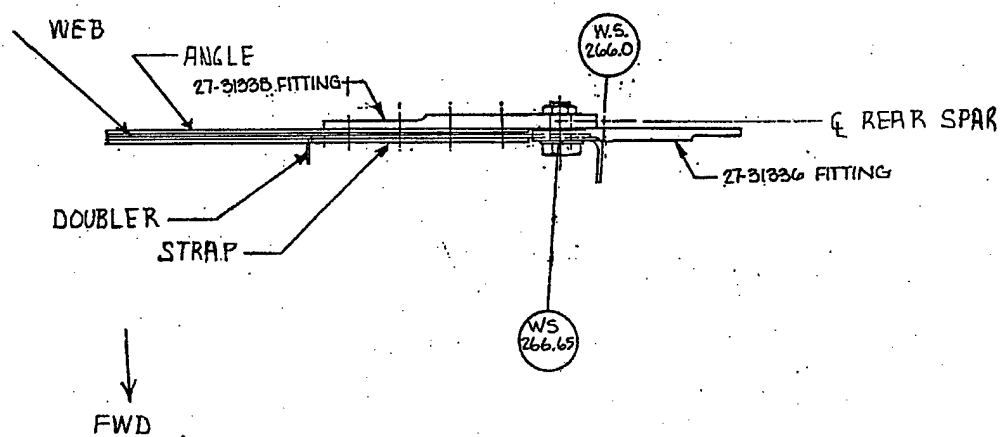
WING TIP EXTENSION FITTING  
 LOWER SURFACE  
 (SKIN NOT SHOWN)

**FIGURE 6-12 W12 - SA227 TIP EXTENSION FITTING REAR  
 SPAR LOWER SURFACE (27-31335)**
