**DOT/FAA/AR-99/20, P1**

# **Development of a Supplemental Inspection Document for the Fairchild SA226 and SA227 Aircraft, Part 1**

September 1999

Technical Report

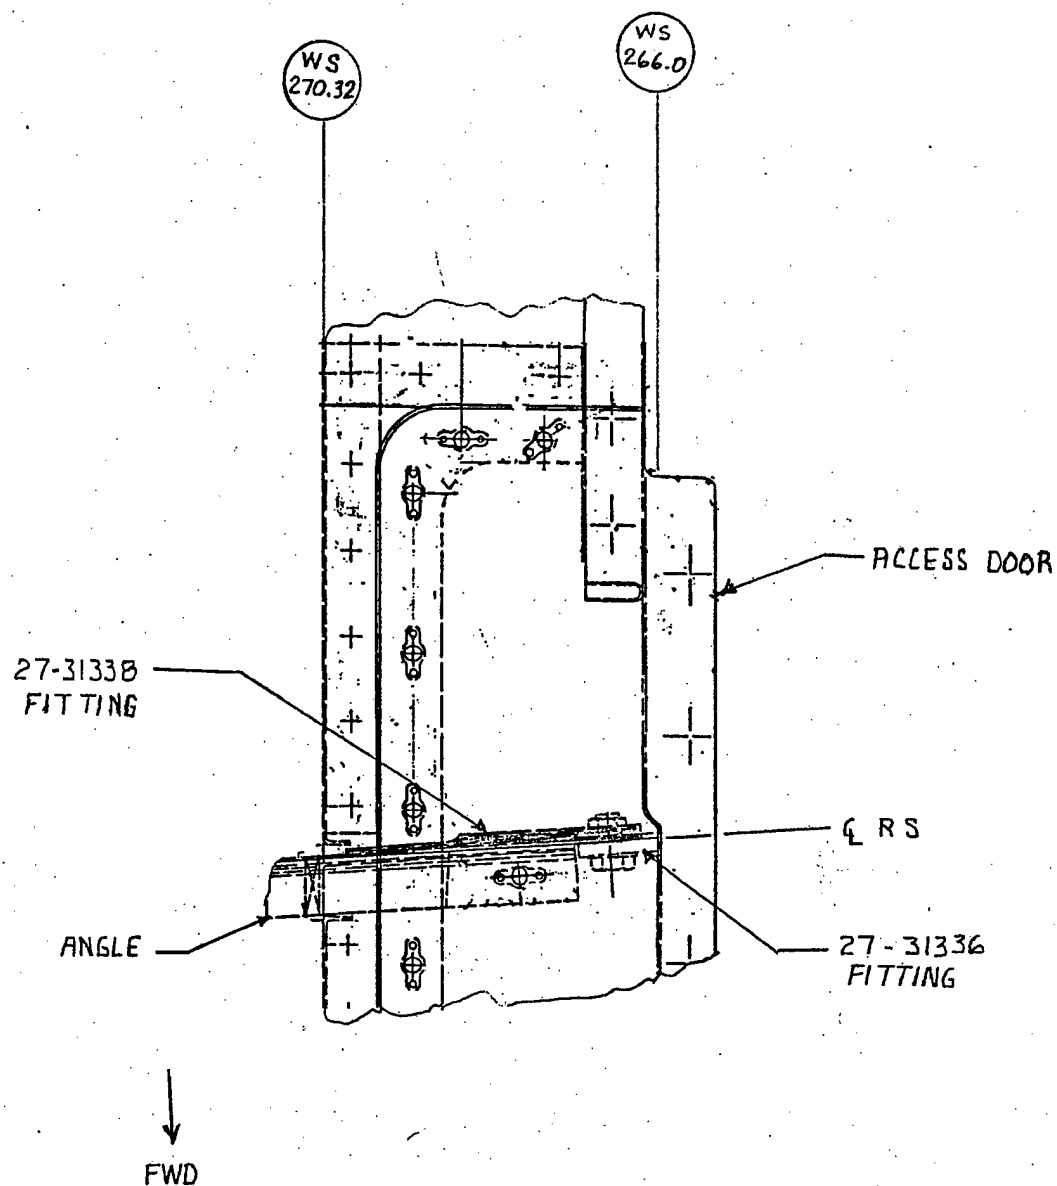
TIP EXTENSION AT END OF OUTBOARD  
FITTING REAR SPAR LOWER SURFACE  
(SKIN NOT SHOWN)

**FIGURE 6-13 W13 - SA227 TIP EXTENSION AT END OF  
OUTBOARD FITTING (REAR SPAR)**

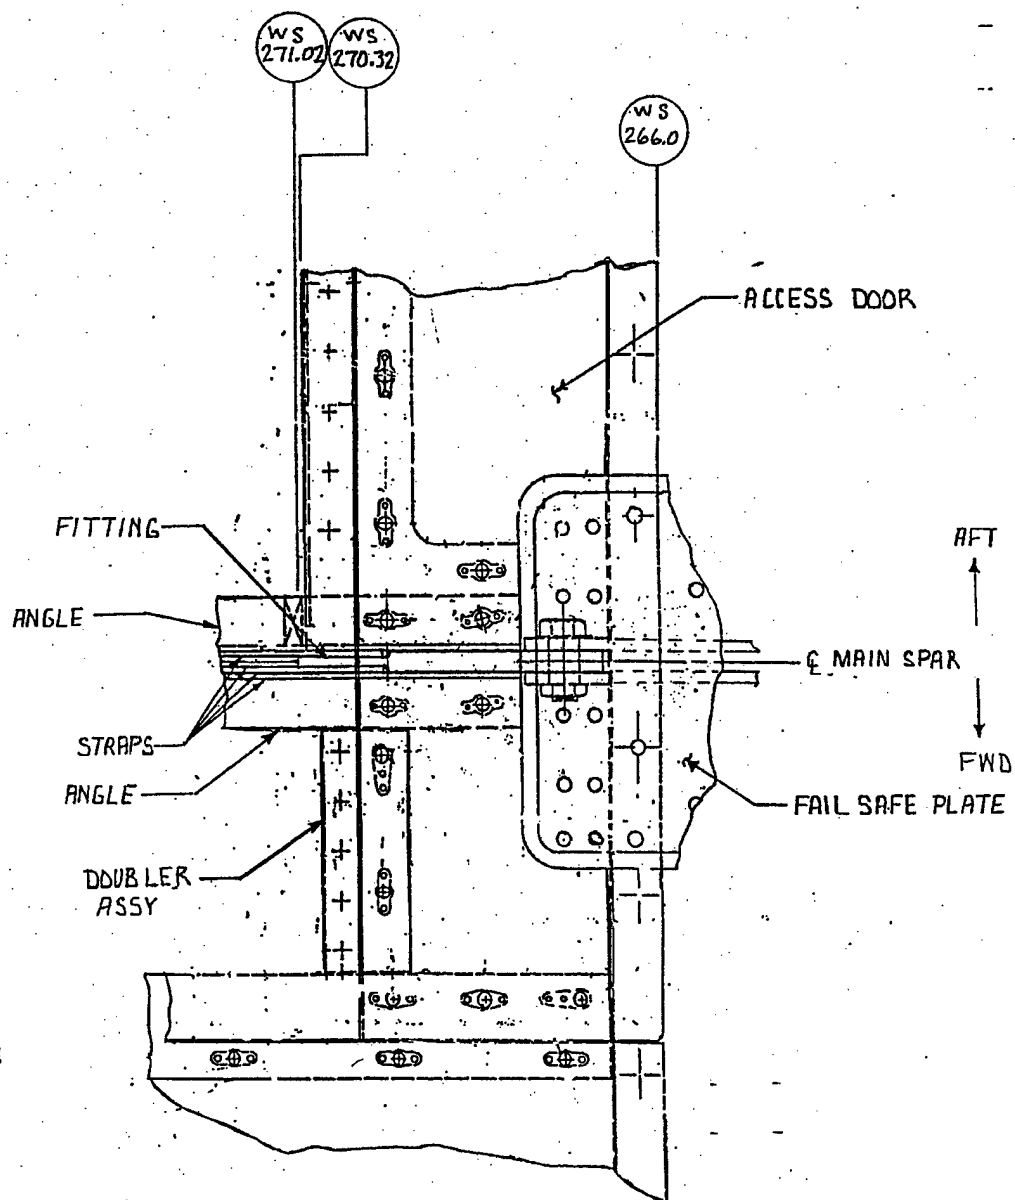
WING TIP EXTENSION AT END OF  
OUTBOARD FITTING MAIN SPAR  
LOOKING UP LOWER SURFACE  
(SKIN NOT SHOWN)

**FIGURE 6-14 W14 - SA227 TIP EXTENSION AT END OF  
OUTBOARD FITTING (MAIN SPAR)**

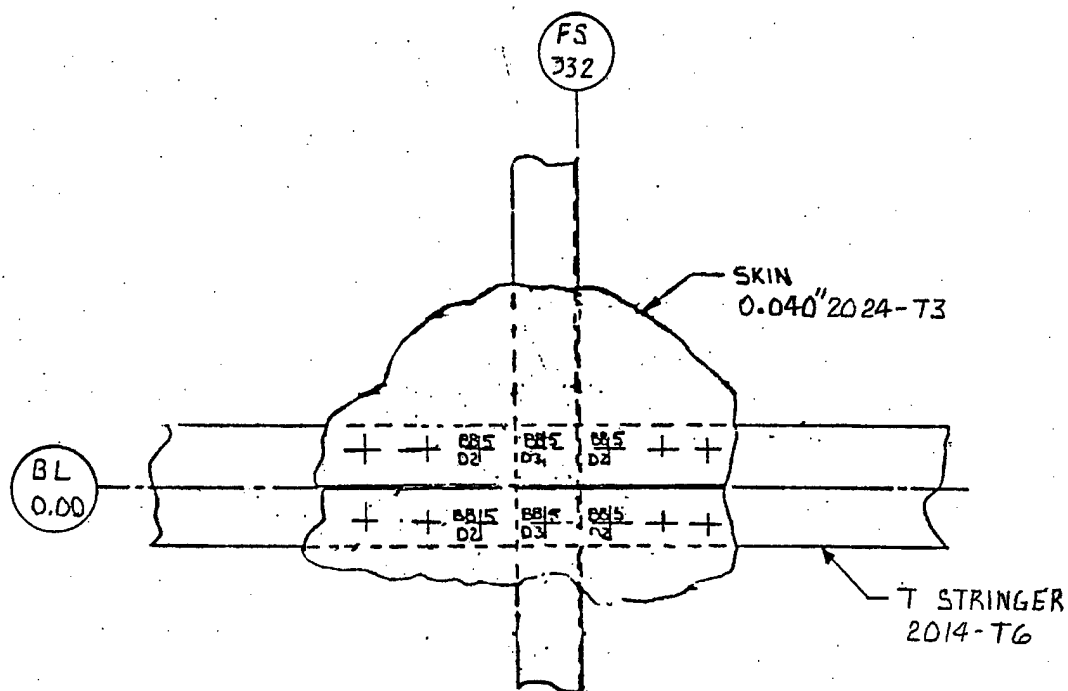
T STRINGER TOP CENTERLINE  
NEAR FS 330

FIGURE 6-15 F1 - SA226 T STRINGER, TOP CENTERLINE  
NEAR F.S. 330

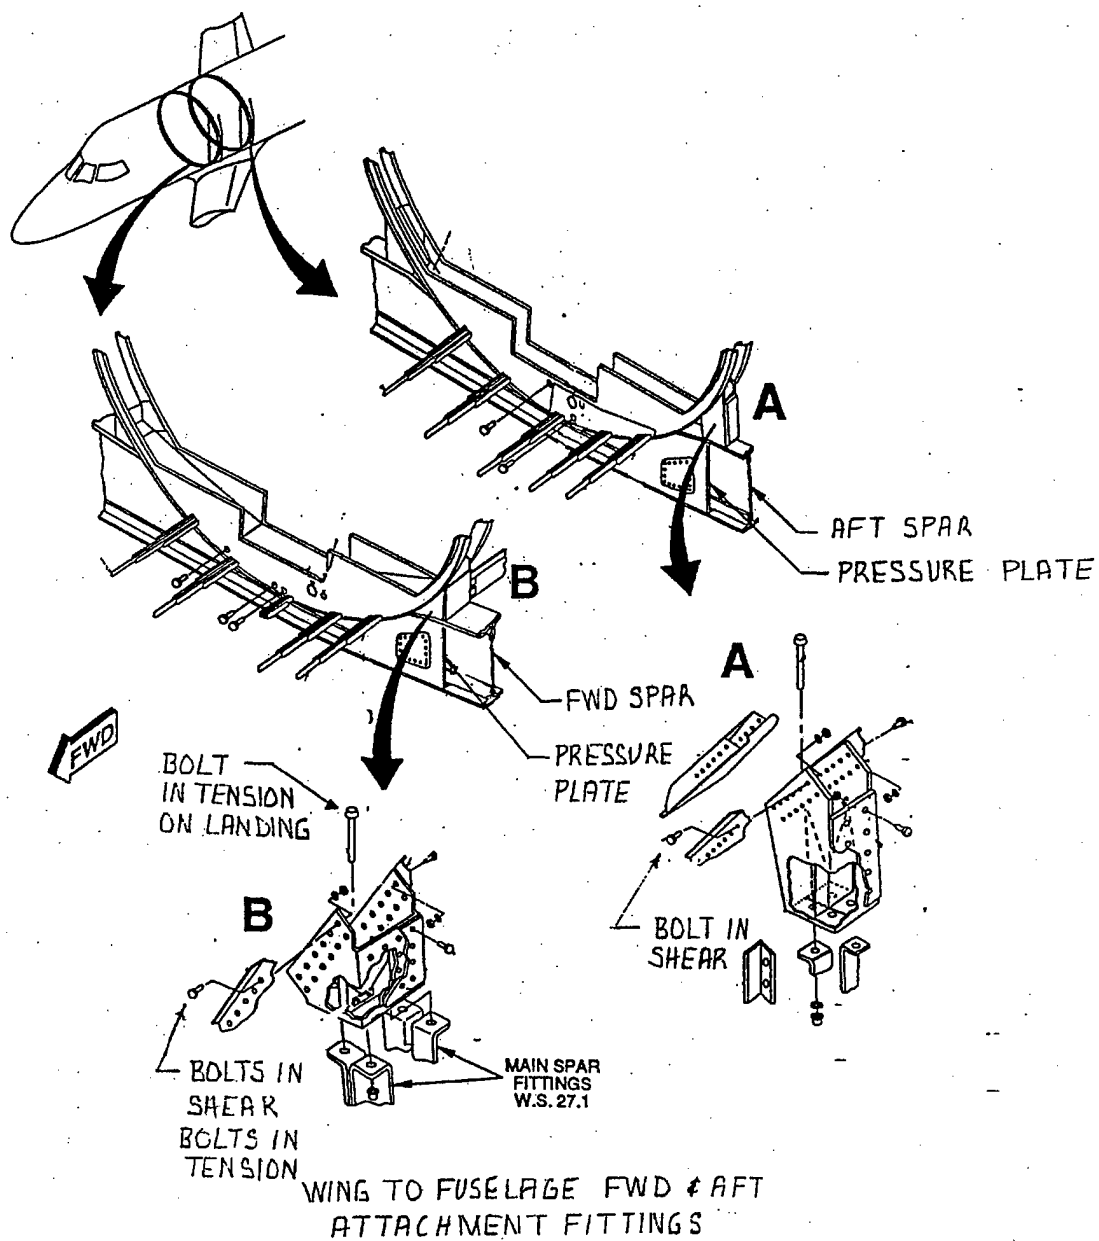
**FIGURE 6-16 F2 AND F3 - SA226 AND SA227 WING FUSELAGE FORWARD ATTACHMENT FITTINGS**

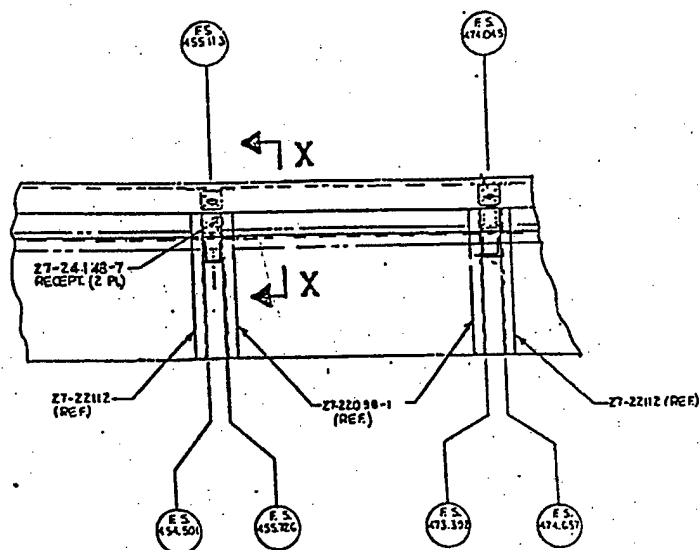
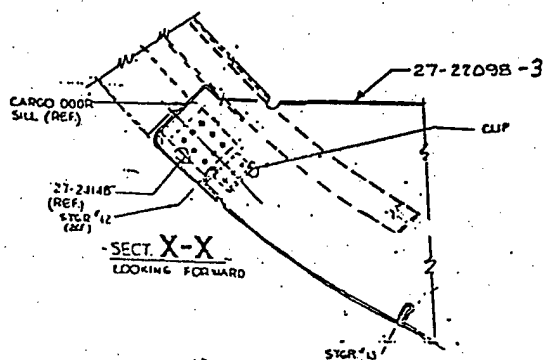
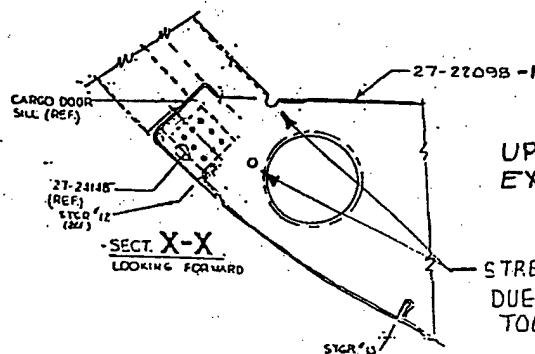
VIEW LOOKING INBD - L.H. SIDE  
SKIN (DOOR OMITTED FOR CLARITY)

SN 479 & UP

UP TO SN 479  
EXCEPT 457 & 470

STRESS CONCENTRATION  
DUE TO NOTCH AND  
TOOLING HOLE

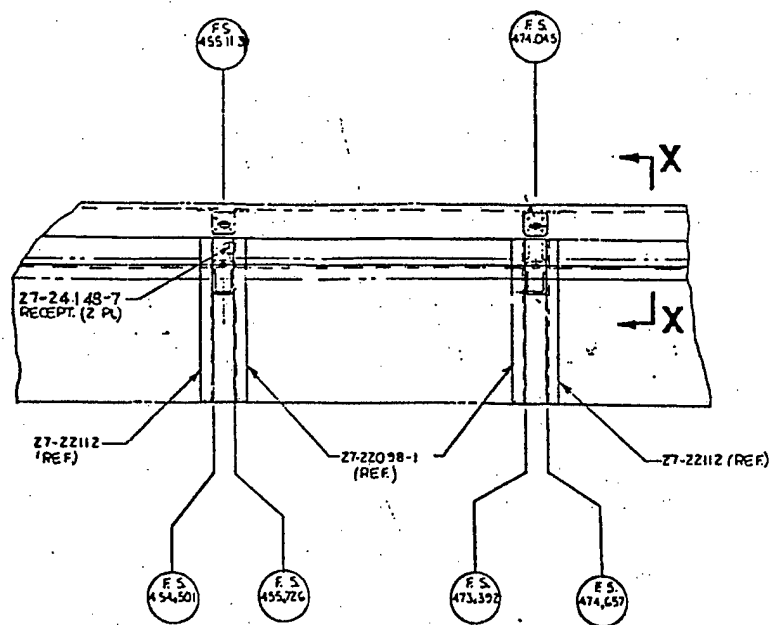
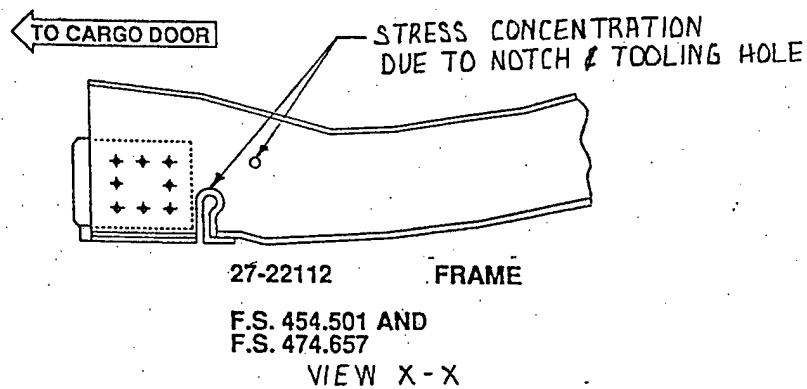
**FIGURE 6-18 F5 – SA226 AND SA227 FUSELAGE FRAME AT CARGO DOOR LATCH**

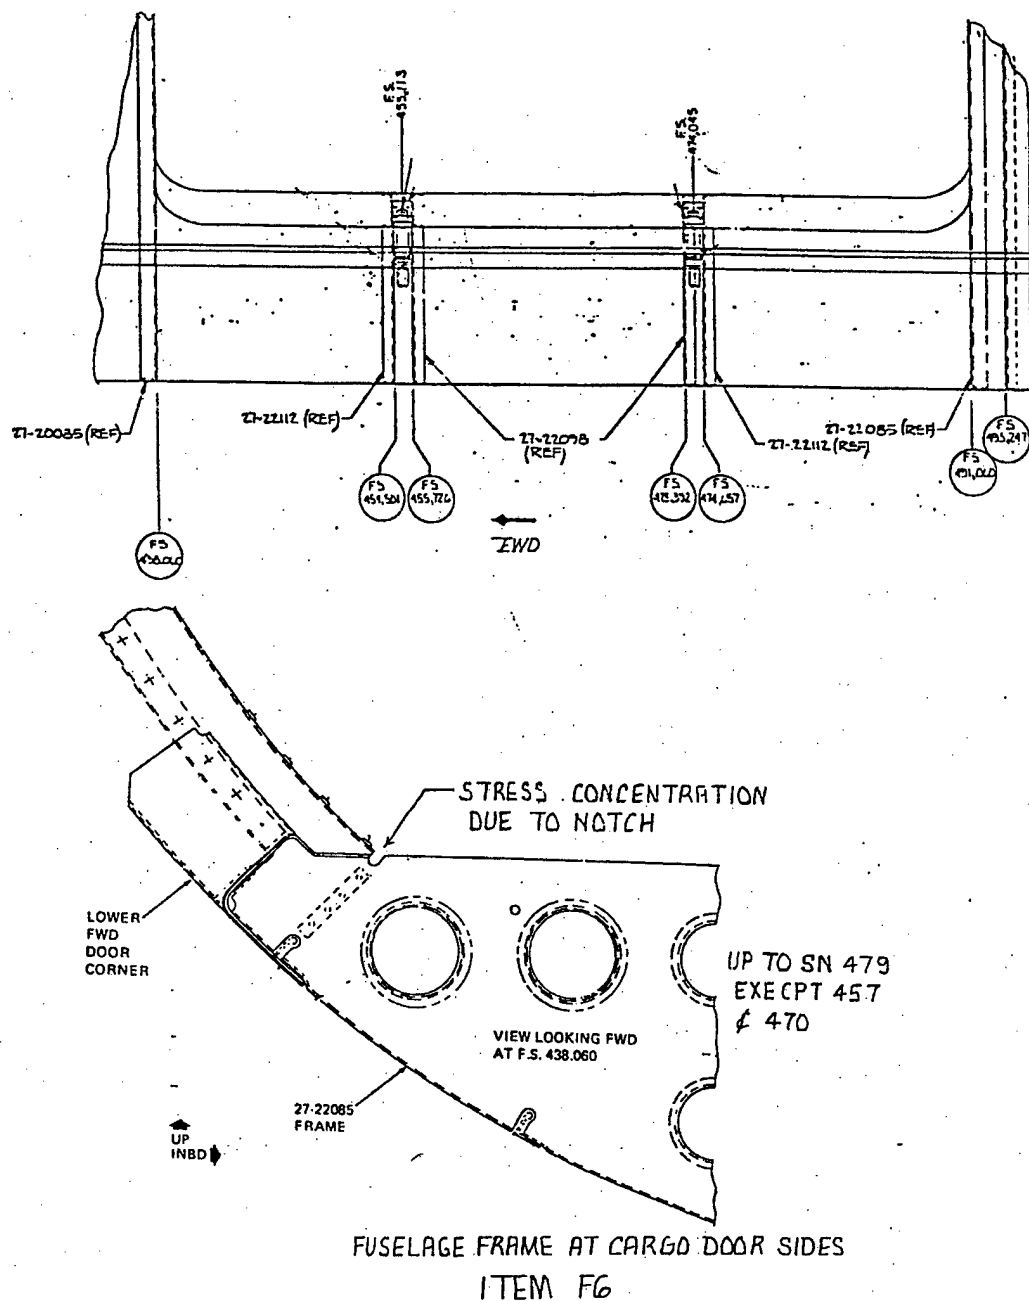
**FIGURE 6-19 F6 - SA226 AND SA227 FUSELAGE FRAME AT CARGO DOOR SIDES**

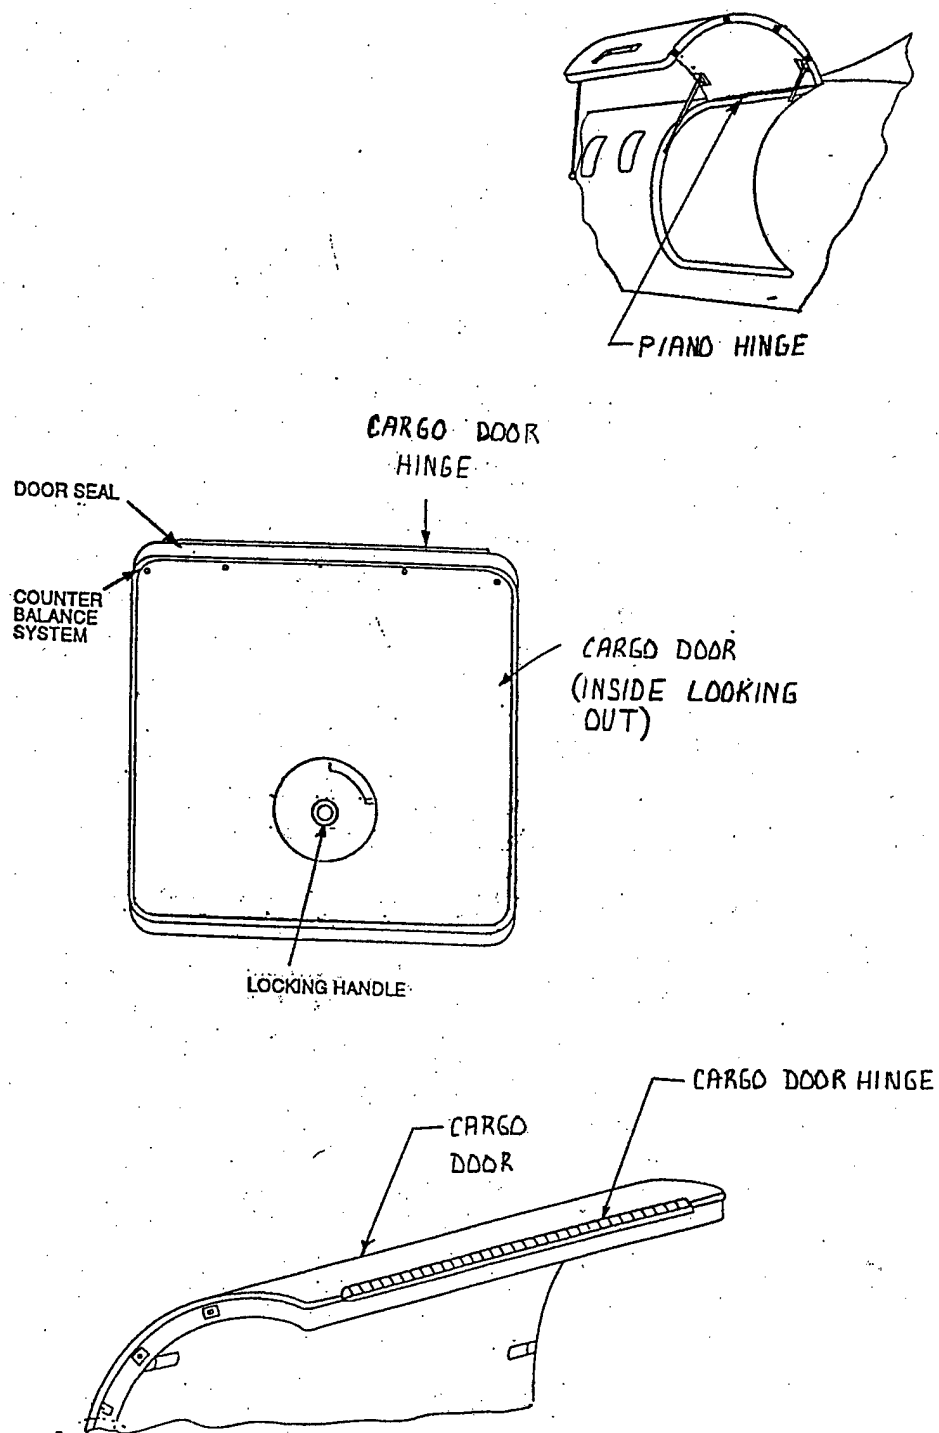
FIGURE 6-20 F7 - SA226 AND SA227 CARGO DOOR HINGE

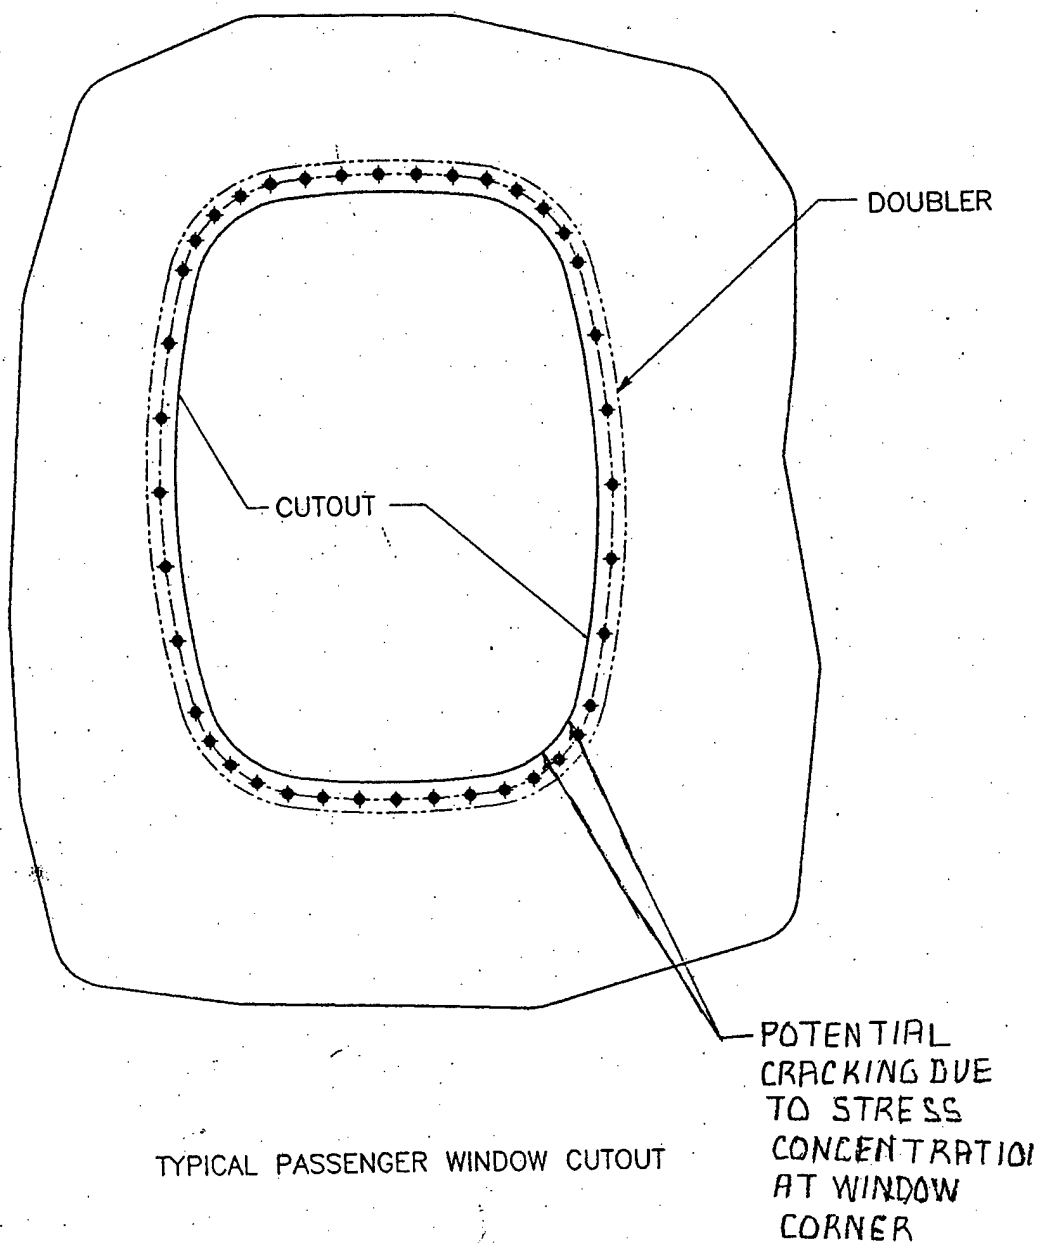
**FIGURE 6-21 F8 - SA226 AND SA227 CORNERS OF PASSENGER WINDOW CUTOUTS**

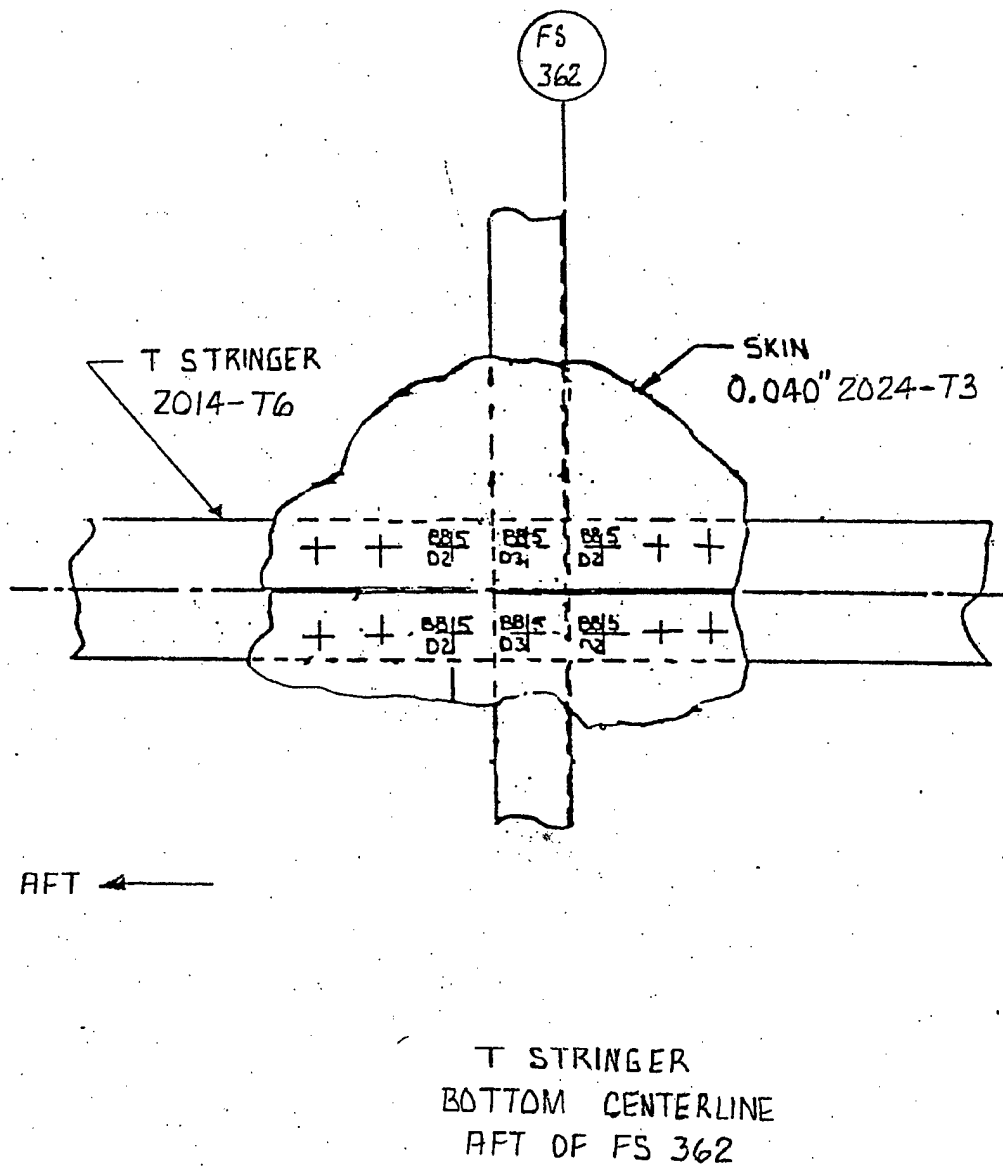
**FIGURE 6-22 F9 - SA226 T STRINGER, BOTTOM CENTERLINE  
 AFT OF F.S. 362**

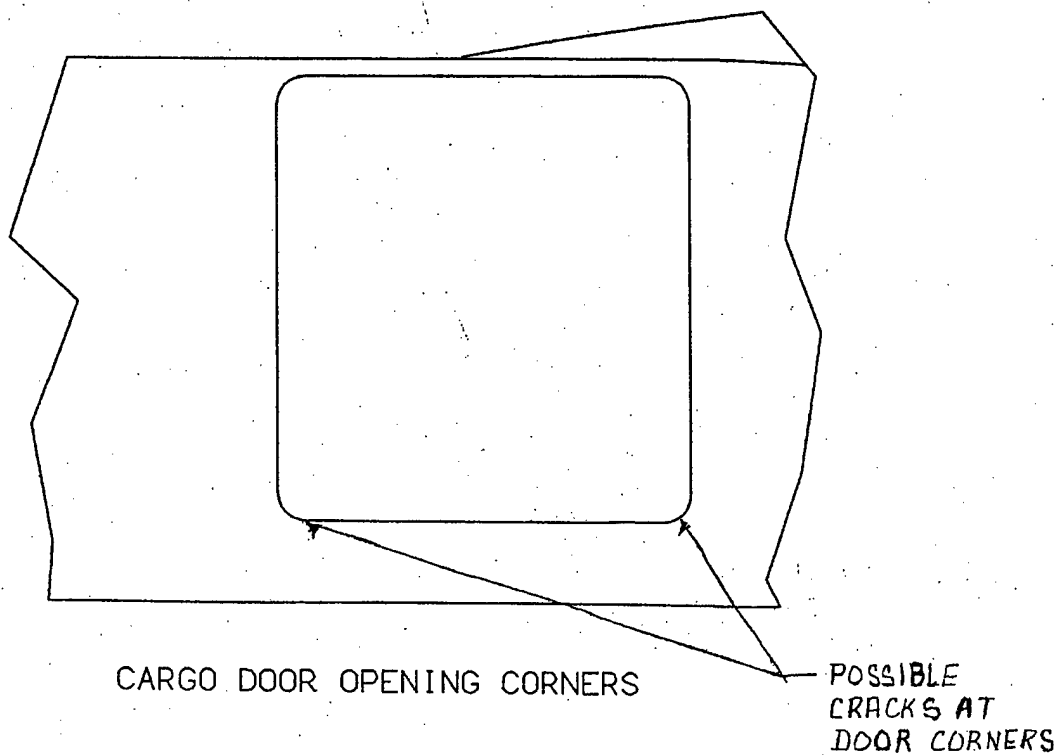
**FIGURE 6-23 F10 - SA226 AND SA227 CARGO DOOR OPENING CORNERS**

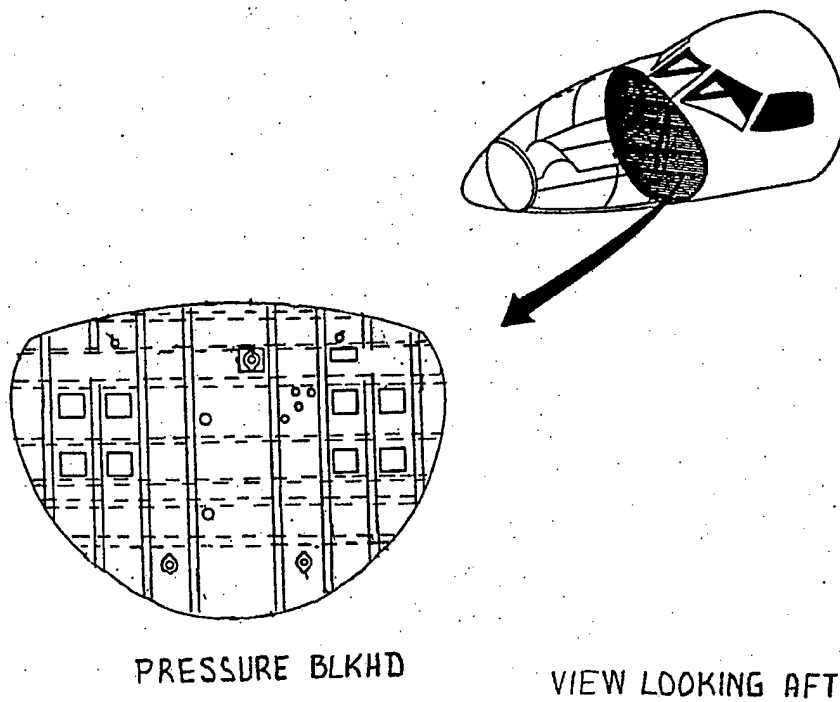
Nose Section, Bulkhead - F.S.69.31

**FIGURE 6-24 F11 - SA226 AND SA227 FORWARD PRESSURE BULKHEAD**

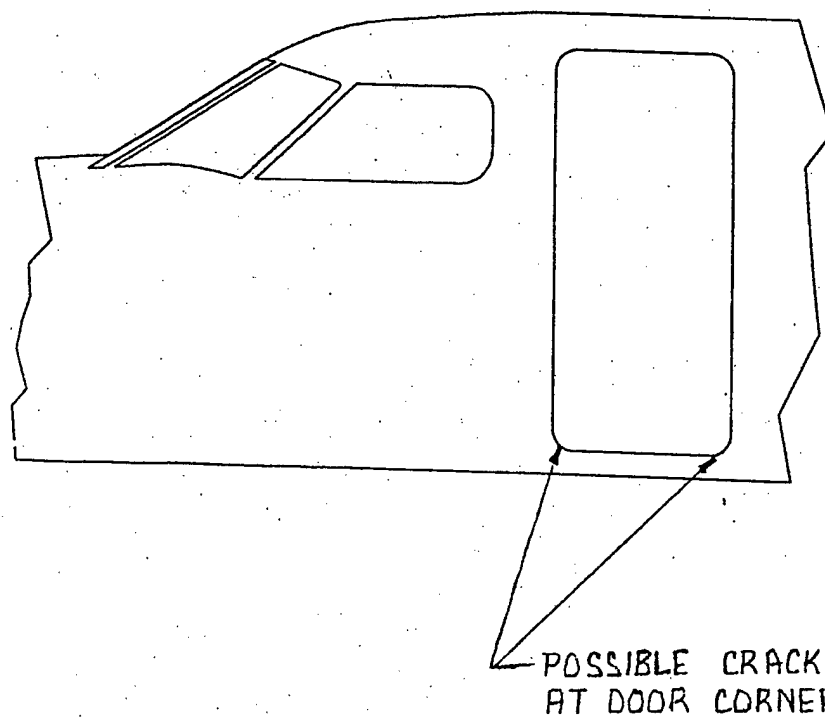
**FIGURE 6-25 F12 -SA226 AND SA227 PASSENGER DOOR  
OPENING CORNERS**

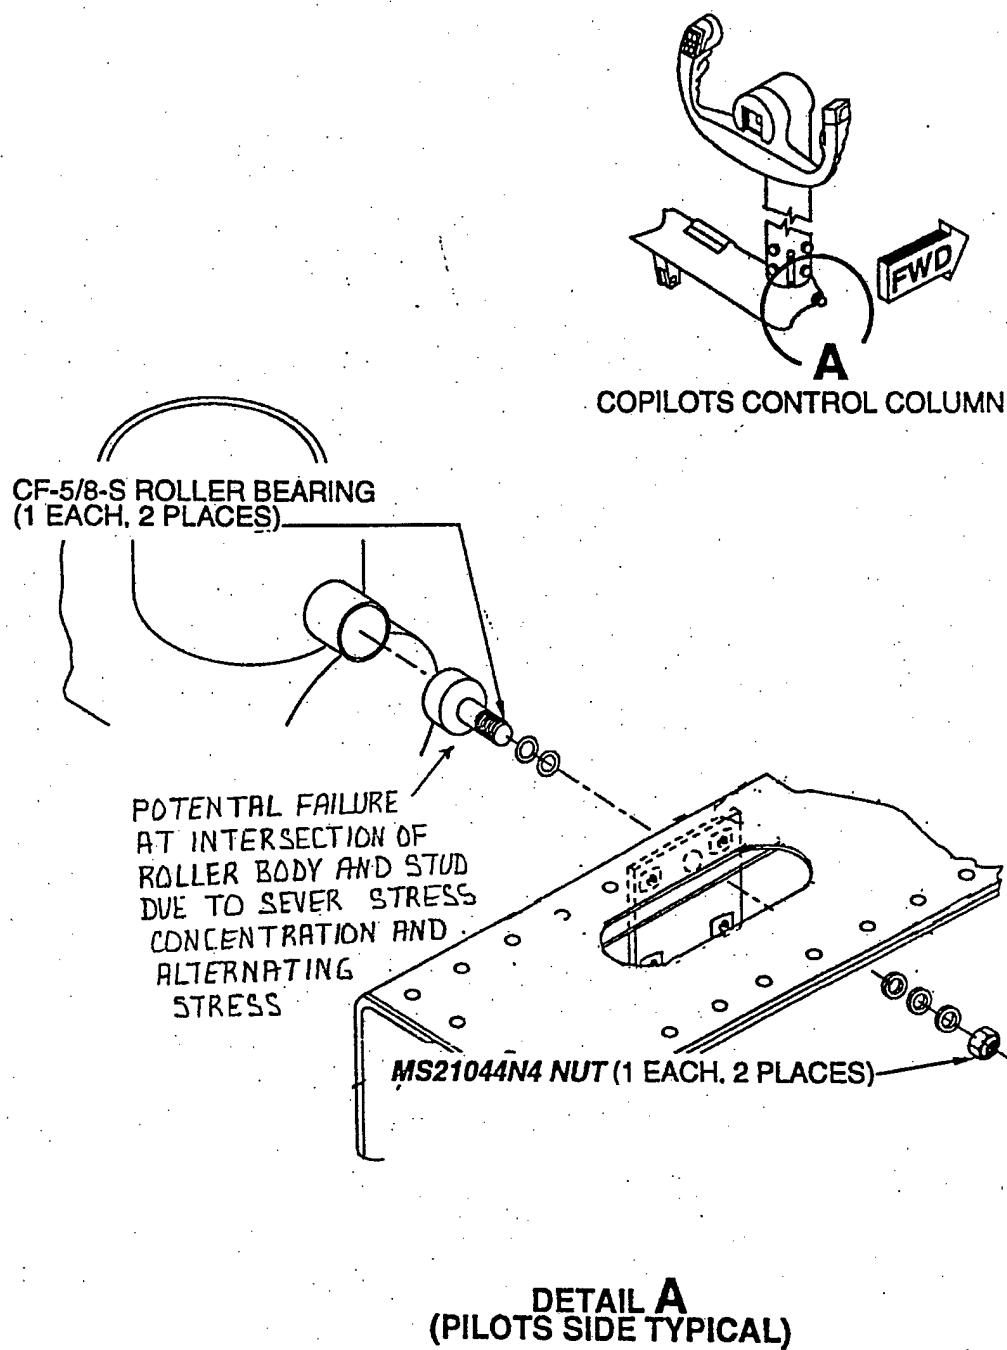
**FIGURE 6-26 F13 - SA226 AND SA227 CONTROL COLUMN  
ROLLER BEARING**

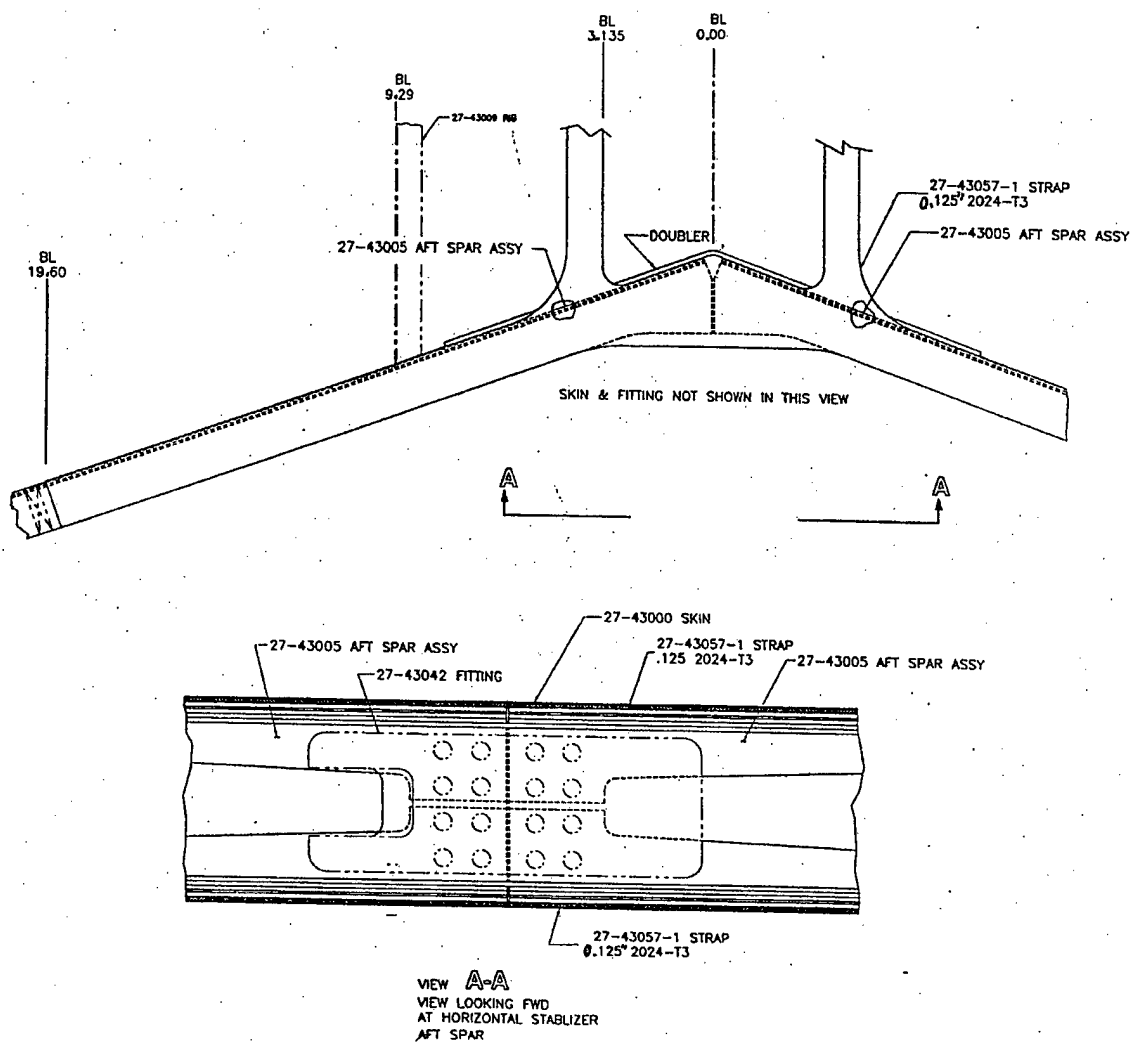
**FIGURE 6-27 H1 - SA226 AND SA227 HORIZONTAL STABILIZER  
RIB STRAP AT REAR SPAR**

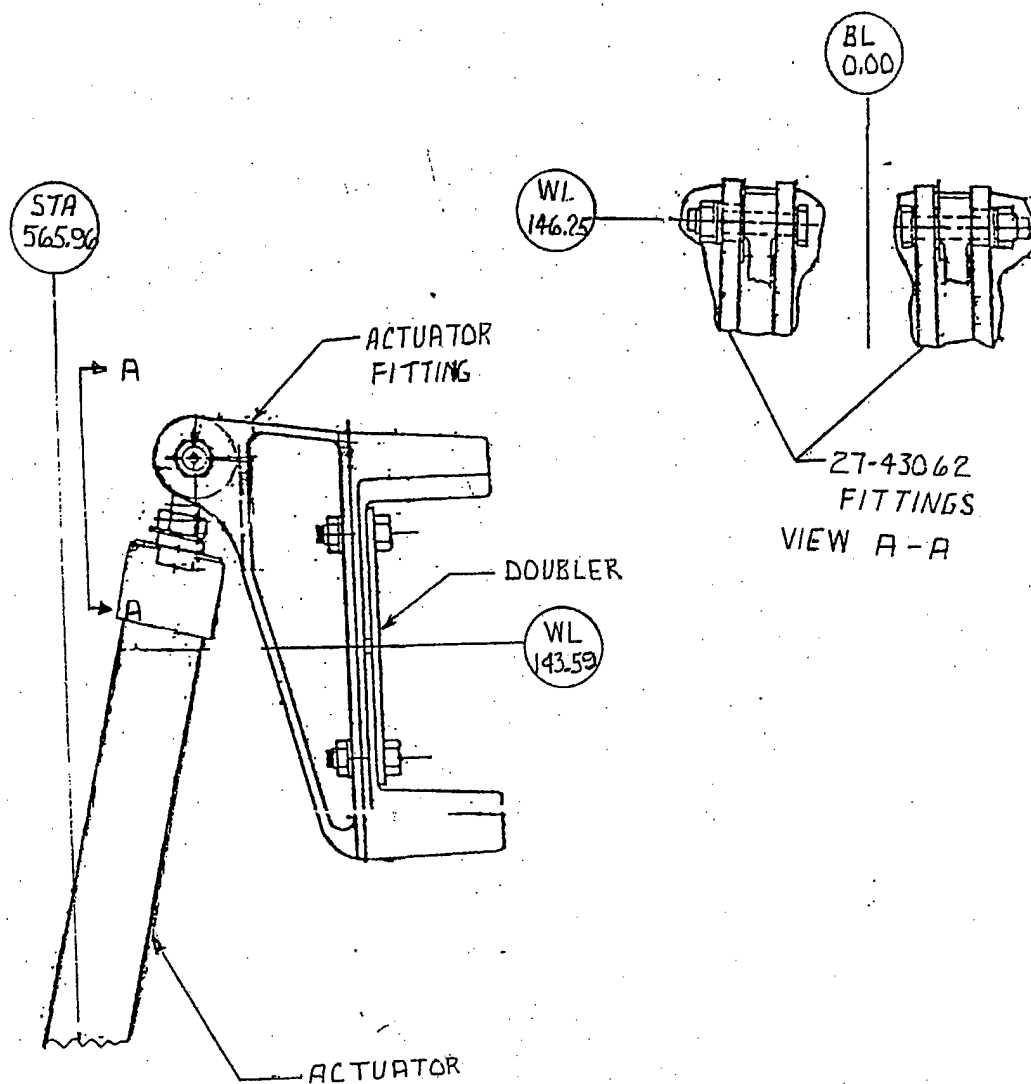
**FIGURE 6-28 H2 – SA226 AND SA227 HORIZONTAL STABILIZER PITCH TRIM ACTUATOR FITTINGS**

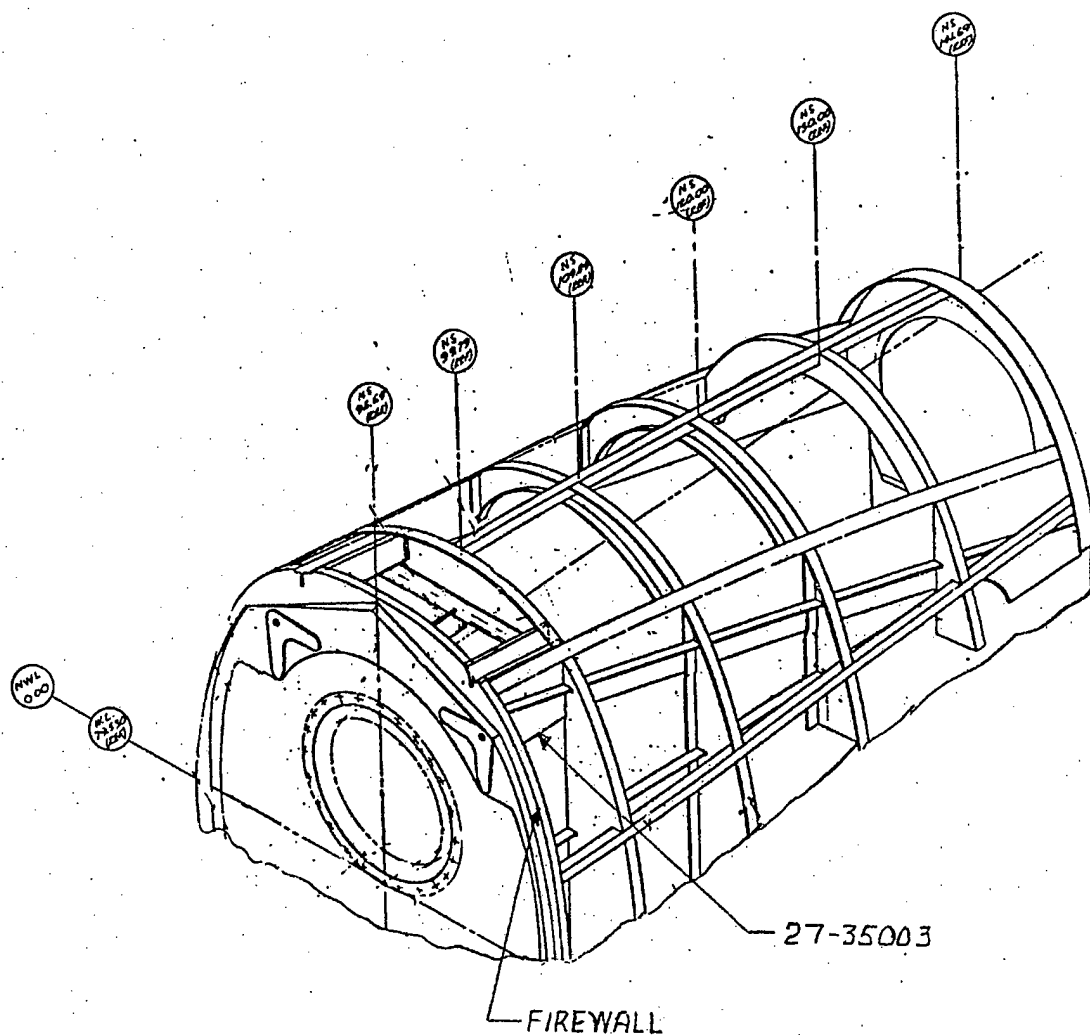
NACELLE UPPER LONGERON  
AT FIREWALL

**FIGURE 6-29 N1 - SA226 AND SA227 NACELLE UPPER  
LONGERON AT THE FIREWALL**

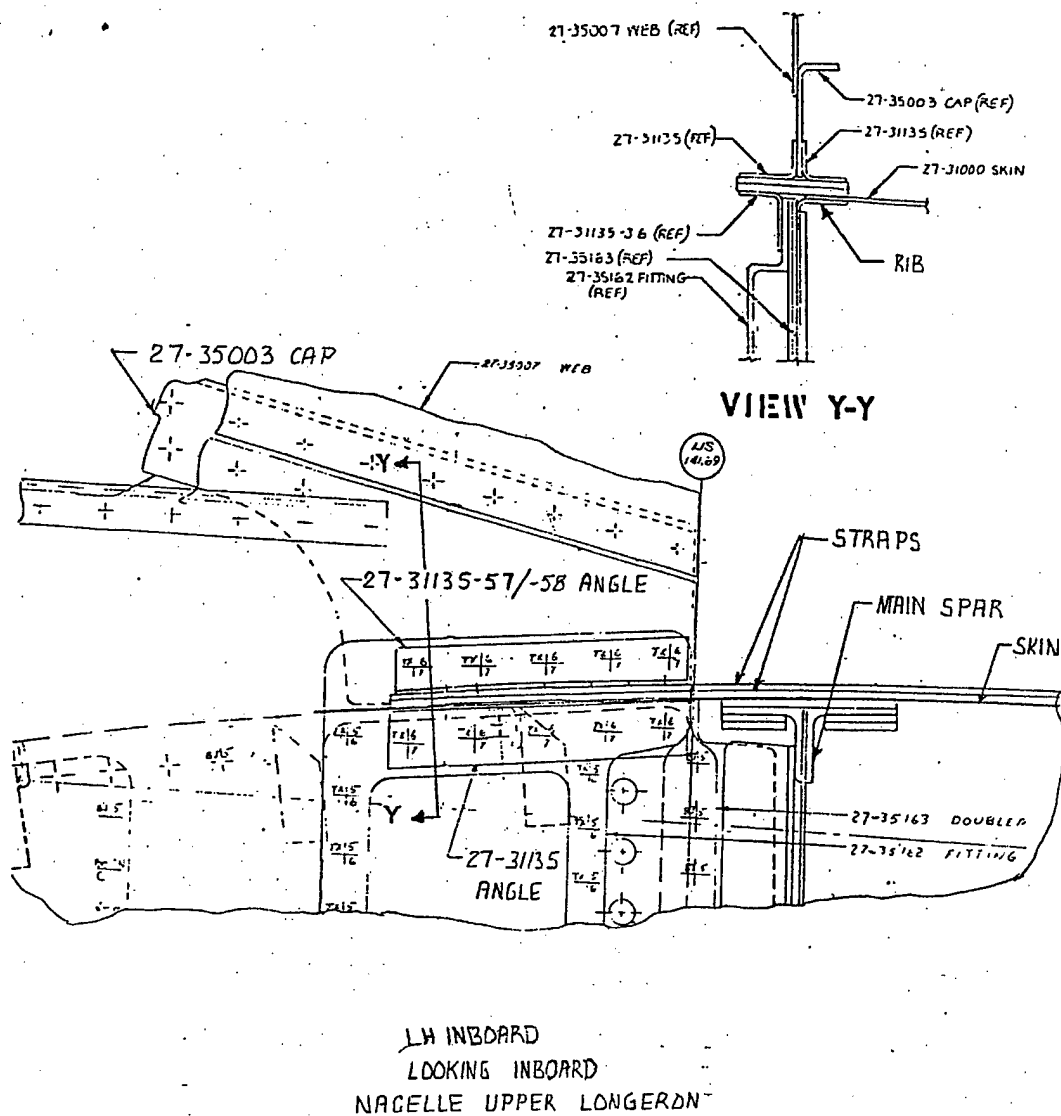
**FIGURE 6-30 N2 AND N3 – SA226 AND SA227 NACELLE UPPER LONGERON AT THE ATTACHMENT TO THE WING RIB**

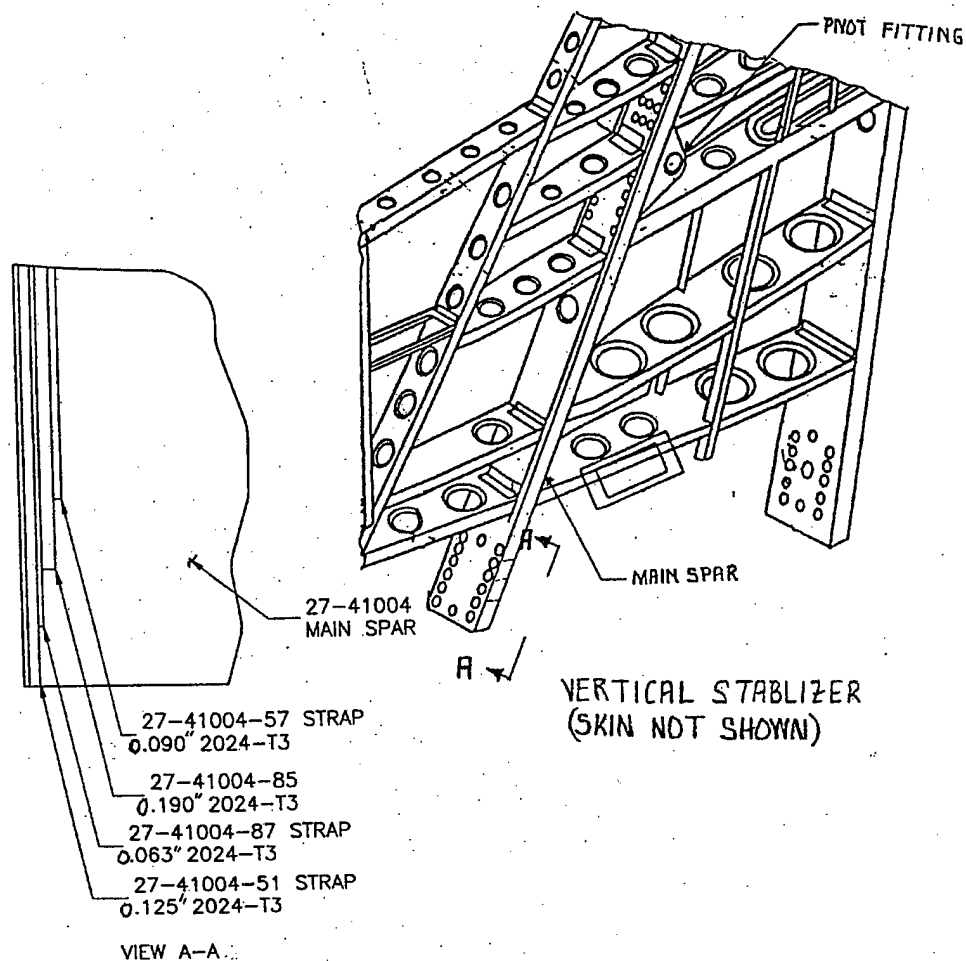
**FIGURE 6-31 V1 - SA226 AND SA227 VERTICAL FIN MAIN SPAR  
CAP STRIPS**

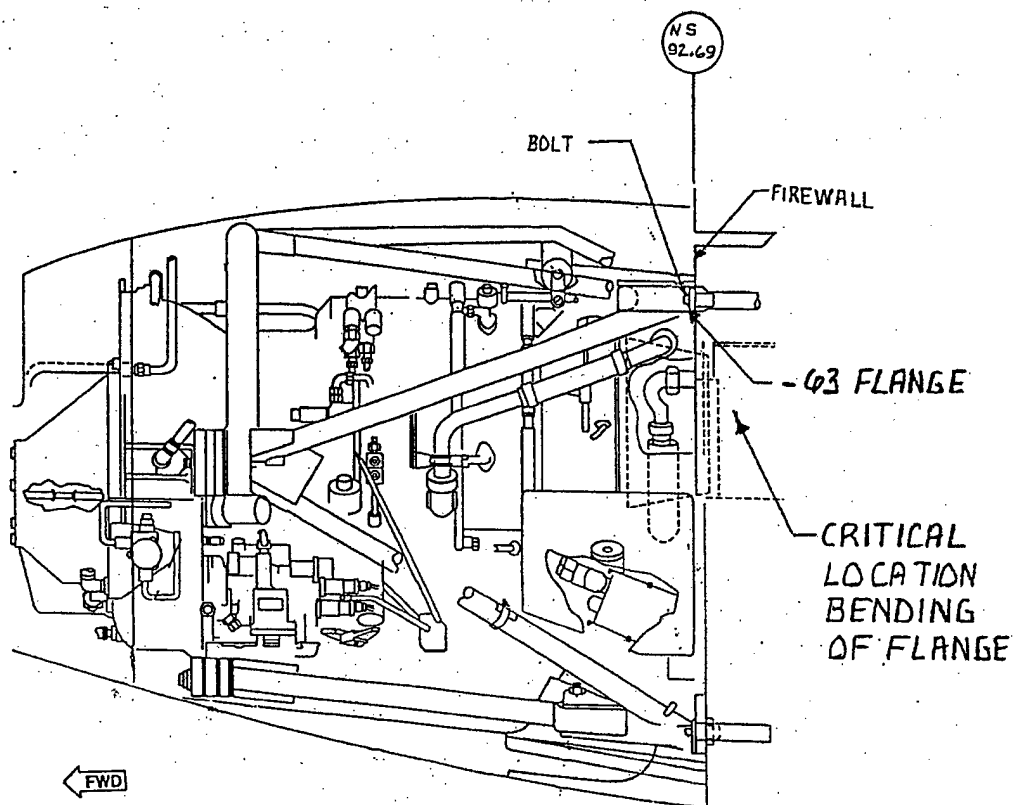
FIGURE 6-32 EM1 - SA227 ENGINE MOUNT AT FIREWALL

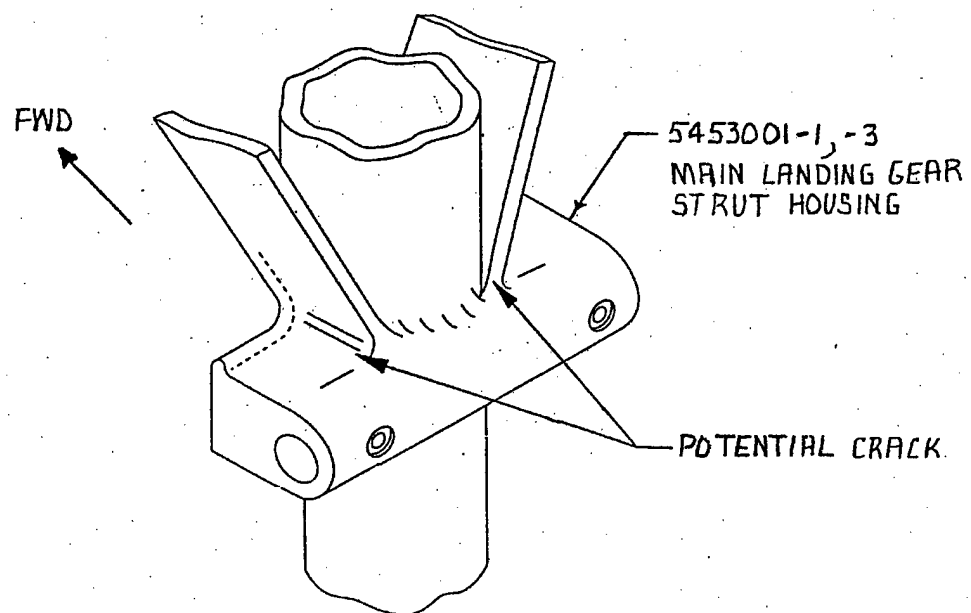
**FIGURE 6-33 LG2 - MAIN LANDING GEAR STRUT**

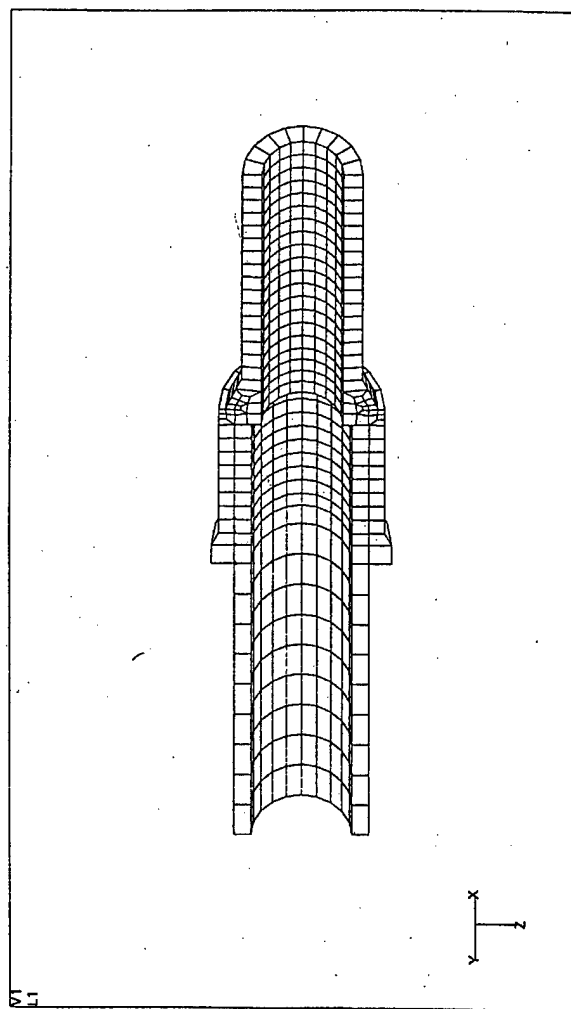
**FIGURE 6-34 METRO III MAIN LANDING GEAR FINITE ELEMENT MODEL**

The main landing gear yoke finite element model shown in Figure 6-34 was developed to analyze the stress distribution around the hole in the body due to thermal stress shown in figure 6-35. With small changes this model is also capable of analyzing the stress distribution with cracks emanating from the hole.
