**DOT/FAA/AR-99/20, P1**

# **Development of a Supplemental Inspection Document for the Fairchild SA226 and SA227 Aircraft, Part 1**

September 1999

Technical Report

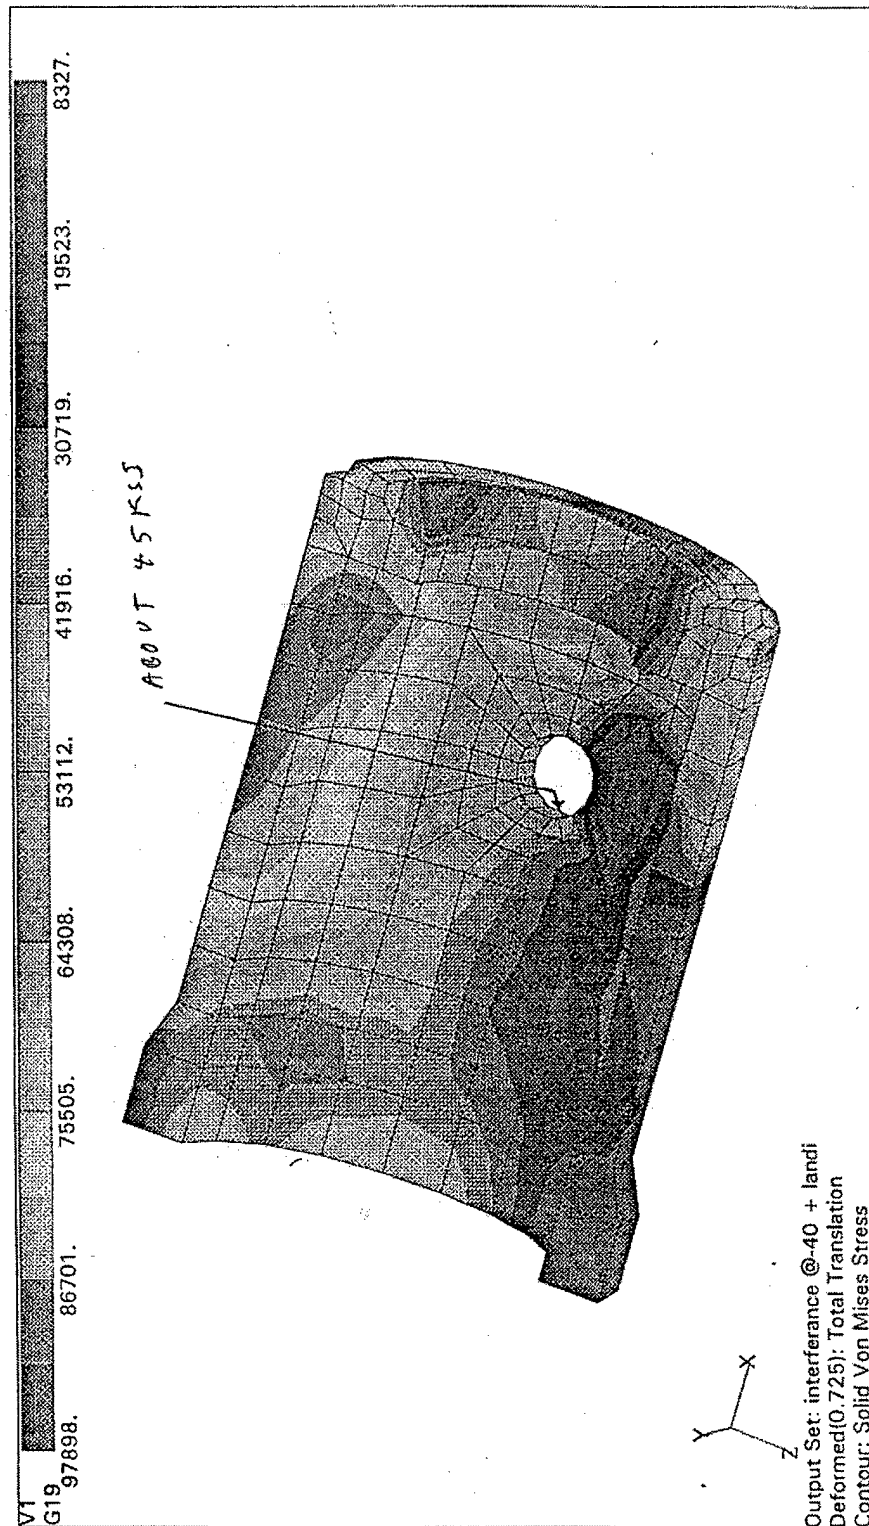
FIGURE 6-35 MAIN LANDING GEAR FINITE ELEMENT MODEL

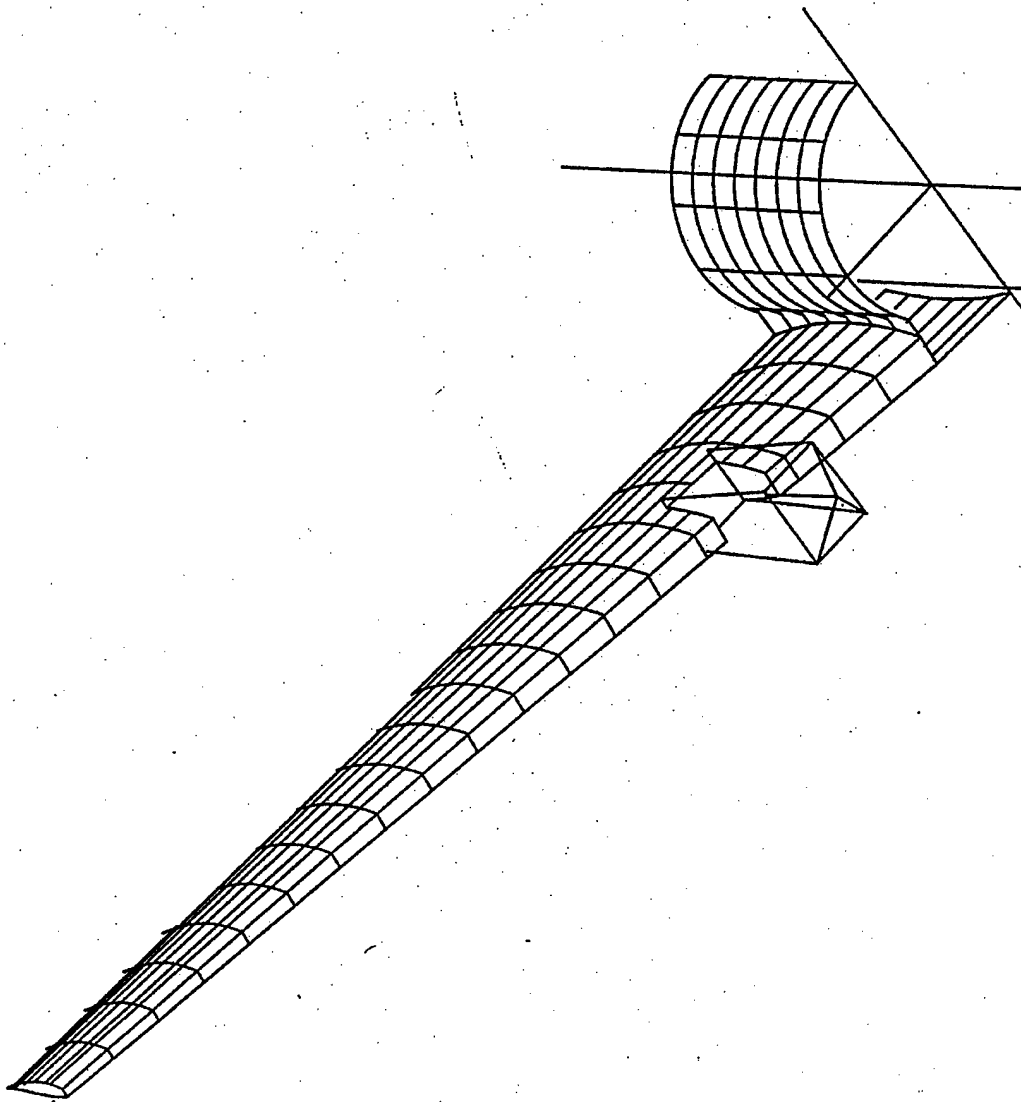
**FIGURE 6-36 WING FINITE ELEMENT MODEL**

The wing finite element model shown in Figure 6-36 was used to analyze the SA227 wing. The distributions were checked during the SA227 wing static test and shown to be within about 1% of the measured stress for the more heavily loaded portions of the wing. These analysis results can be used to determine stresses at locations other than the strain gage locations.

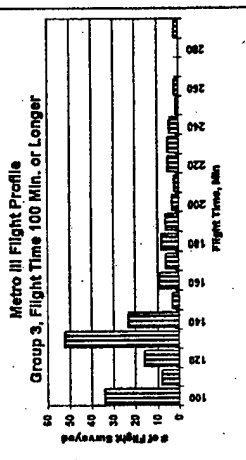
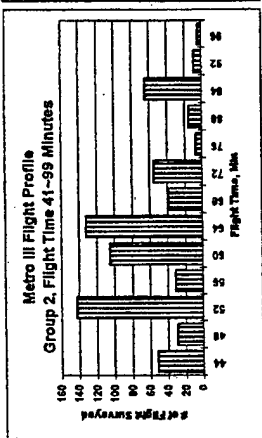
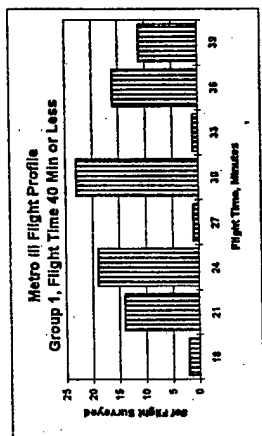
### MISSION PROFILE SELECTION FLIGHT LENGTH COMPARISON

Time (+1 std dev) 186  
Time, Average 144  
Time (-1 std dev) 103

Time (+1 std dev) 74  
Time, Average 62  
Time (-1 std dev) 50

Time (+1 std dev) 36  
Time, Average 29  
Time (-1 std dev) 23

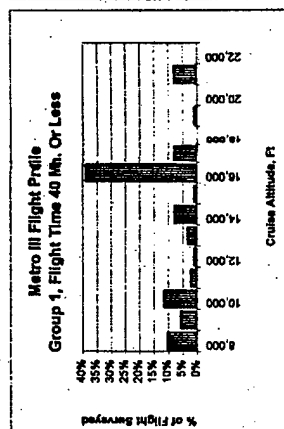
## MISSION PROFILE SELECTION FLIGHT ALTITUDE COMPARISON

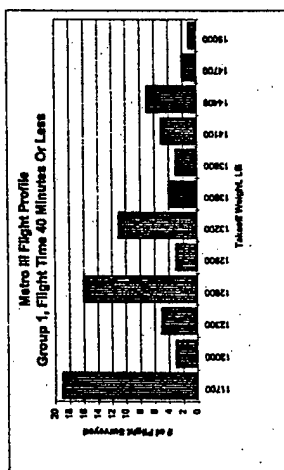
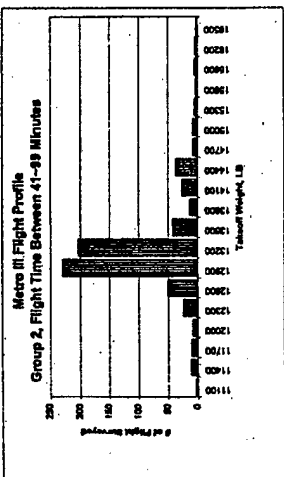
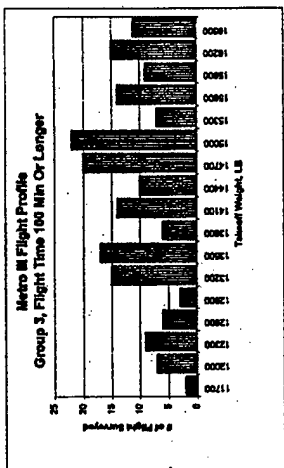
## MISSION PROFILE SELECTION TAKEOFF WEIGHT COMPARISON

Wt. (+1 std dev) 13,765  
Wt. Average 12,753  
Wt. (-1 std dev) 11,741

Wt. (+1 std dev) 13,901  
Wt. Average 13,274  
Wt. (-1 std dev) 12,647

Wt. (+1 std dev) 14,918  
Wt. Average 13,828  
Wt. (-1 std dev) 12,737
