CRREL REPORT

Enhanced Natural Remediation of White-Phosphorus-Contaminated Wetlands through Controlled Pond Draining

November 1999

Prepared for
U.S. ARMY ENVIRONMENTAL CENTER
U.S. ARMY, ALASKA

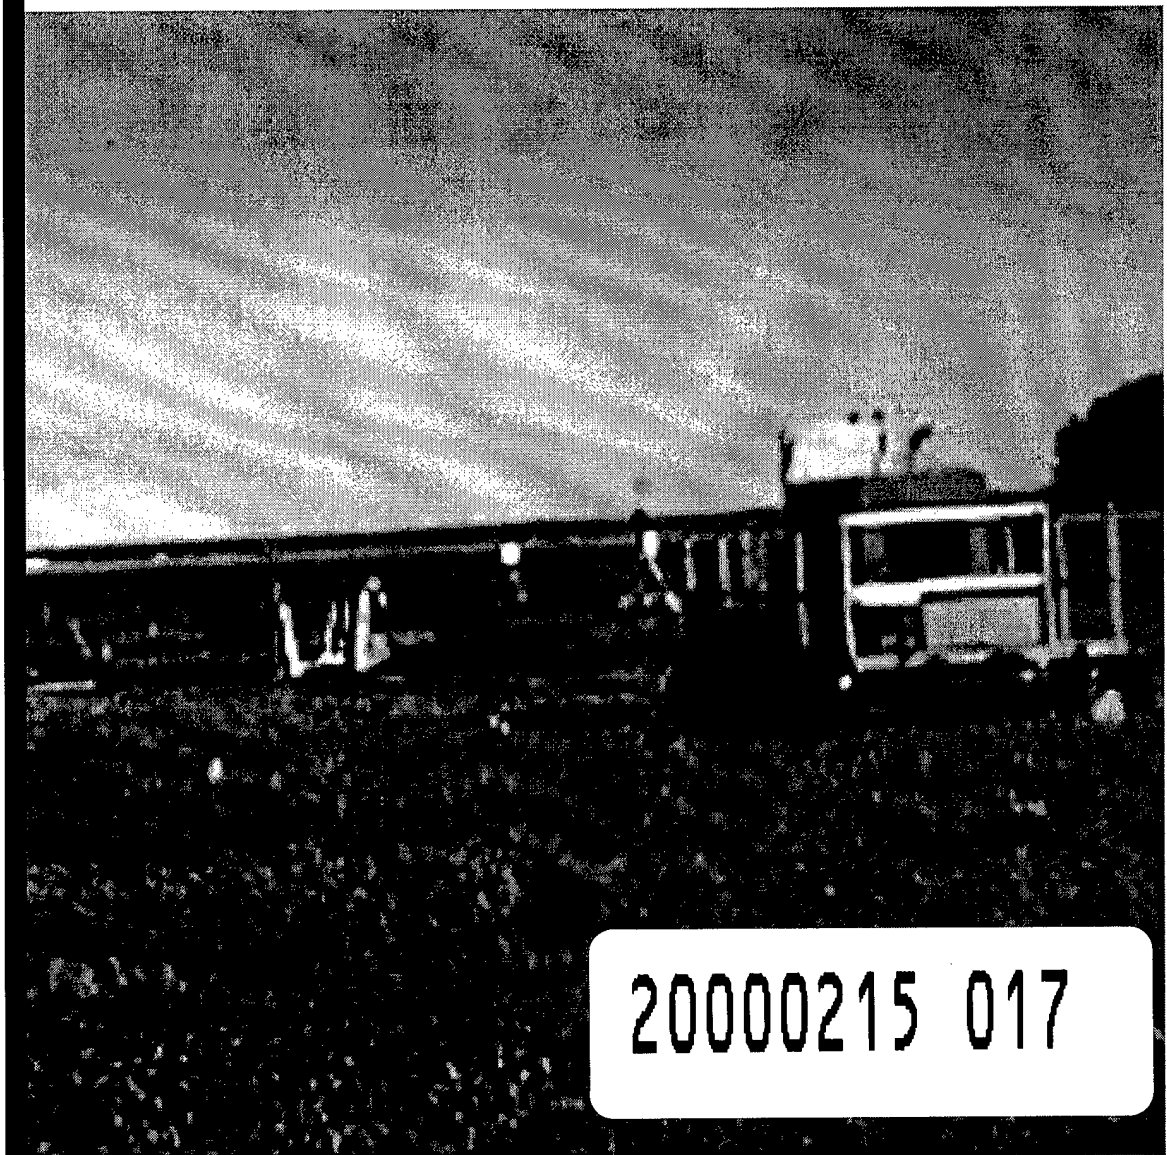
Cover: Pump system 2, located in Pond 730, Area C/D, June 1999. In background are two data acquisition systems used to monitor remediation parameters. (Photo by M.R. Walsh, CRREL.)

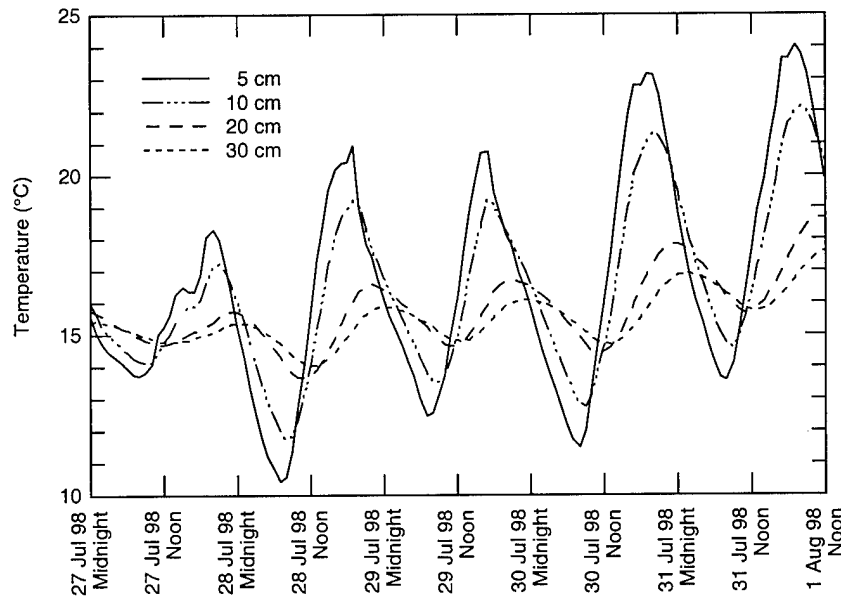
Figure 2. Diurnal temperature variations of surface sediments at ERF.

Temperature is the other major factor that determines persistence in unsaturated sediments, because vapor pressure decreases exponentially with temperature. During summers at ERF, typical surface (top 5 cm) sediment temperatures average around 15°C with a diurnal variation of approximately 10°C (Fig. 2). At these temperatures, sublimation of a 2-mm-diam. particle buried in unsaturated sediment is predicted to take about 90 days. Oxidation will presumably hasten the loss. At ERF, the sediments of contaminated permanent ponds could be decontaminated if they were allowed to desaturate. Desaturation requires that either the sediments be removed to an upland site (dredging) for treatment or water from the pond be removed to allow in-situ drying (draining). Given the enormous expense involved in removing contaminated sediment for treatment, such as is the case in dredging (Walsh and Collins 1998), an in-situ approach is preferred.

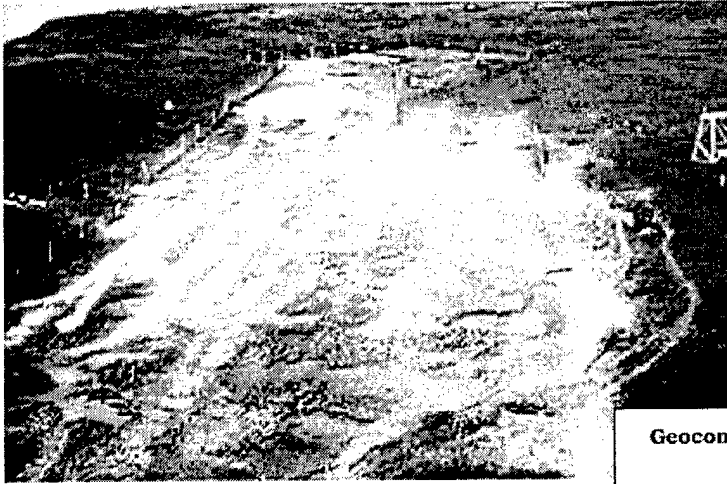
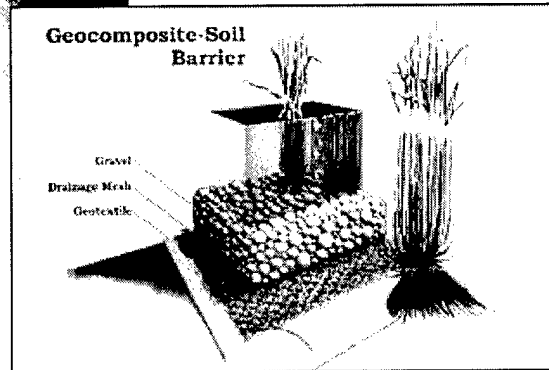
a. AquaBlok® applied to Racine Island.

b. Geotextile barrier concept.

Figure 3. Physical barrier technologies tested at ERF.

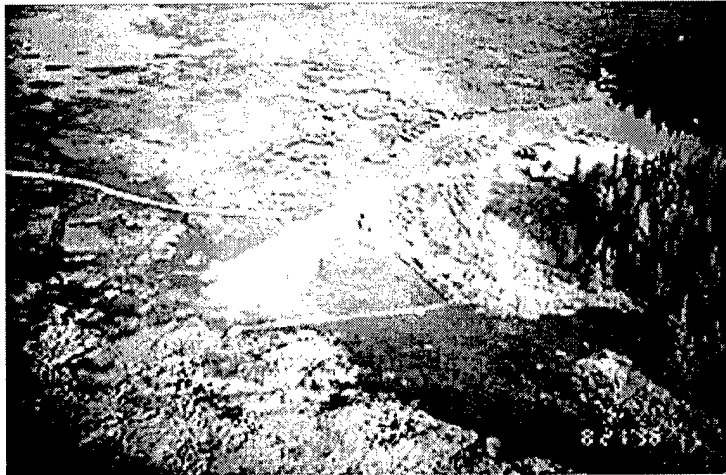
Figure 4. Remote dredge operation in Pond 146.

Use of a remote controlled dredge offered the possibility of physical removal of the white-phosphorus-contaminated sediment from the pond bottoms and the deposition of the sediment at an upland treatment site where the sediment can be allowed to dry and the white phosphorus allowed to sublime and oxidize (Fig. 4). Additionally, the deepening of the pond by dredging would place

any remaining contaminated sediments below the depth that dabbling waterfowl can reach. The presence of unexploded ordnance dictated the use of a remote-controlled dredge to reduce the danger to the dredge operator. A system was tested by CRREL in 1994 and 1995 and operated by a contractor in 1996 (Walsh, M.R., et al. 1996, Walsh and Collins 1998). The dredge and associated

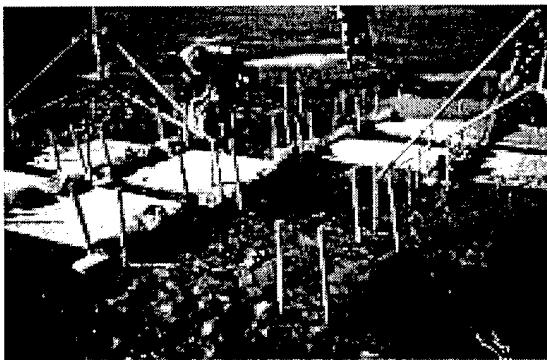
Figure 5. Field trials of surface treatments to enhance in-situ attenuation of WP.

Enhancement of in-situ processes. Enhanced in-situ natural attenuation of white phosphorus is considered the least-invasive remediation methodology for areas conducive to this type of treatment. Natural attenuation of white phosphorus contamination through sublimation and oxidation was identified as occurring in intermittent ponds in ERF (Walsh and Collins 1995) that would lead to the eventual decontamination of these ponds. A treatability study was undertaken to see if enhancing the natural attenuation process was possible through surface warming. Various surface modifications and cover treatments were implemented to change the albedo and warm the soil (Fig. 5). The results showed soil moisture to be the controlling factor affecting

attenuation and that large-scale surface treatments would be difficult and only partially effective unless the water could be drained out of the ponds. Although the concept of in-situ natural attenuation was ideal, another method of implementation was required.

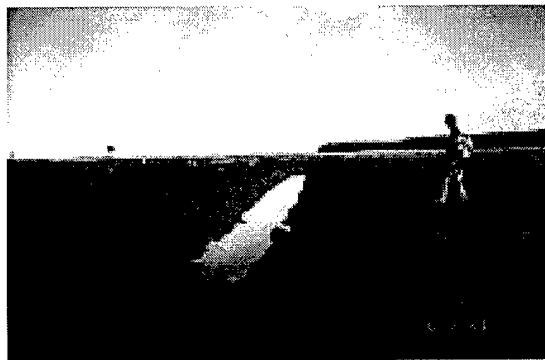
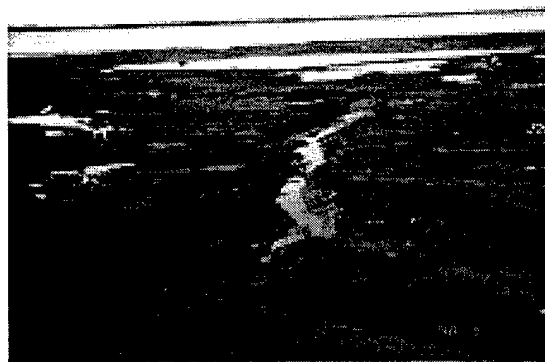
a. Racine Island (Meek's Canyon).

b. Bread Truck Pond (Pond 109).

Figure 6. Explosively excavated ditches for draining of ponds.

Permanent draining of contaminated ponds through explosive excavation of drainage ditches was successfully done for Pond 109 (Bread Truck

Pond) and Pond 293 (Racine Island). These ponds were two of the most contaminated ponds in Eagle River Flats. The excavation of ditches to these ponds, in April 1996 and April 1997 respectively, resulted in the permanent draining of most of the pond areas (Fig. 6). This removed them as habitat during periods of nonflooding tides, keeping the birds from feeding in the contaminated sediments of the areas drained. Permanent draining has been less successful in the removal of the white phosphorus through in-situ oxidation. Because the drainage ditch connecting the pond to the nearby tidal gullies has lowered the threshold flooding elevation into the pond basin, the former ponds are subjected to more frequent tidal inundation. This results in more frequent wetting and slower drying of the sediments and a much slower sublimation and oxidation rate of the white phosphorus (Collins et al. 1996, 1997,

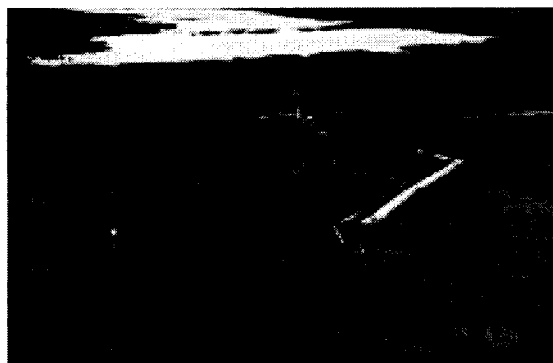
a. System installed in Pond 290. Note datalogger (left).

b. Close-up of floating pump in sump.

Figure 7. Autonomous pumping system for Eagle River Flats.

A 126-L/s pump system had been built to specification for Eagle River Flats in 1995. This is the system mentioned above that had originally been designed to operate in Pond 109. This pump system is composed of two major components: a pump unit consisting of a 15-cm (6-in.) open-impeller centrifugal pump on floats and an 80-kW generator set (genset) with fuel tanks, also on floats (Fig. 7). The two units are connected together by a four-conductor power cord, 70 m in length, and a control wire. The control wire interfaces between the genset control and float switches mounted on or near the pump.

The pump is separated from the genset to pre-

vent damage to the genset and the possible spill of fuel and lubricant in case of ingestion and detonation of unexploded ordnance by the pump. Originally, the pump was to be placed in the deepest section of the pond to be treated. The pump would then scour a small sump while drawing down the pond. Prior to deployment, however, we decided to blast a sump and place the pump within the preformed sump. The sump serves as a deep reservoir for the pump, reducing cycling of the system and thus conserving fuel.

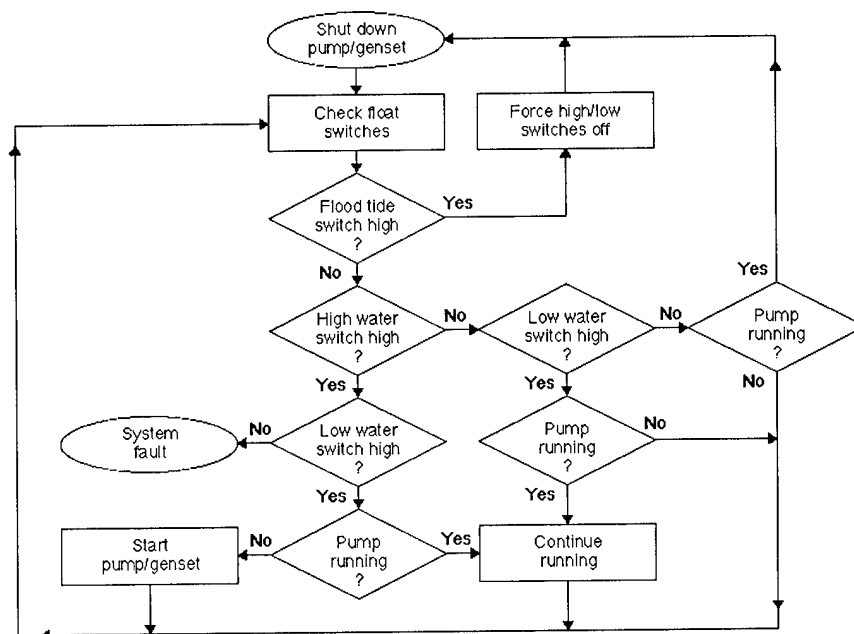
Figure 8. Switch logic diagram for pump operation.

was mounted above it; this would switch on the genset and then the pump when the water level rose in the sump, floating the pump. In operation, the reed-type switches were subject to being clogged by the fine-grained silt in the muddy water. Problems with these switches precluded operating the pump overnight during the first phase of testing. Replacement of the reed switches and modification of the control circuitry improved the system reliability to the point that it was operational by 21 May. The area continued to slowly dewater, and by 22 May, Pond 183 was essentially drained. Only isolated pockets of water remained in depressed areas not draining into the sump. These areas eventually dried through evaporation.

The reed switches were replaced with fully enclosed float switches, a more robust arrangement. Consideration of flooding tides led to the incorporation of a third float switch to shut the system down during flooding events. Circuitry needed to be added and the existing control circuitry needed modification. In July, the third switch was added for the detection of flood tides. The flood tide switch was mounted away from the pump near the rim of the sump to better detect the rising tides. The modifications were tested and operational prior to the flooding tide. On 21 July, a 9.7-m tide inundated Pond 183, triggering the flood tide switch and shutting down the system. The flood tide switch was set to trigger off when the natural drainage after the tide was nearly complete. This maximizes fuel conservation by taking advantage of the natural drainage of the area. Pumping resumed on 25 July. Drawdown of Pond 183 occurred over the next three days. The configuration worked so well during testing that the highwater switch was also mounted off-pump near the sump rim. This further reduces cycling by delaying the resumption of pumping until the sump completely fills. A diagram of the final switch logic is shown in Figure 8.

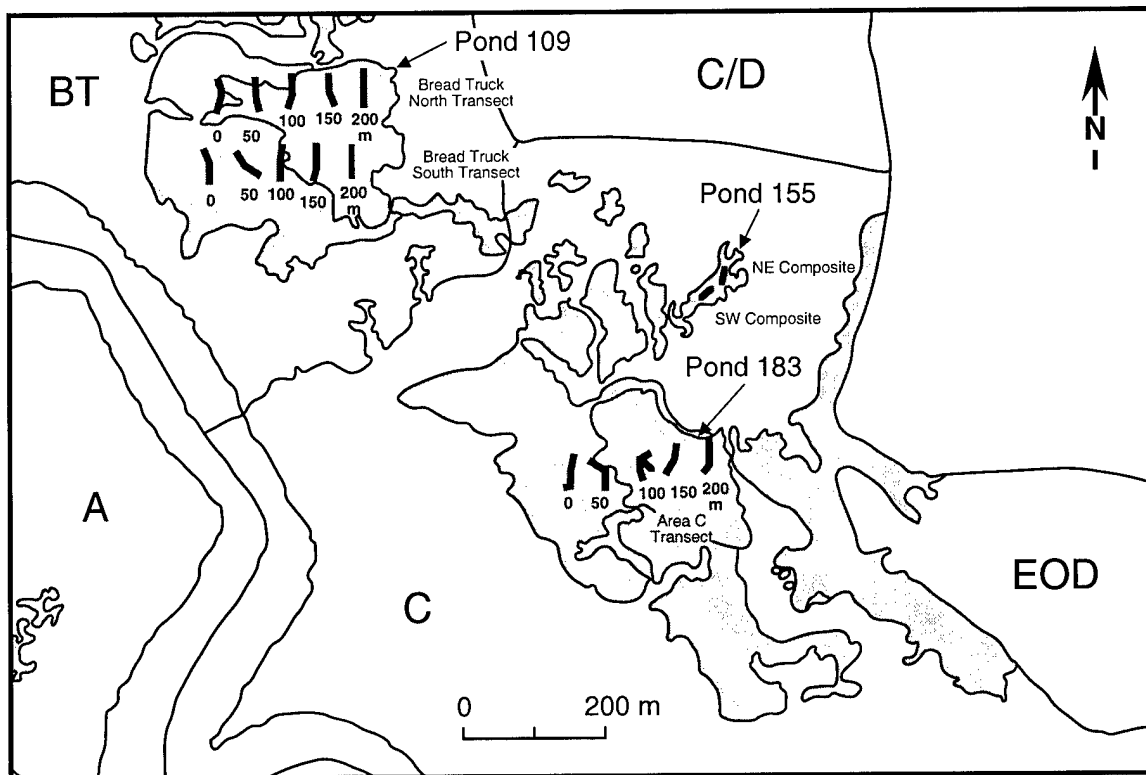
Figure 9. Map of composite sampling transects in Pond 109 (BT) and 183 (Area C).

To determine if the contaminant is present in a given area, composite sampling is conducted. We established transects bisecting ponds to monitor sublimation/oxidation conditions and for baseline and verification sediment sampling (Walsh et al. 1998). Transects were up to 200 m long, and at evenly spaced intervals, composite samples were collected to determine if hot spots (localized areas containing white phosphorus particles) were present (Fig. 9). Each composite sample was made up of sediment cores obtained at the nodes of a 1.82-m square grid covering a 5.46-m-wide area extending up to 20 m perpendicular to the bisecting transect. The grid spacing is based on

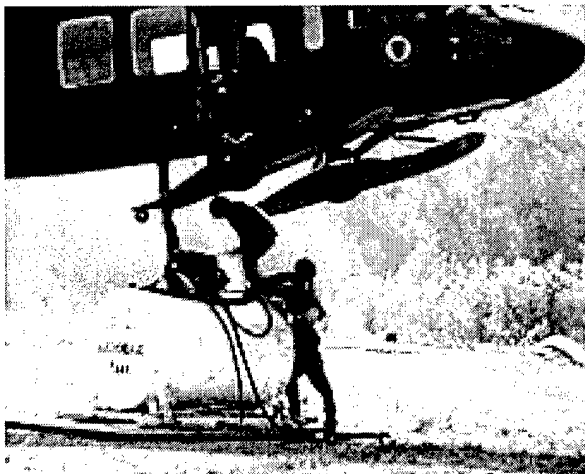
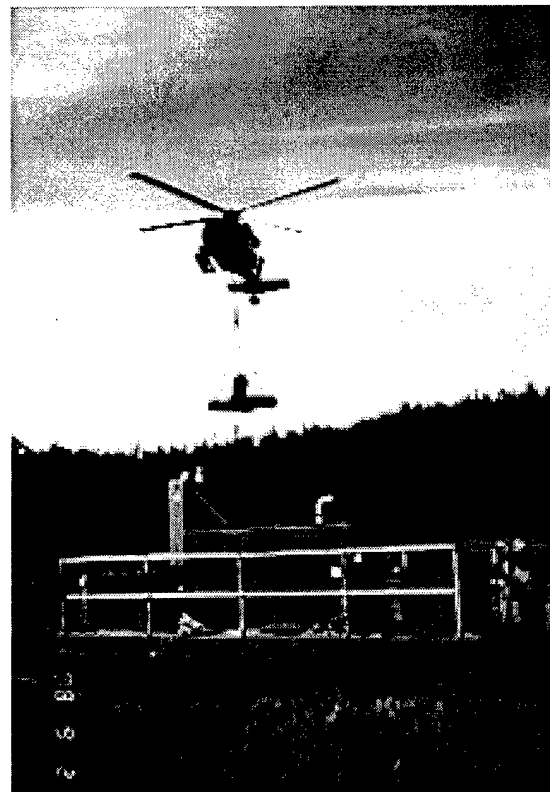
a. Riggers hooking up fuel transfer tank.

b. Airlifting pump.

Figure 10. Airlifting pump equipment.

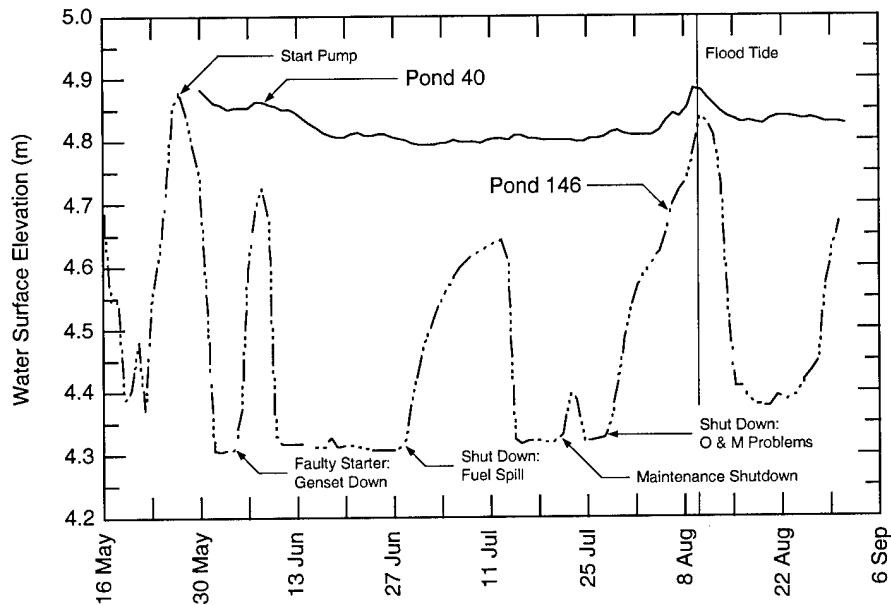
Figure 11. Water level relationships between Area C and Area C/D.

water flowed from the direction of C/D to Pond 146 along the border of ERF, the water does not seem to originate from C/D, but rather as inflow from the uplands adjacent to ERF between C and C/D. The hydrologic separation of these two areas was previously surmised, but has now been demonstrated. Isolation of these areas results in faster drawdown times and more effective drying.

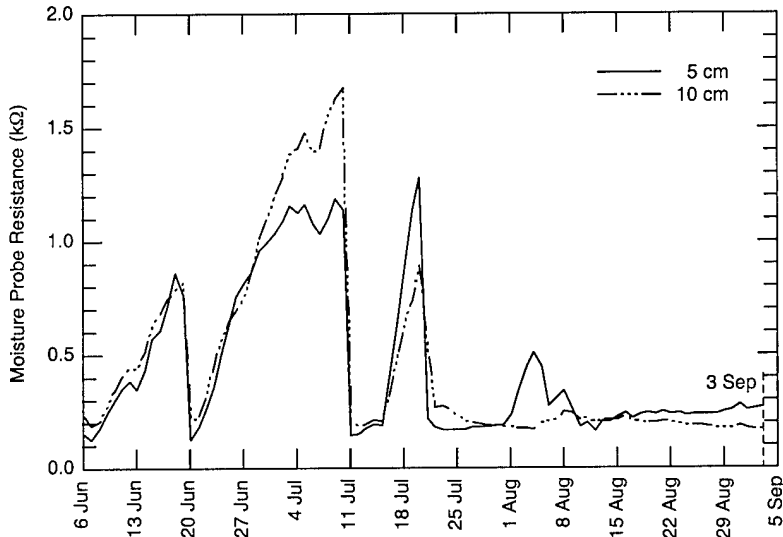
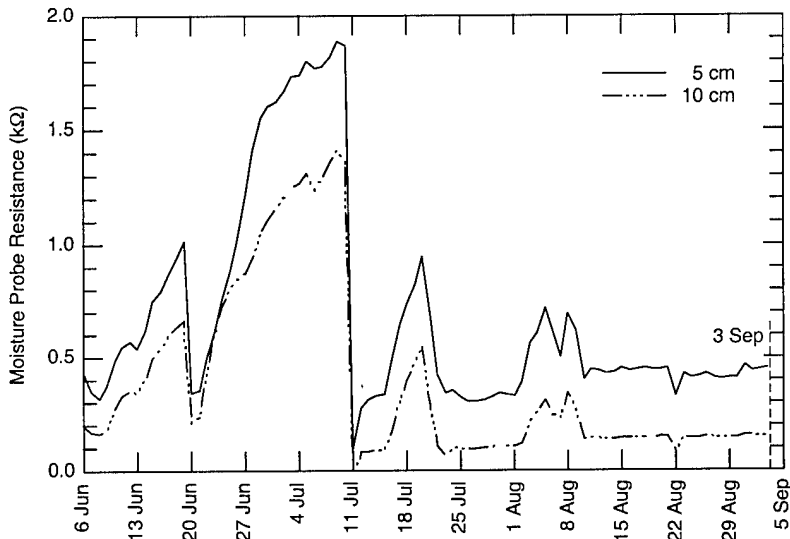
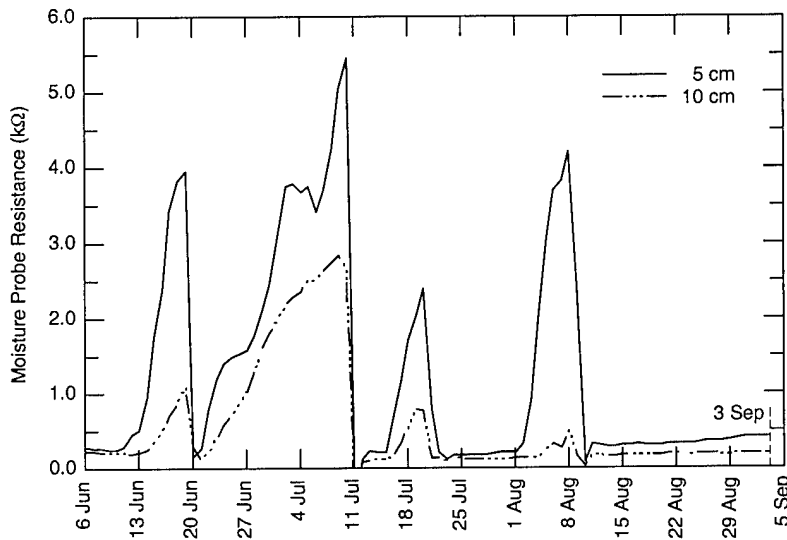
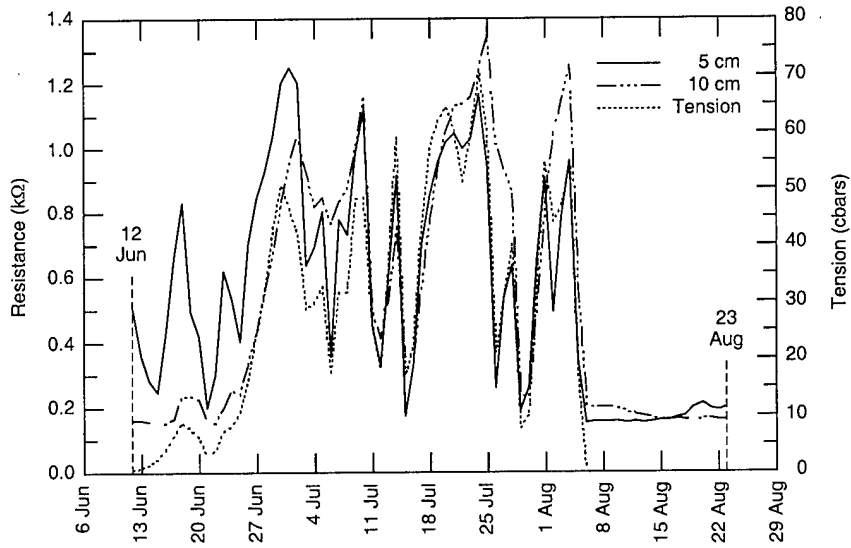
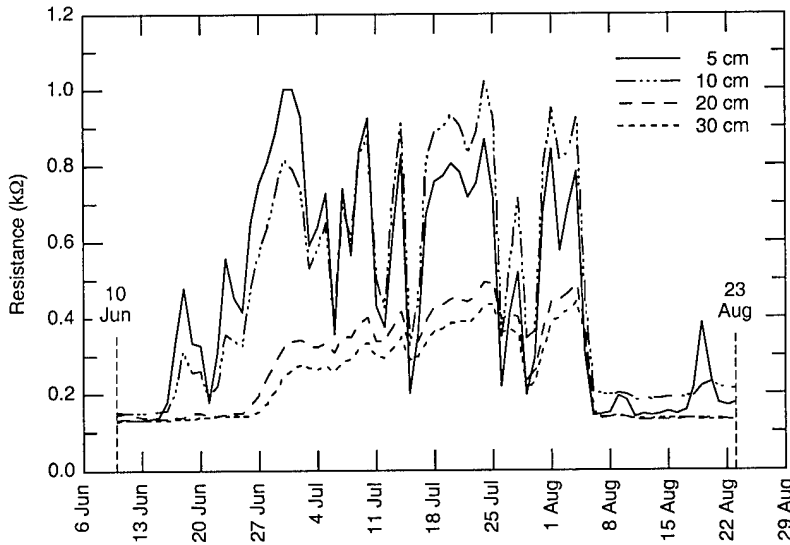
a. 1997 - Transect location 0 m.

b. 1997 - Transect location 100 m.

c. 1997 - Transect location 200 m.

Figure 13. Area C moisture probe sensor output (1997-98). Note: Increasing resistance denotes drying of sediment.

d. 1998 - Transect location 100 m.

e. 1998 - Area C piezometer site.

Figure 13 (cont'd). Area C moisture probe sensor output (1997-98). Note: Increasing resistance denotes drying of sediment.

would desaturate, and based on the output of moisture sensors in Area C, was quite successful at achieving this goal (Fig. 13). Even the station (C 200 m) that is located adjacent to the bulrush marsh dried.

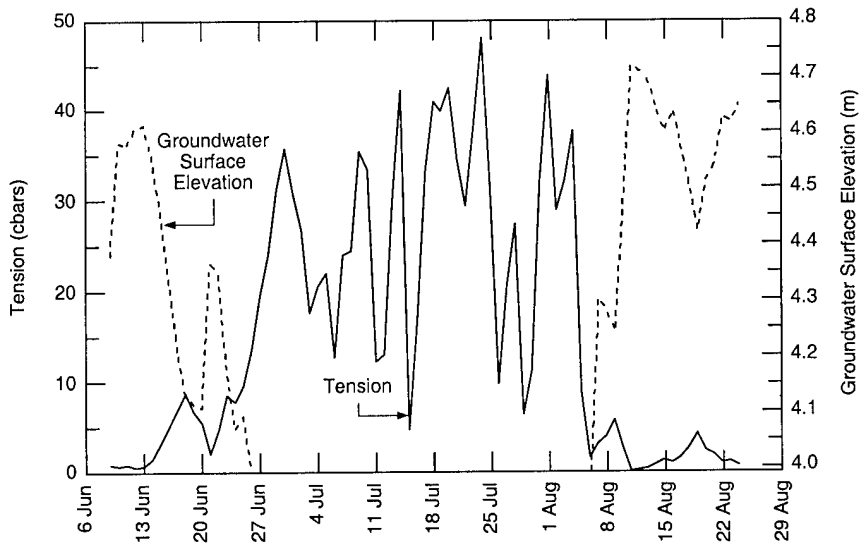
Figure 14. Groundwater elevation and surface moisture content in Area C (1998). Note: Surface elevation is 4.77 m.

To monitor subsurface water level in Area C, we relocated a shallow piezometer well used in 1994 (site 3 in Walsh et al. 1995), and placed the Druck pressure transducer 0.77 m below the sediment surface. We also installed Drucks to monitor depth of any standing water in the ponds. However, the ponds were drained for most of the monitoring period, and exposure to the weather caused erratic readings for most of the sensors.

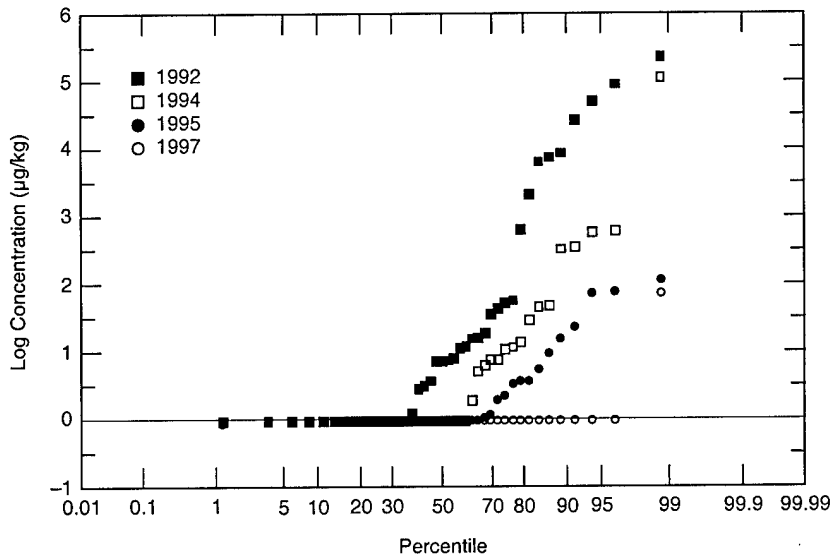
Figure 16. Percentile plot of WP contamination of an intermittent pond site (Site 883).

The first location was initially sampled in 1992 and given the designation "Site 883," southwest of the edge of Pond 183. The white phosphorus concentration found here was one of the highest concentrations found in ERF, over 200 $\mu\text{g/g}$. When 270 mL of sediment from this site was sieved, over 100 white phosphorus particles were isolated. Located within the intermittent pond on the west side of Pond 183, this location was ideal for monitoring the persistence of white phospho-

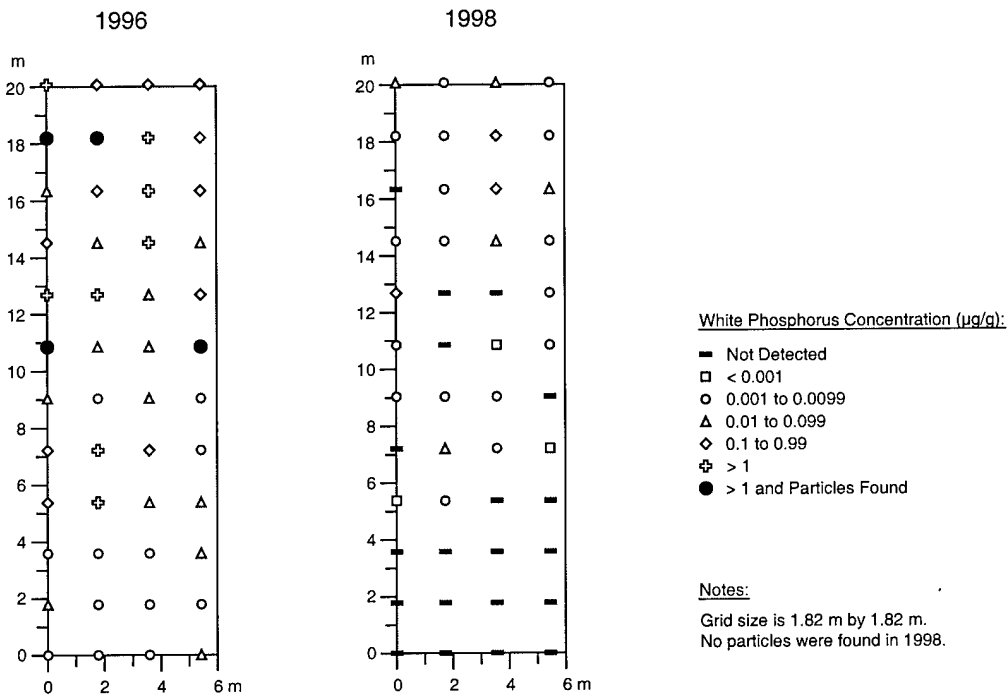
Figure 17. Plot of WP concentrations in DWRC pen 5, Pond 183, Area C.

The location of the DWRC pen 5 is within the permanent pond of Area C and the sediments have been covered by water since the cessation of firing of WP munitions. We intensively sampled this location in 1996 by taking discrete samples at the nodes of a 1.82-m square grid four columns wide

and 12 rows long (Fig. 17). In 1996, all 48 samples contained detectable white phosphorus concentrations ranging from 0.0024 to 421 $\mu\text{g/g}$ (Table 6). Over 300 white phosphorus particles were found, one of which weighed 150 mg (Walsh et al. 1997). In the fall of 1998, white phosphorus was undetectable in 20 of the 48 samples. The concentration range in the positive samples was 0.00062 to 0.84 $\mu\text{g/g}$. In all cases where white phosphorus

was found, the concentrations were lower in 1998 than in 1996, and no white phosphorus particles were found.
