**Hot/Wet Environmental Degradation
of Honeycomb Sandwich Structure
Representative of F/A-18: Flatwise
Tension Strength**

DSTO-TR-0908

**Airframes and Engines Division
Aeronautical and Maritime Research Laboratory**

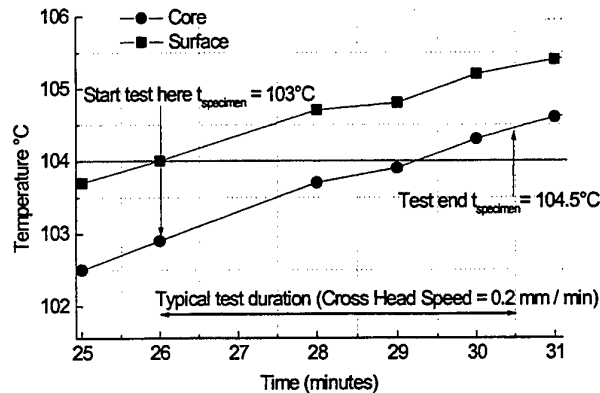
The hot (104°C) test environment was achieved using an Instron model 3111 heater cabinet mounted in the Instron 1185 test machine load frame. In order to maintain an accurate test condition of 104°C at the FM300 skin to core adhesive bondline, a spare FWT coupon (dummy specimen) was used to calibrate the operation. The dummy specimen complete with loading blocks was fitted into the loading fixture along with two thermocouples, one located at the centre of the specimen at the core to skin interface (in the FM300 bondline), and the other located at the top loading block surface. A temperature calibration curve was established as shown in Figure 10. The typical specimen soak time was approximately 30 minutes for the FM300 bondline to reach the test temperature of 104°C. All hot FWT tests were monitored by one thermocouple at the loading block surface and commenced when the temperature of this surface reached 104°C (220F) as shown in Figure 10.

Figure 10: Adhesive bondline temperature calibration curve for hot FWT tests at 104°C

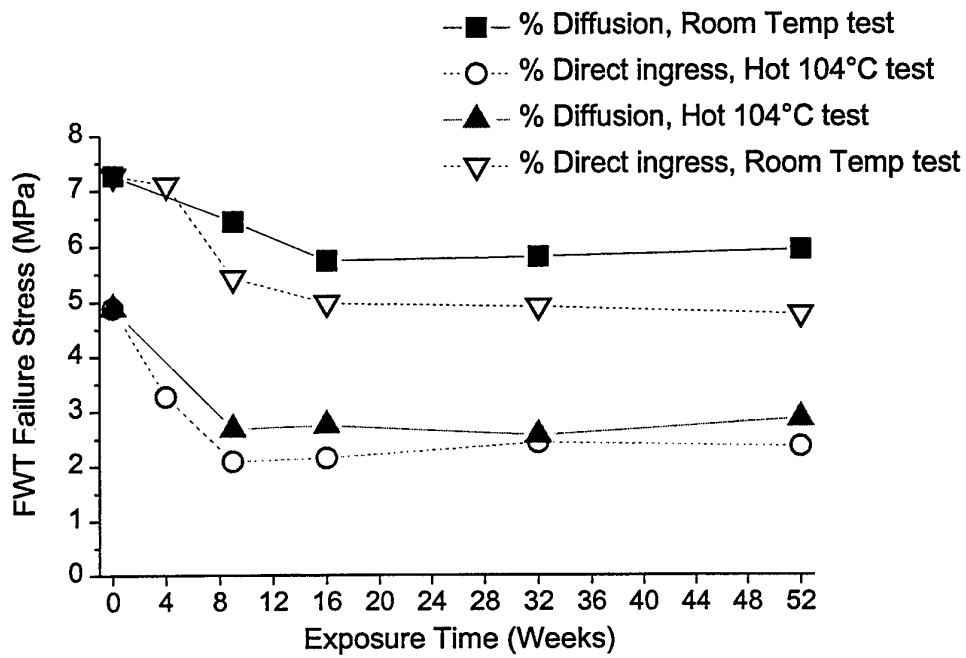
Figure 11 FWT test results for direct moisture ingress and diffusion moisture ingress tested under room temperature and hot 104 °C test conditions.

Figure 11 plots the FWT failure stress (MPa) against the exposure time in weeks. Figure 12 shows the FWT data normalised against the dry baseline result for each of the two test temperatures considered.

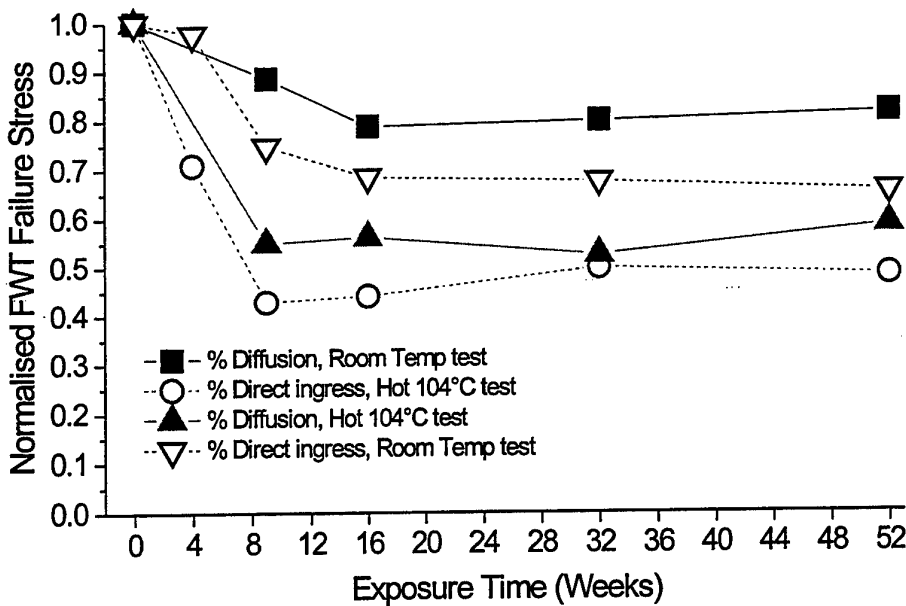
Figure 12 Normalised FWT test data for direct moisture ingress and diffusion moisture ingress tested under room temperature and hot 104°C test conditions

Exposure of honeycomb sandwich structure to hot/wet environments has been shown to decrease flatwise tension strength by up to 50% (Figure 12) at elevated temperature and 25% at room temperature. The loss in FWT properties occurred in the first 16 weeks after which the values remained constant up to the end of the trial at 52 weeks. Also, the difference between the FWT strength values of direct ingress and diffusion ingress specimens is not great. This is a particularly interesting observation since the failure mode of the diffusion coupons remains cohesive during the entire exposure period while the direct ingress samples exhibit gross adhesive failure after long-term exposure. Typically adhesive failure surfaces are associated with failure through the aluminium oxide layer resulting in poor bond strength. Some preliminary surface analysis on direct moisture ingress specimen fracture surfaces has been undertaken to better understand the failure locus. Visually, the failure surface looks very much like an adhesive failure however, surface analysis has indicated that the failure is through the thin layer of adhesive containing the CR III chromium coating. The CR III layer appears to have similar strength to the adhesive layer which may explain the similar FWT values to the diffusion ingress samples but with markedly different failure mode. Further analysis is required in order to adequately explain this observation.

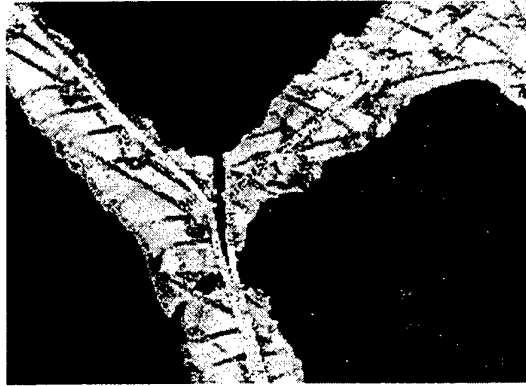
Figure 15. Cracking through the skin to core fillet and into the node bond in a direct moisture ingress sample after 16 weeks exposure.

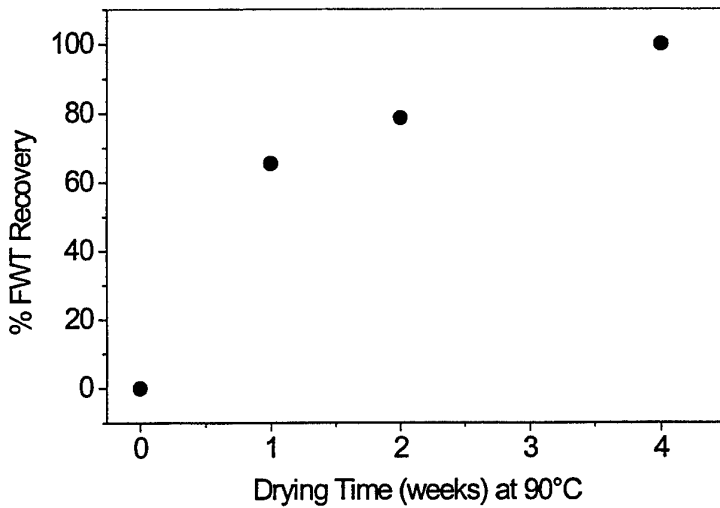
Results of FWT strength versus various drying times at 90°C are shown in Figure 18. All tests were conducted at room temperature on diffusion ingress FWT coupons (ie: non-drilled) which had previously seen 16 weeks exposure to 70°C and 85% R.H. This shows that full recovery of FWT strength is achieved after a period of time required to fully dry the composite skins (ie: 4 weeks).

Figure 18 Dry recovery of FWT strength (dried in oven at 90°C)
