DOT/FAA/AR-99/87

Vertical Drop Test of a Shorts 3-30 Airplane

Final Report

14. Sponsoring Agency Code ANM-100	
15. Supplementary Notes The FAA William J. Hughes Technical Center Project Manager was Gary Frings.					
16. Abstract <p>A Short Brothers PLC, Model SD 3-30, airplane was subjected to a vertical impact drop test at the Federal Aviation Administration (FAA) William J. Hughes Technical Center, Atlantic City International Airport, New Jersey. The objective of the test was to determine the impact response of the fuselage, seat tracks, seats, and anthropomorphic test dummies on a high-wing, commuter type airplane. The test was conducted to simulate the vertical velocity component of a severe, but survivable, crash impact. A final impact velocity of 30 feet per second was therefore selected. The airplane was configured in a typical maximum gross weight flight condition, including seats, simulated occupants, fuel, and cargo.</p> <p>The Shorts 3-30 is a twin turboprop, 30-passenger regional transport airplane. The total test weight of the airplane was 21,210 pounds. The internal seating arrangement consisted of pilot and copilot seats, eight rows of standard passenger seats, an

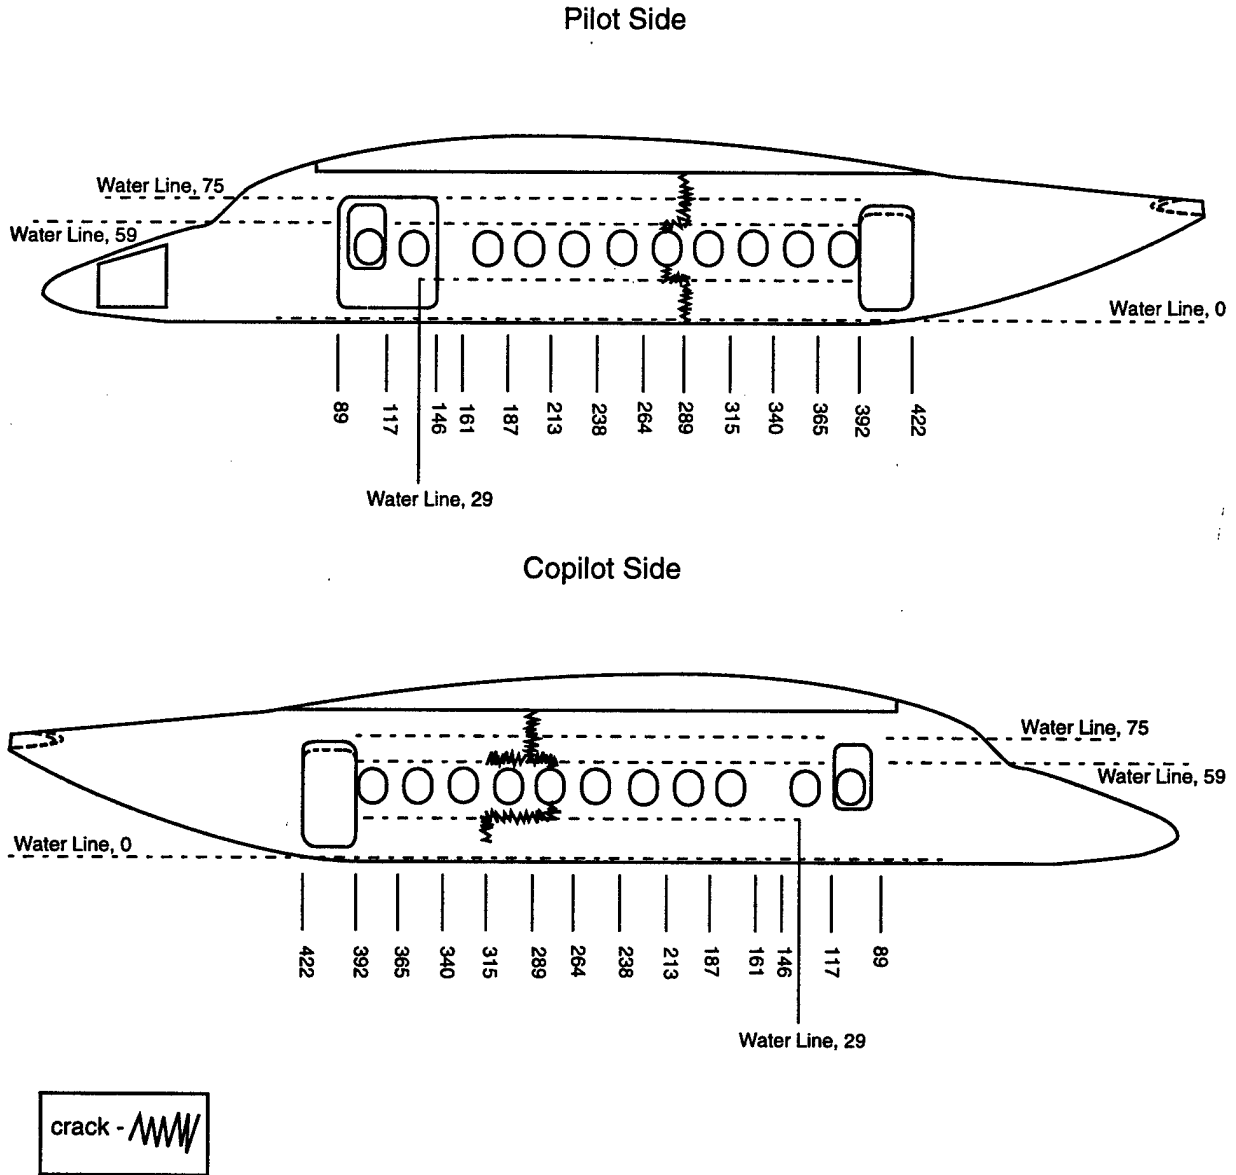
FIGURE 11. FUSELAGE CRACK

There were a number of large cracks in the fuselage skin after impact. The left side experienced a crack at FS 289 from the top of the fuselage to the rivet line at WL 59. The crack then continued forward along the rivet line to FS 277. It then continued downward at FS 277 to the window and then on the bottom of the fuselage to the rivet line at WL 29. The crack then ran aft along the rivet line to FS 289. At FS 289 the crack continued downward to a point approximately 18 inches above the fuselage bottom at WL 18. The crack described above is shown schematically in figure 11.

The right side experienced a similar crack, which also is shown in figure 11. The copilot-side crack began at the top of the fuselage at FS 289. The crack ran down FS 289 to the rivet line at WL 59. At WL 59 it continued both aft and forward the rivet line to FS 315 and FS 277, respectively. The crack then moves down along FS 277 from the WL 59 rivet line to the top of

the window at FS 277 and continues at FS 277 on the bottom of the window down to the rivet line at WL 29. The crack then continues aft along the rivet line at WL 29 from FS 277 back to FS 315. It then continues down FS 315 and ends approximately 12 inches above the bottom of the fuselage at WL 12.

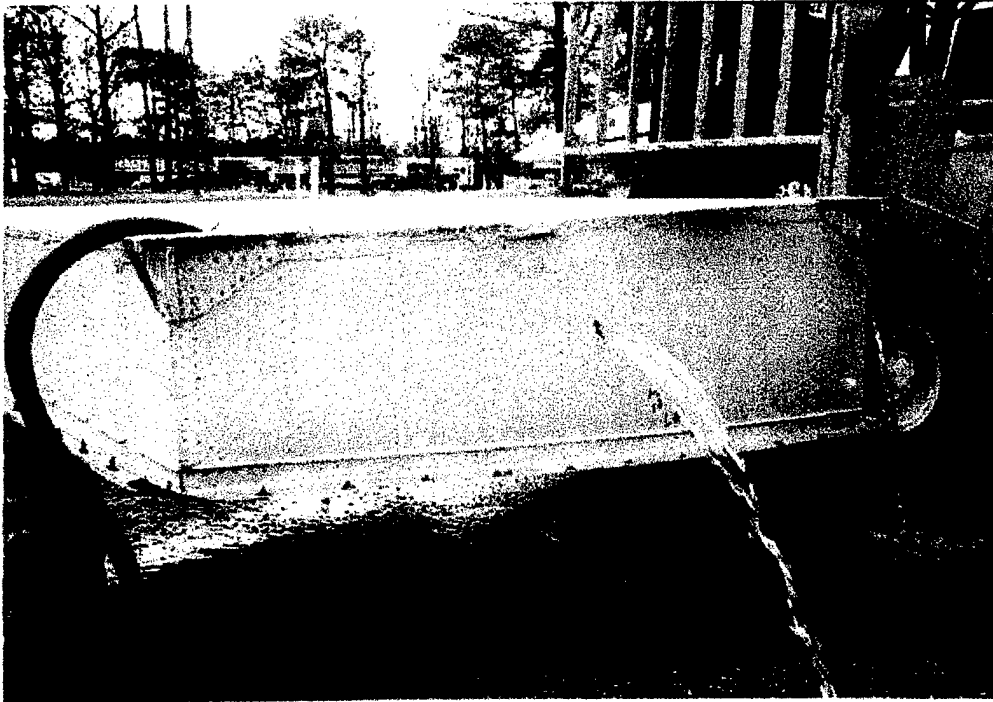
The impact caused major cracks in both the pilot and copilot sides of the tank, figures 17 and 18, respectively. The four gravity feed outlets were crushed. Figure 19 shows typical gravity feed outlet damage. Simulated fuel also leaked from the cell 3 to 4 interconnect pipe.

FIGURE 17. CRACK IN CELL 4 PILOT SIDE

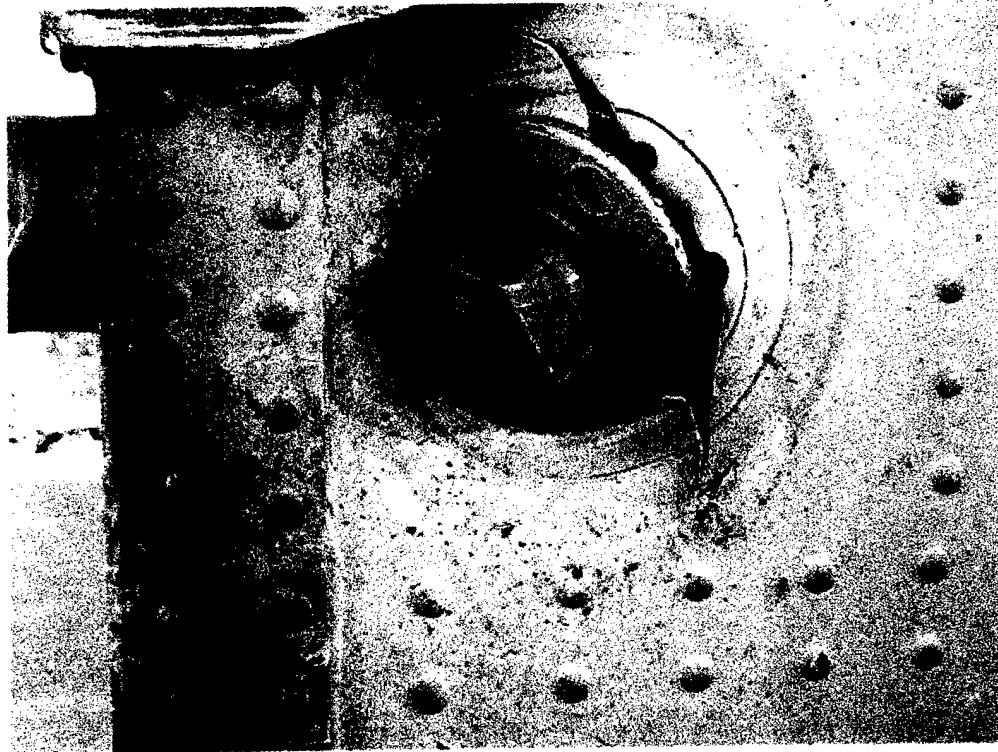
FIGURE 19. CRUSHED GRAVITY FEED OUTLET IN CELL 4
