# Development and Testing of the F/A-18 Replacement MIL-STD-1760 Umbilical<sup>1</sup>

*Abstract—The U.S. Navy F/A-18 aircraft currently uses a generic weapon umbilical cable with the new MIL-STD-1760 interface weapons. The existing cable has been shown problematic during weapon separation/integration testing and general fleet use. Modification of the existing cable was not feasible so redesign was required for replacement. The goals of the replacement cable design were to fix the specific problem areas of the existing cable as well as improving overall performance and service life. The service life goals for the umbilical were to be suitable for reuse for at least 25-30 releases. Naval Air Warfare Center – Aircraft Division (NAWCAD) 4.11.2 developed a testing approach for qualification of the umbilical and to credibly assess service performance potential without specific airborne release tests. The qualification effort is discussed from an overall perspective as well as details of the lightning testing of the connector, static and ejection testing, and captive flight testing of the cable.*

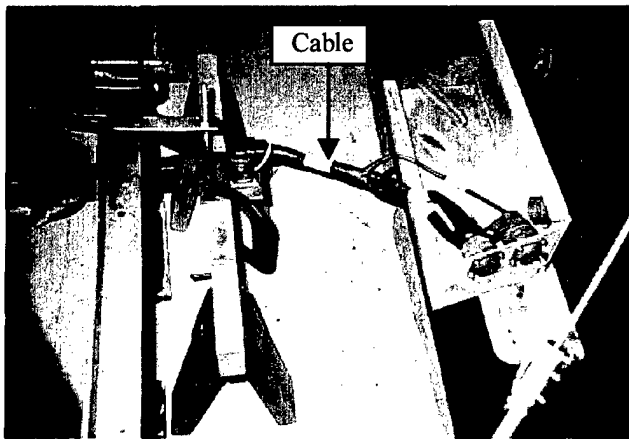
**Figure 2** Photograph of Lightning Test Setup

The lightning testing were performed on 2 samples of the umbilical cables with composite connectors and 2 samples of umbilical cables with other connectors. The cable was connected to the mating connectors mounted on a plate (approximately 4 in x 4 in x 0.25 in) and a test fixture as used in the F/A-18 aircraft as shown in Figure 2. Test

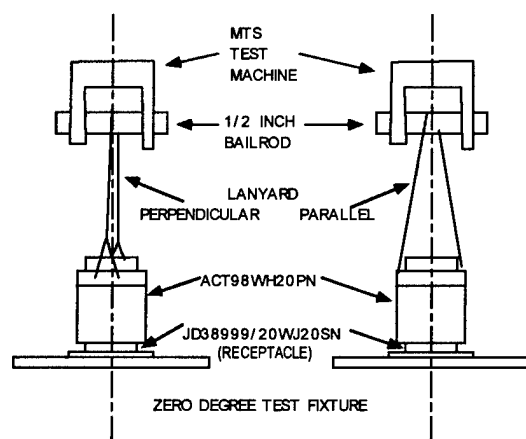
**Figure 4** Composite MIL-STD-1760 Connector Static Test Setup

The static test was designed to systematically test six connectors at pull angles ranging from 0° to 15° in 5° increments in both the pitch and roll directions. Each connector was pulled at a fixed rate of 1.6 in/s for 10 times at 0, 5, 10, and 15° and then as time permitted, pulled at 17, 18, and 20°. The test setup, shown in Figure 4, used a MTS test machine with an adapter plate to which the receptacle was mounted. The plate could be adjusted in orientation for both the angle to the vertical and the rotation of the mount. The pull angles were set by tilting the mounting fixture while the pull force was measured using a force transducer attached to the MTS machine.

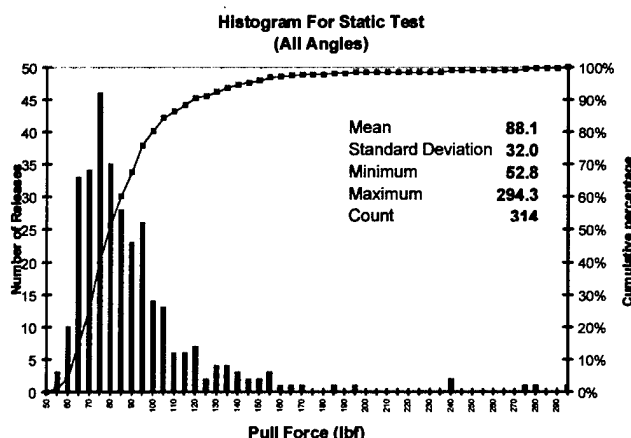
Figure 7 Static Test Histogram

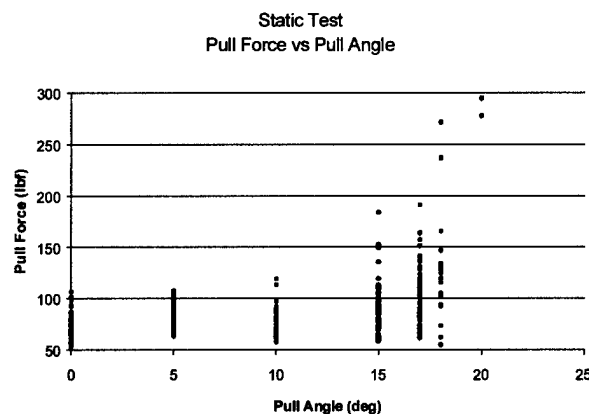
Figure 5 Static Test Pull Force vs. Pull Angle

The static tests were used successfully to screen the connector performance in a simple and controlled manner and resolve a cross-vendor incompatibility prior to ejection testing. The pull forces recorded from the third set of connectors, shown in Figure 5, demonstrates that 89% of the releases were under the limits specified by DOD-C-38999/31 and ranged from 53 lbf up to 184 lbf (a maximum of 294 lbf for out of specification, 20° pull) under the worst case conditions used for the test. A typical pull force measurement is shown in Figure 6. As shown in Figure 5, high pull forces occurred within specification pull angles and low pull forces occurred on high pull angles randomly. Pull angles between 15 and 18 ° were accomplished without damage to the connector. Pull

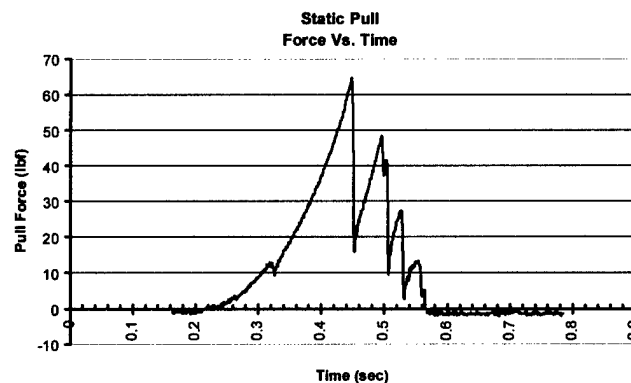
Figure 6 Typical Static Pull Test Force vs. Time

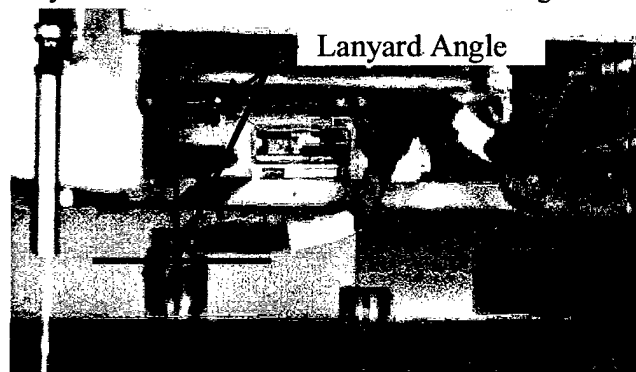
**Figure 9** Pull Angle Measurement Overlay on Video

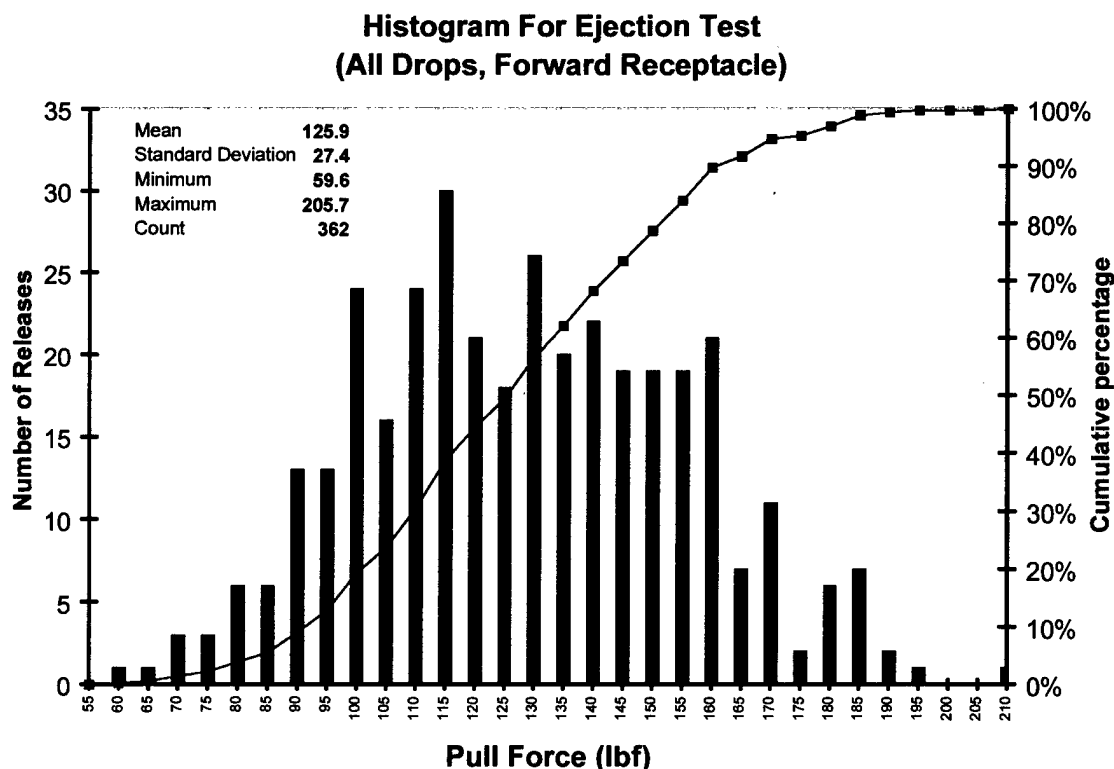
Figure 10 Histogram for Ejection Test for Forward Receptacle, All Drops

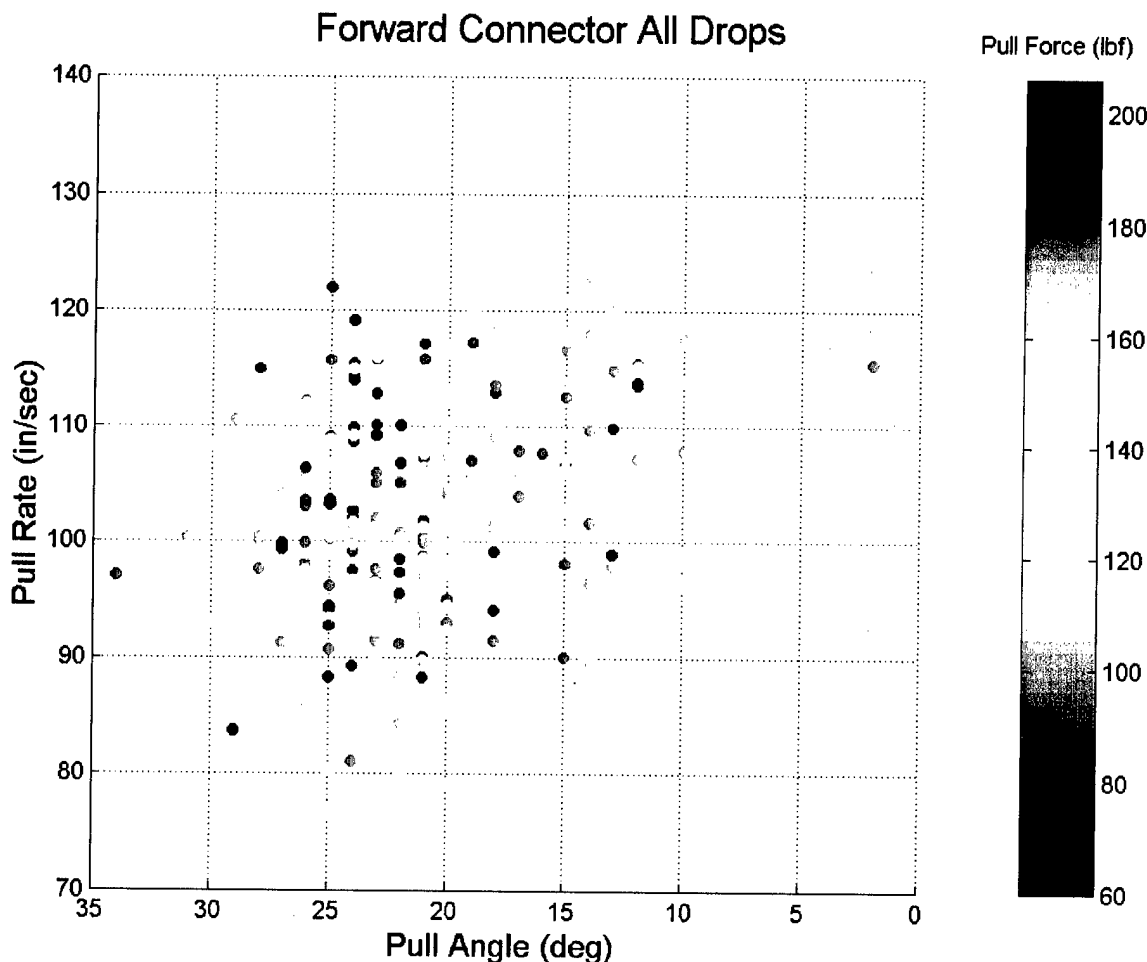
**Figure 11** Scatter plot of Pull Force, Pull Rate, and Pull Angle

vertical position prior to connector release. During these ejected release tests, the connector was released with pull angles ranging from 1° to 34° and at a pull rate ranging from 75 in/s up to 135 in/s. The maximum pull force at the forward receptacle was 206 lbf at a 27° pull angle. The minimum pull force was 60 lbf at a 25° pull angle. This shows, along with the histogram plot in Figure 10 and the 3-D scatter plot of pull force, pull rate, and pull angle in Figure 11 that the pull force is a random function of the pull angle. This is contrary to what was expected. Common thought was that as the pull angle increased, the pull force also increased. The data collected from this test shows that this is not the case for this connector. The inability to constrain pull angles to 15° or to smoothly develop the pull force or angle with a bail bar arrangement is significant and should be understood when comparing this data with the qualification standard. Ejected releases typically show higher pull forces overall than static releases and a wider spread of values. In future efforts, expected pull force characteristics should be empirically determined with a statistically significant number of releases.
