Contractor Report ARWEC-CR-00001

## CRYOFRACTURE DEMILITARIZATION OF MUNITIONS (PHASE II)

John F. Follin  
General Atomics  
P.O. box 85608  
San Diego, CA 92186-9784

March 2000

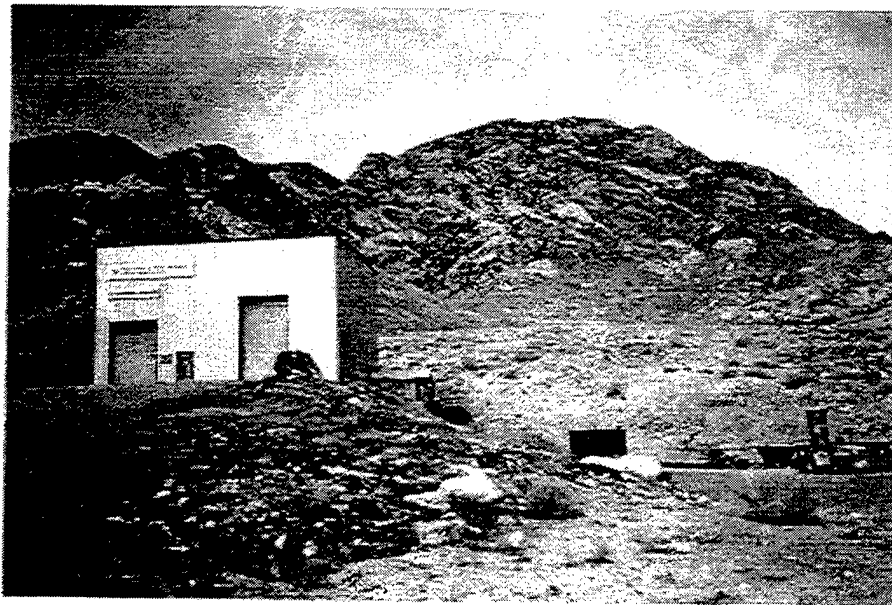
Figure 14  
Munitions cryofracture test facility

The press, robot, and cryobath are housed in a 50 ft x 50 ft metal building (fig. 14). The building is heated and air conditioned. The debris conveyors, induction heater, shuttle box conveyor, and the debris collection system are housed in a smaller building off to the side of the main building (fig. 15). Eight CCTV cameras are installed at key positions in the facility to provide test personnel with visual confirmation that the critical steps in the test operations are performed successfully. Electric power for the building was provided by a variety of 200 kW diesel generators.

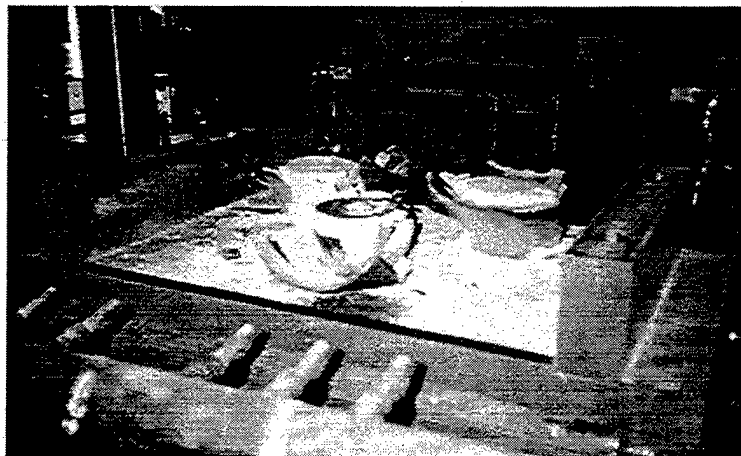
Figure 54  
Cryofracture of live M16 mines

Figure 54 shows the results of the flat plate crush of the M16 mines. The mine body and explosive material were accessed and are seen in many small pieces. Figure 55 shows the debris in the shuttle box after tooling tilt-table operation. Figure 56 shows the debris in the open grate furnace after shuttle box dumping. Good explosive accessing of the 61 M16 mines was accomplished in all 25 tests.
