ERDC/CHL TR-00-3

# **First Powerhouse, Bonneville Dam, Columbia River, Oregon Report 1, Proposed Trash Holding System**

**Hydraulic Model Investigation**

April 2000

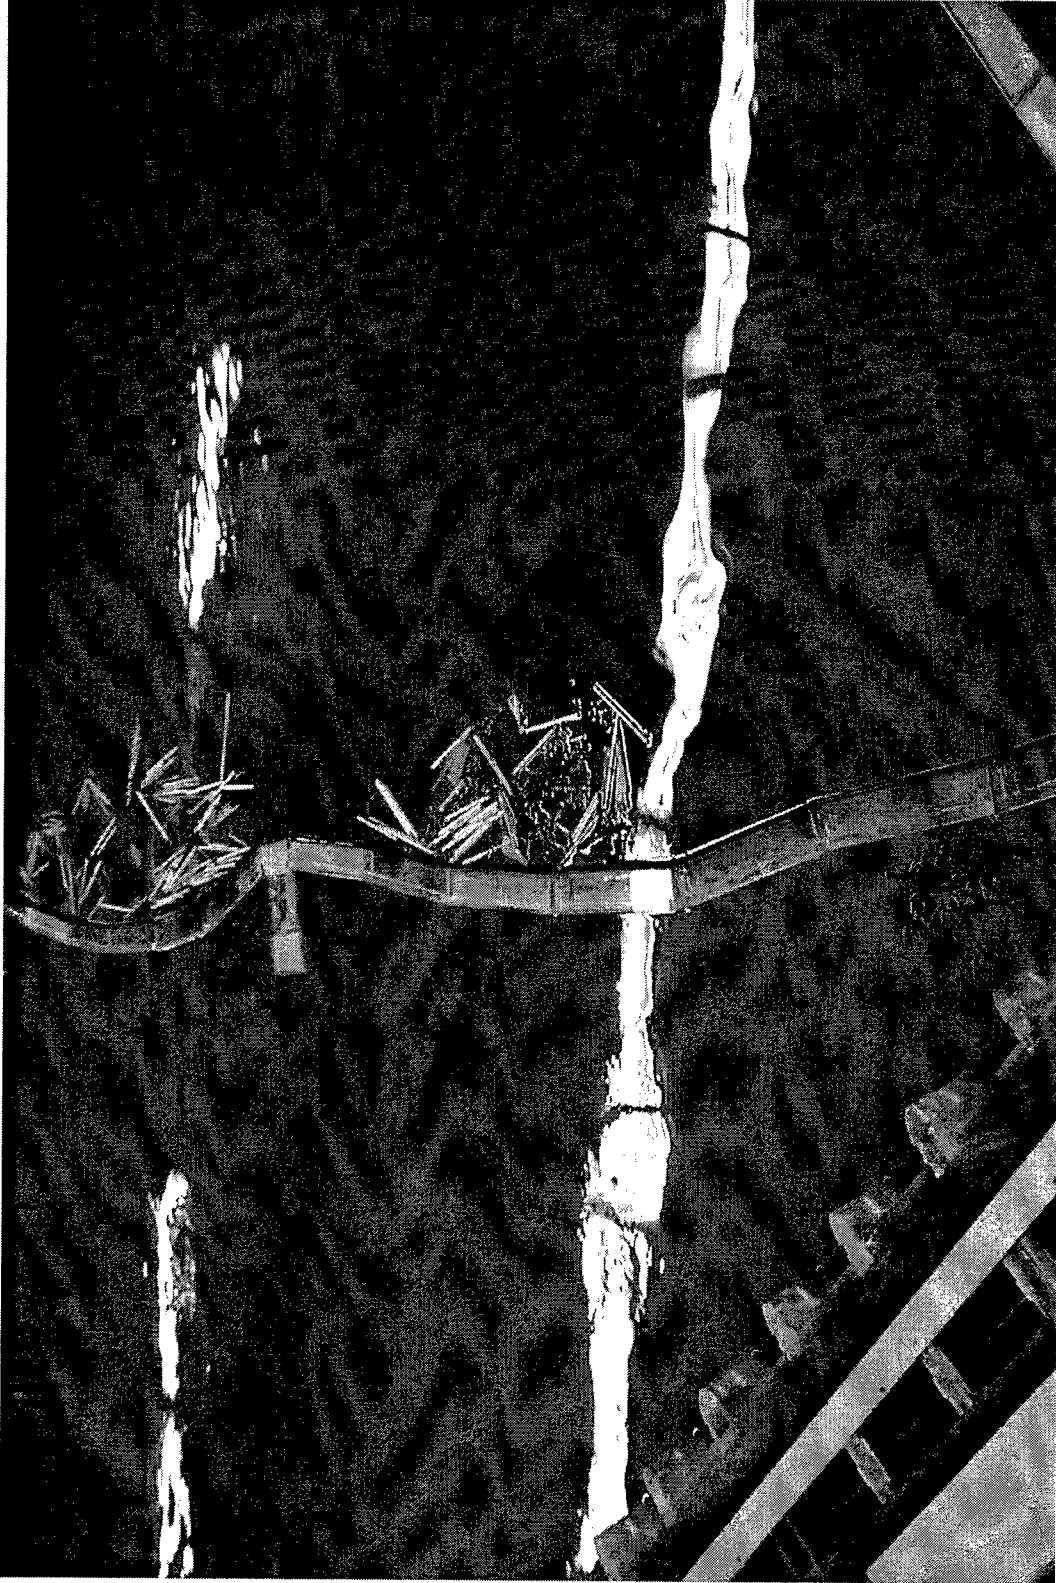
Photo 34. Debris collecting along the trash boom; final boom alignment; discharge per unit 297.339 cu m/sec (10,500 cfs); pool el 74.5

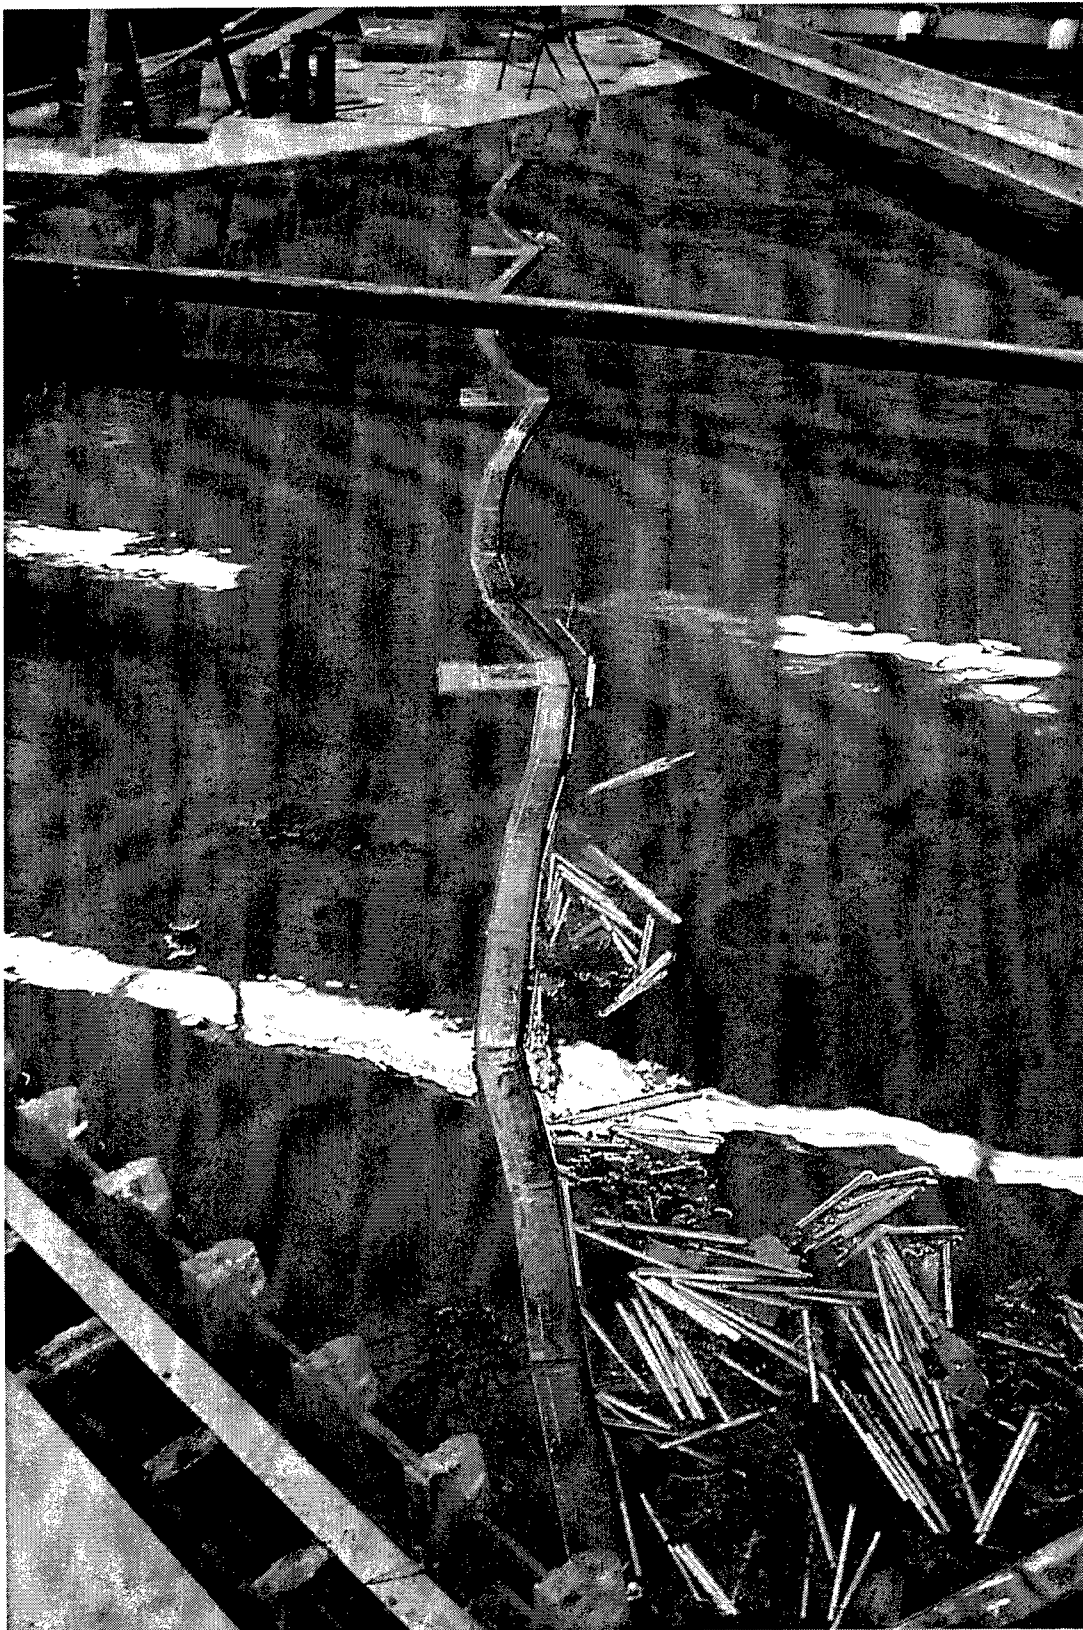
Photo 35. Debris at powerhouse Unit 1 and in Unit 0 sluiceway entrance; final boom alignment; discharge per unit 297.339 cu m/sec (10,500 cfs); pool el 74.5
