**AN INVESTIGATION  
OF ACOUSTIC EMISSION  
FROM DEFECT FORMATION  
IN STAINLESS STEEL WELD COUPONS**

BNWL-902

January 1969

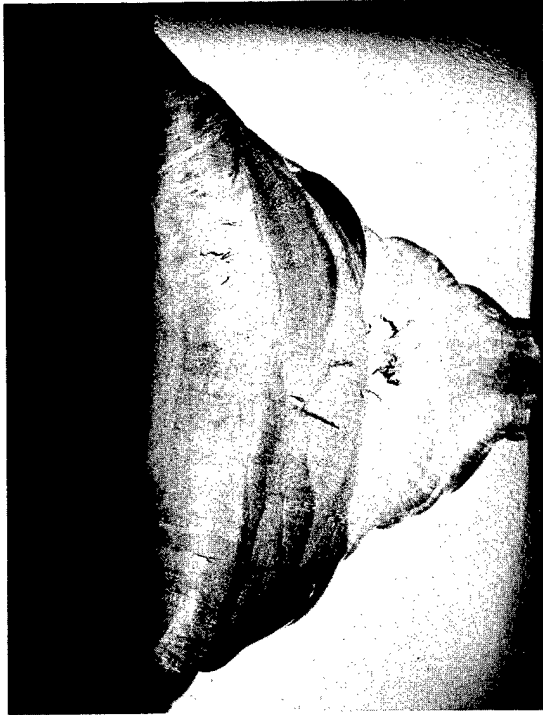
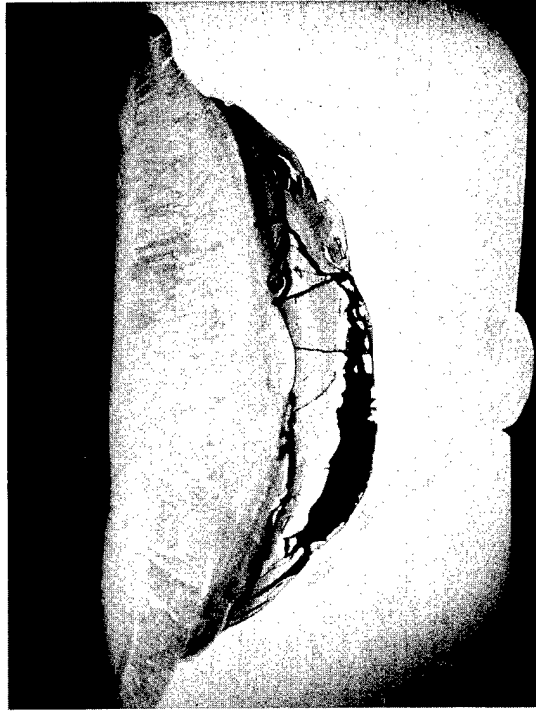
FIGURE 11. *Photomicrographs of Test Welds with Differing Weld Quality*

Typical photomicrographs of the weld region for these samples are shown in Figure 11. The relative crack lengths were 0.52 for Sample 25, 5.4 for Weld 27, and 6.9 for Weld Number 23. As can be seen from the photomicrographs, there is a wide variation in the quality of 27 and 23 but they have

approximately the same crack lengths. This is because of the difficulty associated with determining the actual length of cracks produced by the addition of titanium.

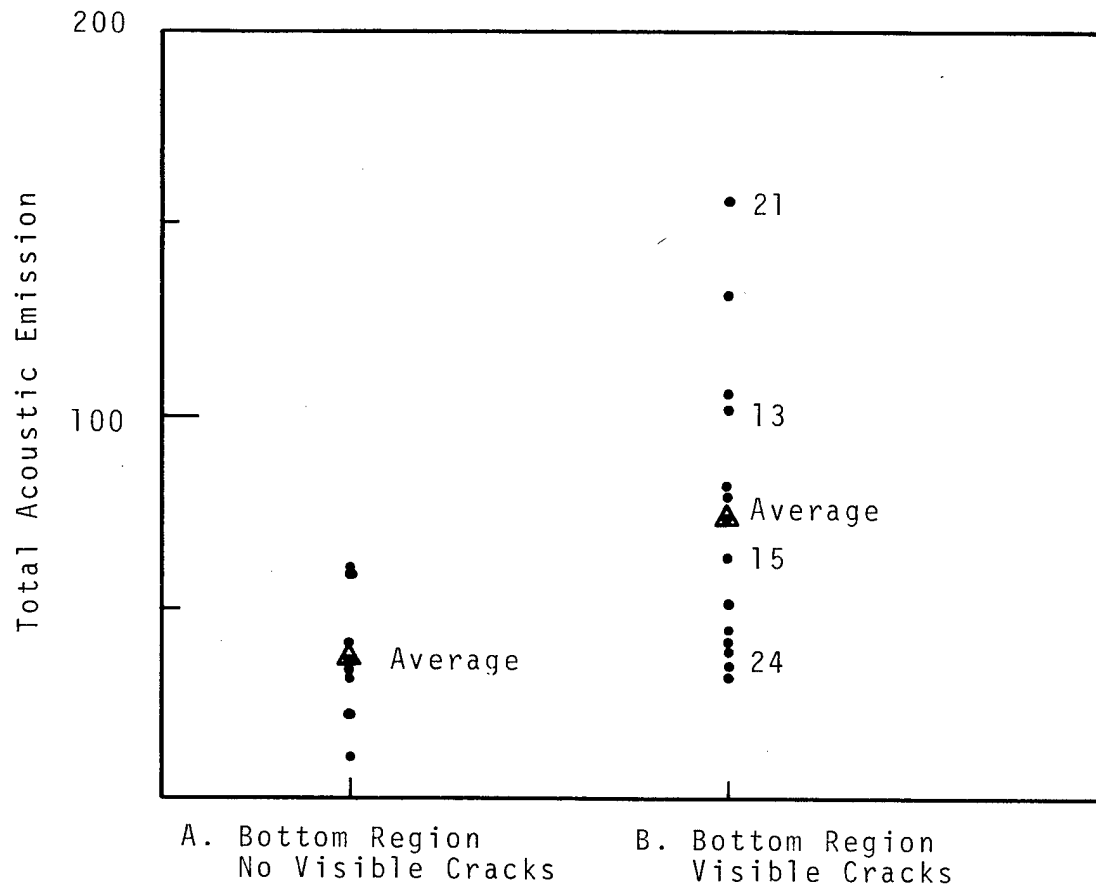
*FIGURE 12. Acoustic Emission from (A) Welds Which Had No Visible Hot Cracks After the First or Second Pass and (B) from Welds Which Contained Visible Hot Cracks During the Same Passes. (See Figure 13 for Photomicrographs of the Numbered Welds in this Figure.)*

Hot cracks which formed in the bottom region appeared to "flow" apart for some distance following the puddle of filler material as it cooled. During this growing period acoustic emission was not produced, which is contrary to experience with emission from crack growth.<sup>(4)</sup> Figure 12 shows, however, that in general more acoustic emission was obtained from samples where visible cracks were detected during the first passes than for those where cracks were not observed. Figure 13 is made up of photomicrographs of the four welds listed on Figure 12. Each of these welds had hot cracks that were observed during welding, but some were apparently remelted since they are not all detectable in the photomicrographs.

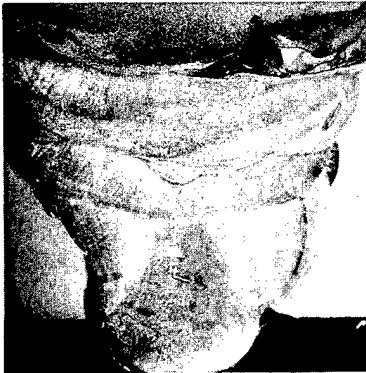
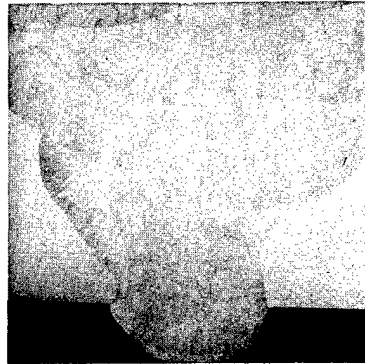
*FIGURE 13. Bottom Region of Weld Samples Where Hot Cracks Formed and Were Detected Visually During the Welding Operation*

Hot  
Cracks

Hot Cracks  
Apparently  
Remelted

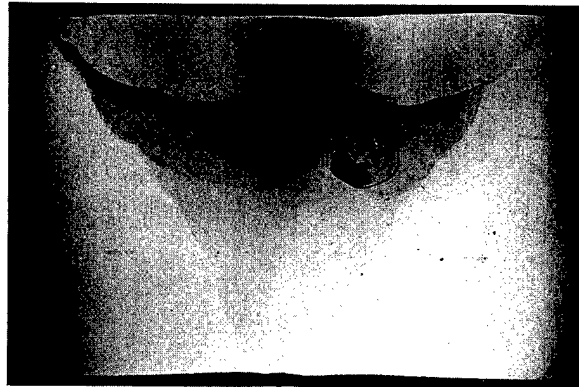
*FIGURE 14. Test Welds Containing Porosity. (Large Amounts of Acoustic Emission Were Produced by These Welds.)*

Crack formation appeared to be the weld defect causing most of the acoustic emission throughout this study. There were, however, indications that gross porosity formation produced some of the emission since high signal levels were obtained from Samples 7, 9, and 20, shown in Figure 14. These samples contain large amounts of porosity as demonstrated by the radiographs and photomicrographs. However, some cracking accompanied the porosity, and this may have been the source of all emission.

A. Test Weld No. 7  
Total Acoustic Emission 426

B. Test Weld No. 9  
Total Acoustic Emission 466

C. Test Weld No. 20  
Total Acoustic Emission 411
