**AFRL-ML-TY-TR-2000-4517**

# ***P-18 SUSPENSION ROLL STABILITY TEST***

| 13. ABSTRACT (Maximum 200 words)<br>The Aircraft Rescue and Fire Fighting (ARFF) community and U.S. Military Organizations have experienced several Emergency Response Vehicle rollover induced accidents in recent years. The Air Force has a large inventory of P-18 water tankers (194) and P-19 ARFF vehicles (399) that are subject to rollover incidents. These vehicles are expected to remain in service for at least 15 years. As a near-term solution, retrofitting the suspension system to increase stability may be the only option available at the present time. This report documents the results of testing a P-18 modified with Davis Technologies International (DTI) strut units. Phase I involved testing the P-18 in its current suspension configuration to establish a baseline set of performance data. Phase II involved retrofitting and testing the P-18 with six DTI strut units (one per wheel end). Testing of the P-18 with the DTI suspension system showed that the vehicle could be operated at increased speeds of 10-30% before loss of vehicle control was observed. In most cases, the lateral acceleration required to roll

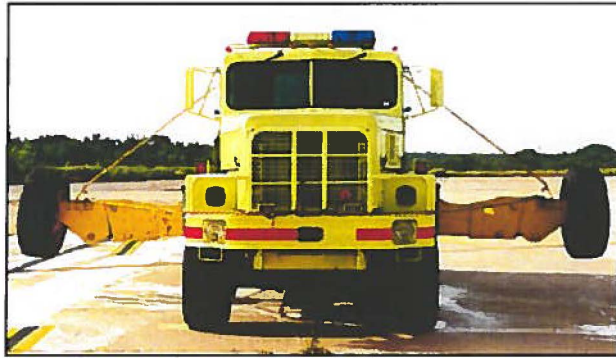
The outriggers were installed near the horizontal Cg position and about 10 inches below the vertical Cg position to minimize any potential effect they might have on the test evaluation and results.

**Figure 2. Front View: Outriggers Attached to P-18**

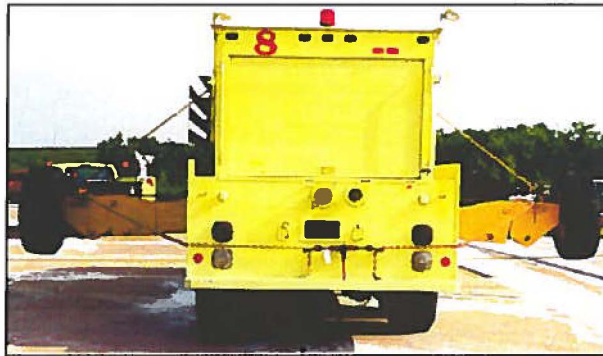
**Figure 3. Rear View: Outriggers Attached to P-18**

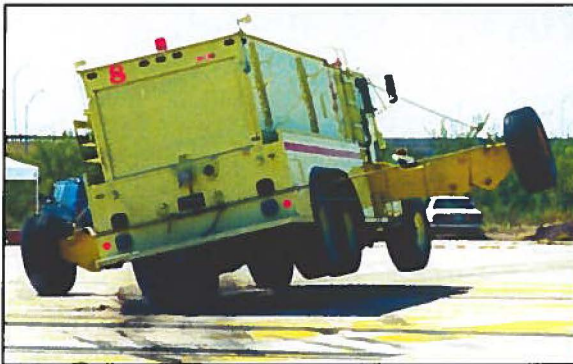
The P-18 test procedures followed the Society of Automotive Engineers (SAE) vehicle test procedures.<sup>1-7</sup> Previous testing by the Canadian Transport Research Center (CTRC) on a T-3000 (CTRC) and by the FAA, E-One and DTI on a High Performance Rescue (HPR) Fire Truck were also used in the design of the test series. The matrix of test conditions, courses and test equipment recordings was utilized to investigate the steady state and dynamic state operations to the limits of vehicle control loss and rollover. Phase I and Phase II testing of the P-18 were conducted in Texas at the DWF Airport on a level paved test pad (Figure 6 & 7).

**Figure 6. Phase I Dynamic Testing**

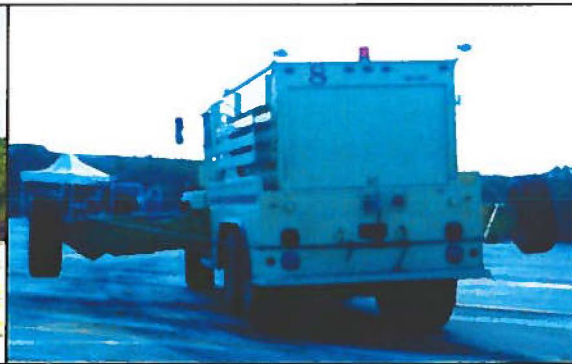
**Figure 7. Phase II Dynamic Testing**
