Technical Report M10

**SEDIMENTATION STUDY OF THE MISSOURI RIVER,  
COPELAND BEND  
Miles 569 to 564.5**

**HYDRAULIC MICRO MODEL INVESTIGATION**

U.S. ARMY CORPS OF ENGINEERS  
ST. LOUIS DISTRICT  
HYDROLOGIC AND HYDRAULICS BRANCH  
APPLIED RIVER ENGINEERING CENTER  
FOOT OF ARSENAL STREET  
ST. LOUIS, MO 63118

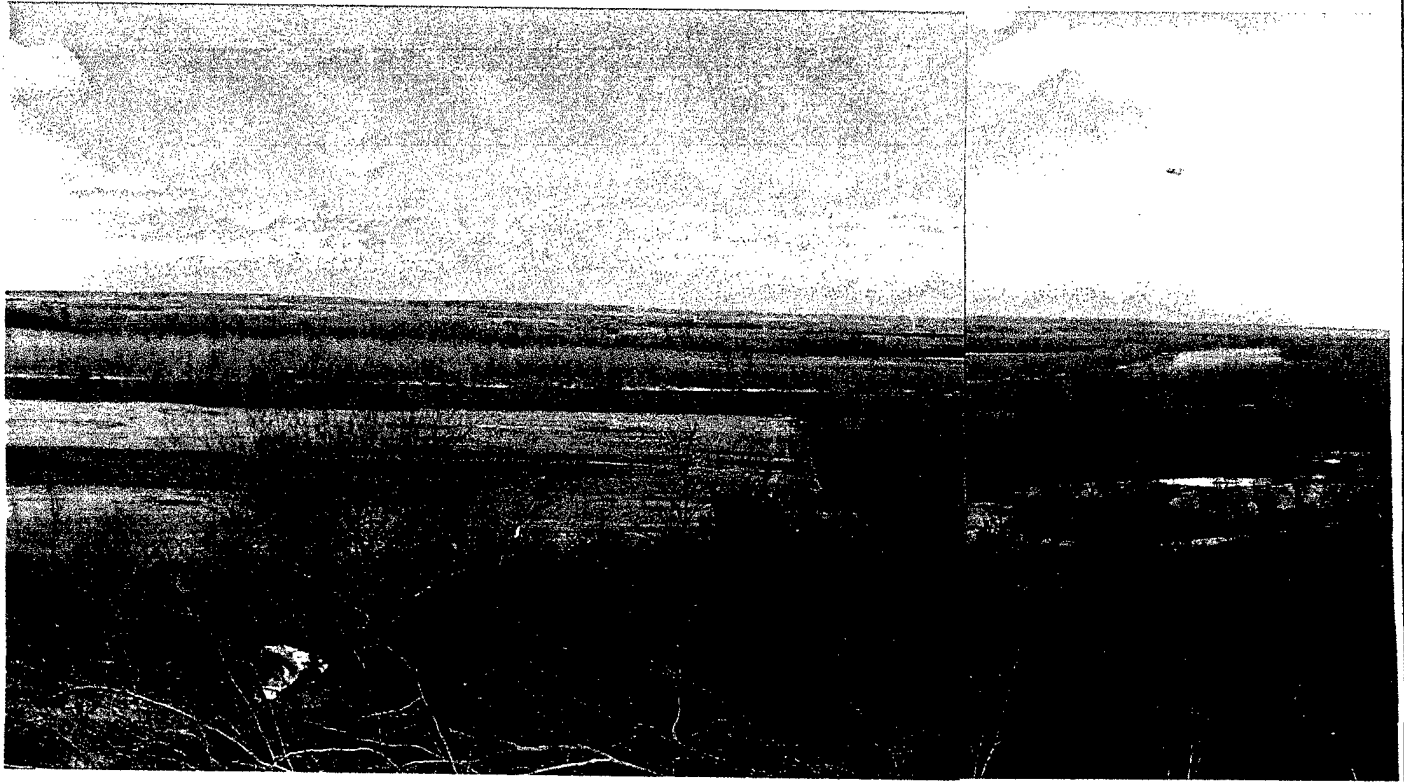
**Copeland Bend, Looking Across the Floodplain Toward  
the Left Descending Bank, From Nebraska Bluff**

In December of 1998, river engineers from the St. Louis District made a field investigation of the study reach. Plates 4 through 10 are photographs taken during this inspection. The following observations were noted:

- All of the dikes were angled slightly downstream, which has caused small bankline roundouts to occur below each structure. The bankline roundouts appeared to be stable, however, and the integrity of the dikes was not in jeopardy.
- An unusual amount of mature trees were destroyed near and along the left descending bankline due to beaver impacts. This could cause future lateral erosion of the existing bankline.

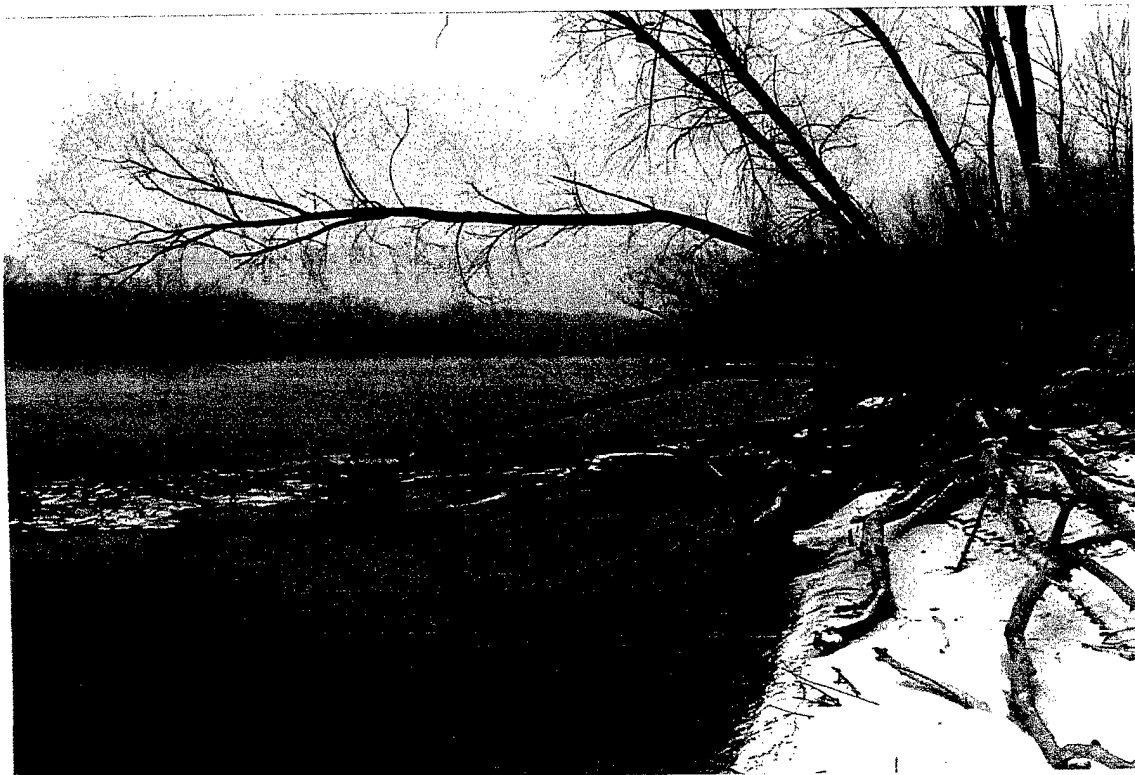
5

Copeland Bend, Looking Upstream at Dike 612.5

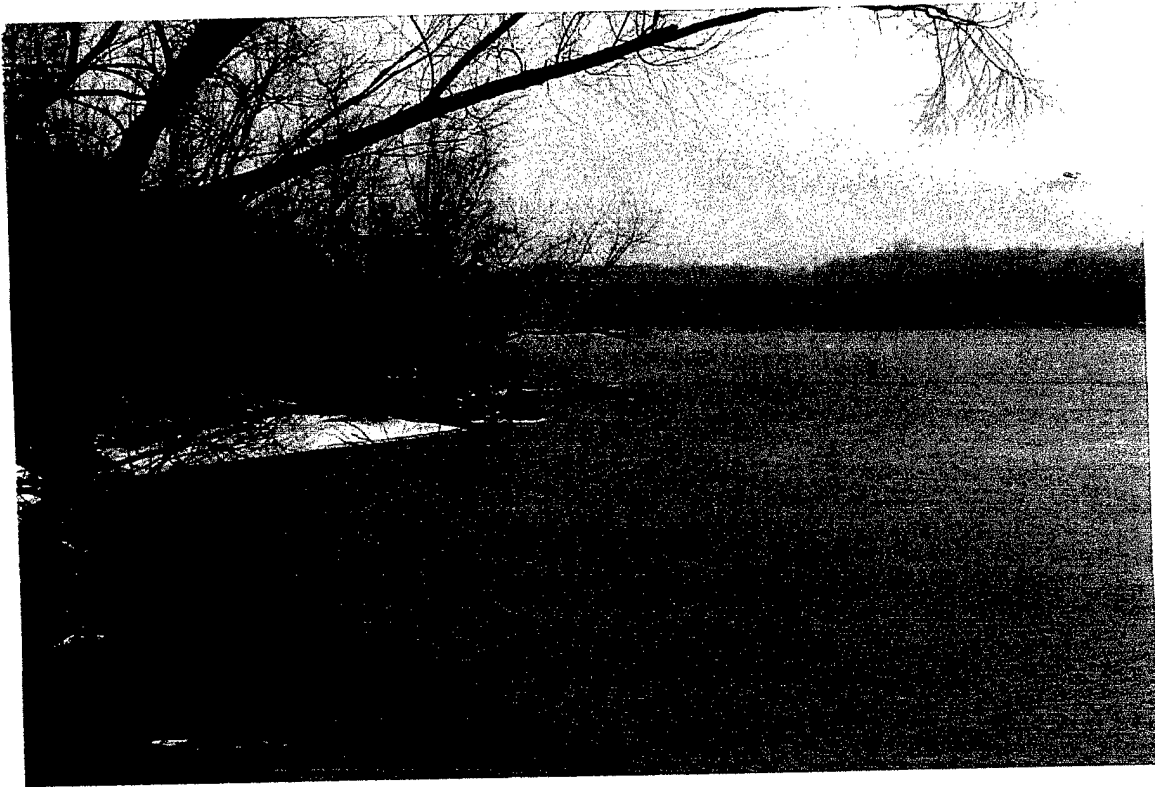
6

Copeland Bend, Looking Downstream At Dike 612.5

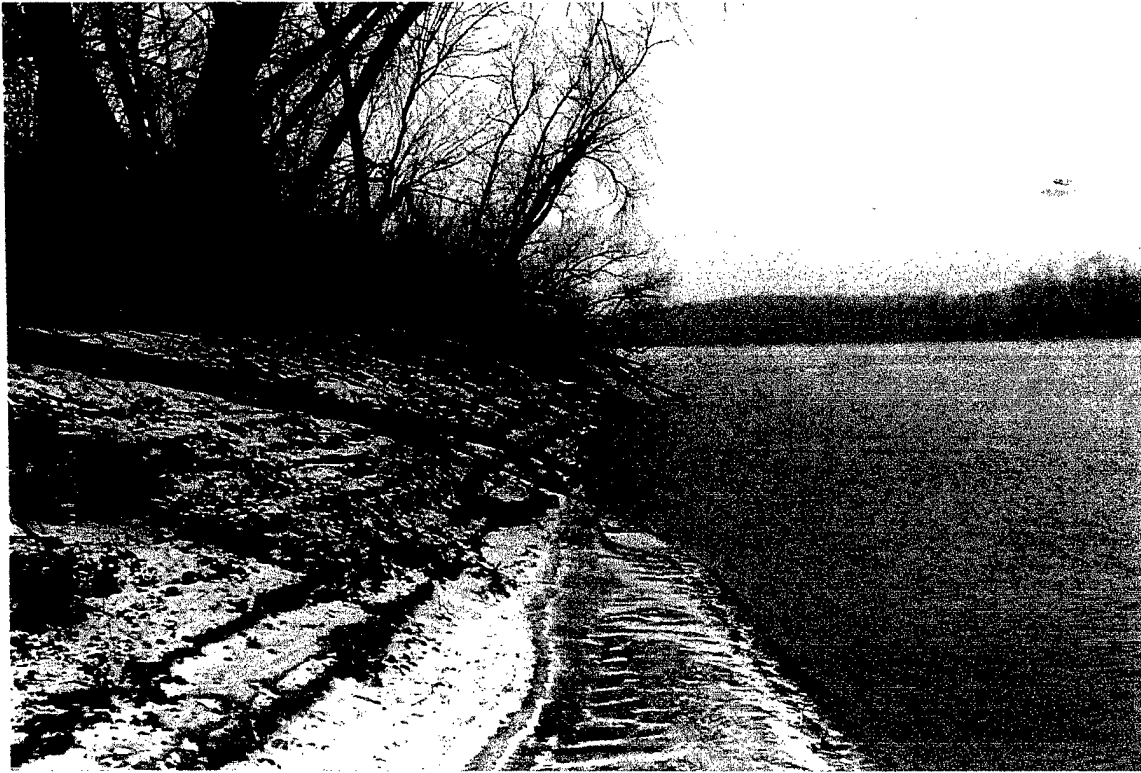
7

Copeland Bend, Looking Downstream From Dike 612.5

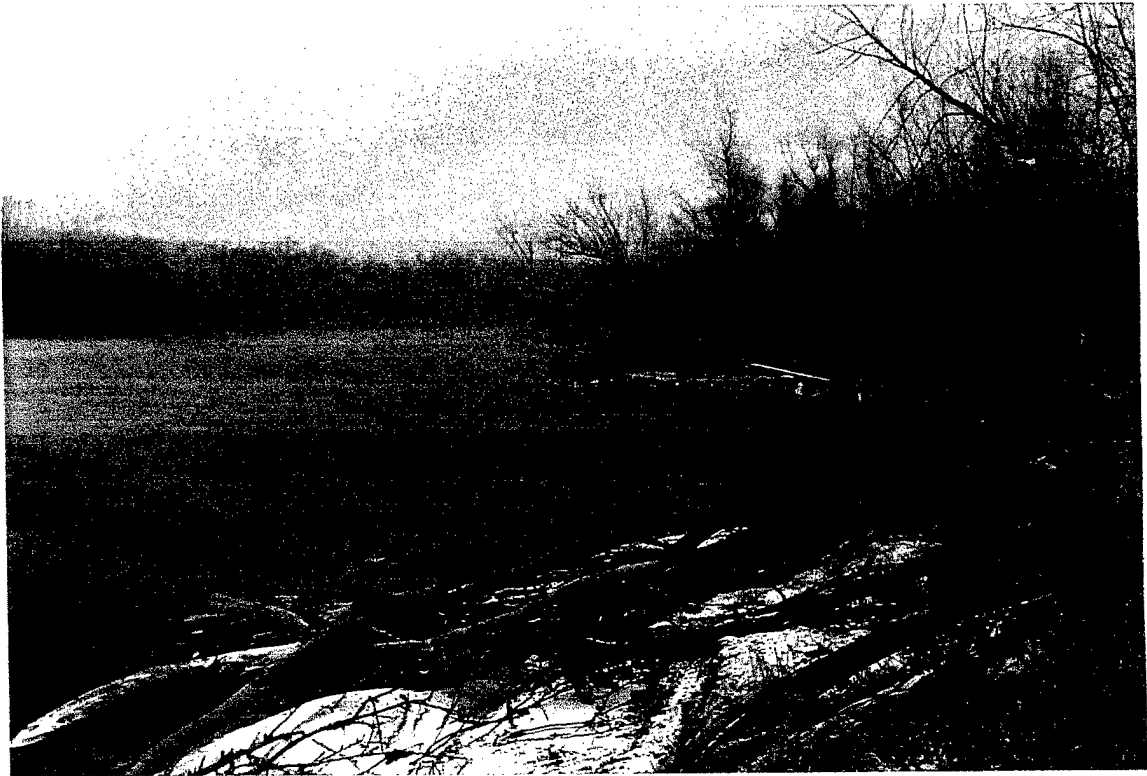
8

**Copeland Bend, Looking Upstream at Dike 612.6**

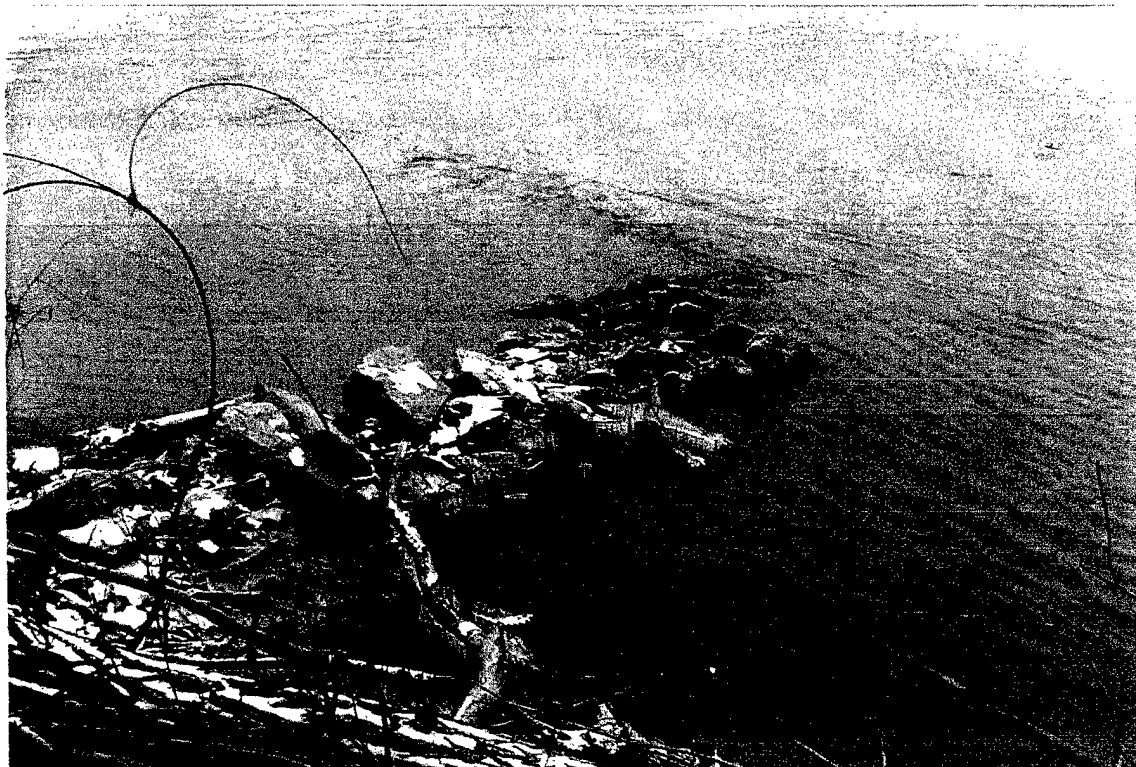
9

Copeland Bend, Looking Directly at Dike 612.6

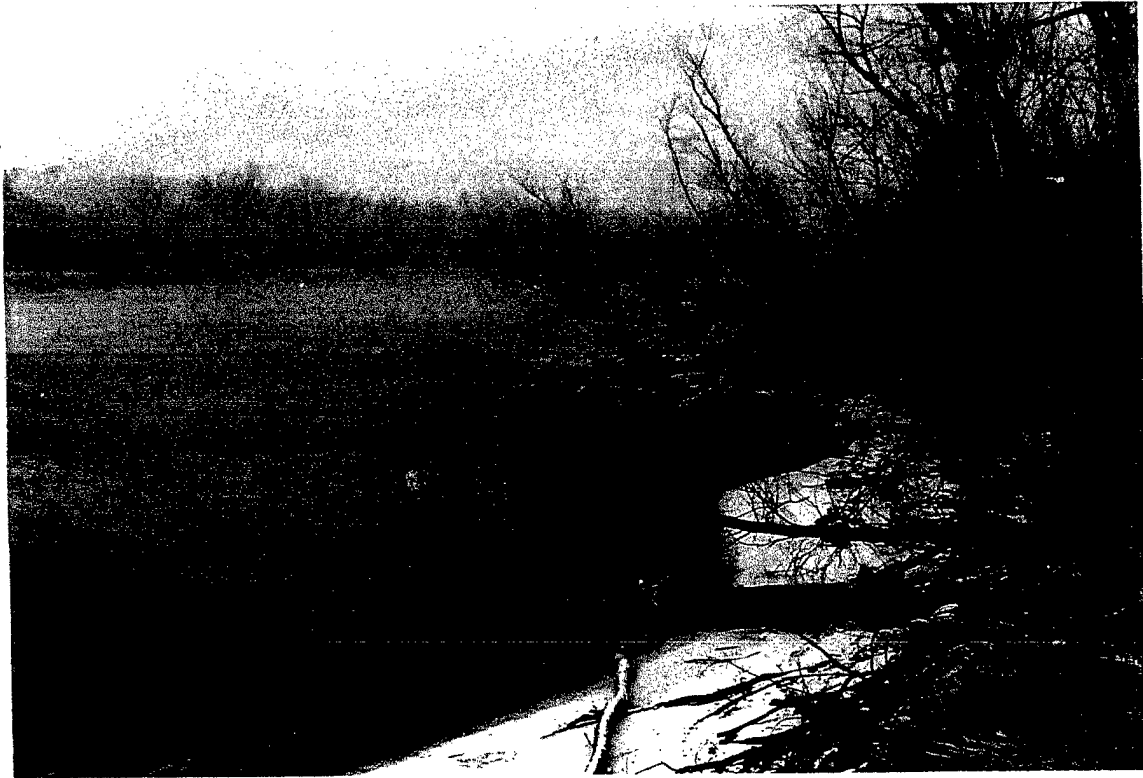
PLATE NO. 10

**Copeland Bend, Looking Upstream at Dike 612.7**

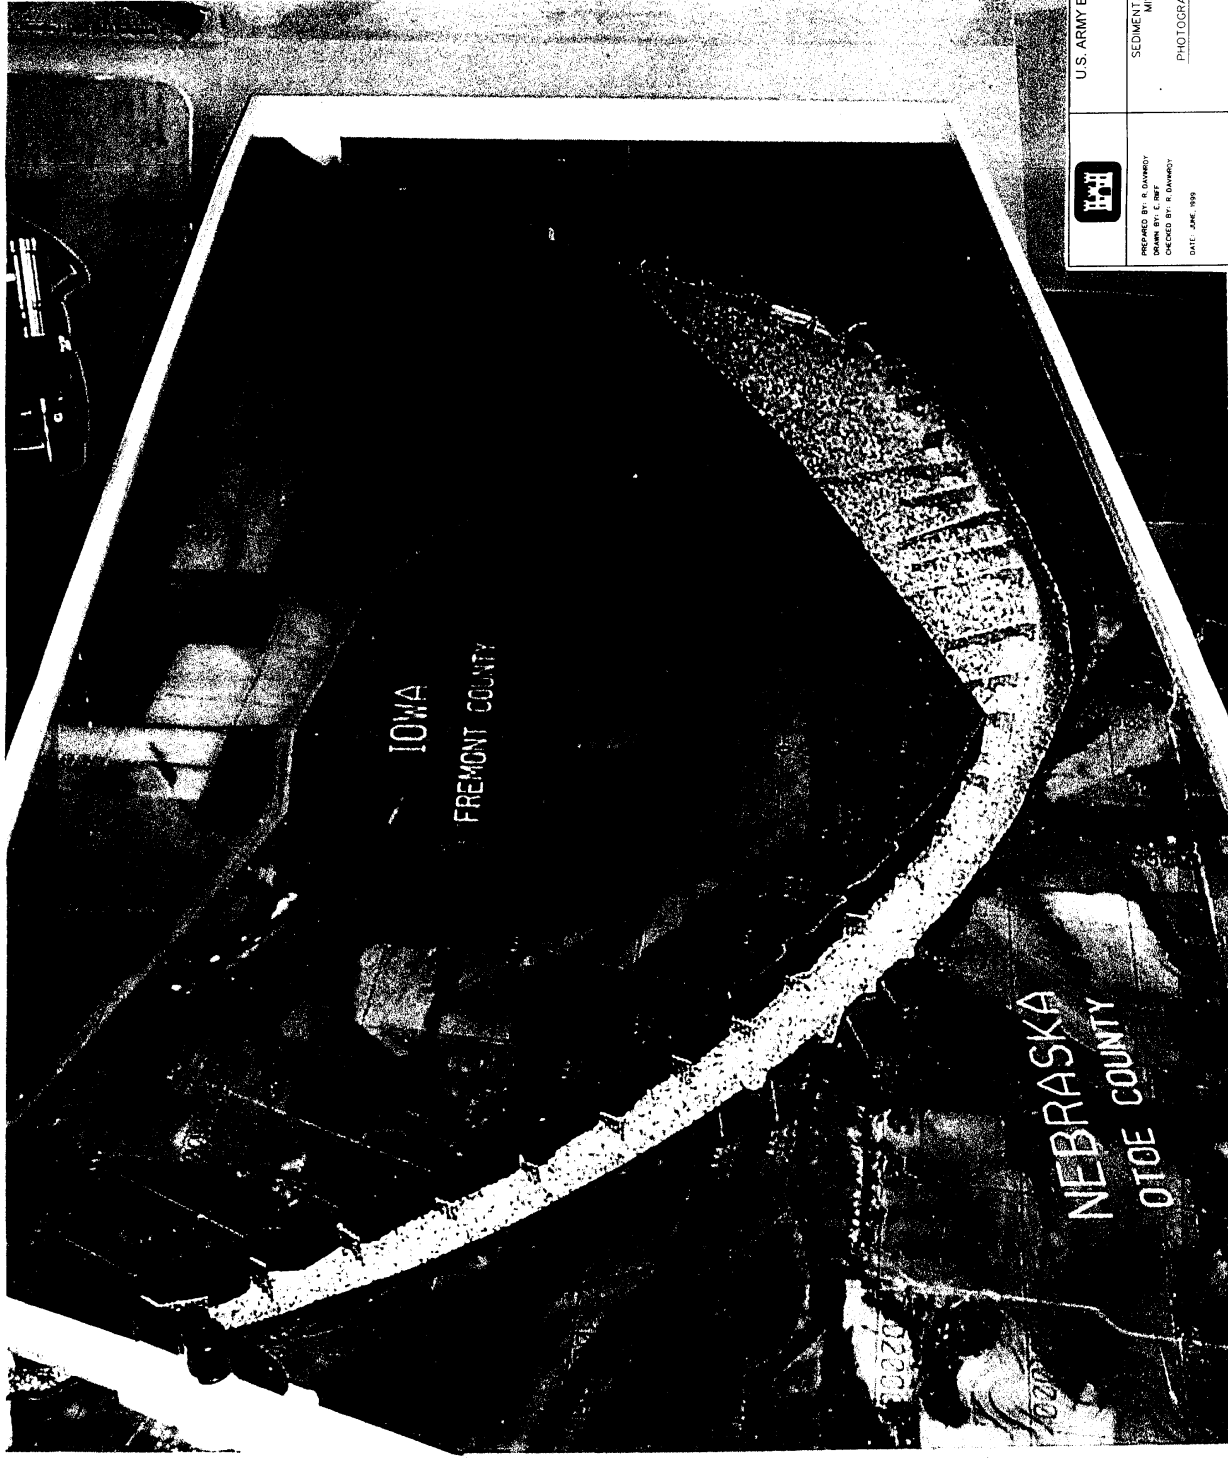
PAGE NO: 11

Plate 11 is a photograph of the Copeland Bend hydraulic micro model used in this study. The scales were 1 inch = 300 feet, or 1:3600 horizontal, 1 inch = 20 feet, or 1:240 vertical, for a 15 to 1 distortion ratio. This distortion supplied the necessary forces required for the simulation of sediment transport conditions similar to those of the prototype. Both the bed material and the erodible floodplain section were composed of granular plastic urea, Type II, with a specific gravity of 1.23.

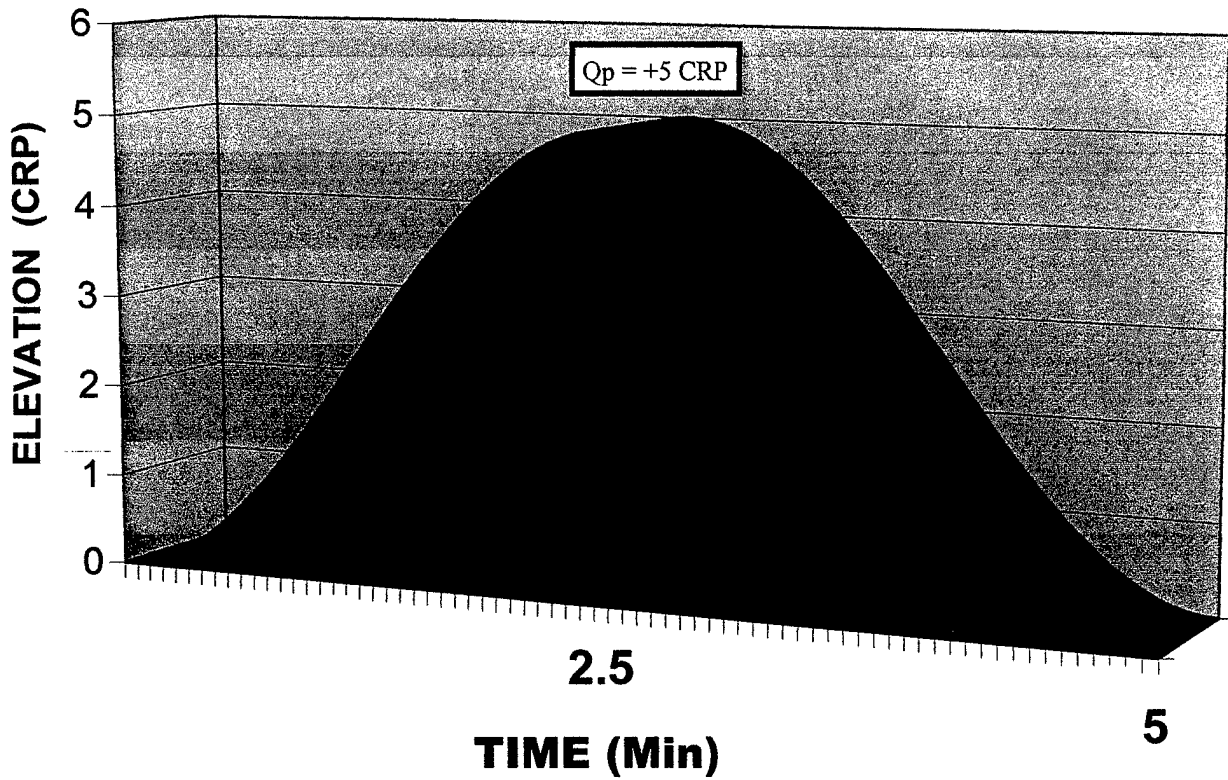
The effective discharge run throughout this model study represented that hydrograph generating an average expected sediment response expected to occur in the prototype. Plate 12 shows the graph of this model hydrograph. Because of the constant variation experienced in the prototype, the effective discharge was used to theoretically analyze the average expected sediment response during any given year. During all testing, the design hydrograph was run successively until stability was observed in both the channel and along the left descending bankline.

It should be realized that because of the nature of the lightweight bed sediment materials that are typically used in movable bed models, hydrographs are not directly scaleable. Thus, in this particular study, although the peak stage of the hydrograph used for testing was at +5 CRP in the micro model, the energy of the model under this condition was representative of much higher flows experienced in the prototype. The design hydrograph then, in simplistic terms, represents an energy condition in the model that effectively enables the model to replicate realistic sediment response conditions similar those observed in the prototype.

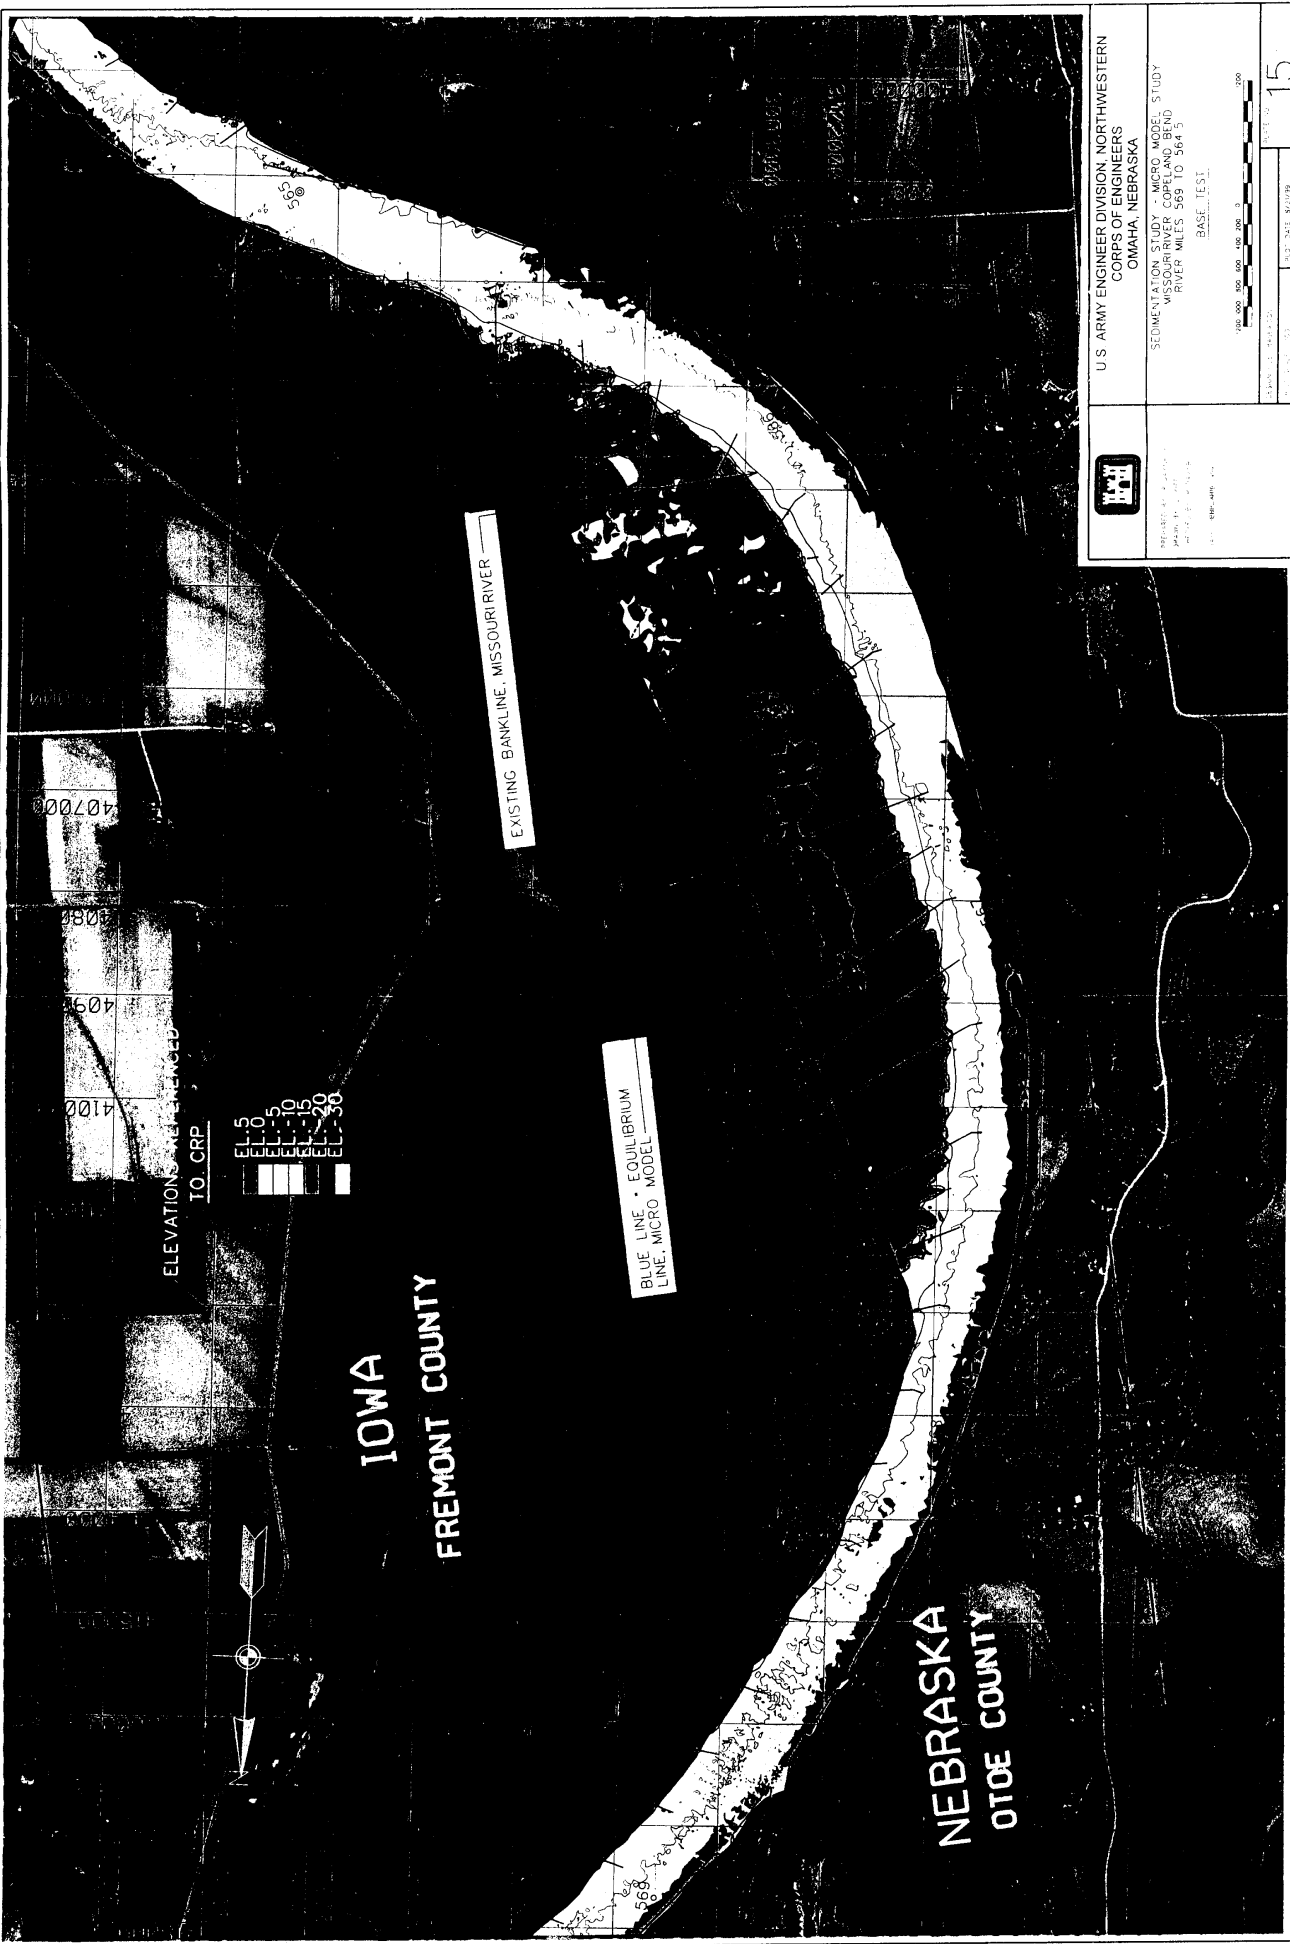
Plate 15 shows the resultant bed configuration of the micro model base test. The base test was developed from the simulation of successive design hydrographs until bed stability was reached and a similar bed response was achieved as compared with the prototype surveys. The observed trends of the model were as follows:

SEDIMENTATION STUDY - MICRO MODEL STUDY  
MISSOURI RIVER COPELAND BEND  
RIVER MILES 569 TO 584.5  
BASE TEST

The general bathymetric trends of the base test were very similar to those of the two observed prototype surveys of 1991 and 1996. Generally, the thalweg was located in the same positions as in the prototype. The depositional patterns

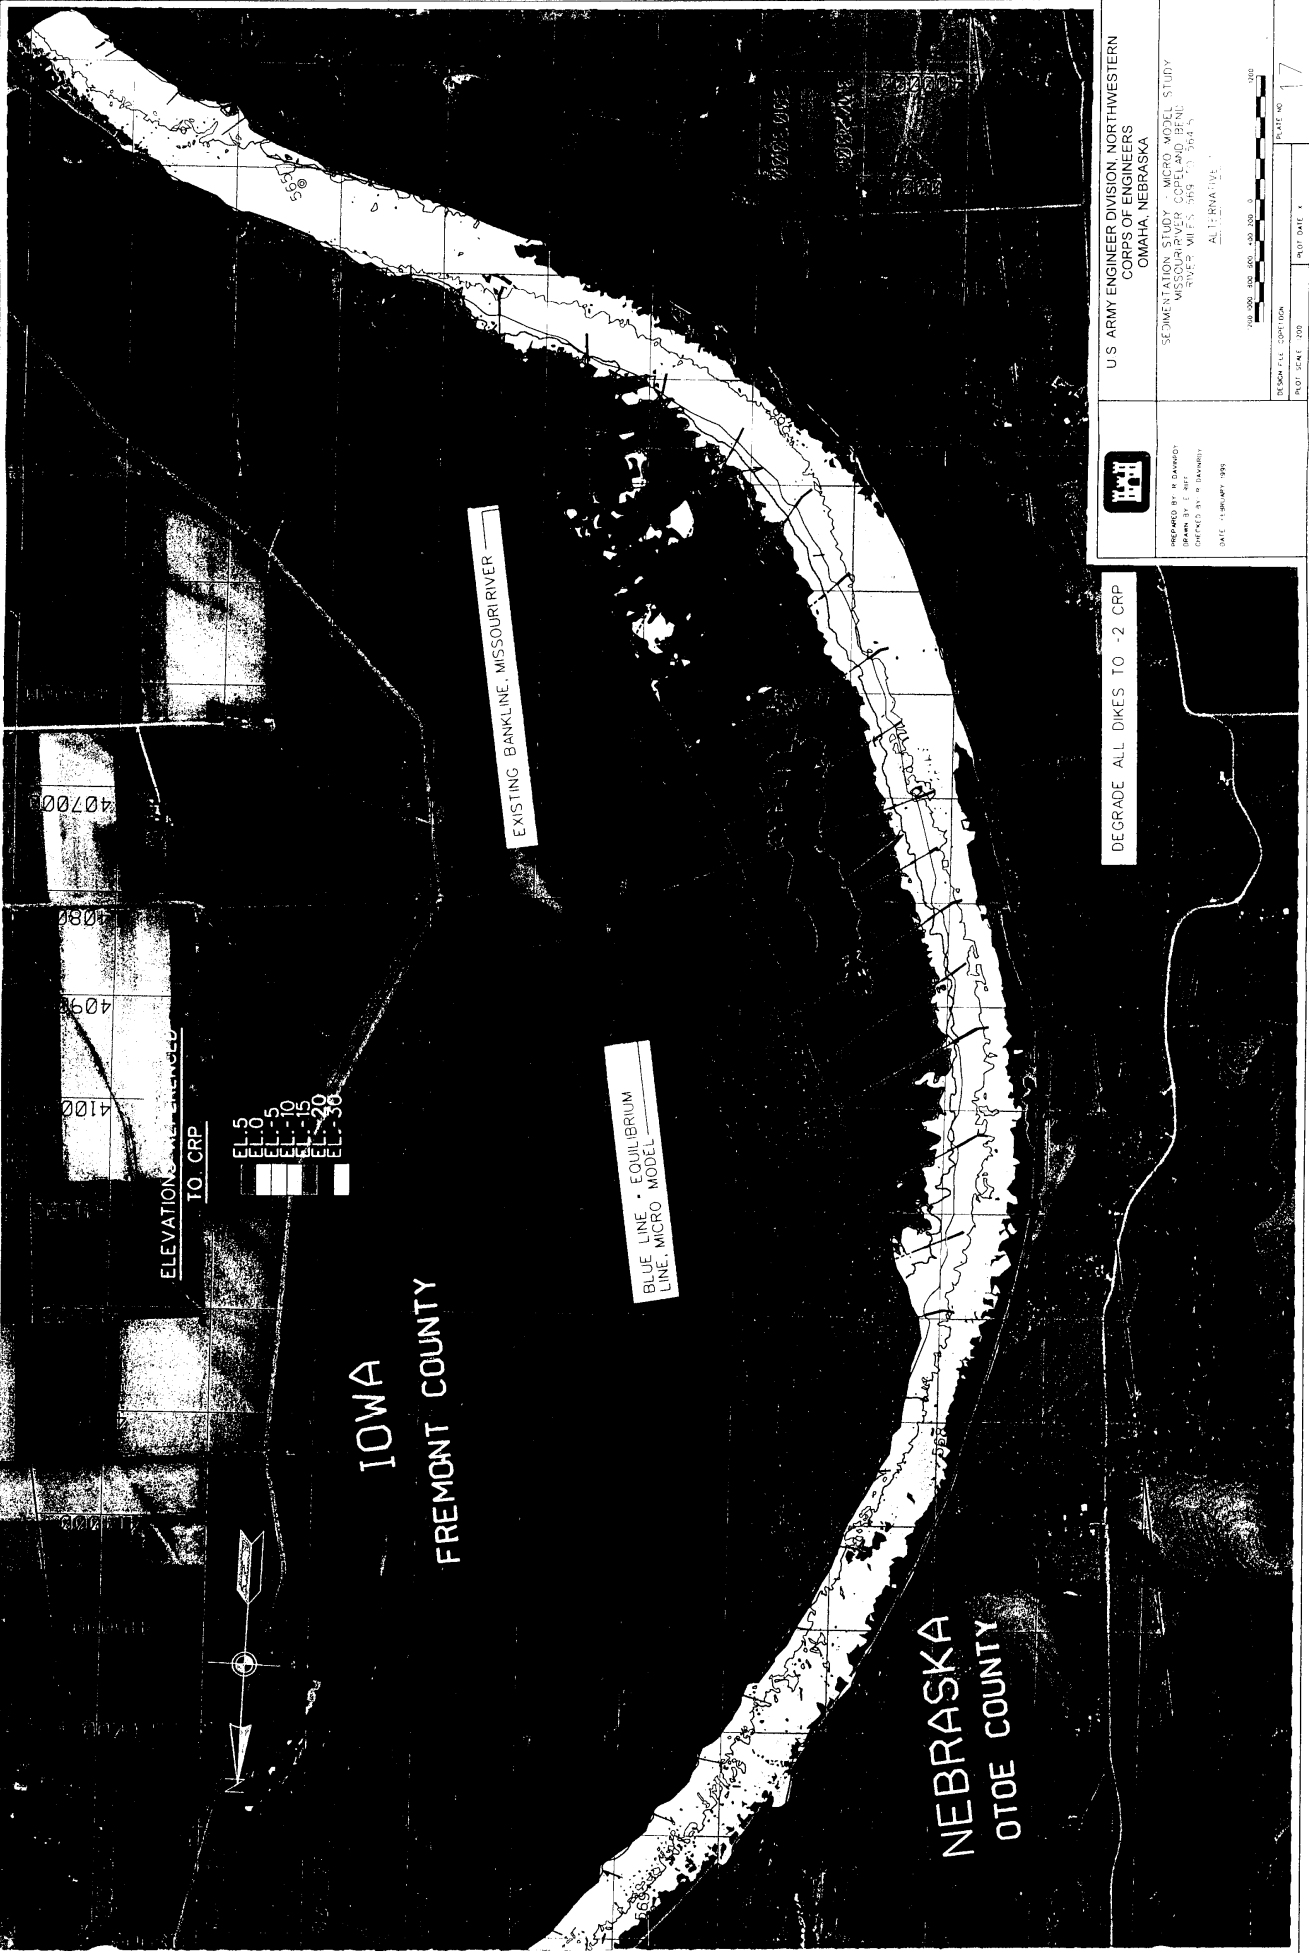
DESIGN FILE CONTINUA  
PROJECT NO. 17  
SHEET NO. 17

**Alternative 1. Degrade All Existing Dikes To -2 CRP.** Alternative 1 involved the degradation of all dikes to -2 CRP on the left descending bank, between Miles 567.8 and 565.3. Results (Plates 17, 18, 19) indicated the following trends:

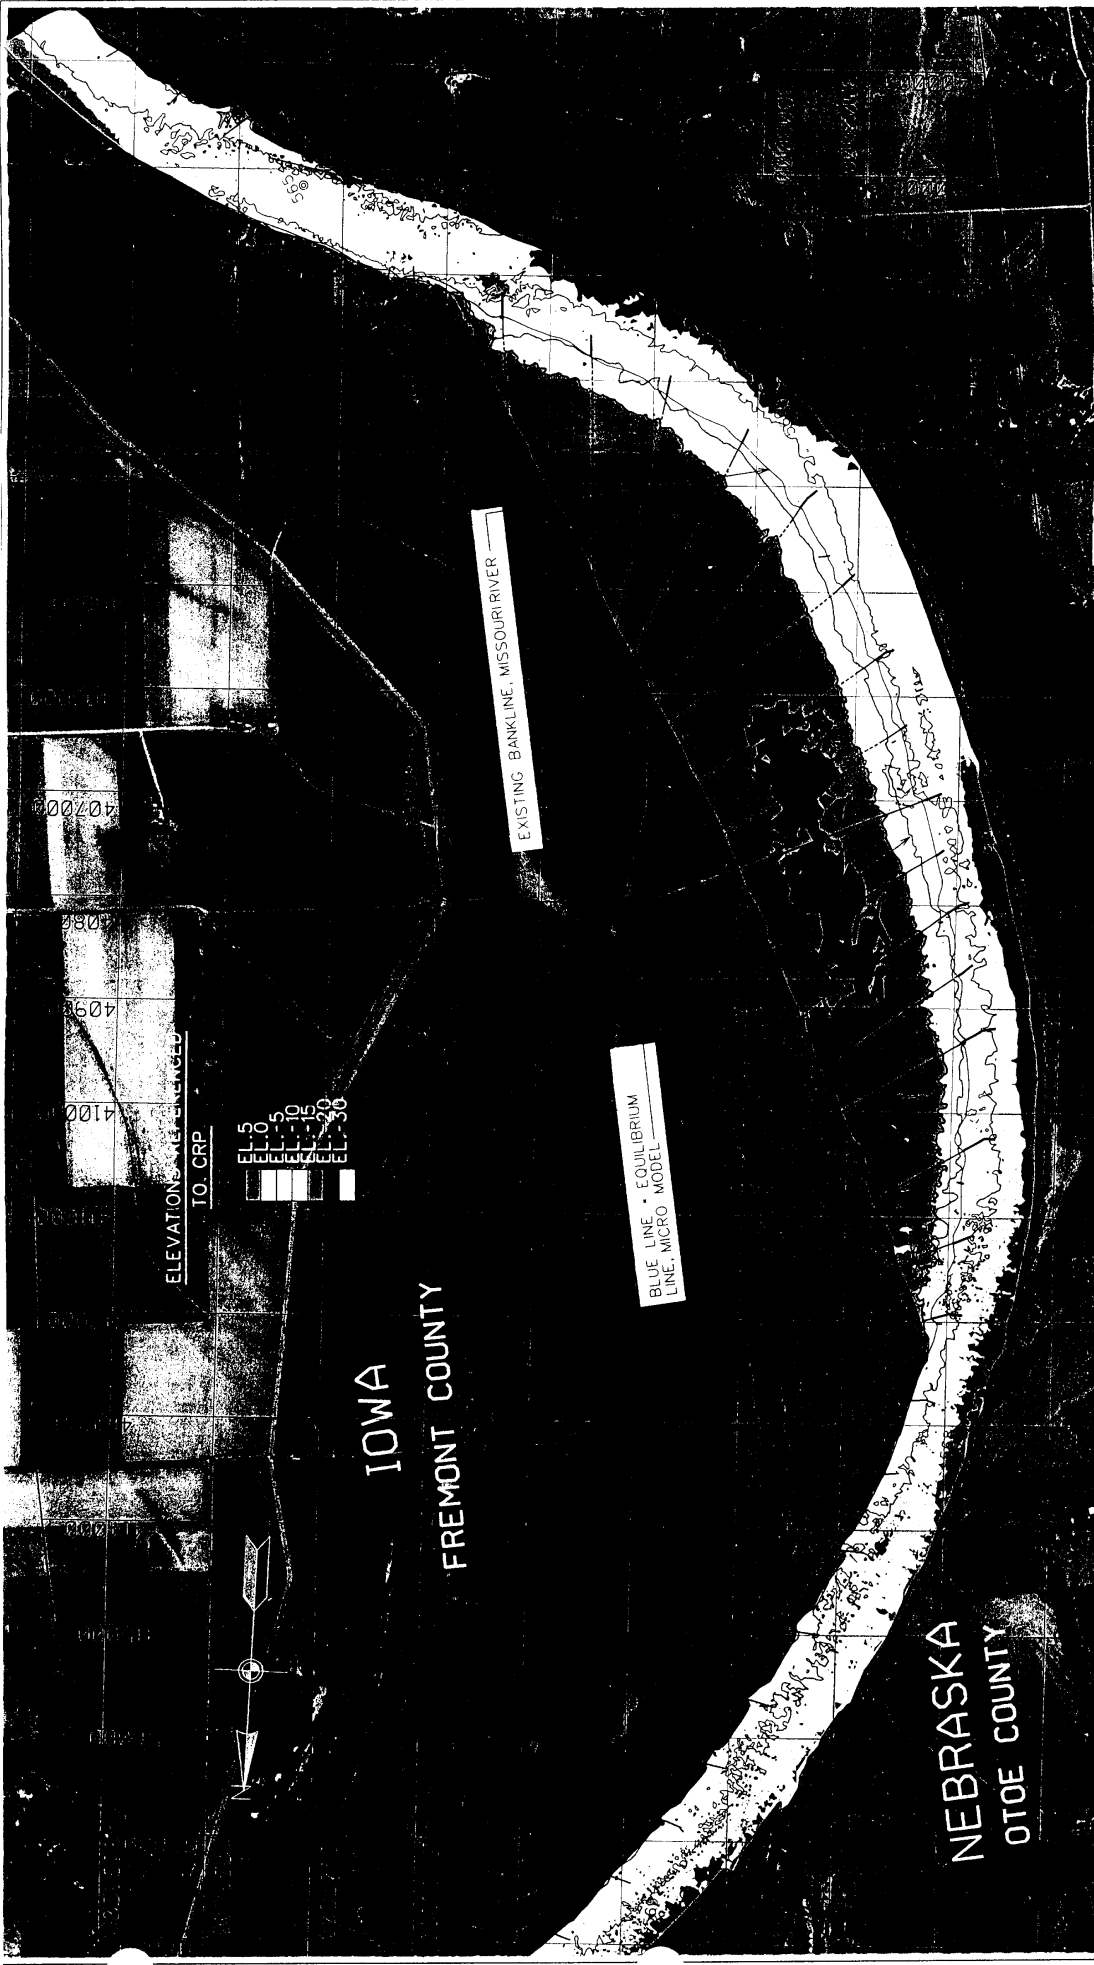
DESIGN FILE CORRELATION  
 H-37 SCALE 1:500  
 PLOT DATE: 8/27/93  
 SHEET NO. 38

Alternative 8 involved degrading the left descending bankline between 0 and 400 feet, or approximately 300 feet on the average landward from the base test equilibrium line, to a depth of approximately -10 CRP. Results (Plates 38, 39, 40) indicated the following:

Depths and widths in the navigation channel remained similar to the base test. Some slight deposition was observed in the channel between 566.6 and 566.7. Since the bankline was artificially degraded, no additional lateral erosion was observed.

**SEDIMENTATION STUDY - MICRO MODEL STUDY**  
 MISSOURI RIVER AT LAND BEND  
 RIVER MILES 569 TO 594.5  
 ALTERNATIVE B

- Alternative 8 showed that a relatively large amount of bankline degradation and increased depth distribution could be permitted on the inside of Copeland Bend as long as the existing dikes were not removed. Alternative 9 showed that the removal of all dikes threatened the integrity of the navigation channel.
