## **Stress Analysis of the F-111 Wing Pivot Fitting**

DSTO-TN-0271

**Airframes and Engines Division  
Aeronautical and Maritime Research Laboratory**

A number of high stress and potential cracking sites in the F-111 wing pivot fitting (WPF) have been identified using a validated 3D finite element model. Selected locations have been analysed in detail, and ranked according to the magnitude of the peak stress. These locations have also been compared with known sites of in-service cracking. Overall, there is very good agreement between the locations identified from the finite element model and those experiencing in-service cracking. The results from this investigation may assist the RAAF in reviewing inspection requirements for the F-111 WPF.

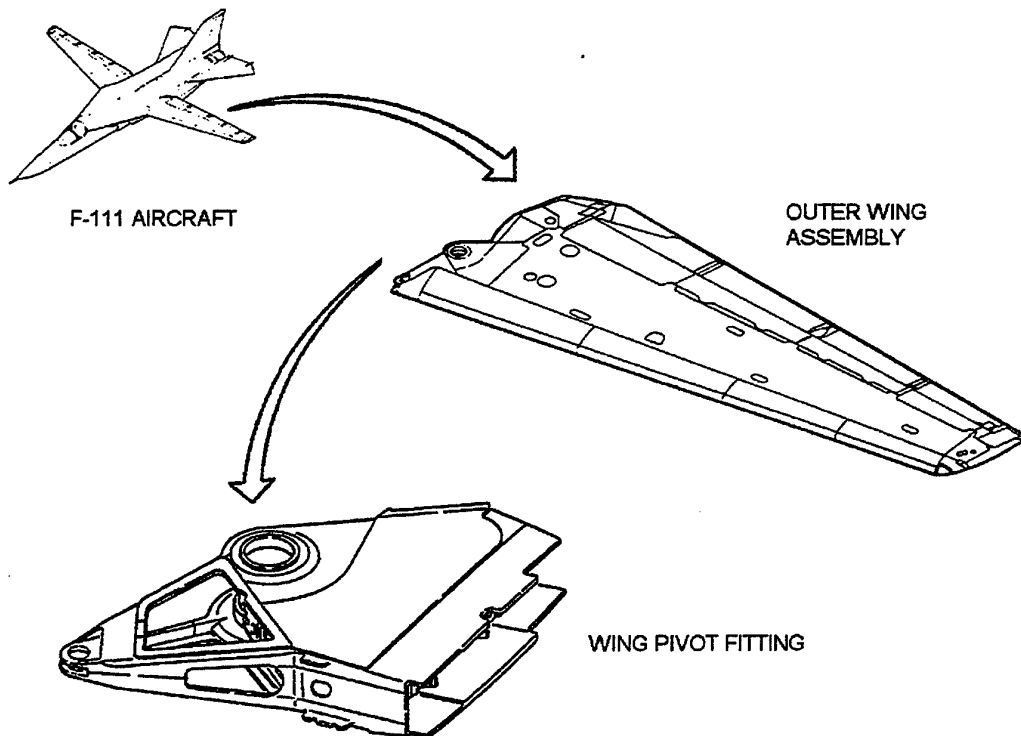
The location of the WPF is shown in Figure 1. It is designed to transmit wing loads to the wing carry through box, and as such it has high structural importance. The use of D6ac steel in its construction offers high strength but fairly low fracture toughness, making it sensitive to fatigue cracking, especially in areas of high stress concentration. To ensure the safety of the aircraft, in-service wings undergo extensive periodic inspections, and a periodic proof load test known as the cold proof load test (CPLT)<sup>1</sup>. The purpose of the CPLT is to confirm that any undetected cracks are not critical, thus clearing the aircraft for a further period of safe flight.

Figure 1: Location of the F-111 wing pivot fitting
