January 31, 1968

Final Report

## INTERACTION OF LIQUID SODIUM WITH 304 STAINLESS STEEL

SRI Project PMU 6694

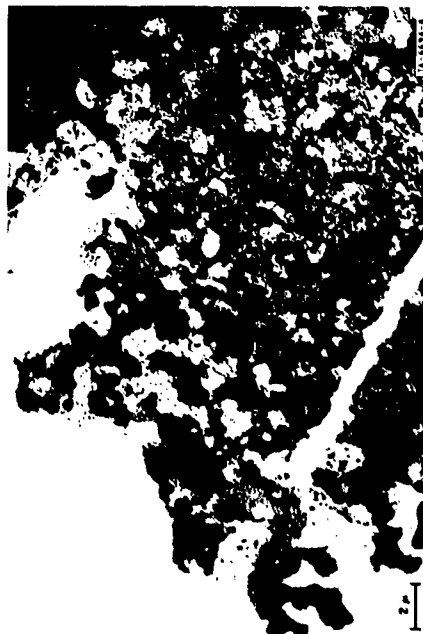
FIG. 8 TRANSMISSION ELECTRON MICROGRAPH OF 304 STAINLESS STEEL FOIL, AFTER ION BOMBARDMENT. The micrograph shows very fine grain structure which resulted from recrystallization due to excessive heating during ion bombardment treatment. Damage to the edge of the foil also occurred during this process.

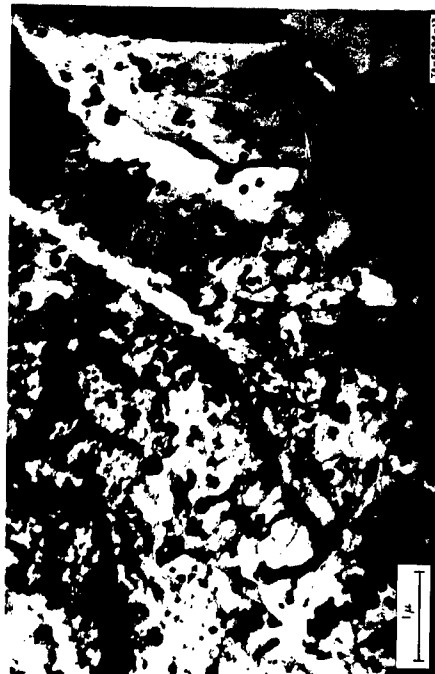
FIG. 13 TRANSMISSION ELECTRON MICROGRAPH OF 304 STAINLESS STEEL FOIL AFTER ELEVEN HOURS EXPOSURE TO LIQUID SODIUM AT 1200°F. Structure shows a severely attacked foil.

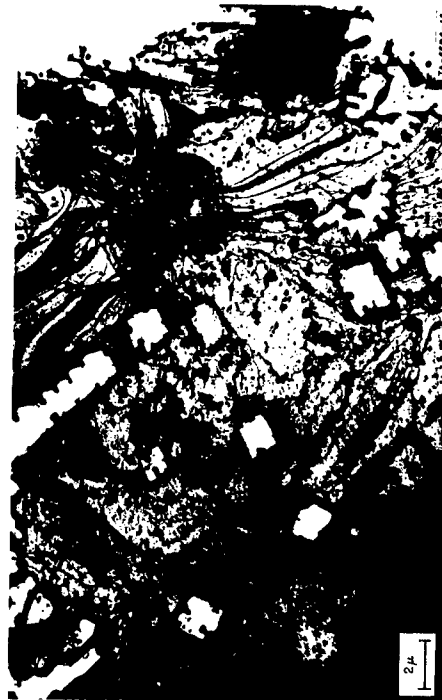
FIG. 14 TRANSMISSION ELECTRON MICROGRAPH OF 304 STAINLESS STEEL FOIL AFTER FIFTEEN HOURS EXPOSURE TO LIQUID SODIUM AT 950°F. Micrograph shows holes etched in surface by liquid sodium. The very ragged edge of the foil has also been severely attacked.

deposited on almost all the grains, appears dark because it is thick enough to absorb all the electrons that otherwise would pass through the foil. The deposit always has a geometrical shape, which varies from grain to grain, often a grain is heavily deposited, but a twinned section of the same grain is relatively free of deposit. So far it has not been possible to identify this deposit by transmission electron diffraction. In view of the fact that stainless steel foils can be cleaned so successfully after exposure to liquid sodium at and below 700°F, it is felt that this precipitate is neither sodium nor sodium oxide. One grain boundary shown in Fig. 10 has been attacked by the liquid sodium. Rather large holes with very ragged edges can also be seen in this micrograph. These holes may well have been small pinholes in the electropolished foil (Fig. 6) that have been enlarged by attack of the liquid sodium metal. The grain boundary attack can be more clearly seen in Fig. 11, which is a higher magnification micrograph of the same area of the foil. Only a few of the grain boundaries were attacked, but no detailed orientation studies were made to determine which boundaries were involved. Figs. 12 and 13 reveal grain boundaries that have been severely attacked, leaving the edges with the characteristic ragged effect. This etching behavior is always observed at the edges of the foil: thus, a very smooth edge (Fig. 7) becomes ragged and irregular after exposure to liquid sodium at 1200°F (Figs. 14 and 15).

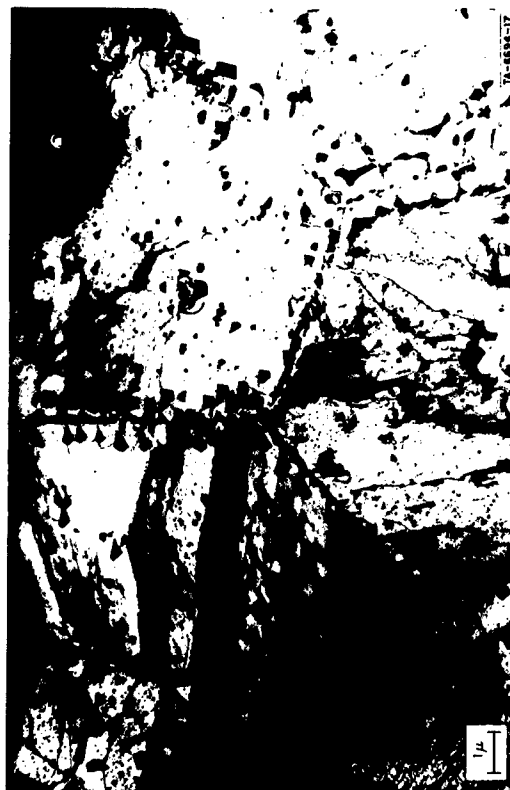
FIG. 17 TRANSMISSION ELECTRON MICROGRAPH OF 304 STAINLESS STEEL FOIL AFTER ELEVEN HOURS EXPOSURE TO LIQUID SODIUM AT 1200°F. Micrograph clearly shows geometrical grain boundary precipitate.

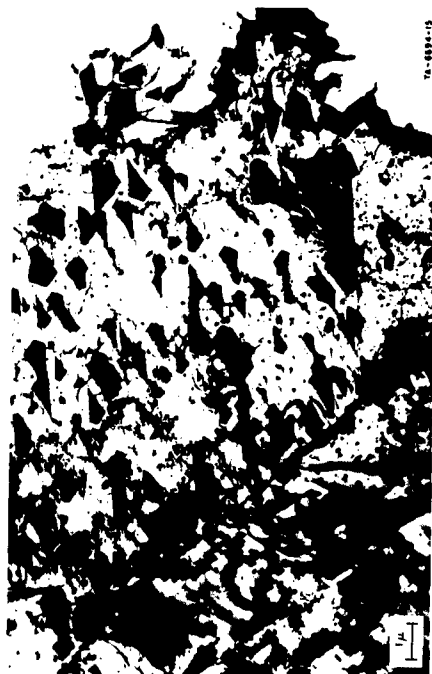
FIG. 15 TRANSMISSION ELECTRON MICROGRAPH OF 304 STAINLESS STEEL FOIL AFTER SIX HOURS EXPOSURE TO LIQUID SODIUM AT 1200°F. Micrograph shows attacked foil edge as well as surface and grain boundary deposit.

The nature of the residual surface precipitate can vary greatly from one experiment to the next. This is clearly seen by contrasting the structures in Figs. 15 and 10. In Fig. 16, most grains are relatively free of this deposit, only a few grains having a surface precipitate. This figure illustrates the dependence of the precipitate upon the orientation of the stainless steel grain. A section of a given foil is free of precipitate but a twinned section of the same grain is heavily deposited. Another striking observation in this micrograph is the preferential deposit of the precipitate along grain boundaries. A higher magnification micrograph of the same foil, Fig. 17, clearly illustrates this. At times, the precipitate appears to be deposited totally within the grain boundary. This is shown in Fig. 18, which also reveals that the twin boundaries remain clean. This lack of deposit in or at twin boundaries is always observed.
