1. REPORT DATE		2. REPORT TYPE Viewgraphs	3. DATES COVERED		
4. TITLE AND SUBTITLE NDE R&D at NAWC			5a. CONTRACT NUMBER		
			5b. GRANT NUMBER		
			5c. PROGRAM ELEMENT NUMBER

NDE R&D at NAWC

**Naval Air Warfare Center, Aircraft Division
Patuxent River, MD
October 16, 2000**

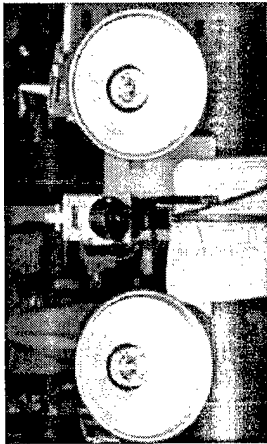
Thermography

- Corrosion
- Impact Damage
- Delamination
- Water Intrusion

- Non-Contact
- Wide Area
- Fast
- Cuverd Surfaces

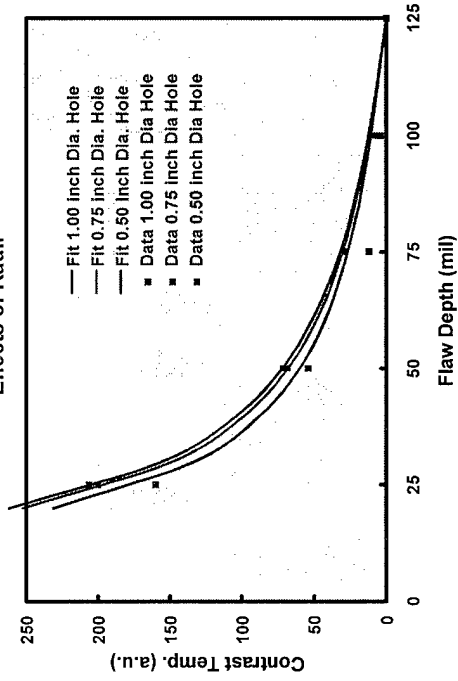
Effects of Radii

$$\Delta T_{front}(t) = \frac{Q}{\rho c} \cdot \frac{e^{-\frac{2 \cdot k_n \cdot t}{\rho c R^2}} - e^{-\frac{k_n \cdot t}{2 \rho c \left(\frac{t_0}{d} + (t_0 - d) \right)}}}{d \cdot \left(1 - \frac{4 \cdot d^2 \cdot (t_0 - d) \cdot k_n}{R^2 \cdot t_0 \cdot k_n \cdot t_0 - d} \right)}$$

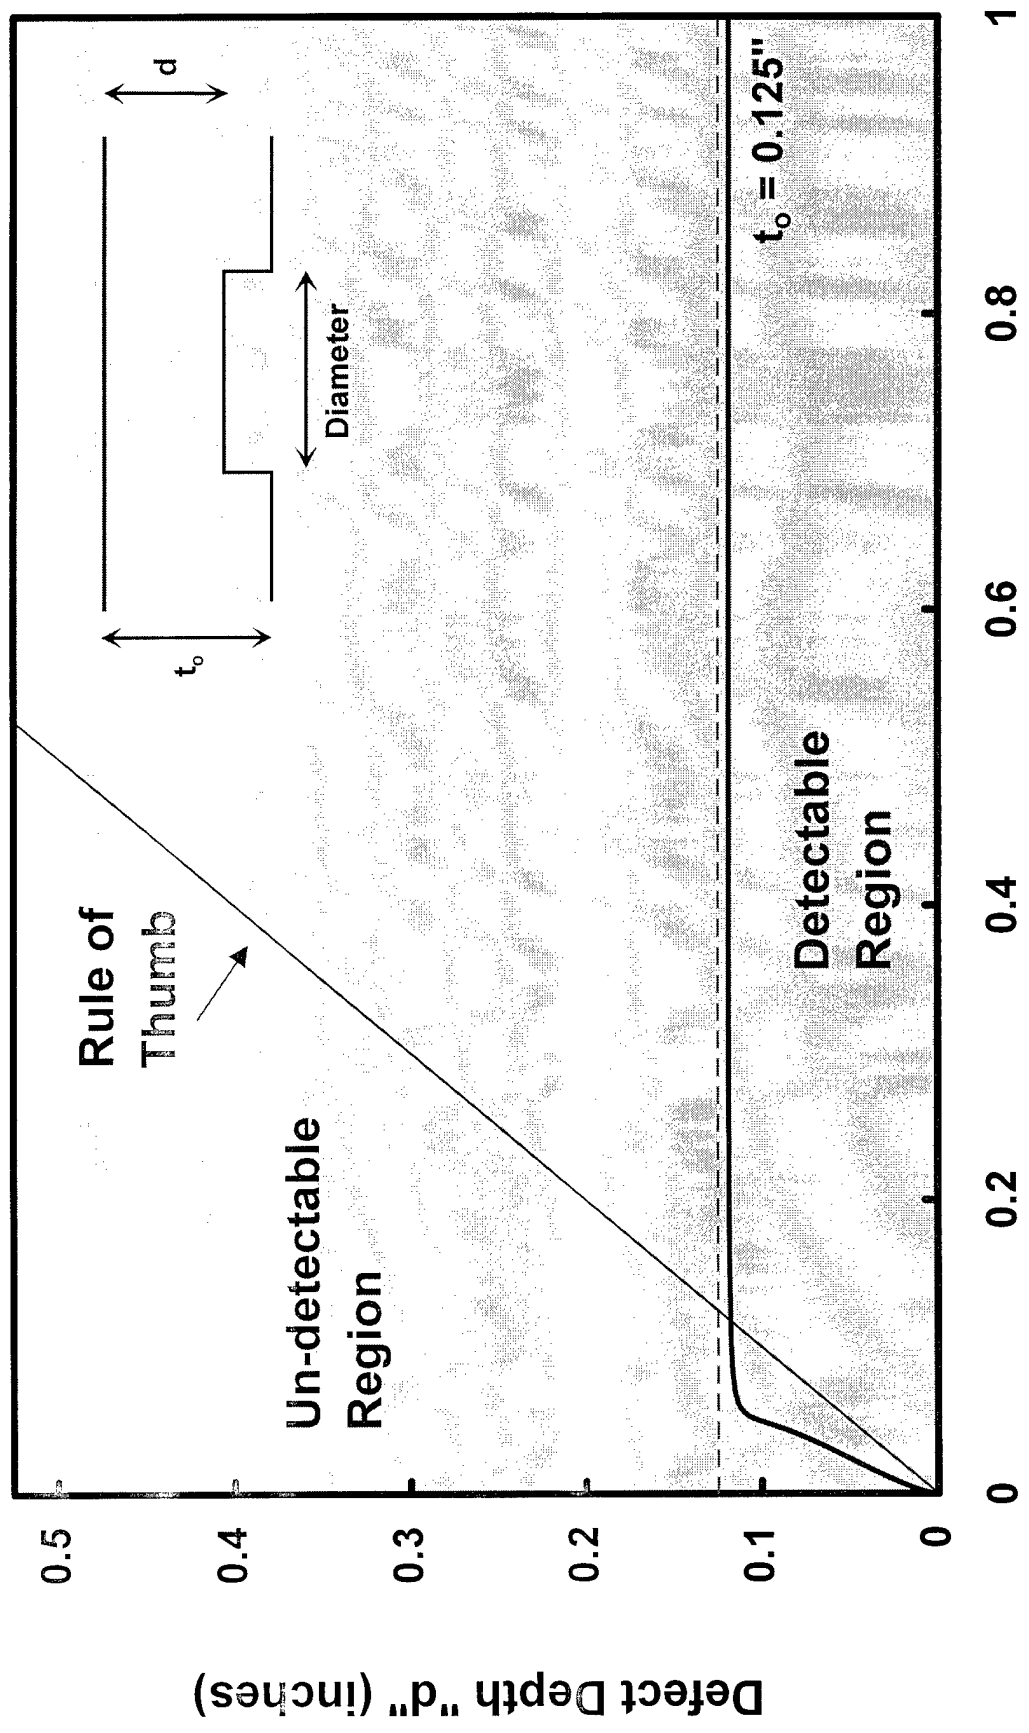
Depth of Resolution

Defect Diameter "2R" (inches)

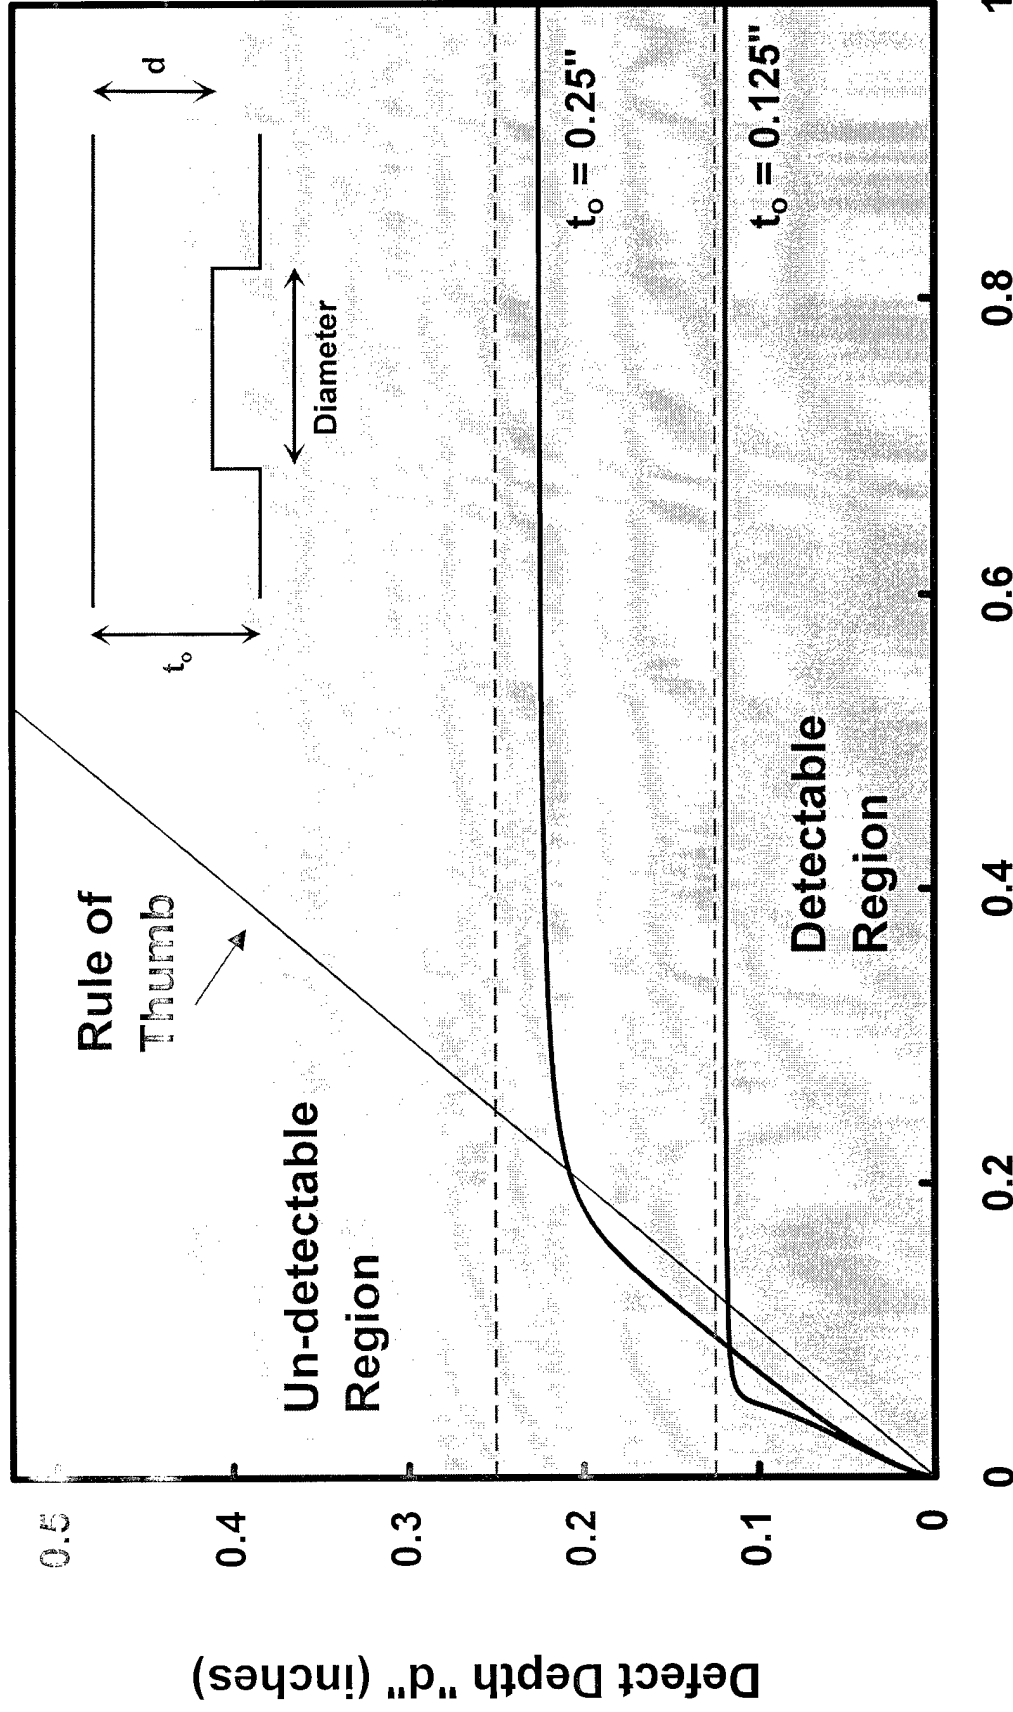
Depth of Resolution

Defect Diameter "2R" (inches)

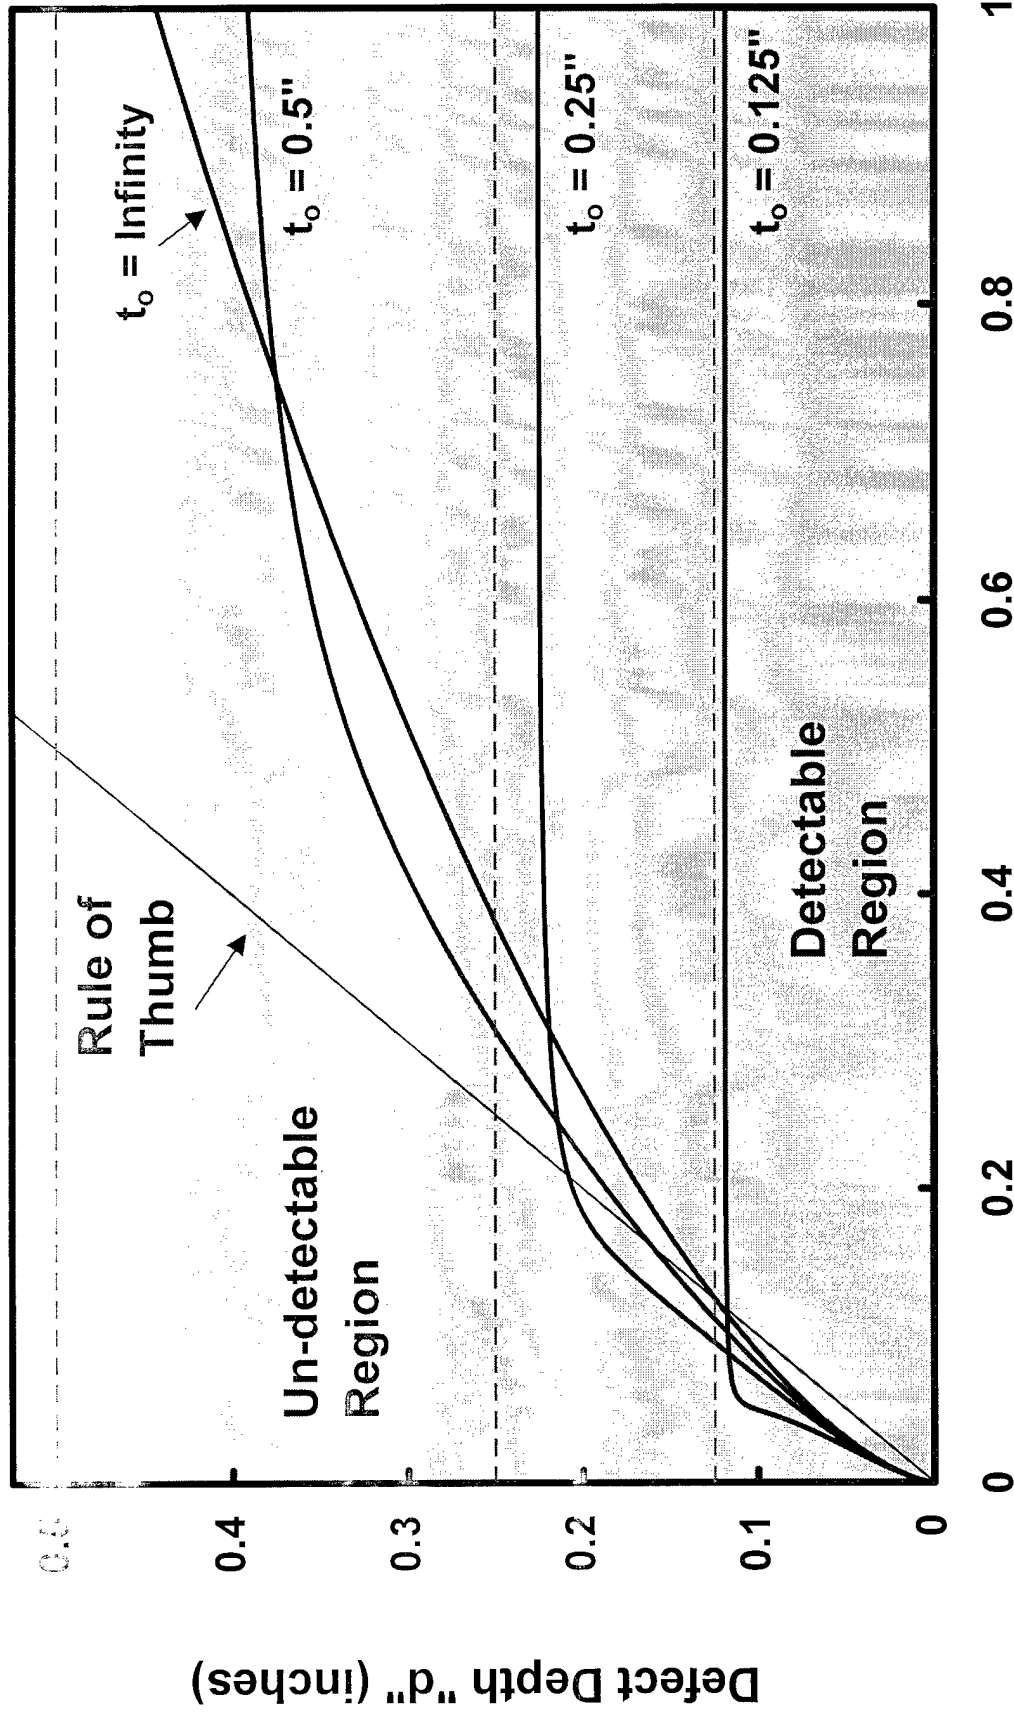
Depth of Resolution

Defect Diameter "2R" (inches)

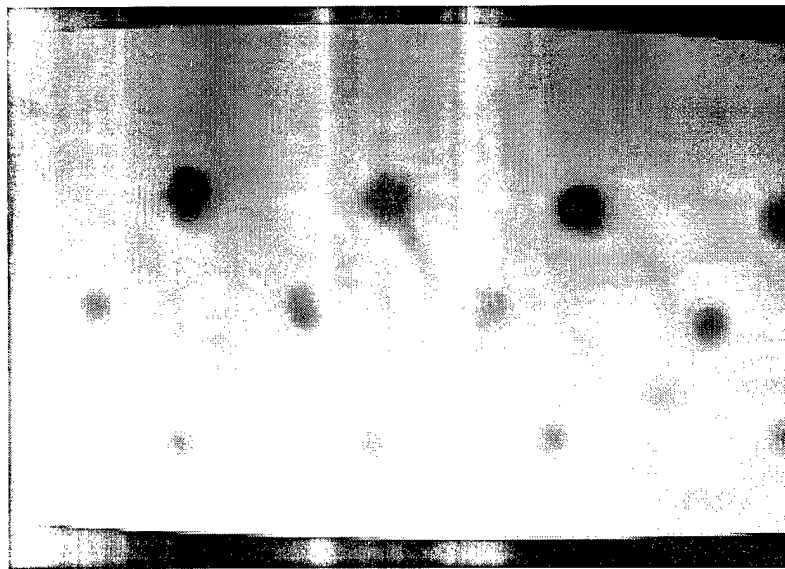
SAMPLES PREPARATION

R = 1/4" 3/8" 1/2" 1/8"

Experimental Parameters for Drops and Panels		
Al Thickness	Straw Diameter	Water Height
$t_o = 1/32''$	$D = 1/8''$	$d = 0''$
$t_o = 1/16''$	$D = 1/4''$	$d = 1/16''$
$t_o = 1/8''$	$D = 3/8''$	$d = 1/8''$
	$D = 1/2''$	$d = 3/16''$
		$d = 1/4''$

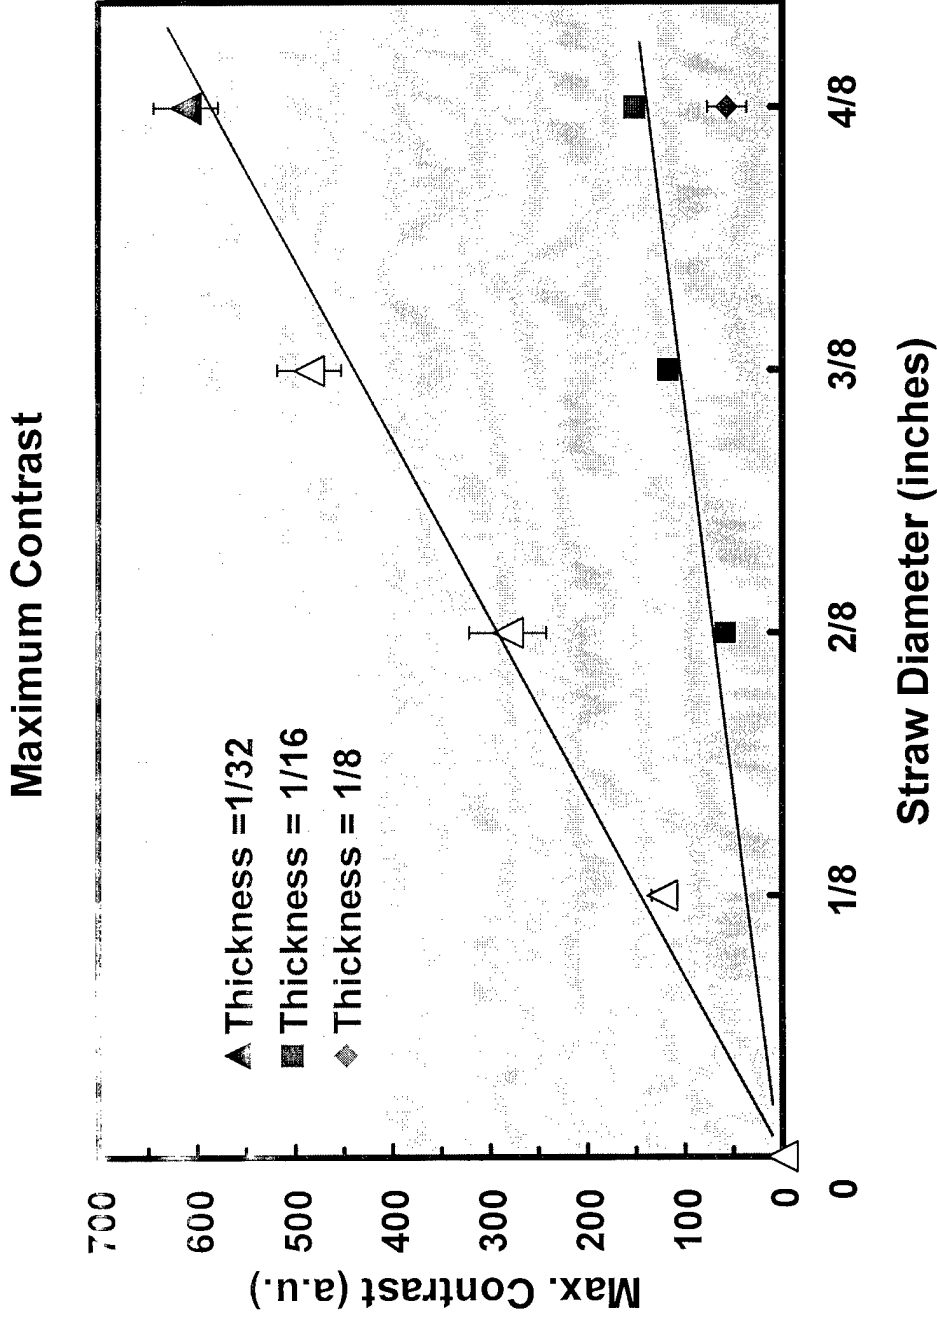
Experimental Data II

- The thinner the aluminum substrate the larger the contrast
- The smaller the straw diameter the smaller the contrast
- The amount of water in the straw does not affect the contrast (error bars small)

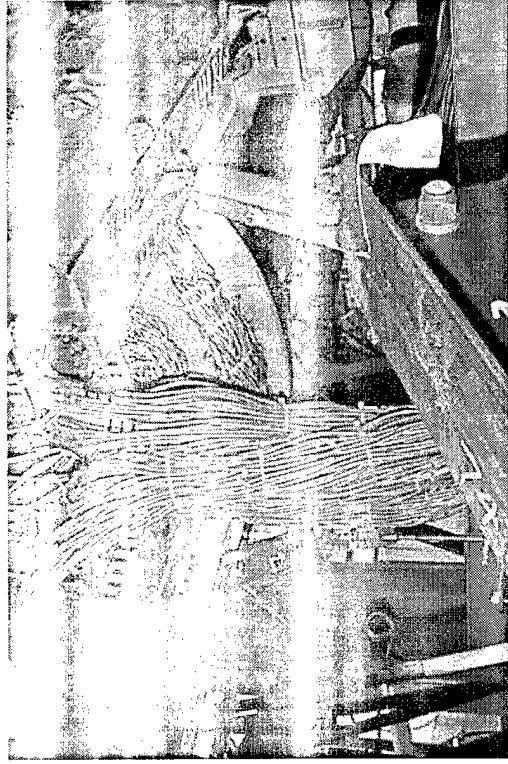
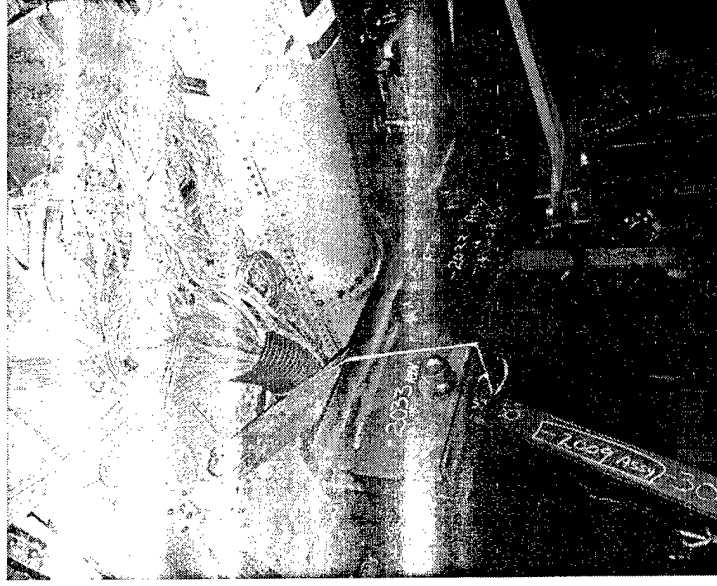
F-18 E/F Full Scale Fatigue Test

Wiring for strain sensor instrumentation during a full scale fatigue test of F-18 aircraft. Every sensor requires a minimum of two electrical leads. Each sensor requires a calibration file. Special care has to be taken to avoid EMI.

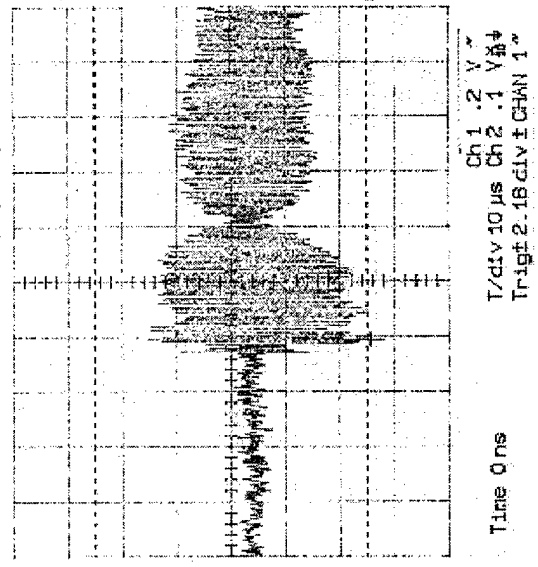
AE Event

- Acoustic Emission event detected with a single fiber-optic Bragg grating

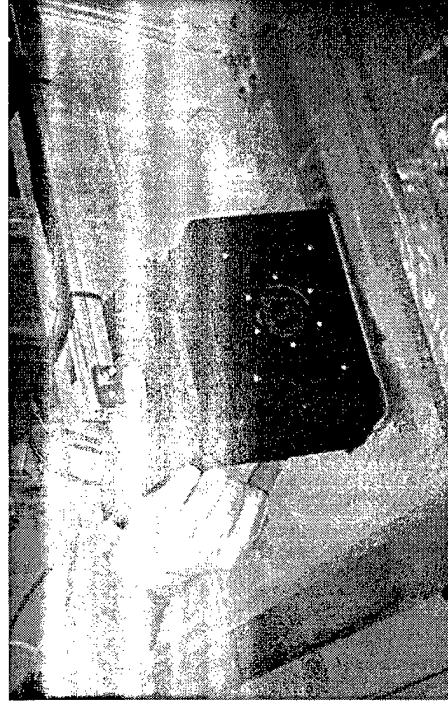
Immersion System

Camera

Acoustic Lens

Target

Source Transducer

Camera Enclosure

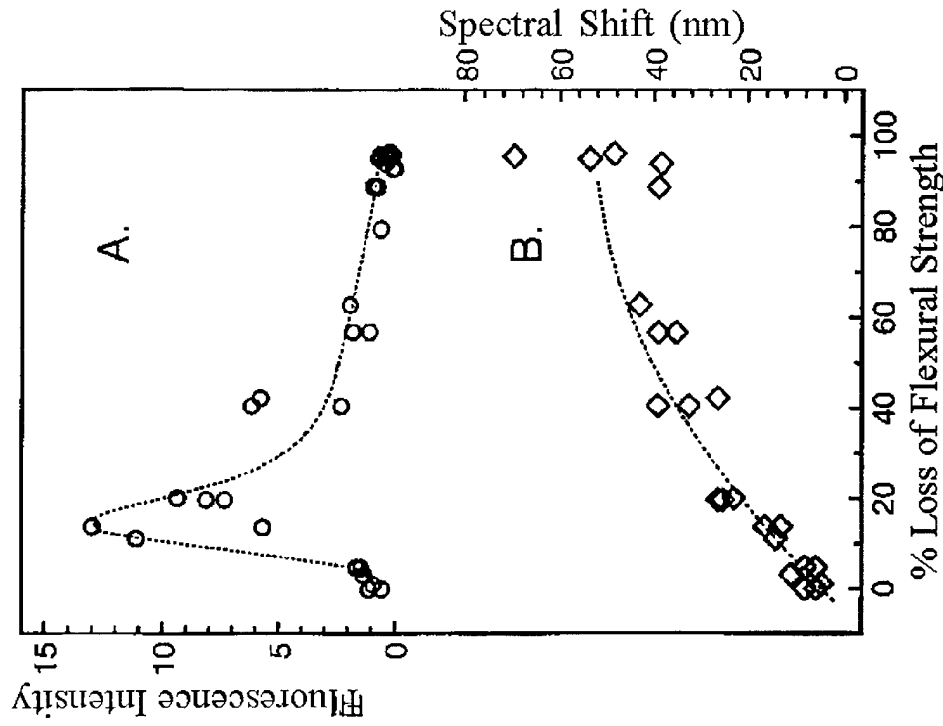
LIF Concept

- The composite is illuminated using a laser
- The laser light excites electrons to higher energy states
- When the electrons return to their natural state, light is emitted at a longer wavelength (fluorescence)
- The spectrum of the fluoresced light is extremely sensitive to variations in material properties
- Previous work has demonstrated that the fluorescent spectrum changes as organic matrix composite materials are subjected to heat

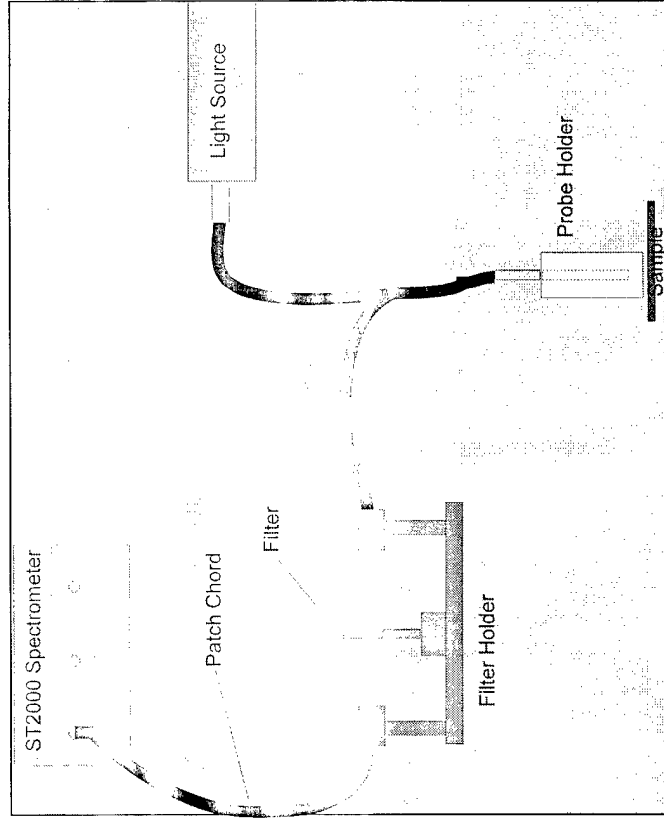
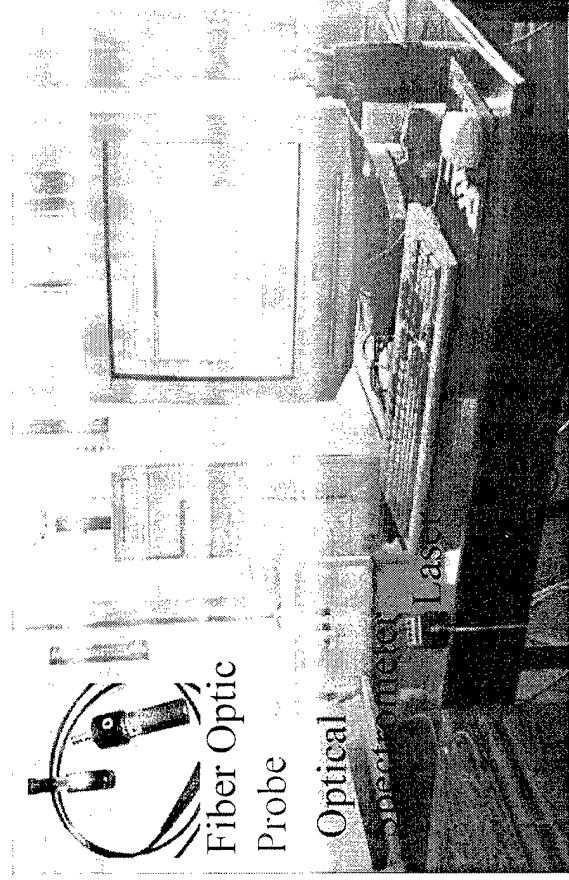
Portable LIF Measurement Concept

- The portable LIF measurement concept is identical to that of the imaging system except the measurements are made at a single point
- A small laser is used in conjunction with a fiber optic emitting and receiving probe to illuminate the surface and gather the fluoresced light
- An optical spectrum analyzer is used to determine the wavelength at which the peak fluorescence occurs

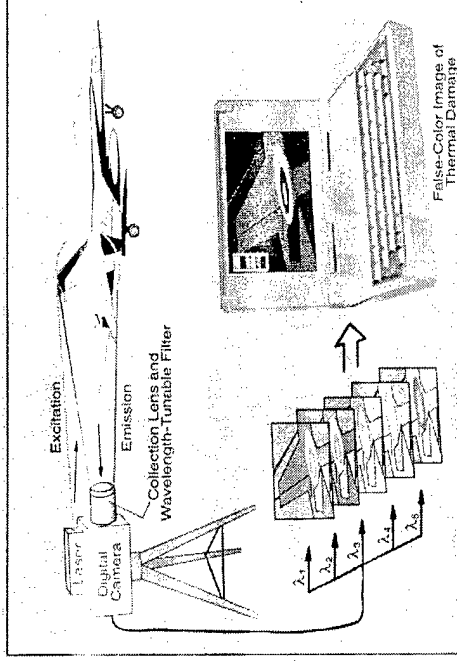
LIF Imaging Concept

- Using filters and a digital camera the fluorescent light can be captured and false colored images can be created
- Previous work demonstrated the feasibility of creating intensity-based images within a narrow (30nm) spectrum
- Current work involves analyzing the entire fluorescent spectrum and creating images based on the wavelength at which peak fluorescence occurs
- Spectrum analysis is accomplished using an acousto-optical tunable filter

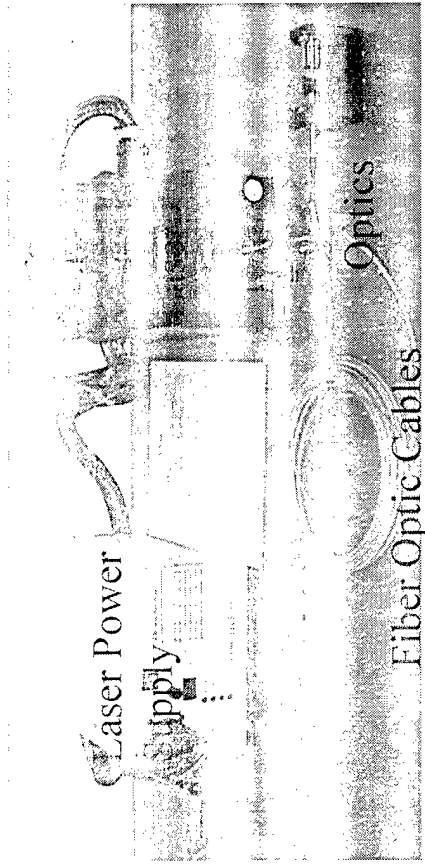
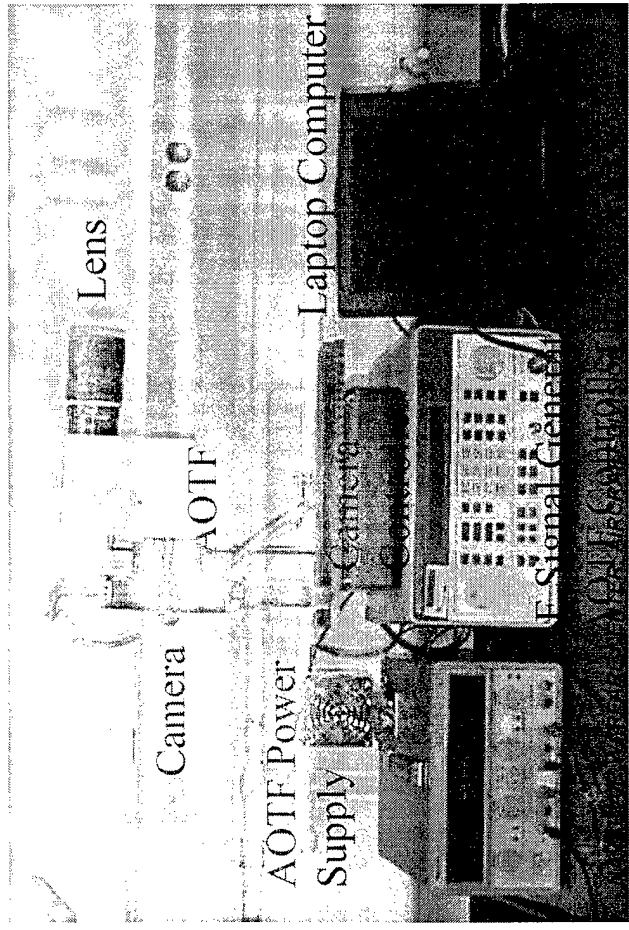
LIF Imaging System Configuration

- AOTF functional and operation successfully demonstrated
- Laser illumination successfully demonstrated
- Computer control software module developed for the AOTF
- System fully integrated and demonstration of imaging at different wavelengths completed
