**DRAFT**  
**Bioventing Pilot Test**  
**Final Report**  
**Site ST14, Fuel Loading Area**  
**Carswell AFB, Texas**

**August 1993**

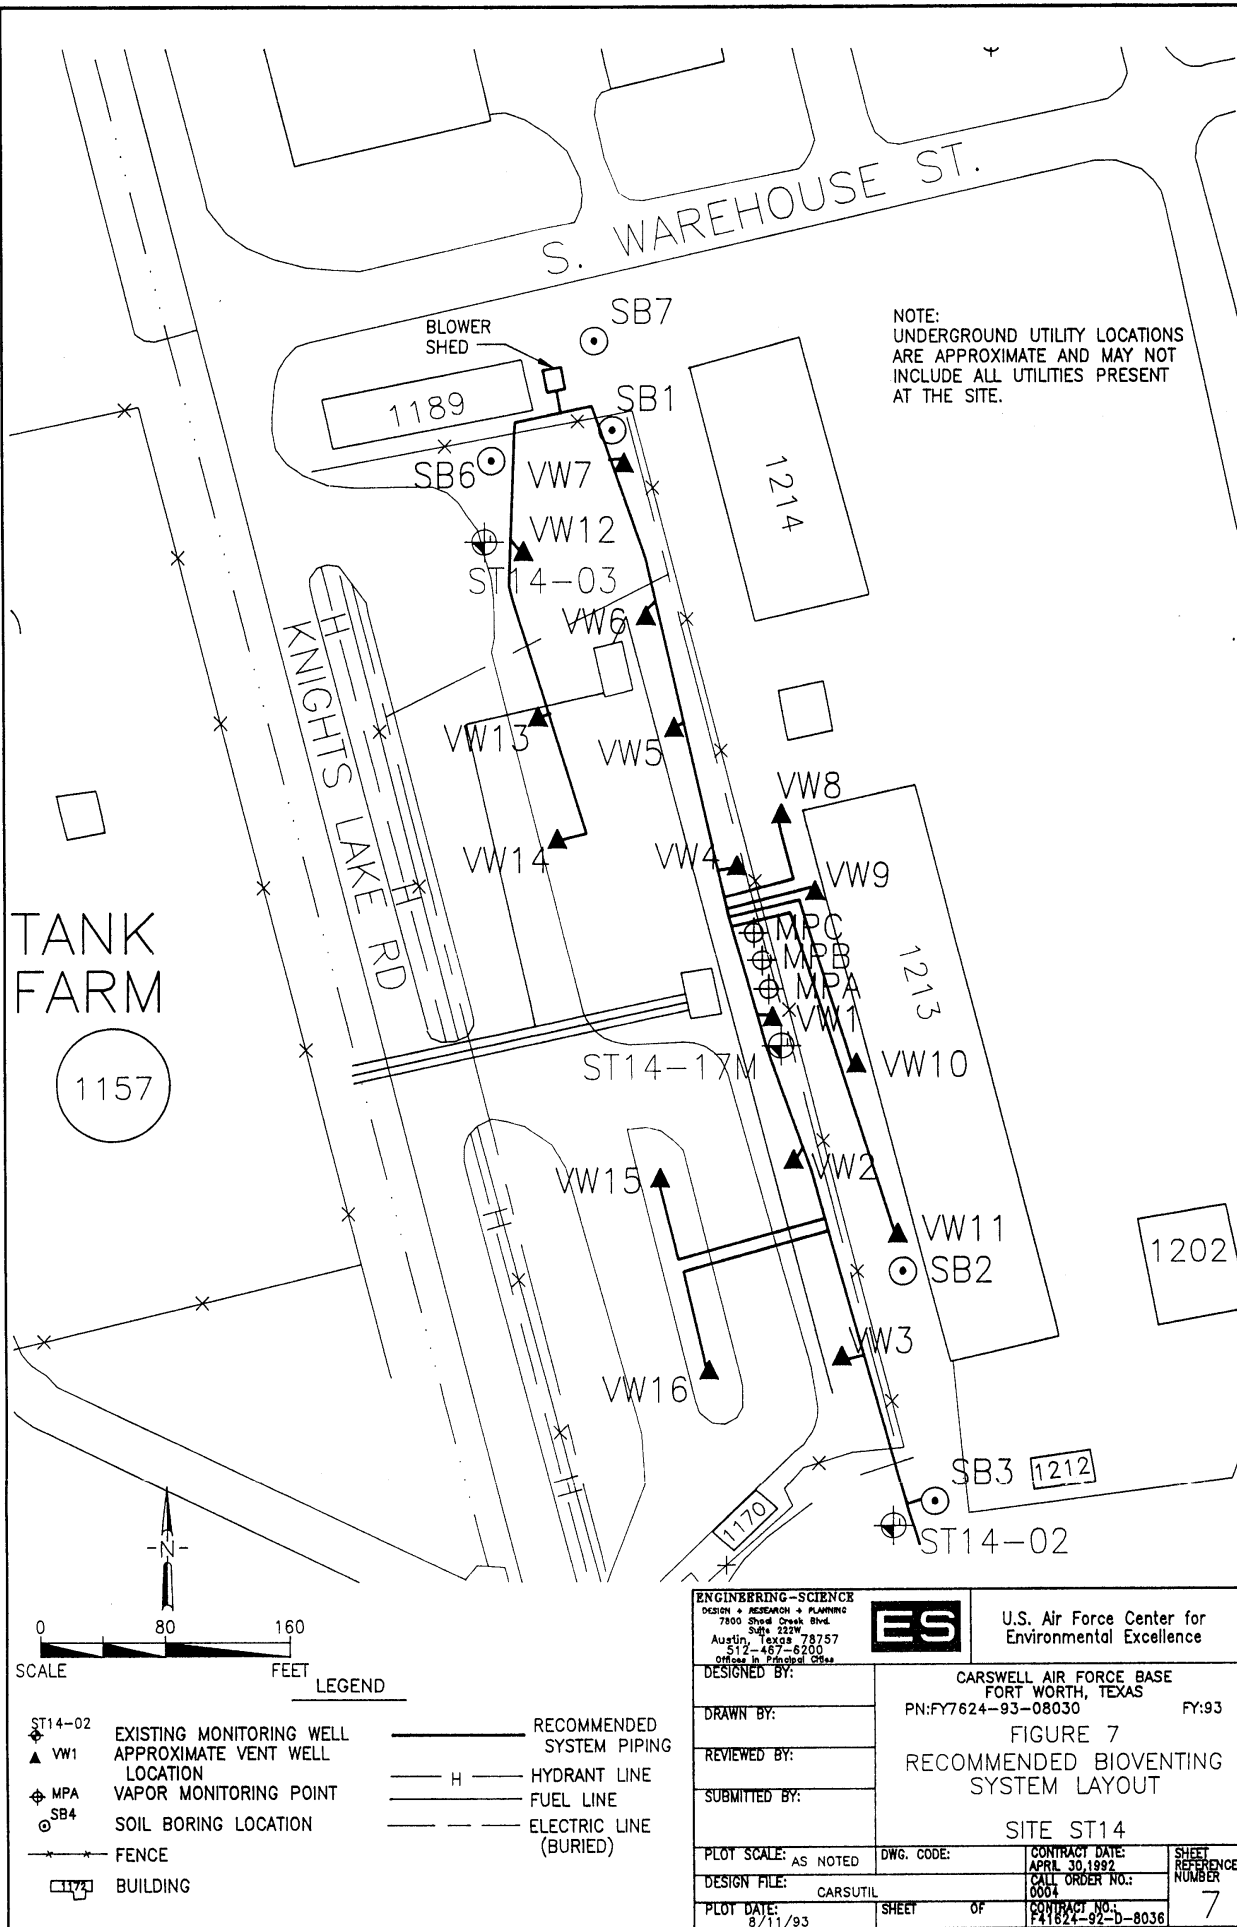
A recommended air delivery system layout is presented in Figure 7. It is recommended that the blower unit be housed in a shed, outside the perimeter fence for ST14, on the northern end of the site. This location allows relatively easy access to the blower shed and does not interfere with normal site activities. A header branches east and west from the outlet of the blower unit and then runs south along the east side of ST14 and south to the vent wells on the northwest end of the site. Lines branch off the header for each vent well. A vent well should be constructed at SB3 as part of this full scale system, and a soil boring should be drilled (for possible conversion to a vent well) between SB3 and SB4. This recommended configuration was developed to minimize the need to cross over underground utilities, and to limit the number of trenches crossing traffic areas.

As discussed in section 3 of this report, an air delivery rate of 15 to 20 acfm at approximately 2 psi yielded a radius of influence in excess of the 45-foot design value used for placement of the vent wells. Considering these test results, the recommended blower for the full-scale system should be capable of delivering up to 20 acfm at 2 psi to each vent well. For the sixteen vent wells in the full scale system, it is recommended that a single blower with a capacity of 320 acfm at 2 psi be installed. Because of the need for low-maintenance equipment in the full-scale system, a regenerative blower is recommended. The blower system should be installed outside explosive hazard areas unless explosion proof equipment is specified.

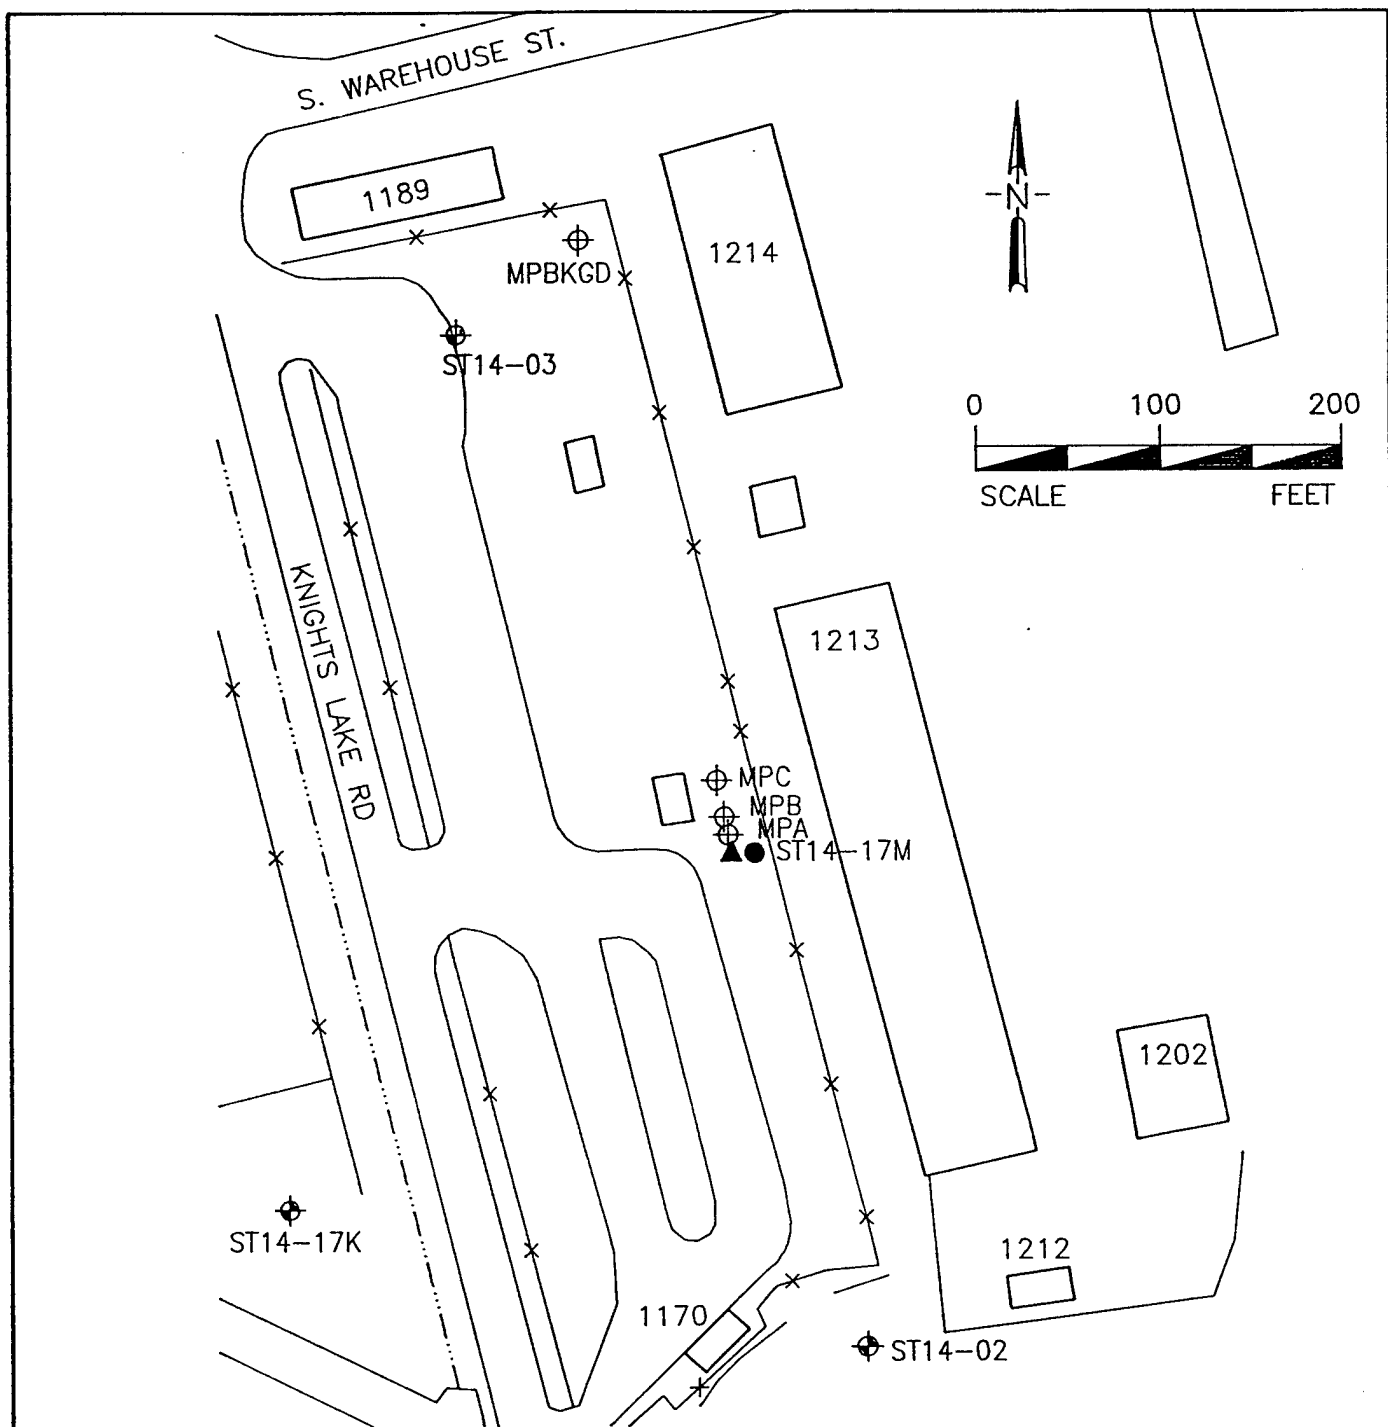
Criteria for siting a central VW and vapor MPs are described in the protocol document (Hinchee et al., 1992). Figure 3.1 illustrates the proposed locations of the central VW and the MPs at this site. The final locations may vary slightly from the proposed locations if significant fuel contamination is not observed in the boring for the VW. Based on existing site investigation data, the central VW should be located

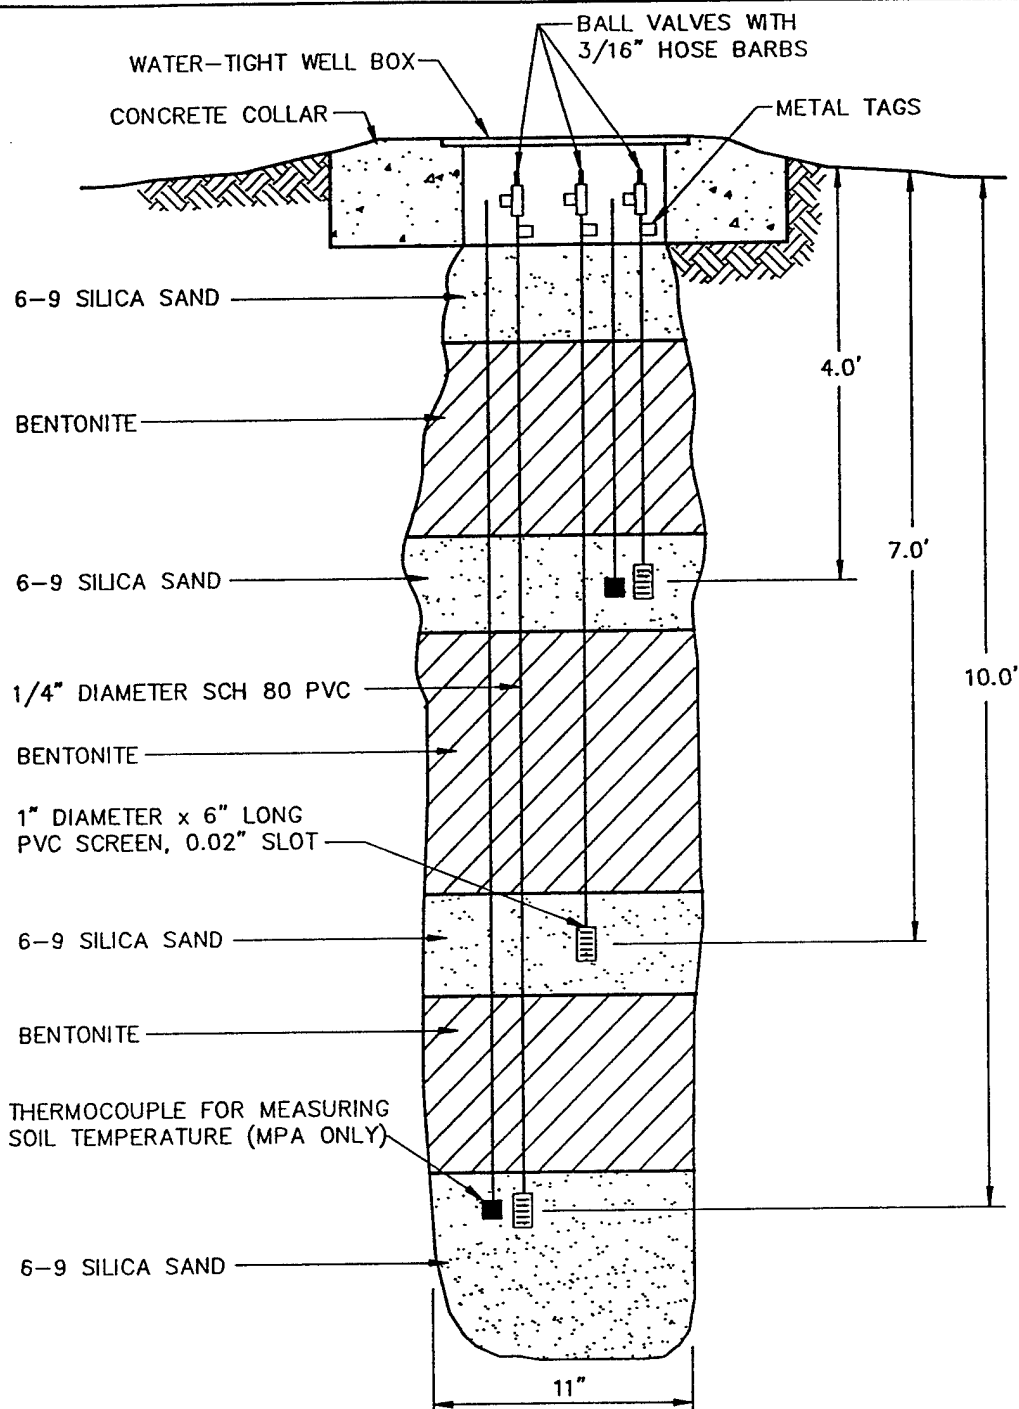
A typical multidepth vapor MP construction for this site is shown in Figure 3.4. Soil gas oxygen and carbon dioxide concentrations will be monitored at depths of 4 feet, 7 feet, and 10 feet at each location. Where the water table is less than 10 feet BGL, only two MPs may be constructed. Multidepth monitoring will confirm that the entire soil profile is receiving oxygen, and will serve to measure fuel biodegradation rates at each depth. The depths or number of monitoring points will be adjusted in the event the water table is encountered at depths shallower than 10 feet, such that the deepest monitoring point screen is a minimum of 1 foot above the water table. The spaces between monitoring intervals will be sealed with bentonite to isolate the intervals. As with the central VW, several inches of hydrated bentonite pellets will be used to shield the filter pack from rapid infiltration of bentonite slurry additions. Soil temperature will be monitored using thermocouples installed at depths of 4 feet and 10 feet BGL in the monitoring point closest to the vent well (MPA). Additional details on VW and MP construction are found in section 4 of the protocol document.

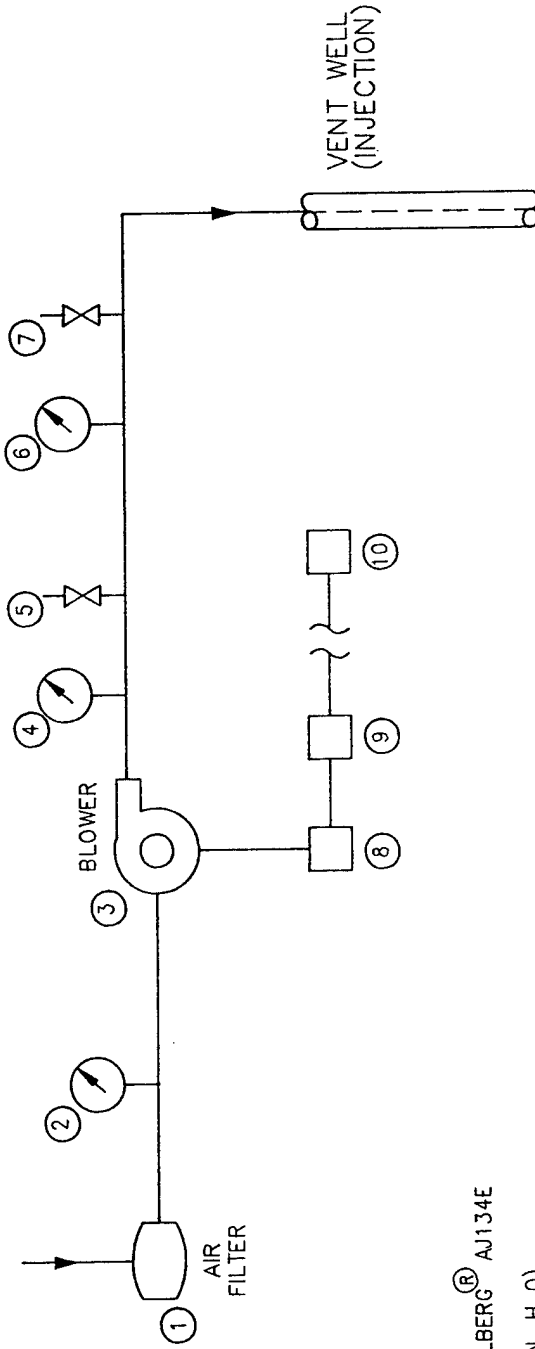
1. INLET AIR FILTER - SOLBERG® AJ134E
2. VACUUM GAUGE (0-60 IN. H<sub>2</sub>O)
3. BLOWER - GAST® 1HP R4110-50
4. PRESSURE GAUGE (0-100 IN H<sub>2</sub>O)
5. AUTOMATIC PRESSURE RELIEF VALVE, SET TO RELEASE AT 58 IN H<sub>2</sub>O PRESSURE
6. TEMPERATURE GAUGE (0-250°F)
7. MANUAL PRESSURE RELIEF (BLEED) VALVE - 1 1/2" GATE
8. STARTER - FURNAS® 14CSD33DA NEMA 3, NO START/STOP, OVERLOAD SET AT 6 AMPS
9. DISCONNECT SWITCH - 240V/SINGLE PHASE/30 AMP, FUSED DISCONNECT (GENERAL DUTY)
10. BREAKER BOX - 30 AMP

During the initial pilot test, a portable 3-horsepower Roots™ 22U-RAI positive-displacement blower unit was used. A 1-horsepower Gast™ R4110-50 regenerative blower unit was installed at site ST14 and connected to the air injection VW for the extended pilot test. The fixed unit is energized by 240-volt, single-phase, 30-amp line power from a newly installed underground power line and aboveground breaker attached to building 1213. The power is provided by the base. The configuration, instrumentation, and specifications for this blower system are shown on Figure 6. The blower is currently transporting air at a flow rate of approximately 15 actual cubic feet per minute (acfm) for the extended pilot test. A portion of this flow is bled off through the gate valve. After blower installation and startup, ES engineers provided base personnel with an operation and maintenance (O&M) manual, including maintenance instructions, equipment specifications, and monitoring forms. A copy of the O&M instructions is in appendix A.

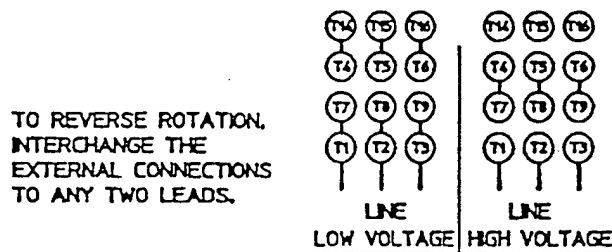
### MOTORS WIRING DIAGRAM FOR R4310P-50

TO REVERSE ROTATION, INTERCHANGE THE EXTERNAL CONNECTIONS TO ANY TWO LEADS.

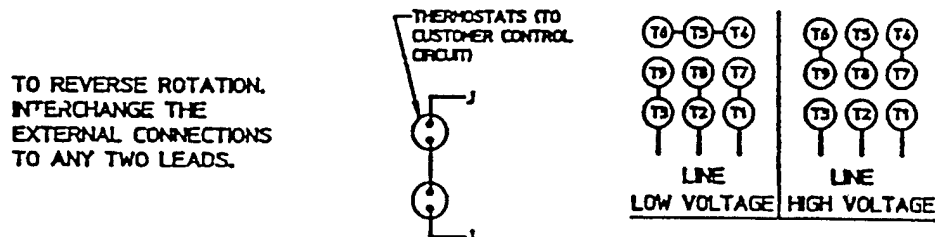
### MOTORS WIRING DIAGRAM FOR R5325R-50, R6350R-50, R6P355R-50, & R7100R-50

TO REVERSE ROTATION, INTERCHANGE THE EXTERNAL CONNECTIONS TO ANY TWO LEADS.

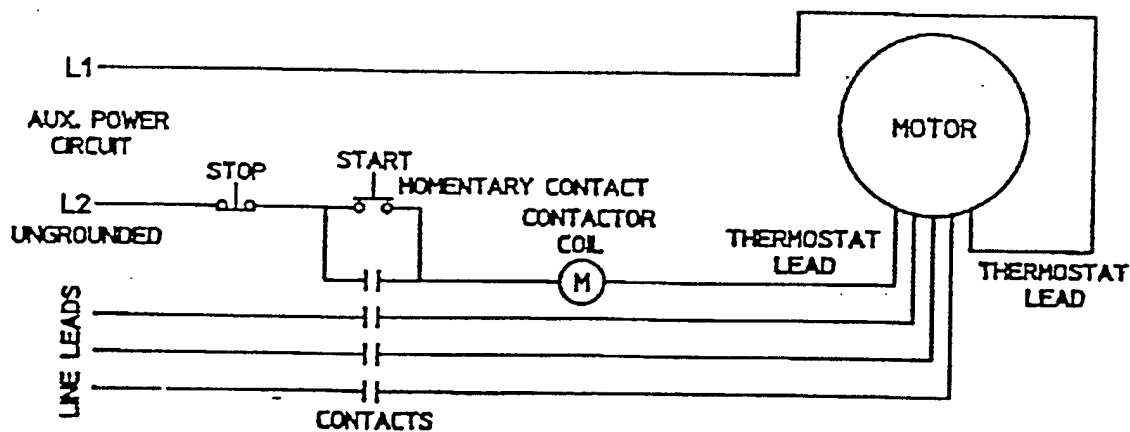
## CONNECTION FOR THERMOSTAT MOTOR PROTECTION

TERMOSTATS TO BE CONNECTED IN SERIES WITH  
CONTROL AS SHOWN. MOTOR FURNISHED WITH  
AUTOMATIC THERMOSTATS RATED A.C. 115-600V. 720VA

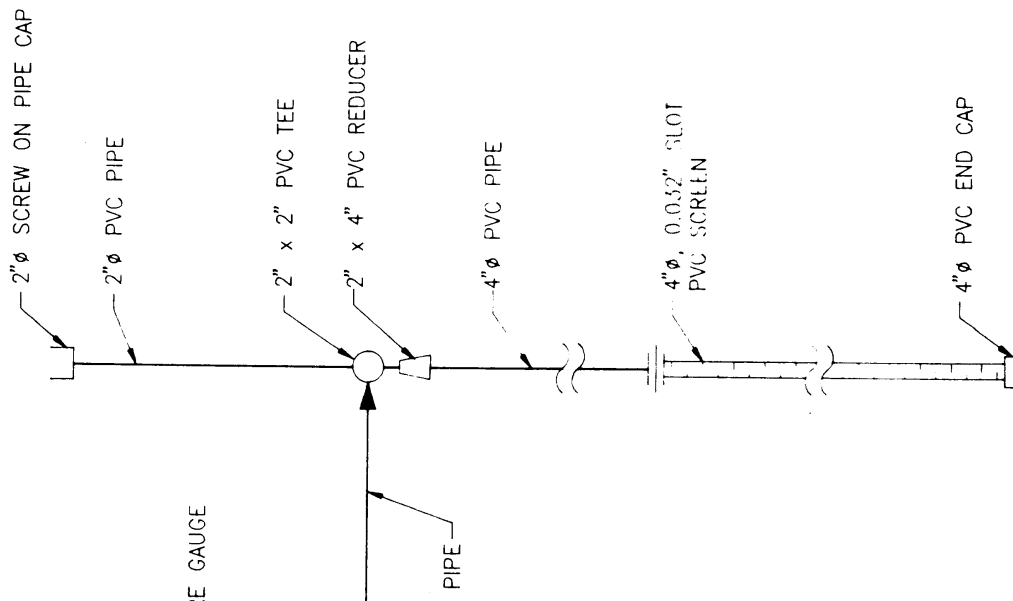
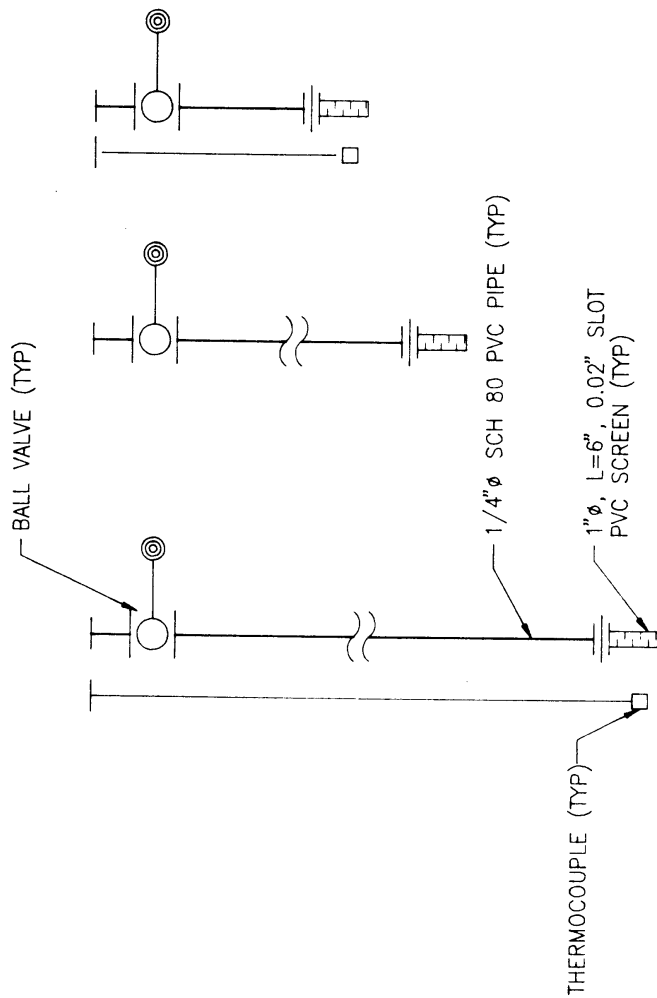
VENT WELL-VW1

# AIR INJECTION AND VENT WELL SYSTEM

MONITORING POINT MPA  
NOT TO SCALE

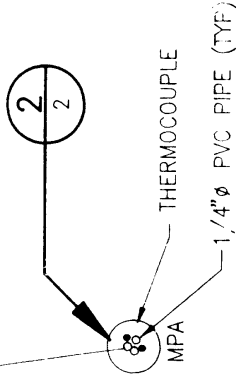
# **BLOWER PLAN**

4' x 3' WOODEN  
BLOWER  
ENCLOSURE

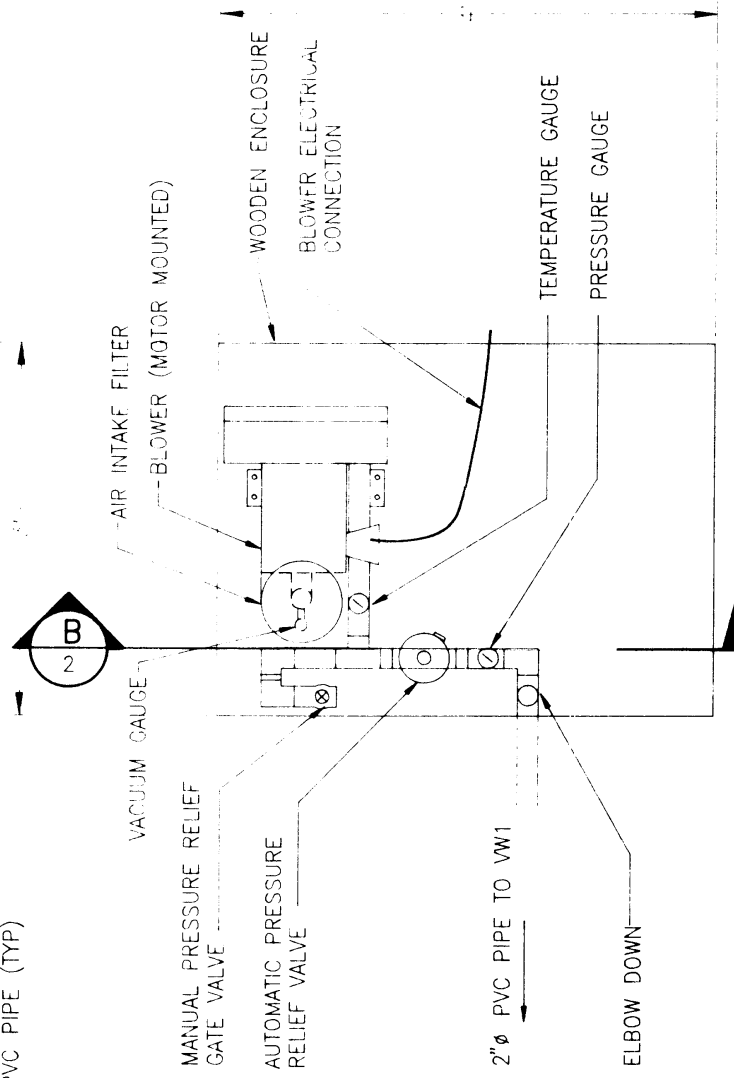
# **BLOWER ASSEMBLY DETAIL**

4-10 SILICA SAND
