1. REPORT DATE (DD-MM-YYYY) 01-12-2000		2. REPORT TYPE Final Technical Report		3. DATES COVERED (From - To) 01-06-1997 to 31-05-2000	
4. TITLE AND SUBTITLE Conducting Polymers for Corrosion Control of Coated Aircraft				5a. CONTRACT NUMBER	
				5b. GRANT NUMBER F49620-97-1-0376	
				5c. PROGRAM ELEMENT NUMBER

Final Technical Report

Study of Electroactive Polymers as Corrosion Inhibitors of Aluminum 2024-T3 and Cold Rolled Steel

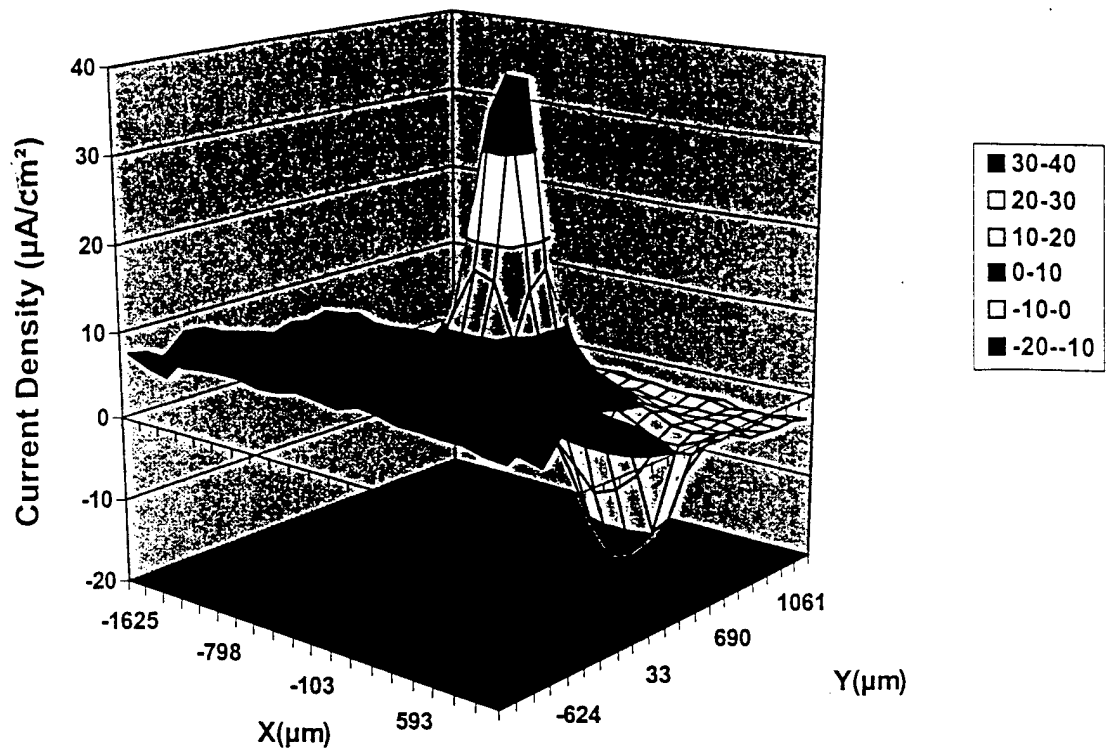
introduced by scribing through the coating to the bare metal surface. The results of these experiments are exemplified by the result for steel shown in Figure 2. Clearly visible in the micrograph of Figure 2 is the 2-mm by 2-mm scan area defined by the Polyester 5 adhesive tape. The defect, which is parallel to the X-axis, is visible within this scan area. From Figure 2, it is clear that the major current flow is from a single anodic site to a single cathodic site, each located within the defect. This confirms that the coating is effectively removed by scribing, exposing the bare metal. In every such control experiment for steel and aluminum, similar behavior was observed, with oxidation and reduction currents confined to the defect. With steel, the onset of corrosion within the defect was very rapid, typically observed in the first scan (i.e., within 5 min.). With aluminum, the onset of corrosion within the defect was somewhat more variable, but was typically observed by the second scan (i.e., within 20 min.). For the steel sample of Figure 2, the current slowly diminished toward zero over the course of approximately 3.5 hours, at which point the leftmost two-thirds of the defect area was covered with corrosion product (Figure 3). The cathodic site remained free of corrosion product throughout the experiment.

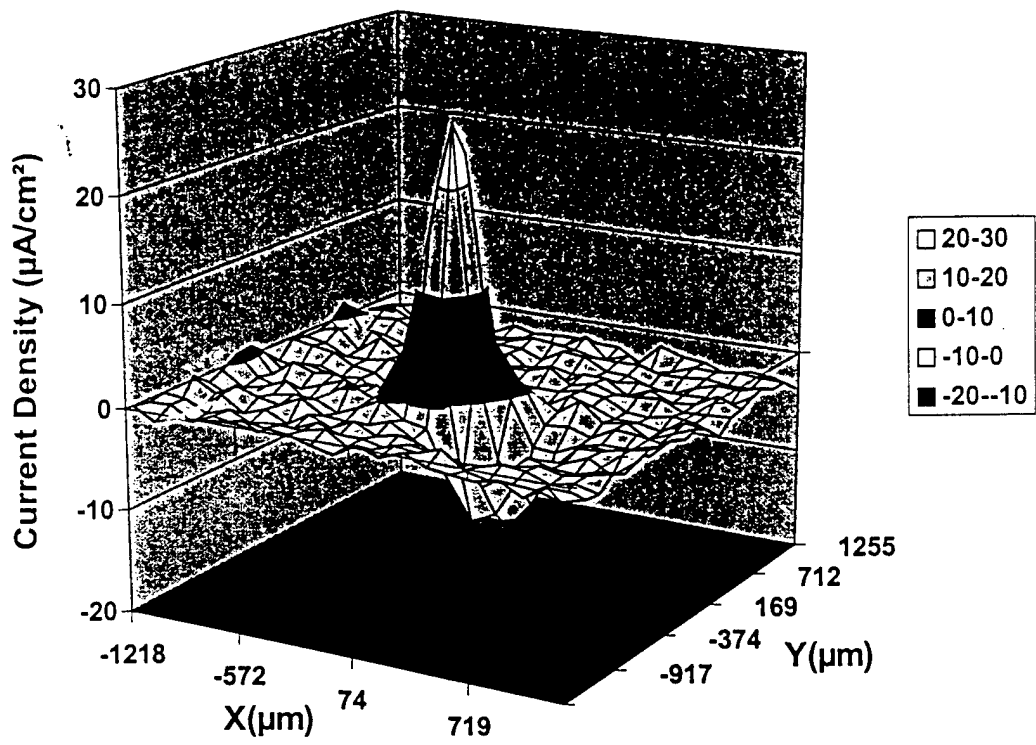
Figure 3

- Figure 3. Current density maps for plain epoxy primer on steel at 192-minutes immersion in 3% NaCl. Top: three-dimensional representation of the z-component of the current density. Bottom: optical micrograph of the sample (current density vectors omitted for clarity). Corrosion product is visible over much of the defect area.

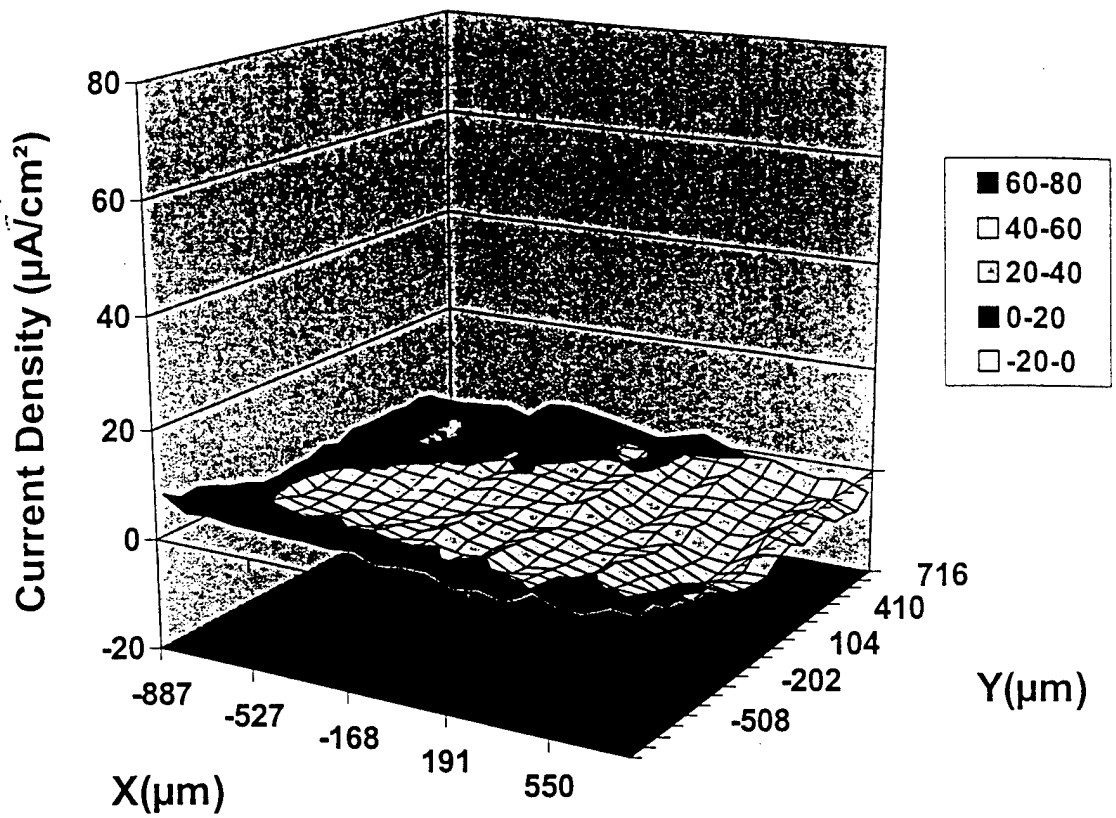
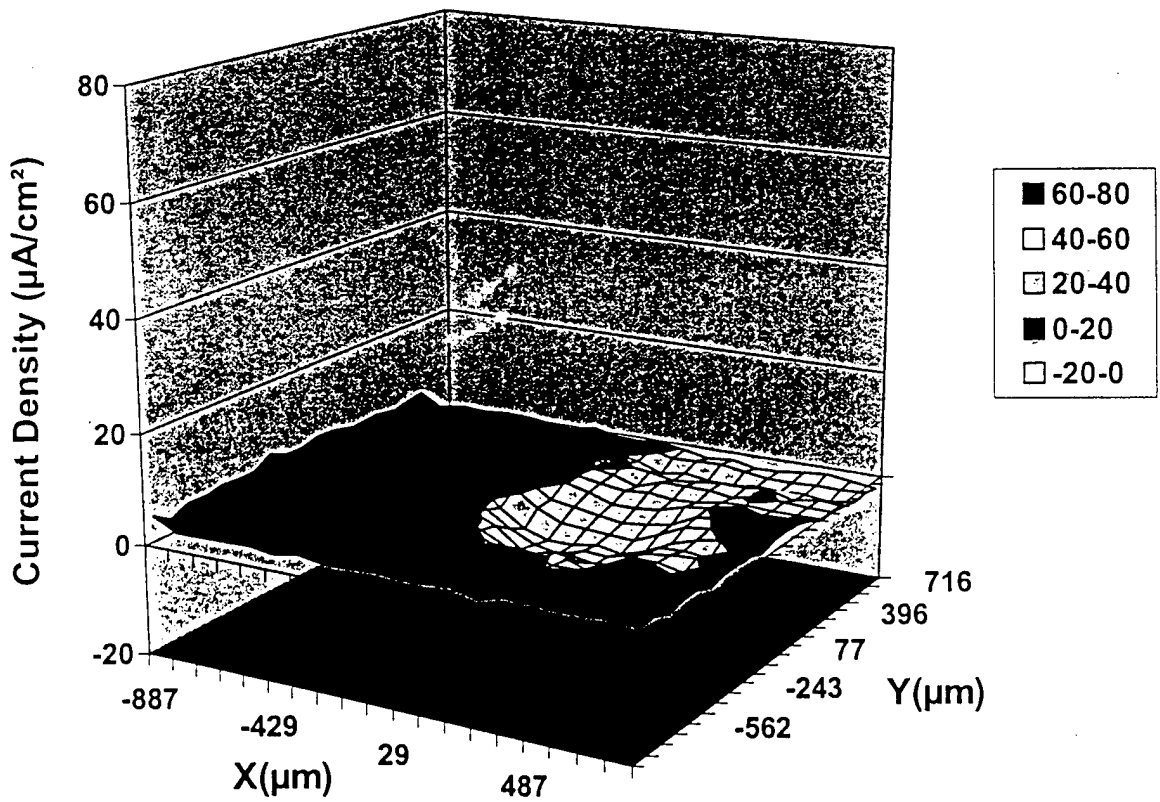
Figure 4 shows a sample after 169-minutes of immersion (the first observable current for this particular sample was at 42-minutes immersion). Oxidation was clearly occurring within the defect and corrosion product is visible at the anodic site in the optical micrograph. However, little if any reduction occurred within the defect. Rather, reduction appeared to occur more or less uniformly across the coating surface. Since the reduction current was spread out over a relatively large area, the current density at any one point was rather small, similar in magnitude to the noise level. Therefore, we repeated this experiment eight times to confirm this general behavior. In every case the surface of the coating was uniformly depressed below zero current (i.e., uniformly cathodic), with little or no reduction current within the defect. With the plain epoxy control experiments, the total anodic current and total cathodic current flowing above the defect were approximately equal. In these chromated-epoxy experiments, the anodic current was always greater. We conclude that reduction in these experiments did indeed occur over the chromated-epoxy coating.

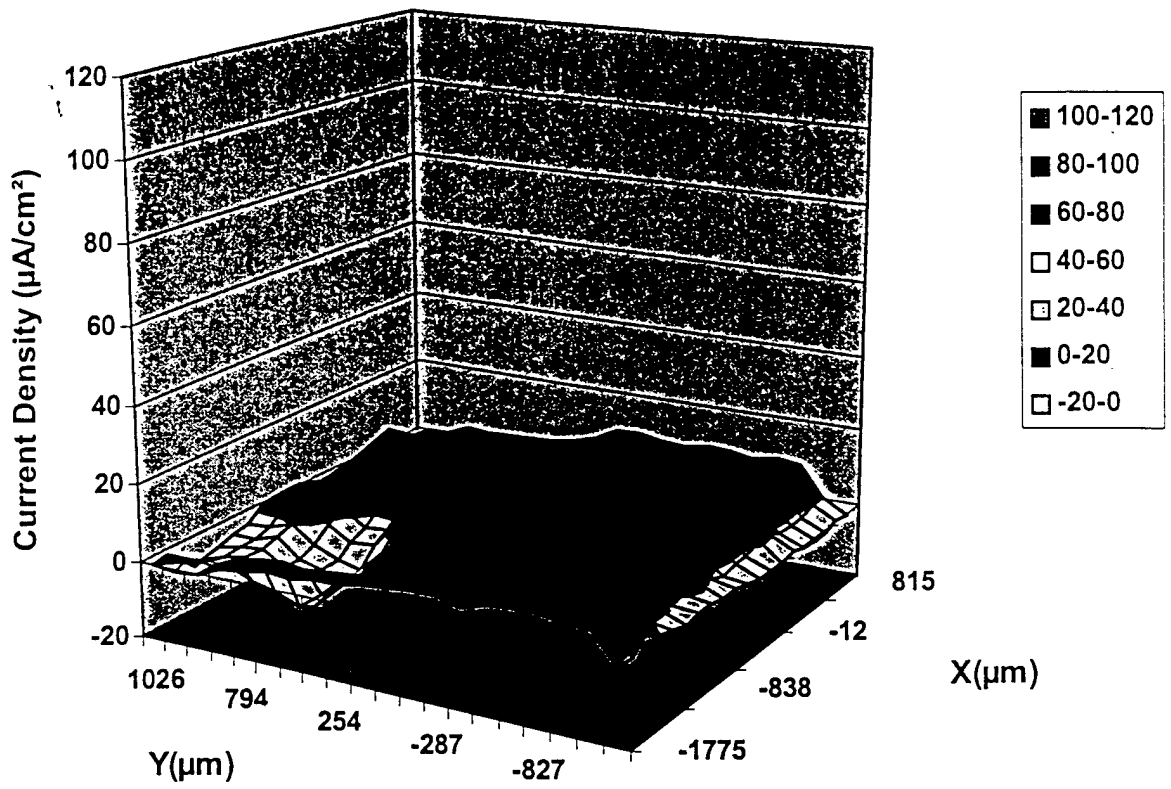
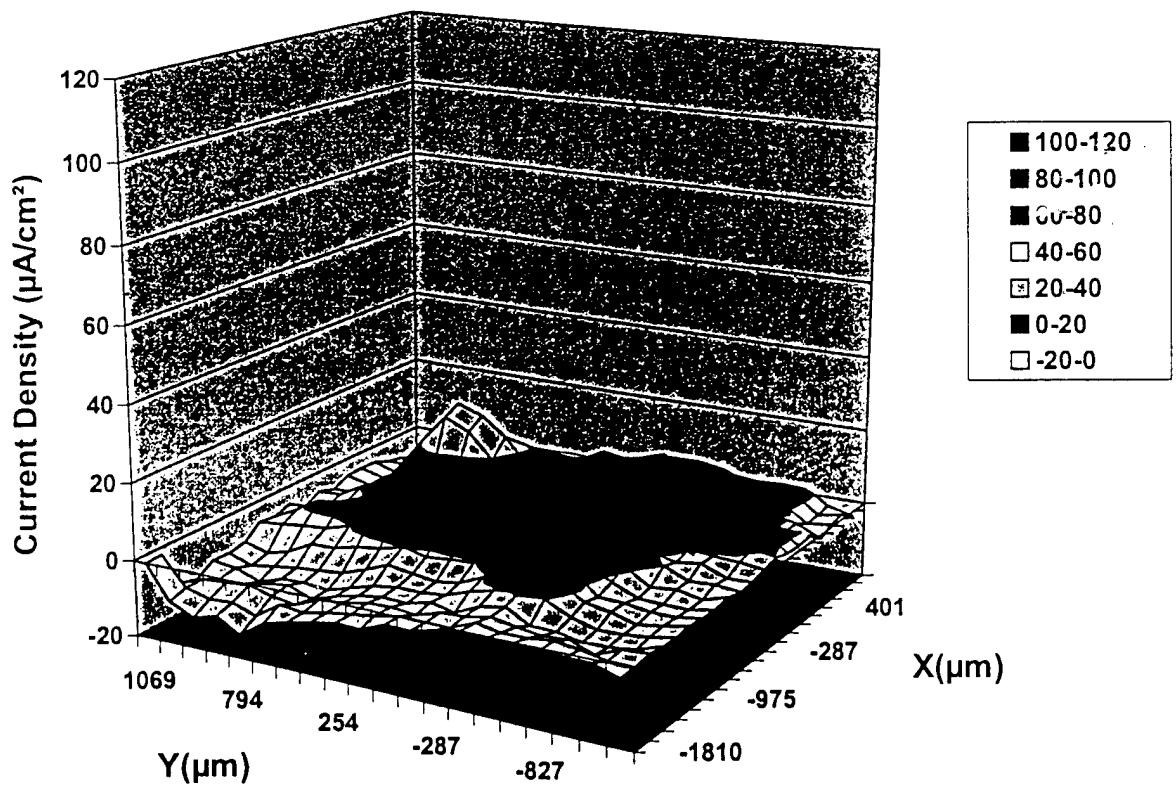
Chromated-Epoxy Primer on Al 2024-T3. The chromated-epoxy primer on Al 2024-T3 alloy, as on steel, significantly retarded the onset of corrosion. Whereas corrosion activity was observed within ca. 20 min. for the plain epoxy control samples, the first detectable current with the chromated-epoxy samples was typically after 5-hours of immersion. The results are exemplified by Figure 5, which shows the current density maps for a particular sample after 5-minutes immersion and after 5.5-hours immersion. The 5-minute map is typical of those obtained over the first 5-hours of immersion, showing no detectable corrosion of the metal exposed in the defect. The exposed metal in the defect remained shiny during this period. The first sign of corrosion is displayed in the 5.5-hour map (Figure 5), with both oxidation and reduction being confined to the defect area. As with the steel samples, this corrosion current continued to increase over the next several hours of immersion, and most of the exposed metal area in the defect turned dark in color. Figure 6 shows the current density maps for the same sample after 17.5-hours immersion, by which time the current had increased substantially but still appeared to be confined to the defect area. Two local cathode sites, one on each side of the anode site, are observed. As noted in the previous section, this behavior is in contrast to that on steel where cathodic currents above the coating were observed. The site of corrosion is clearly visible in Figure 6 as the remaining shiny metal spot in the micrograph.

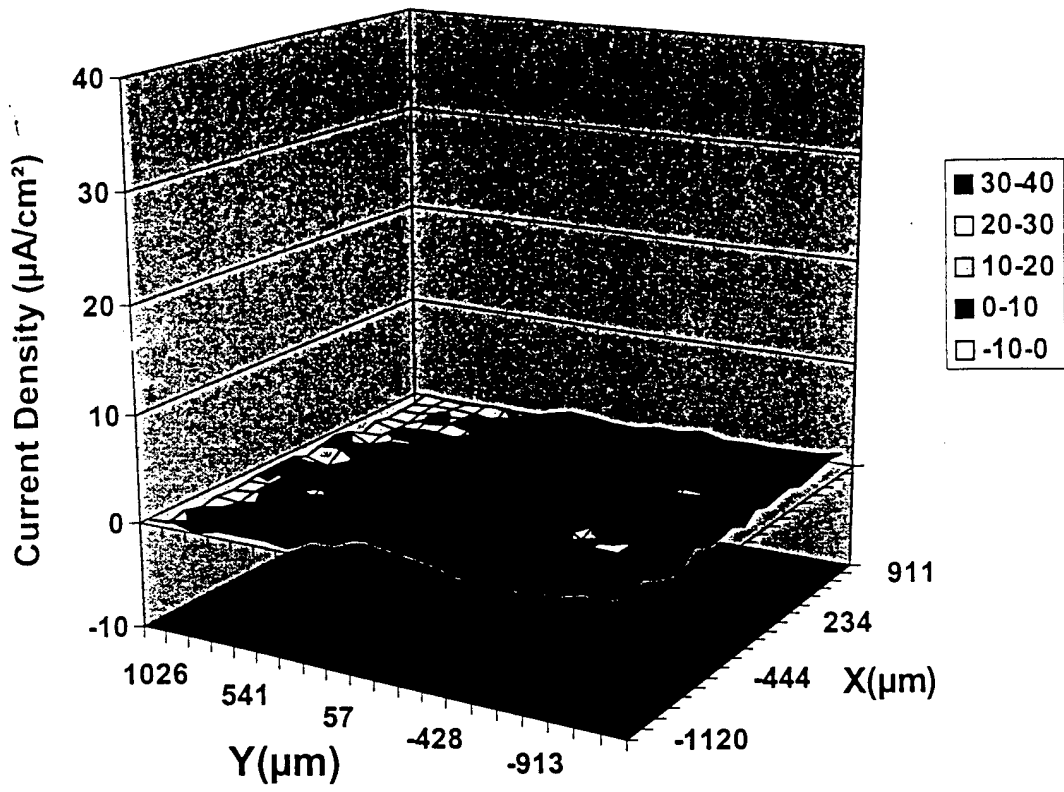
Figure 8

In these experiments, the current associated with the defect is always anodic, with two main anodic sites for this particular sample apparent in the current maps of Figure 8. Significant cathodic current was never observed within the defect. Rather, the cathodic current was always distributed more or less uniformly across the conducting polymer surface, as clearly evident from Figure 8. We postulate that oxygen reduction occurs at the POP/electrolyte interface, with electron transfer from the metal to oxygen being mediated by the POP. This process drives the oxidation reaction observed in the defect, which ultimately leads to passivation of the exposed metal within the defect. Of course, the oxidizing potential of POP may be an important factor in this mediation process. Kinlen³⁸ and coworkers recently reported a similar observation for polyaniline-coated steel where the scanning reference electrode technique revealed localized anodes in pinhole defects and a delocalized cathode spread over the polyaniline surface.

would not be observed by the SVET. The POP coating may mediate the oxidation of the alloy by shuttling electrons from the alloy to oxygen (or other oxidant) at the POP/electrolyte interface, as observed for steel (Figure 8). Indeed, reduction at the POP/electrolyte interface (as well as in the defect) was often observed with the Al alloy (e.g., see Figure 13). However, the mediation of electron transfer by the POP would not explain the absence of oxidation within the defect and the localized undercoating oxidation.

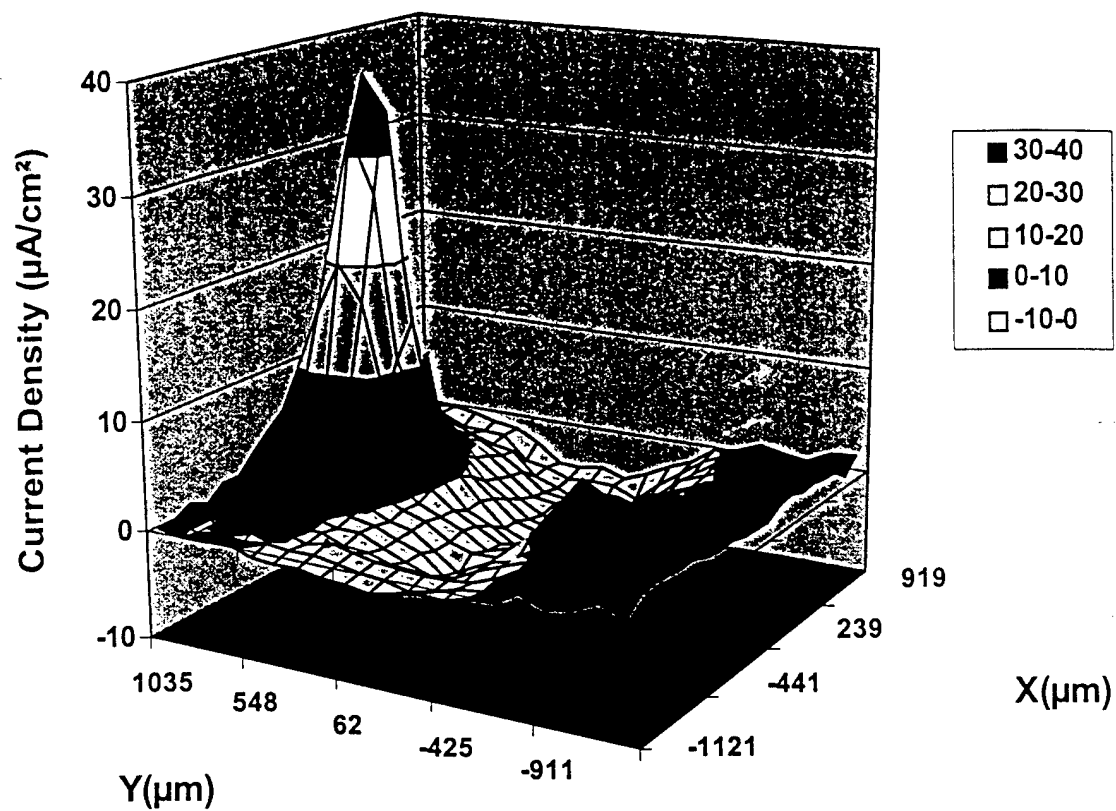
The first significant current flow at this sample was observed after 22-hours, 14-minutes of immersion, shown in Figure 10 (top). However, in contrast to other combinations of coatings and metals we have examined where oxidation always occurred at the defect, the oxidation current in this case appeared to originate at a coated area of the aluminum alloy. The current increased over the next hour during which time the defect area exhibited a rather uniform reduction current (Figure 10). Indeed, from this time of immersion onward, oxidation at the defect was never observed with these samples. The metal within the defect remained shiny throughout the immersion experiment with no visual evidence of corrosion products. To assess the reproducibility of this observation, a total of eight POP-coated samples were examined by the SVET. In every case, the above general behavior was observed, with no significant oxidation occurring at the defect of any of the eight samples. Additionally, there appeared to be no coating defects (e.g., pinholes) that might account for the observed behavior.

The oxidation current observed in Figure 10 continued to increase over the next several hours, reaching the level shown in Figure 11 (top) after 26-hours, 34-minutes immersion. The optical micrograph of Figure 11 (bottom) confirms that the oxidation is occurring at a coated region of the alloy and not at the defect. The current continued to flow for several days, dropping to ca. $20 \mu\text{A}/\text{cm}^2$ after 5 days, at which point the experiment was terminated and the coating removed by dissolving in chloroform followed by acetone.

The oxidation currents observed in Figures 10 and 11 indicate that anions were moving into (or equivalently, cations out of) the POP coating. There are at least two possible explanations for this observation: either the POP coating itself was oxidized or the aluminum alloy beneath the coating was oxidized. An optical micrograph of the Al 2024-T3 surface after removal of the POP coating is shown in Figure 12. The POP coating has been removed from the 2-mm x 2-mm scan area, but not from the surrounding area protected by the Polyester 5 tape. Visible within this scan area is the original defect (the scribe mark). Also visible (and much more apparent under binocular observation) are pits formed in the alloy surface at the site of the oxidation current (compare the micrographs of Figures 11 and 12). Thus, we conclude that the observed oxidation current was due to the oxidation of the aluminum alloy (i.e., pitting corrosion) beneath the POP coating.

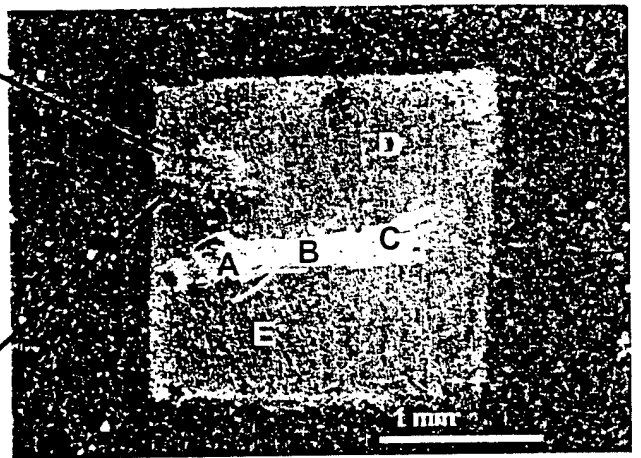
Figure 14 shows scanning electron micrographs of the sample of Figure 13. Seven regions are labeled on the micrographs: A, B and C in the scribe area; D and E in defect-free regions; and F and G in the pit area. The copper content of each of these regions is reported in Table 1. The "mass effect" may render these analytical results semi-quantitative at best,⁶⁵ and the actual Cu content in the Cu rich regions may be higher than that reported in Table 1. It is clear from these results that the site where the pitting occurred is a Cu-rich site, containing well above the 4% to 5% average Cu content expected for this alloy.

While we cannot assign a specific phase to the Cu-rich regions F and G, the most common such phase for this alloy is reported to be the S phase particles (Al_2CuMg), comprising approximately 60% of particles greater than 0.5 to 0.7 μm and covering approximately 2.7% of the alloy surface.⁶⁶ Furthermore, S phase particles are active relative to the aluminum matrix phase and are reported to undergo partial dissolution by dealloying.⁶⁶ Such active regions are likely candidates for the site of oxidation observed in the SVET experiments. The Cu content of S phase particles is ca. 45% and increases as a result of dealloying.⁶⁶ Our observation of only ca. 20% Cu in regions F and G suggests that Cu is preferentially removed from these particles, perhaps a consequence of its ability to complex with the conducting polymer as noted above.

Region	A	B	C	D	E	F	G
Cu (wt.%)	5.6	8.5	11.2	4.0	5.2	20.5	20.7

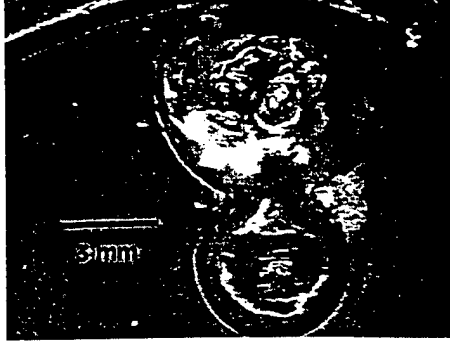
Figures 16a, 16b, and 16c

Optical micrograph of Polyurethane/Cr-Epoxy/Al 2024-T3

Optical micrograph of Polyurethane/POP/Al 2024-T3

Optical micrograph of Polyurethane/PODP/Al 2024-T3

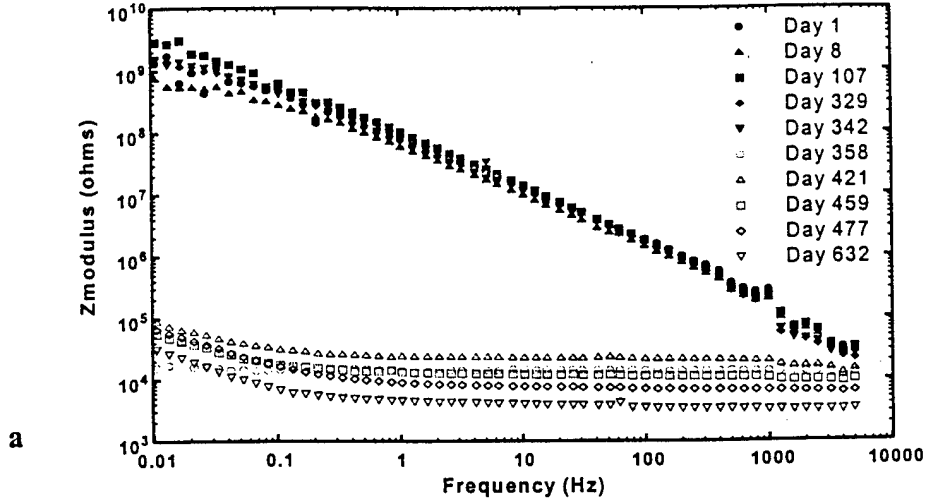
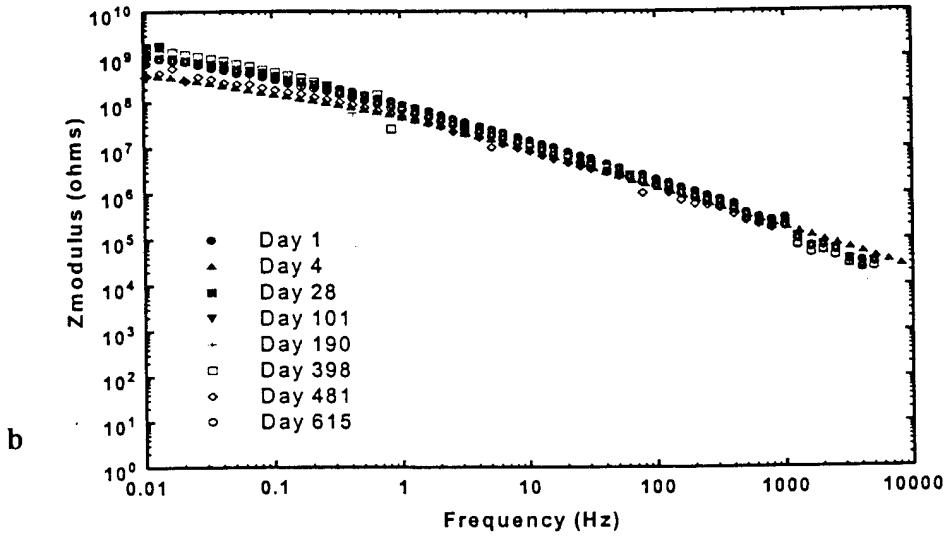
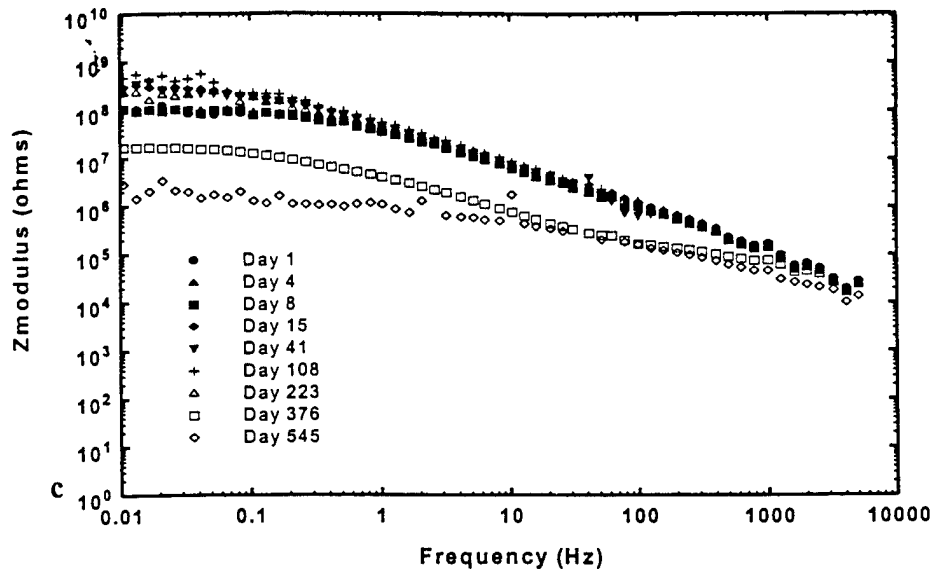
Figures 17a and 17b

In addition to visual changes, electrochemical changes were evident by the impedance spectra shown in Figure 17. In Figure 17a, it can be seen that the Polyurethane/Cr-Epoxy/Al 2024-T3 sample had a high impedance at the start of immersion (greater than 10^9 Ohms). Although initially stable, the sample showed drastic failure at 358 days. At the time of failure rather large blisters, over 3 mm in diameter, were evident (Figure 16a). The rapid growth and/or rupture of this blister may be responsible for such a drastic drop in impedance. The Polyurethane/POP/Al 2024-T3 sample continued to maintain the initial impedance value (Figure 17b) and the Polyurethane/PODP/Al 2024-T3 sample started to show signs of failure, with the impedance decreasing at day 376 to a value of 10^7 (Figure 17c). The visual appearances of the samples shown in Figure 16 support the EIS results of Figure 17, with the sample exhibiting the smallest visual change (the polyurethane/POP/Al 2024-T3) also displaying the smallest decrease in impedance.

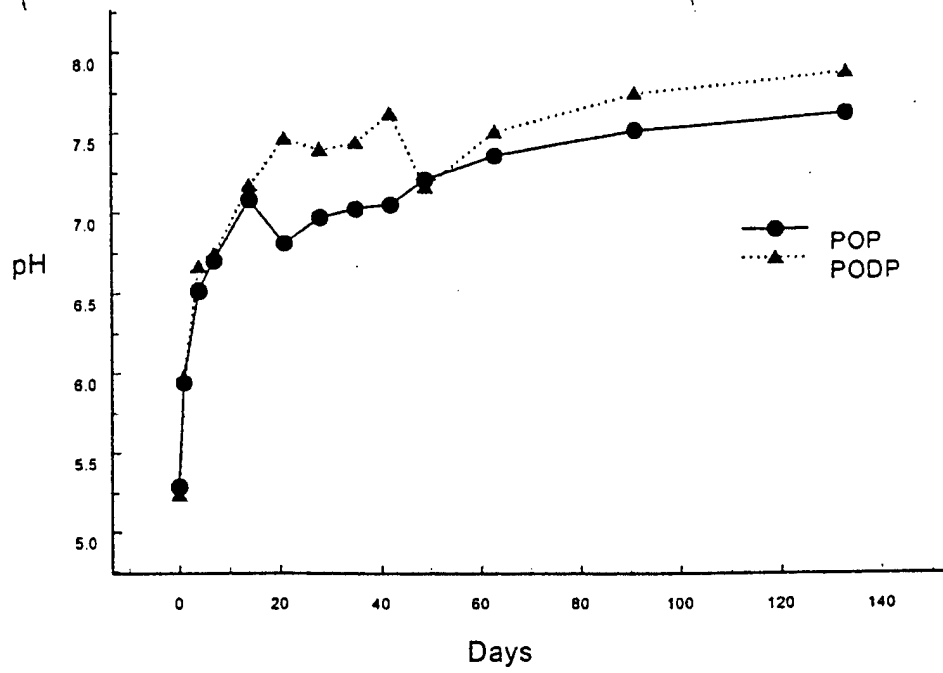
Figure 20

pH Changes During Immersion in DHS. The pH changes of the immersion electrolyte solution were monitored during the ENM experiments. It can be seen (Figure 20) that the general trend is an increase in pH during immersion time. It is interesting to note that the increase in pH found in this present study is in direct opposition of the results reported for polyaniline.¹⁸ It is proposed that the increase in pH seen in this study is due to aluminum hydroxide that is the corrosion product of the aluminum alloy 2024-T3. Aluminum hydroxide is slightly soluble in water, and thus increases the pH of the immersion solution. The decrease in pH for polyaniline reported elsewhere is attributed to the dedoping of the polyaniline, thus releasing H^+ into the immersion electrolyte.
