ERDC/CERL TR-01-6

## **Demonstration of Anti-Scale Corrosion Resistant Coatings for Hot Water Heat Exchangers**

Vincent F. Hock, Henry Cardenas, Richard H. Knoll,  
and Virginia Hall

January 2001

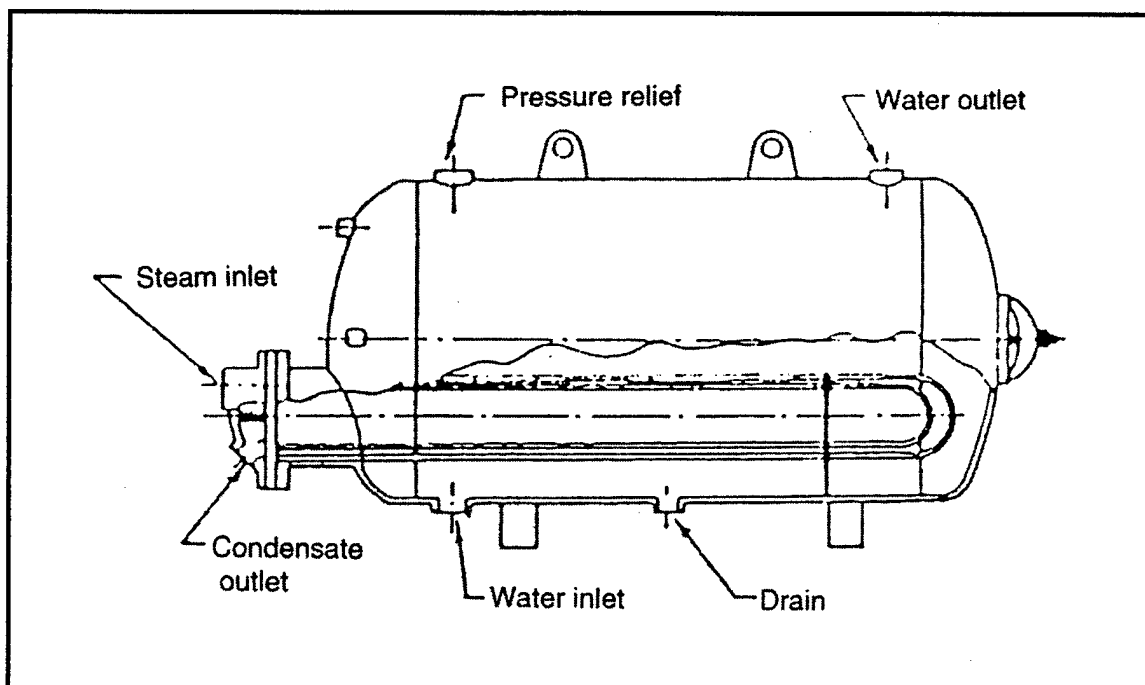
A heat exchanger system commonly used in the Army is the domestic water storage heater (DWSH) (Figure 1). The system is composed of a cylindrical steel reservoir lined with concrete for corrosion protection. A water inlet at the bottom provides access to a U-tube bundle assembly. At Fort Hood, this assembly is 71.5 in. long and has 13 individual tubes of copper alloy with a surface area of 29.7 sq ft. By sustaining a large hot water reservoir, the system can provide sufficient hot water during the times of peak demand. Typical facilities that use these systems are dining halls, barracks, and laundries.

Figure 1. Domestic hot water storage heater.

Steam or hot water is circulated through the interior of the tube bundles. Heat is transferred from the steam through the copper pipe wall and into the domestic water medium. The domestic water enters the reservoir at one end beneath the U-tube assembly and exits at the top. This path provides the greatest amount of thermal exposure to maximize heat transfer. Under normal conditions at Fort Hood, the inlet waters at buildings (Bldg.) 29006 and 87017 enter the respective reservoirs at 60 to 70 °F and exit the top at 140 to 160 °F.

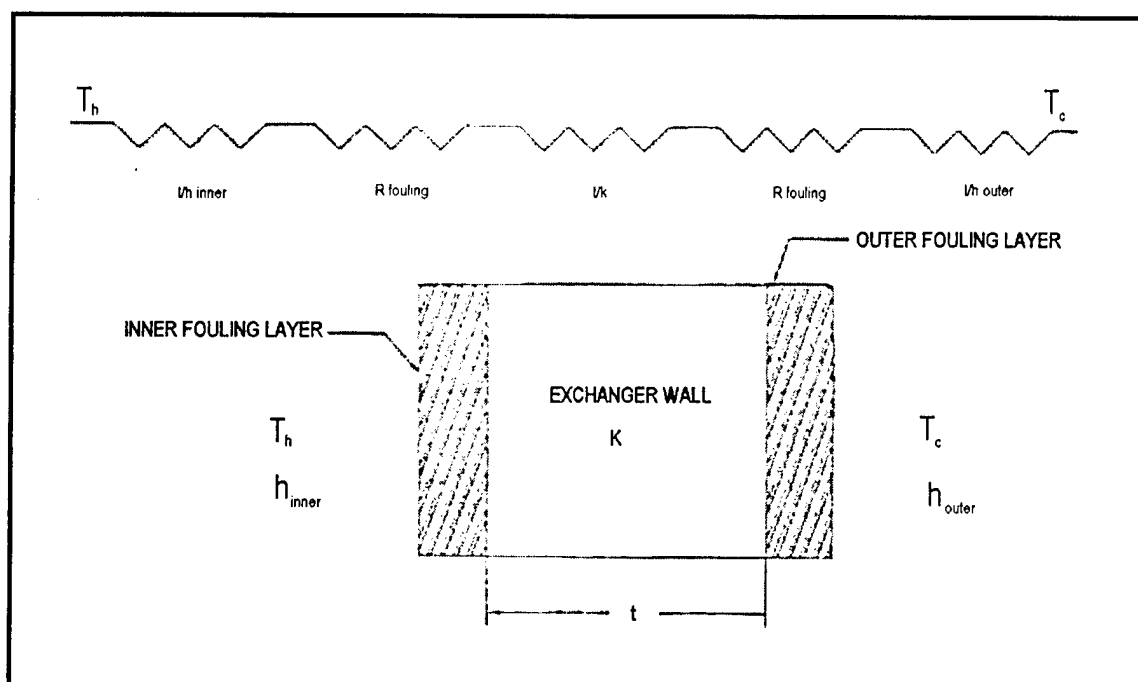
Using these factors, it is possible to construct an overall expression of resistance to heat flow in the heat exchanger. It is important to note that heat flow resistance contributed by a coating would take a form similar to that of the fouling-induced resistances  $R_{f,h}$  and  $R_{f,c}$ .

Figure 2. Thermal barriers on heat exchanger tube.

- $h_h$  = convective heat transfer coefficient on the hot side of the copper tube
- $R_{f,h}$  = fouling factor on the hot side of the copper tube
- $t$  = thickness of the copper tube wall
- $k$  = thermal conductivity of the solid barrier
- $R_{f,c}$  = fouling factor on the cold side of the copper tube
- $h_c$  = convective heat transfer coefficient on the cold side of the solid barrier.

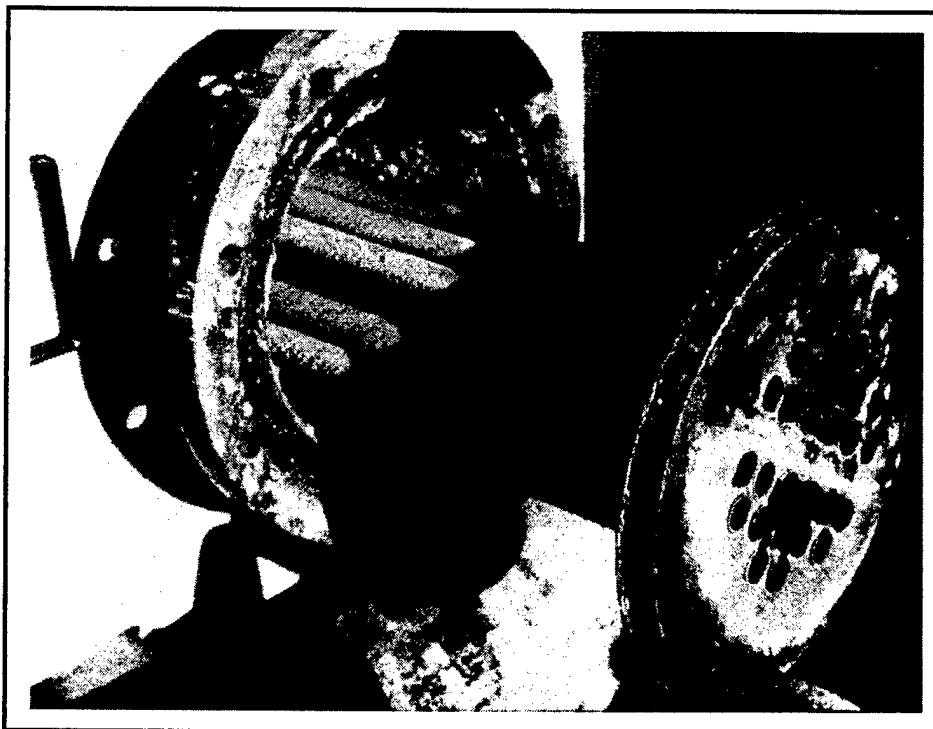
In March 1986, Fort Hood, TX, personnel reported continuing problems with scale forming on the surfaces of copper tube bundles in domestic hot water heaters. During a May 1986 site visit, investigators examined a water storage heater located in a dining facility (Building 29006). The cement-lined tank has a capacity of 2115 gal. Typical daily hot water use is 11,000 gal. Recurrent difficulties were reported in sustaining the dining hall hot water supply above the required 140 °F. When the heat exchanger tube bundles were removed they appeared as shown in Figure 3.

Figure 3. Scaled heat exchanger tube bundle, Fort Hood, TX.

The tube bundle assembly is made of copper and measures 71.5 in. long with a total surface area of 29.7 sq ft. Each of the 13 tubes has an outside diameter of 3/4 in. A 0.07-in. deposit, comprised primarily of calcium carbonate, coated the exterior or water side surfaces of the tubes. The 12 psi steam supply that runs through the tubes is generally adequate for generating the 140 °F service water temperature. However, the presence of the scale layer significantly diminishes the overall heat transfer coefficient of the system. Examination of maintenance records revealed that this heat exchanger had gone 4 months since the last cleaning.

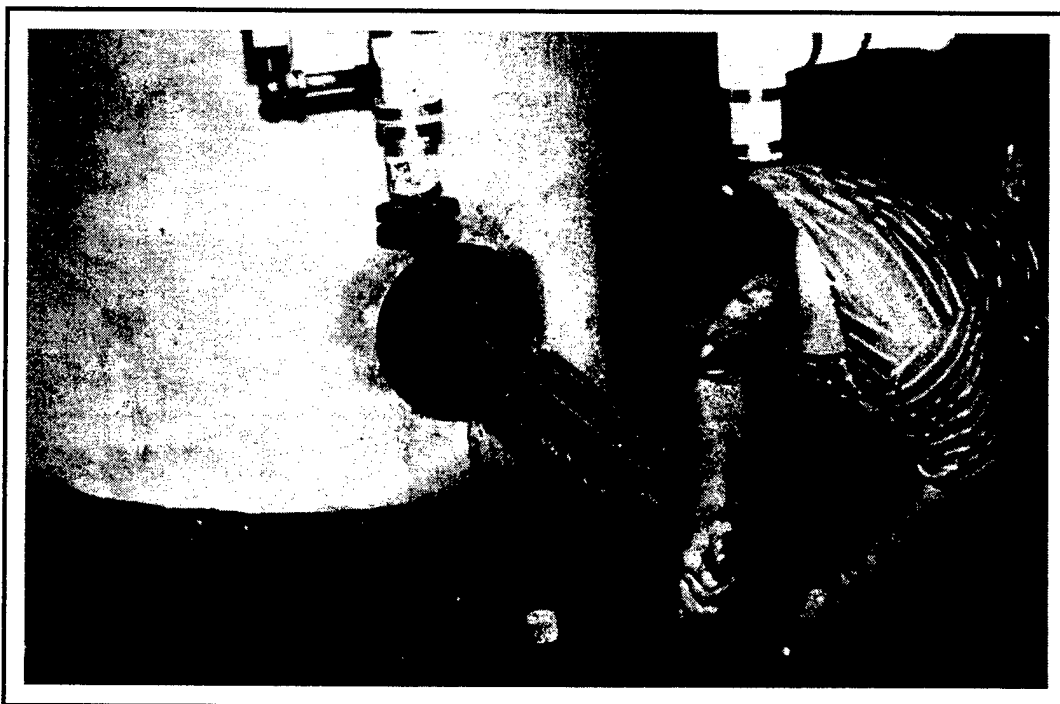
Figure 4. Removal of tube bundle, Bldg D-2248, Fort Bragg, NC.

The heating medium is high temperature hot water at 375 to 385 °F, which flows through the tube bundle and heats the domestic water in the tank to approximately 130 °F. The tube bundles had been in service for approximately 17 yr, and their waterside surfaces were covered with a brownish-colored scale deposit with thicknesses up to 0.14 in. Subsequent energy dispersive spectroscopy and microchemical analysis revealed that the deposit was comprised of calcium carbonate, hydrated hematite ("red rust"), and products containing phosphorus. The source of the hematite was most likely the corrosion of ferrous-based materials upstream from the heaters. This is understandable since the water at Fort Bragg is relatively corrosive. The deposit immediately adjacent to the bundle surface also contained aluminum, zinc, and copper. It is possible that the sources of the phosphorus and aluminum were chemicals used to treat the river water supply.

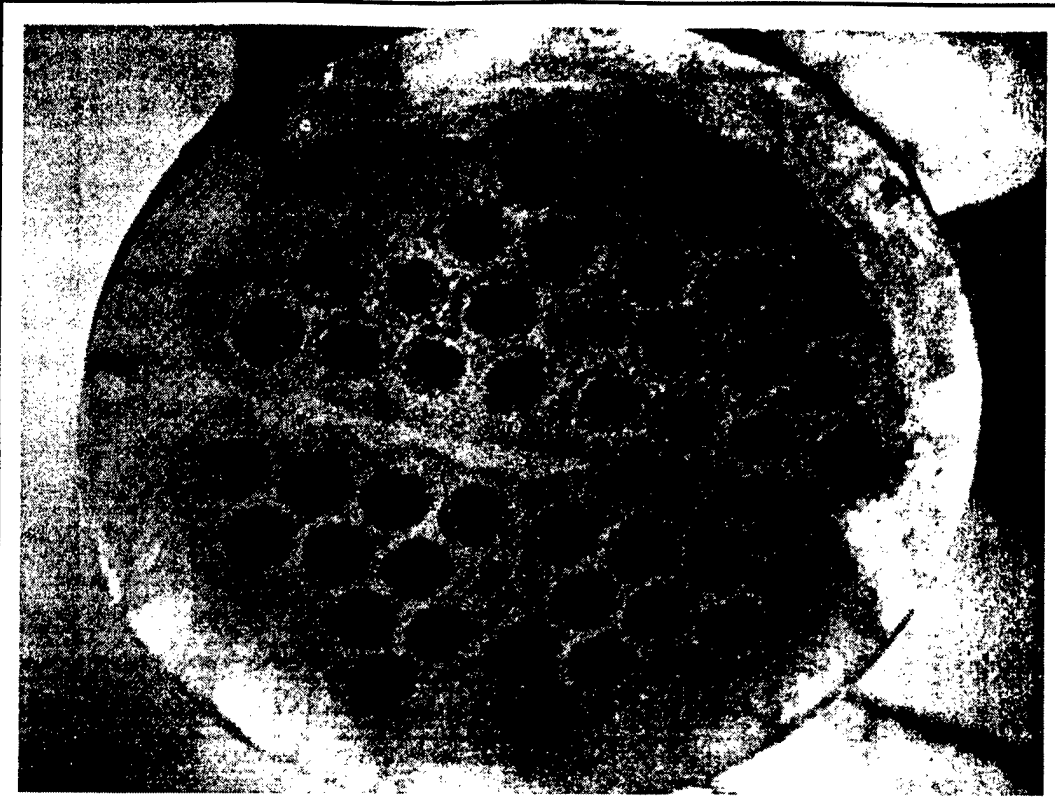
During the June 1987 site survey, two of the hot water storage tanks were drained and the tube bundles were pulled out for observation. One of the exchangers was located in Building 3281, a dining hall. The heating fluid is high temperature (220 to 240 °F) hot water. The incoming cold water is heated to approximately 150 to 170 °F. It was observed that a loosely adherent, reddish brown deposit was present on the tube bundle, mostly near the tube sheet (evident in Figure 5). Erosion of the ends of the tubes in the bundle was observed (Figure 6).

Figure 6. Erosion of tube bundle, Fort Lewis, WA.

According to Fort Lewis personnel, erosion corrosion as described above commonly occurs immediately in front of the tube sheet or at the U-bend in the tube bundle. In a new tube bundle, the tubes extend about 1/8 in. beyond the tube sheet. Some of the ends of the tubes are flared. At Fort Lewis, this part of the tube erodes away by the water, eventually causing a leak in the vicinity of the tube sheet. The leaks are usually repaired with brass plugs and the bundle is returned to service, but eventually the leaking becomes so severe that the bundle must be replaced. According to Fort Lewis personnel, the average life of a heat exchanger tube bundle at Fort Lewis is 3 to 5 yr.

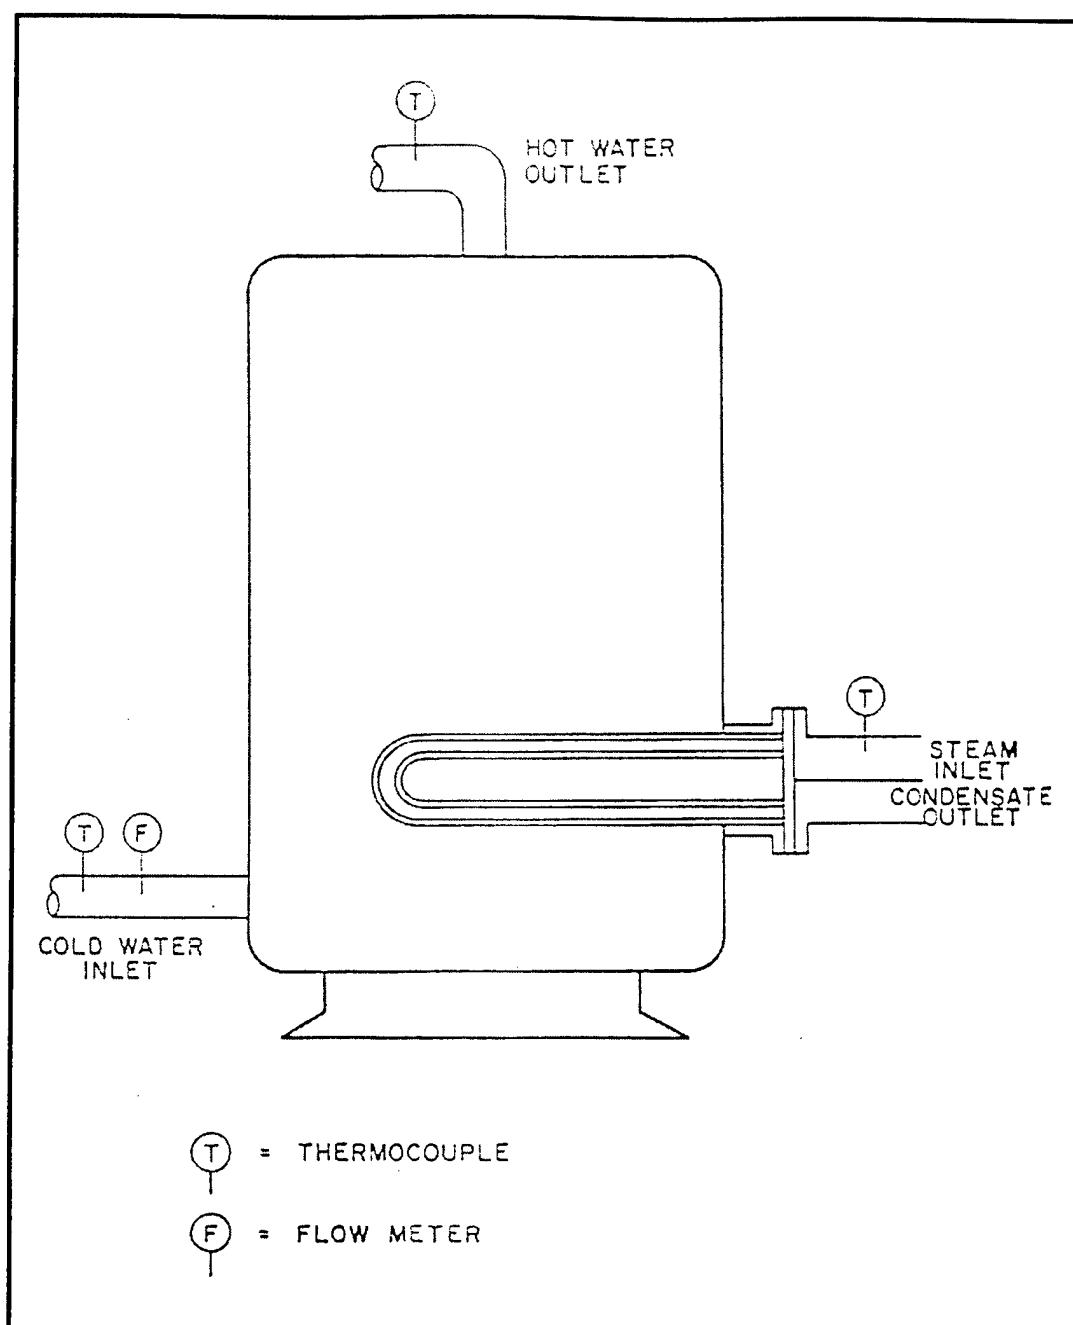
Figure 7. Placement of sensors on heat exchangers.

Because the performance of a heat exchanger may be characterized by the overall heat transfer coefficient ( $U$ ), the presence of corrosion or scale on a tube surface would cause a reduction in  $U$  and hinder the delivery of heat. Over time, the amount of tube fouling renders the heat exchanger unable to deliver hot water at the required temperature despite maintaining a constant full flow of steam or high temperature hot water. Under these circumstances the evaluation of the heat exchanger performance can be conducted by installing a thermocouple at the hot water outlet (as shown in Figure 7) and monitoring the hot water exit ( $T_h$ ) values. In this case, data was collected continuously on a data logger and downloaded to disk once a month for analysis.

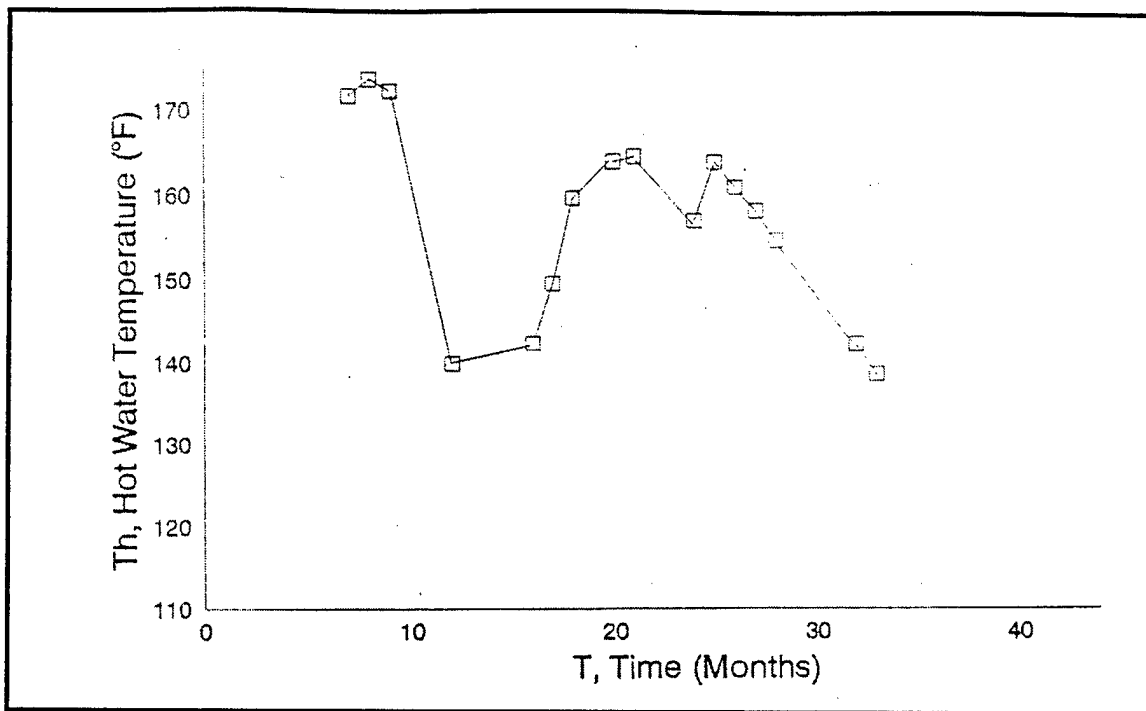
Figures 8 and 9 show field measurements for the hot outlet water temperatures. The data is plotted as monthly averages occurring over a 48-month period starting in May 1988 and ending in May 1992. The average monthly hot water temperature was maintained between 137 and 170 F for Buildings 29006 and 87017 over a 48-month period. Neither of these figures appears to reveal any trend of degradation. However, note that the heat exchanger was removed from Building 29006 on 28 April 1992 to rehabilitate the coating that had failed due to spalling after 4.5 yr of an estimated 5-yr service life.

Figure 8. Hot outlet water temperatures for phenolic-coated heat exchanger, Bldg 29006, Fort Hood, TX.

Completely absent from the hot water outlet patterns (as shown in Figures 8 to 11) of either site is any indication of a negative sloping trend among the hot water delivery values. Additionally, the average hot water temperature was maintained at 140 °F at Fort Hood, and above 147 °F at Fort Lewis. Similarly, the personnel at Fort Bragg have experienced no difficulty in maintaining the 140 °F required hot water temperature. These observations indicate that the scale has not formed on the coated tube bundles at Fort Hood and Fort Bragg and the corrosion fouling did not form on the tube bundles at Fort Lewis. For Fort Hood Building 87017 in particular, this finding means that a 90-day cycle of acid cleaning may be replaced by a one-time fix that has provided over 4 yr of satisfactory performance.

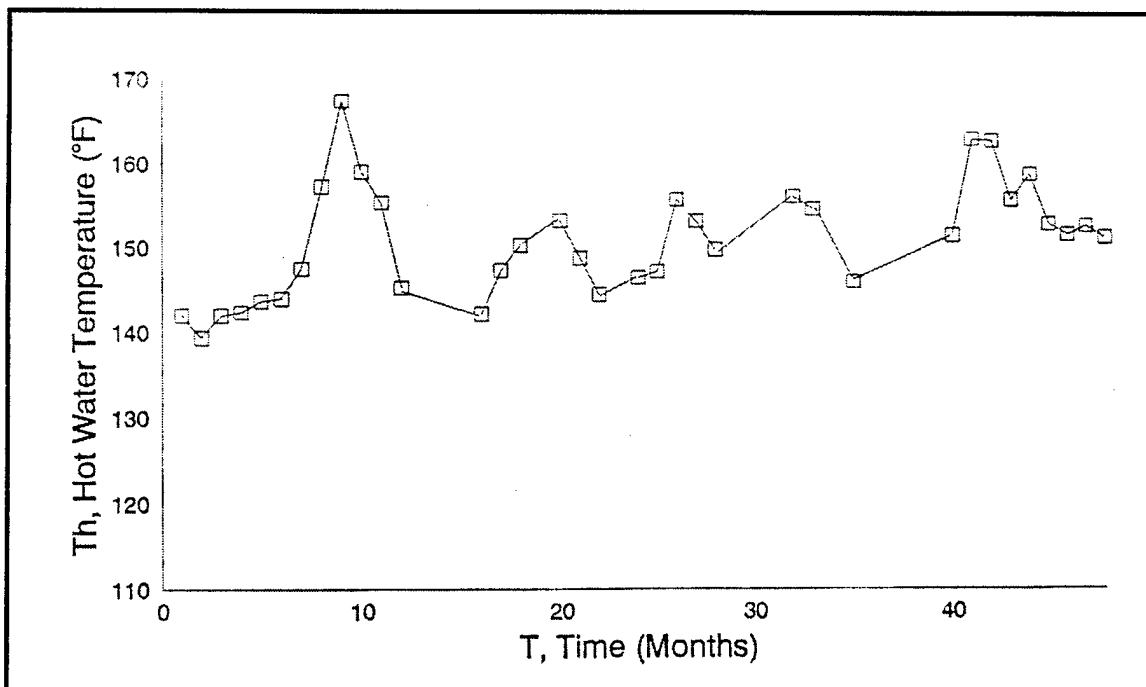
Figure 9. Hot outlet water temperatures for phenolic-coated heat exchanger, Bldg 87017, Fort Hood, TX.

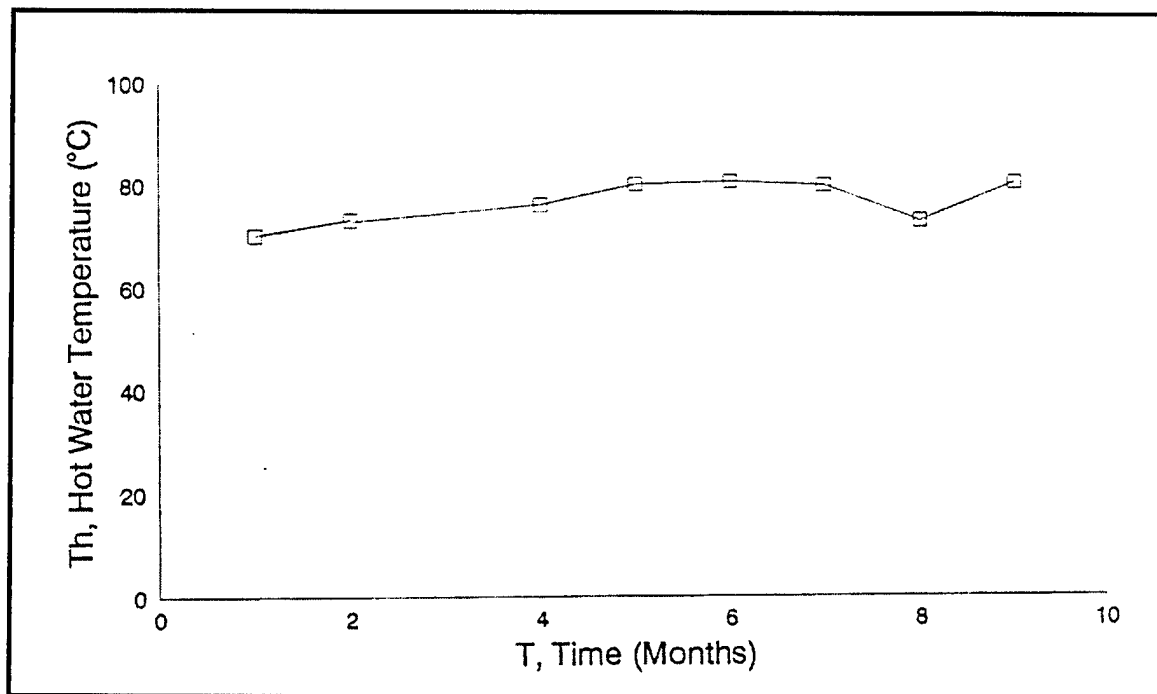
Figures 10 and 11 show field measurements for hot outlet water temperatures at Buildings 3654 and 3657. The data is plotted as monthly averages occurring over a 10-month period starting in December of 1990 and ending in October of 1991. Hot water outlet temperature values shown in Figures 10 and 11 were observed to remain within the range of 64 to 81 °C (147 to 178 °F). The warmest values in each case occurred during the month of September.

Figure 10. Hot outlet water temperatures for phenolic-coated heat exchanger, Bldg 3654, Fort Lewis, WA.

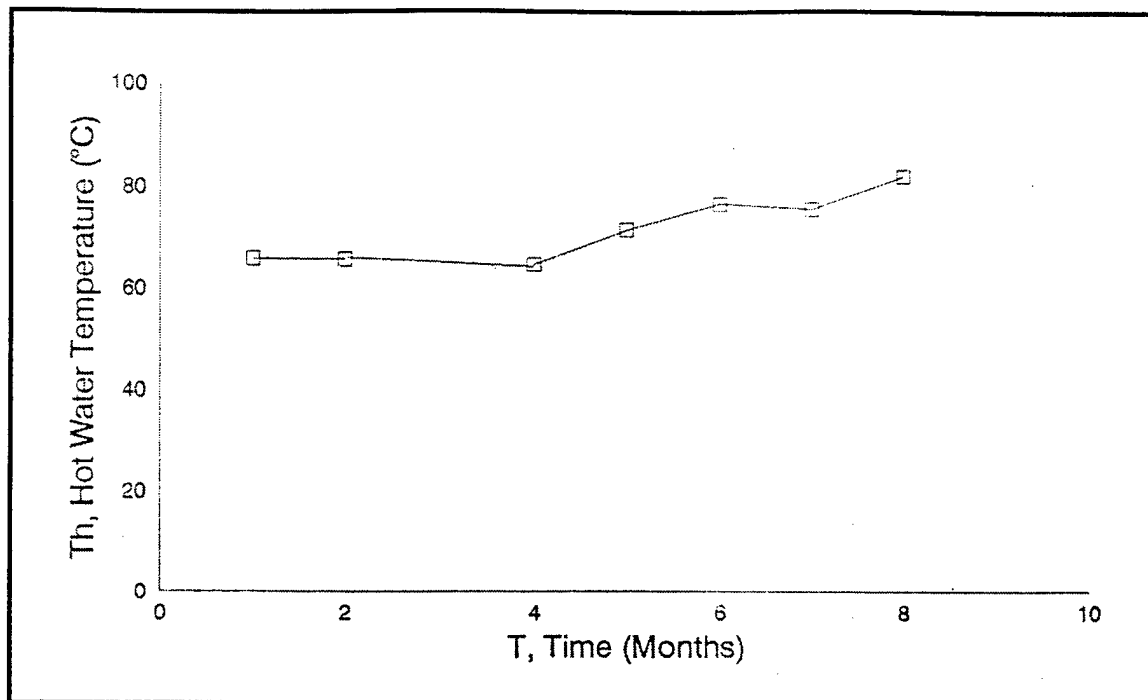
Figure 11. Hot outlet water temperatures for phenolic-coated heat exchanger, Bldg 3657, Fort Lewis, WA.
