# Operation UPSHOT-KNOTHOLE

NEVADA PROVING GROUNDS

Project 5.1

ATOMIC WEAPON EFFECTS ON  
AD TYPE AIRCRAFT IN FLIGHT (U)

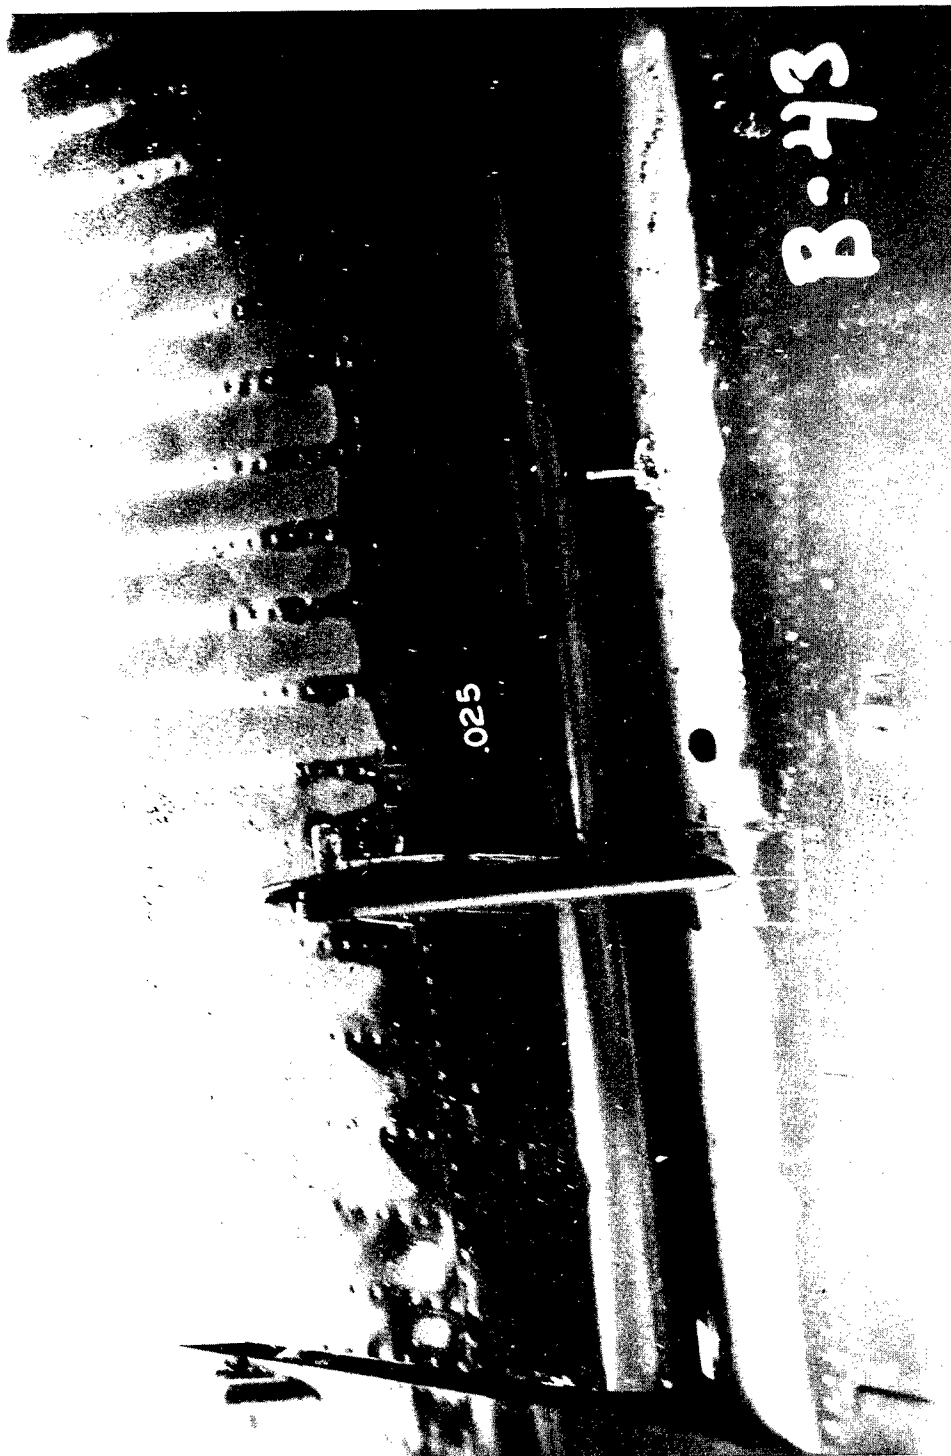
Fig. 2.3 AD-2, Port Elevator and Horizontal Stabilizer  
Showing Scorched Blue Paint on 0.016 Skin -  
Shot 2

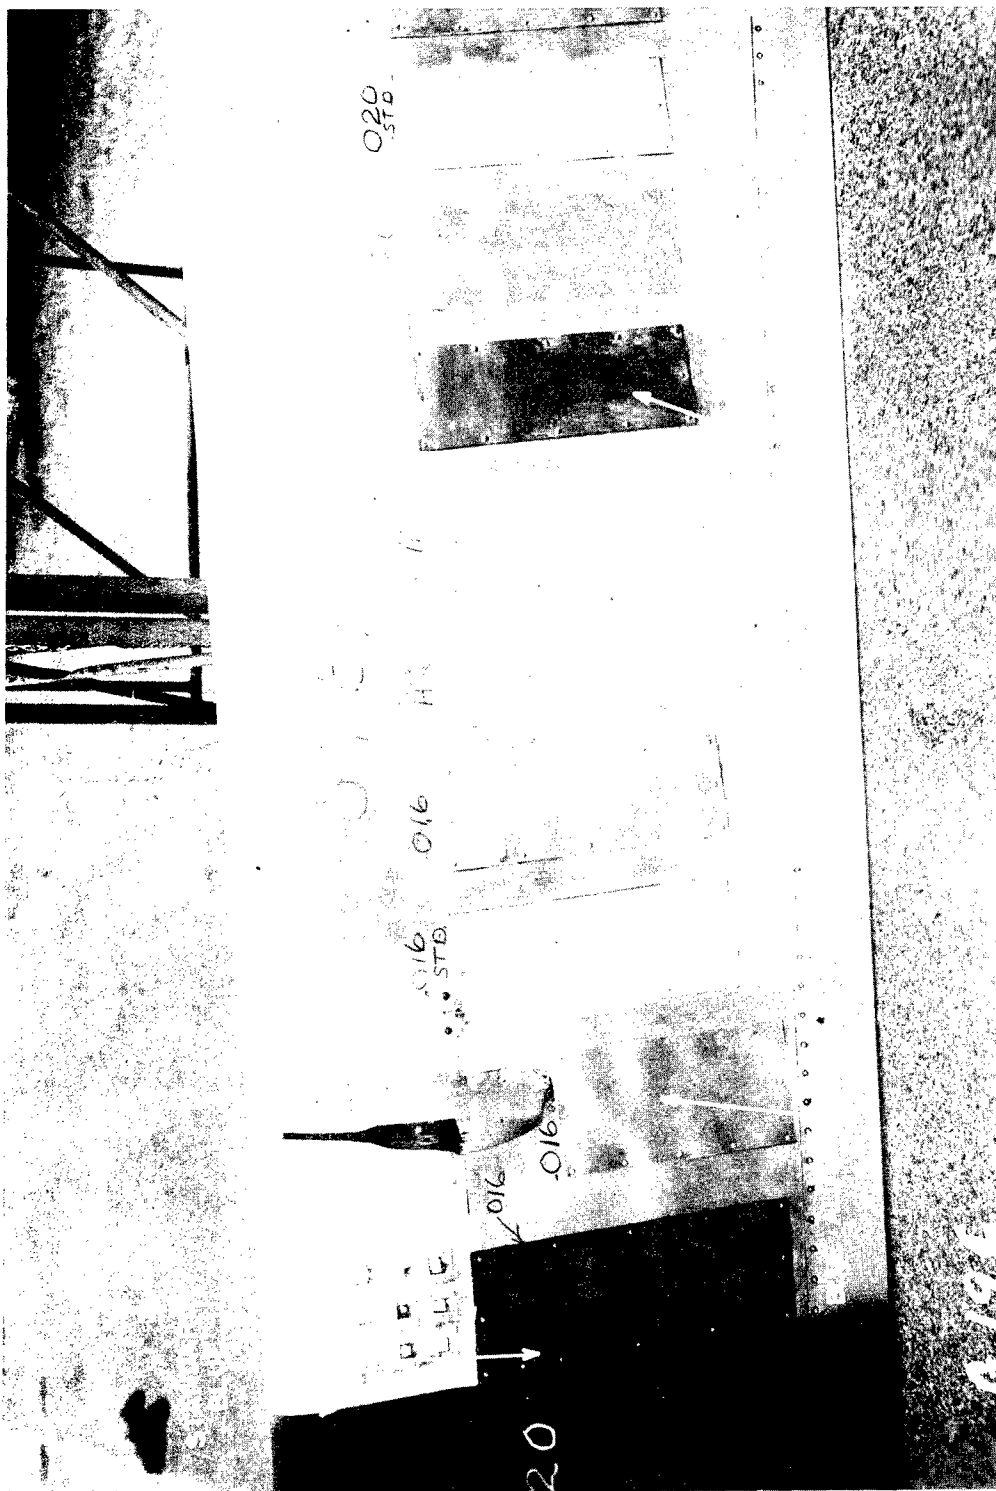
Fig. 2.23 XBT2D-1, Port Elevator Showing Scorched Painted Surfaces. Note skin ripples on 0.016 standard blue painted and aluminized lacquered surfaces. - Shot 8

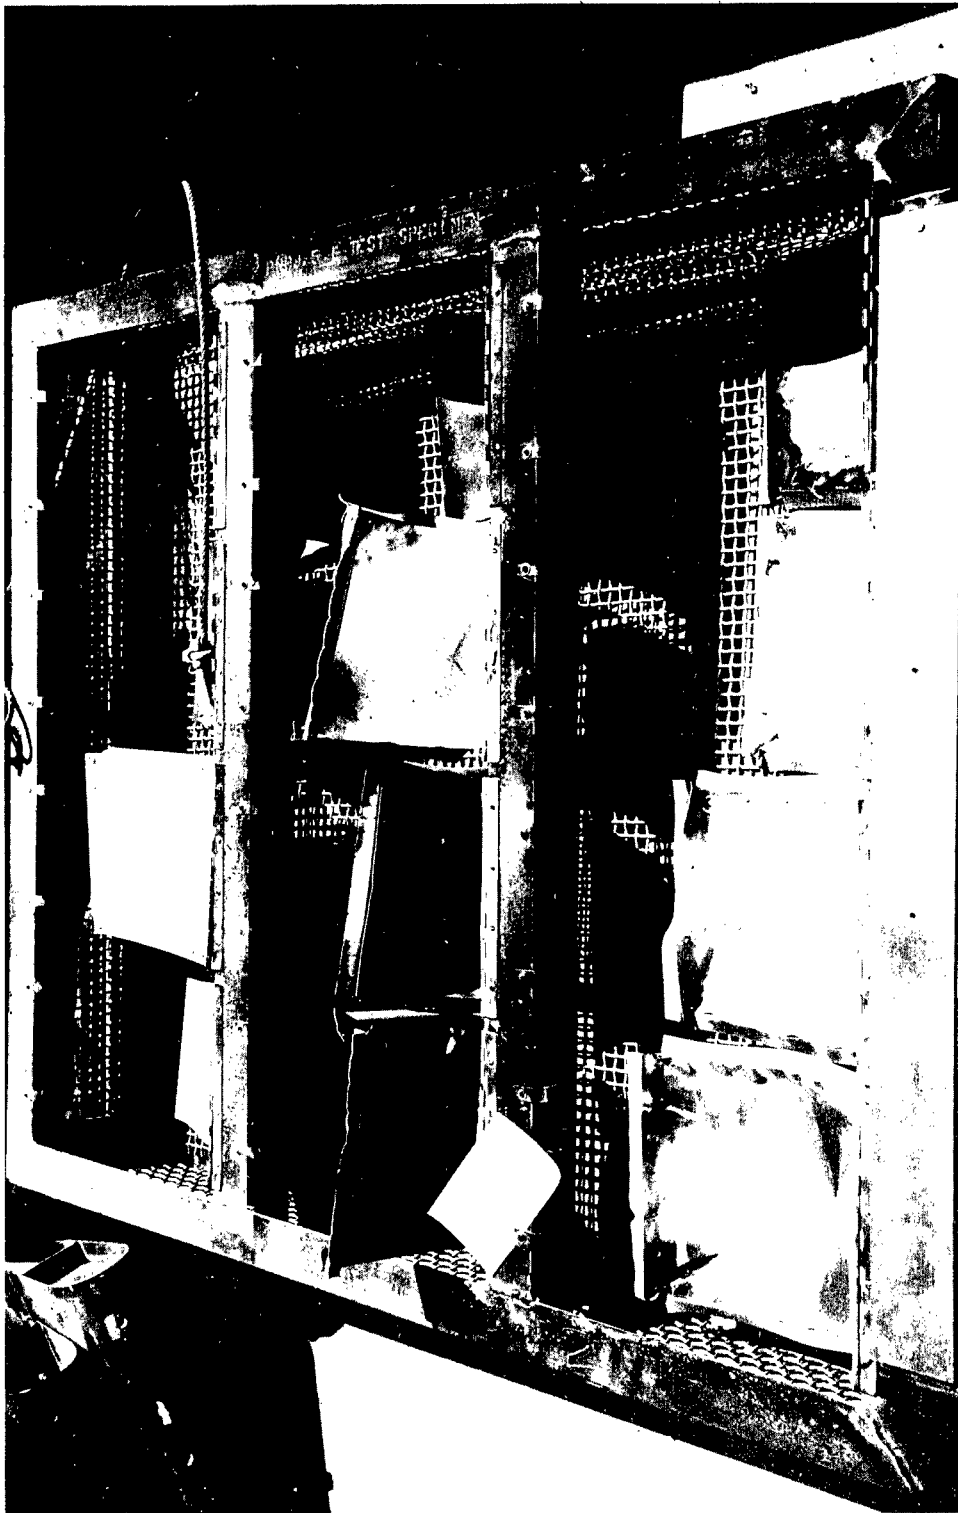
Fig. B.13 Frame Number 2 after Exposure - Slant  
Range 5330 Ft, Thermal Energy 30 cal/cm<sup>2</sup>
