AFRL-PR-WP-TR-2001-2024

**ANALYSIS OF SIMULATED AIRCRAFT
LIGHTNING STRIKES AND THEIR
ELECTROMAGNETIC EFFECTS**

FEBRUARY 2001

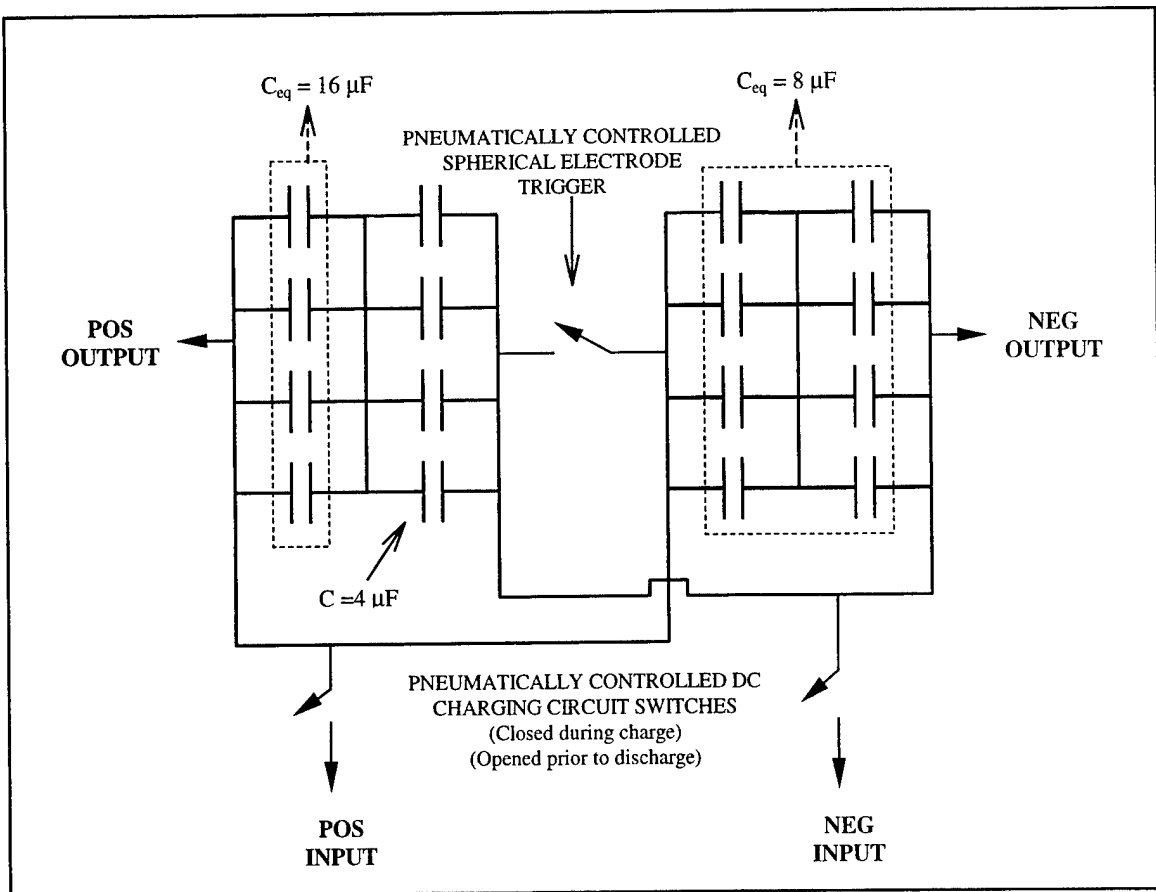
Figure 1. Capacitor Bank Configuration

A high current pulse generator was used to simulate the lightning return stroke. The generator consisted of two $8 \mu\text{F}$ capacitor banks in series. Each capacitor bank consisted of eight $4 \mu\text{F}$ capacitors in a series-parallel arrangement (Figure 1). [1] The $8 \mu\text{F}$ capacitor banks were charged in parallel to $100 \text{ kV}_{\text{max}}$ by a DC power supply through closed charging switches. When the desired charging voltage was reached, the charging switches were pneumatically opened to isolate the capacitor banks. The two capacitor banks then discharged in series through a pneumatically controlled spherical electrode resulting in a maximum energy level of 80 kilojoules.

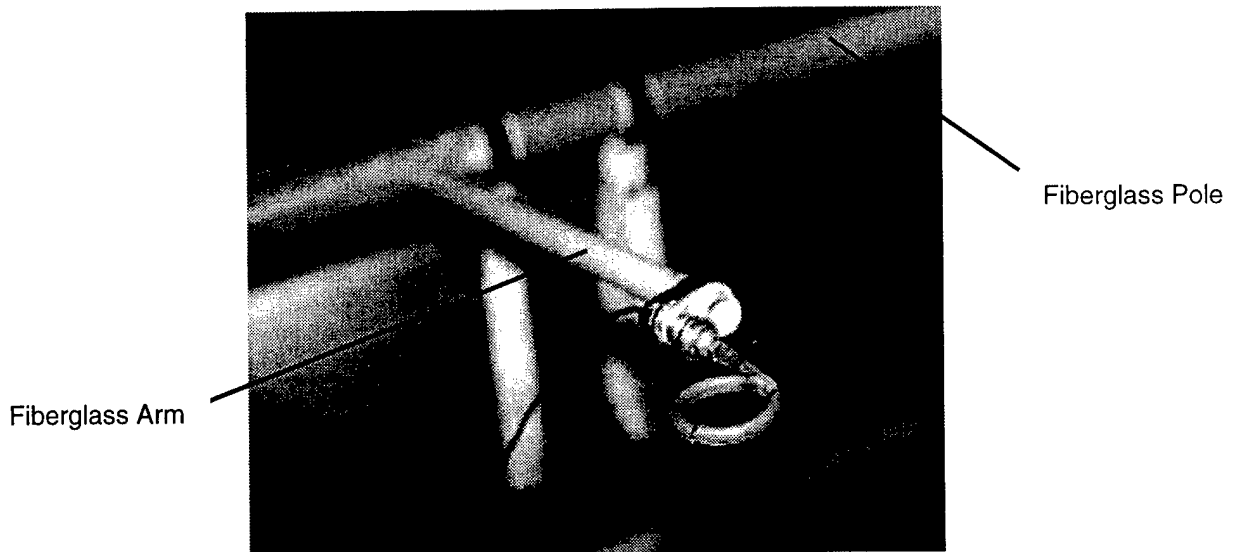
Figure 5. Magnetic Field Loop Sensor

The primary reason for conducting these simulated lightning strike tests was to track and record the resulting magnetic fields at different locations inside the aluminum cylinder as the current pulse from the capacitor bank traveled down the length of the simulated aircraft fuselage. Since the magnetic fields of primary concern were internal to the “closed” cylinder, a scheme was devised to locate a magnetic field loop sensor at various positions within the cylinder.

The scheme consisted of a long fiberglass pole running through the center axis of the cylinder with internal bearing supports appropriately spaced along the pole’s length. Perpendicular to the pole was a smaller fiberglass arm that was used to mount the magnetic field loop sensor (Figure 5). Since the centrally located pole protruded through the ends of the cylinder, it could be rotated to obtain various angular positions for the sensor. It could also be moved along the axis of the cylinder to obtain various axial sensor positions. The location of the sensor on the smaller arm provided a range of radial positions as well. This sensor-positioning scheme enabled magnetic field “mapping” inside the cylinder where panels had been removed or reconfigured. It also saved a considerable amount of time when repositioning the sensor since the panels, which each had 38 screws fastening them to the cylinder, did not have to be unscrewed and then re-screwed into the cylinder each time the sensor needed to be repositioned.

To better understand the analysis, it should be noted that the magnetic field loop sensor's active plane is parallel to the cylinder's radius (Figure 5). Therefore, magnetic flux *parallel* to this plane does not generate a signal. The sensor's "directionally dependent" signal only measures flux with a vector component orthogonal to its "active" plane. The fact that the sensor's signal may go to "zero" or change polarity implies nothing about the resultant magnitude of the total magnetic field, just the component that is normal to its "active" plane. [3]

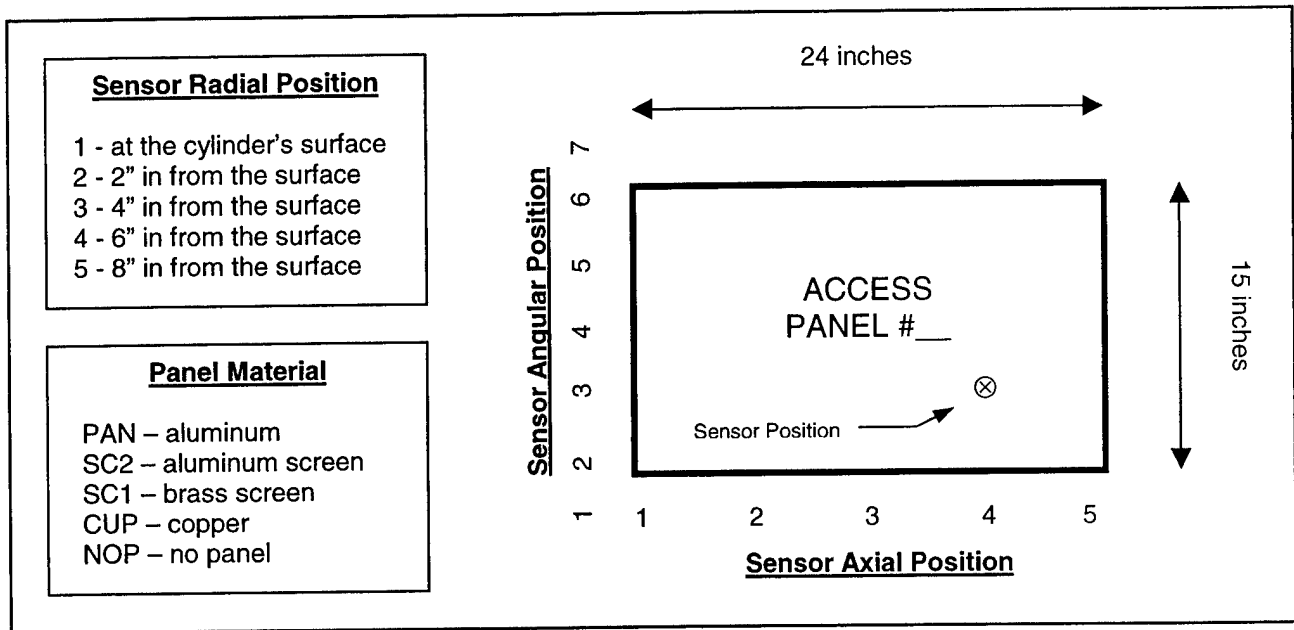
Figure 6. Sensor Location and Panel Material Identification

To track sensor position during a test, a grid system was established for the cylinder's removable access panels that identified the position of the sensor during data acquisition (Figure 6). Each of the access panels was numbered 1 through 16 starting at the cylinder's end closest to the capacitor bank. We also investigated four types of panel materials in one area of the cylinder. The "materials" included aluminum, copper, brass screen and air (no panel).

To assist in managing data files, each test run was assigned a file name with the following format: X_##_YYY.###. The "X" represented the type of sensor being used, i.e. S = H-Field loop sensor, I = current sensor, etc. "##" identified the cylinder's panel number where the test occurred. "YYY" represented the panel's material (Figure 6). "###" identified the axial, angular, and radial positions respectively of the loop sensor. As an example, file S_03_PAN.433 contained the signal from the loop sensor (S) located 4" below the surface of Panel #03 (material: aluminum). The sensor's axial and angular position are located in Figure 6 with the "⊗" symbol.
