AFRL-ML-WP-TR-2000-4144

**ADVANCED NONDESTRUCTIVE EVALUATION (NDE) FOR
RETIREMENT FOR CAUSE/ENGINE STRUCTURAL INTEGRITY
PROGRAM (RFC/ENSIP)**

FINAL REPORT FOR THE PERIOD 02 FEBRUARY 1996 - 31 AUGUST 2000

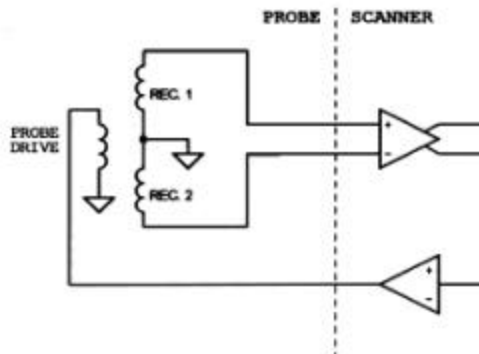
Figure 2. Probe/Scanner Interface

The coils typically used in the eddy current probes are differential reflection coils, which have one drive coil and two receive coils (see Figure 2). When the probes are inserted into the ECIS scanner for an inspection, the outputs of the two receive coils travel through the probe and are applied to the two inputs of a dual output differential amplifier located in the scanner.

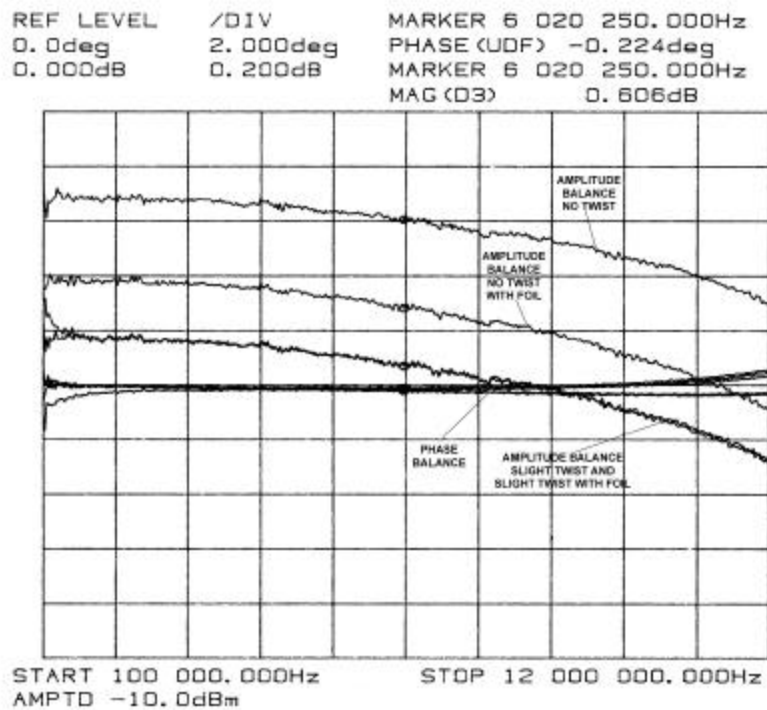
Figure 5. Twisted Wire Phase and Amplitude Plots

Figure 5a. Improperly Twisted Wiring Response

Figure 5b. Properly Twisted Wiring Response

twist configuration of the four hookup wires. For this test, the receive 0 and receive 180 wires formed one twisted pair, and the probe drive and ground wires formed the other. The same three-twist configurations were used as for the coil assembly testing; no twist, light twists (1 to 2 twists per inch) and a tight twist (4 to 6 twists per inch). In addition to the three-twist configurations, foil shielding was used over both the six-wire and the four-wire areas to see what effect the additional shielding would have (see Table 17). Figures 5A and 5B show the Network Analyzer Plots of the various configurations tested. The center horizontal line of both plots of Figure 5 is the 0dB point for the amplitude balance and 0-degree point for phase balance, while the center vertical line is the 6MHz point. The coil used in these tests was a 6MHz coil, so the point of interest is the intersection point of the 0dB/0-degree and 6MHz lines. Ideally, both the phase balance and the amplitude balance would be 0 at the 6MHz-intersection point. From Table 17 and the plots in Figure 5, it is clear that the proper twisting of the wires is essential for maintaining a good coil balance. The additional foil shielding seems to help with wiring that is improperly twisted, but has little effect on properly twisted wiring. The results of this testing shows that to achieve the best coil balance without adding components is to twist both the coil assembly wires and the coil hookup wires with four to six twists per inch. It also shows that going with the added cost of additional shielding will result in little improvement, which means that simple twisting of the wires, is sufficient.

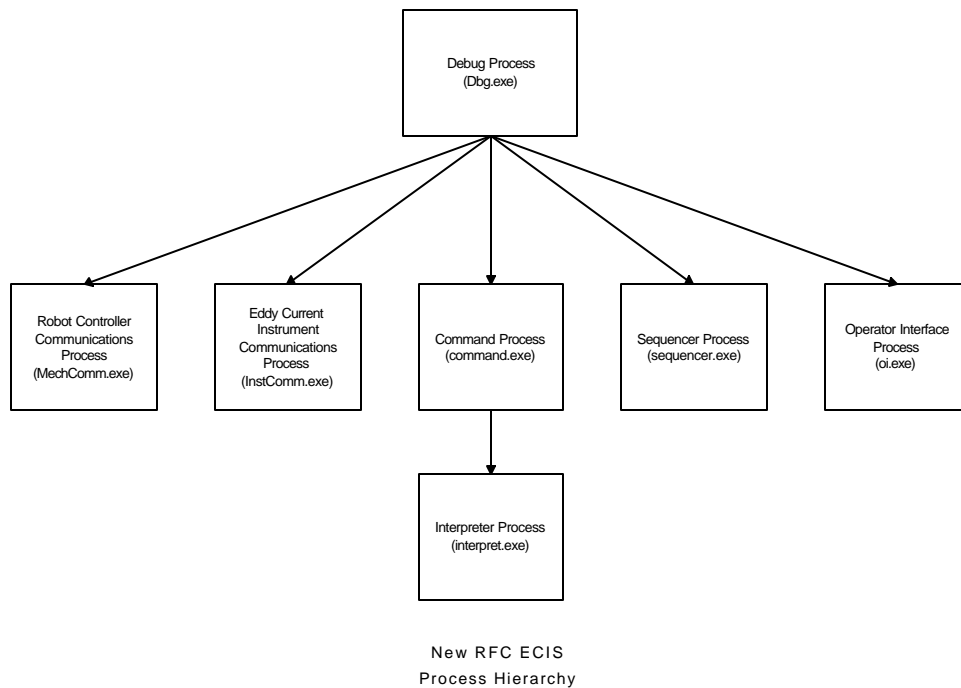
Figure 11. Process Hierarchy

A block diagram illustrating the processes resulting from the conversion is shown in Figure 11 below.

As shown, the ECIS application software consists of seven processes. This is a significant reduction from the 13 processes required in the old Multibus-based computer. The reduction in the number of processes mainly results from the simplification of the computer architecture. The old computer system required two chassis: a Multibus I and Multibus II chassis, and two single board computers. The simplification of the computer system is possible because of increased processor and memory capabilities as well as reduced size of the peripherals and add-on I/O cards.
