ARL Experimental Facility 108 A/B Blast Tests - Summary Report

ARL-MR-511

April 2001

Weapons and Materials Research Directorate, ARL

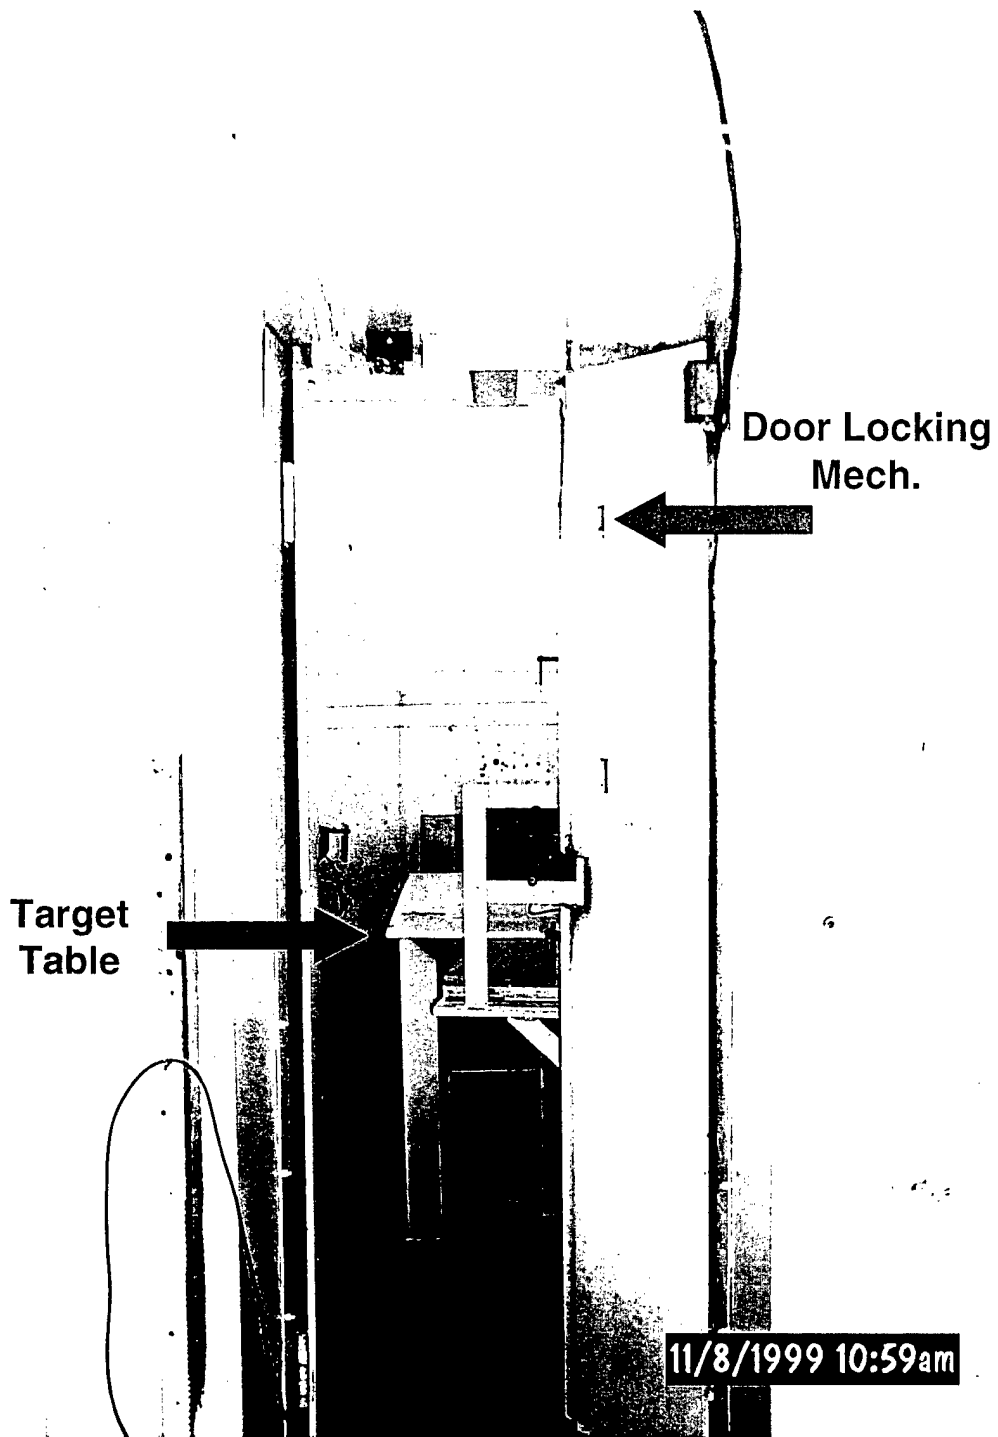
Figure 1. Photograph of entrance to chamber showing locking mechanism and target stand.

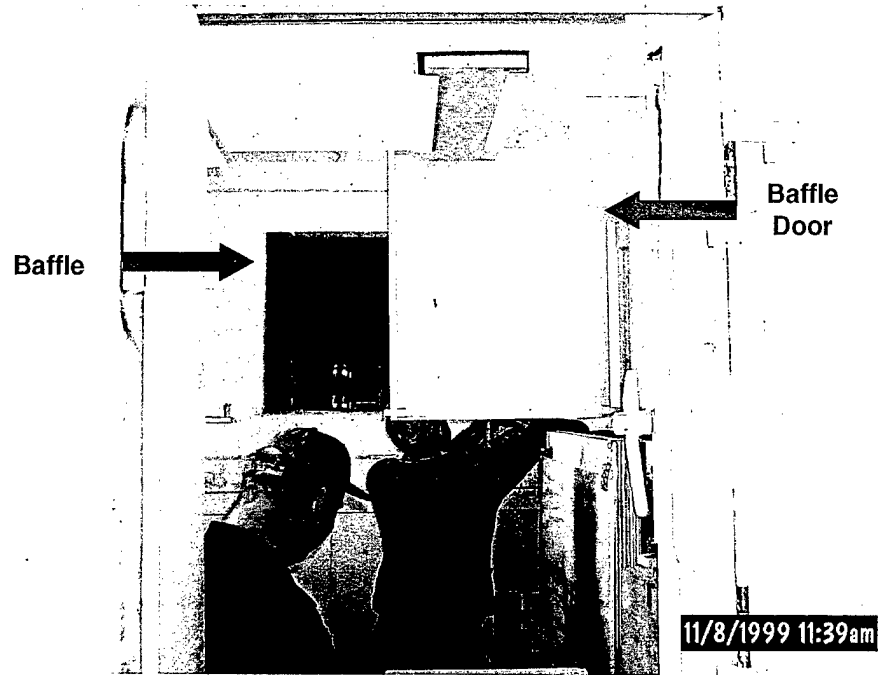
Figure 2. Photograph of chamber showing locking mechanism and baffle opening.

pressure transducers can be found in Figures A-4 and A-5.) Figure 5 shows the approximate layout of the chamber with dimensions. The approximate volume of the chamber is 669 ft³. The chamber has an additional baffle that can be opened. This baffle has a 107-ft² opening and is shown in Figures 2 and 6.

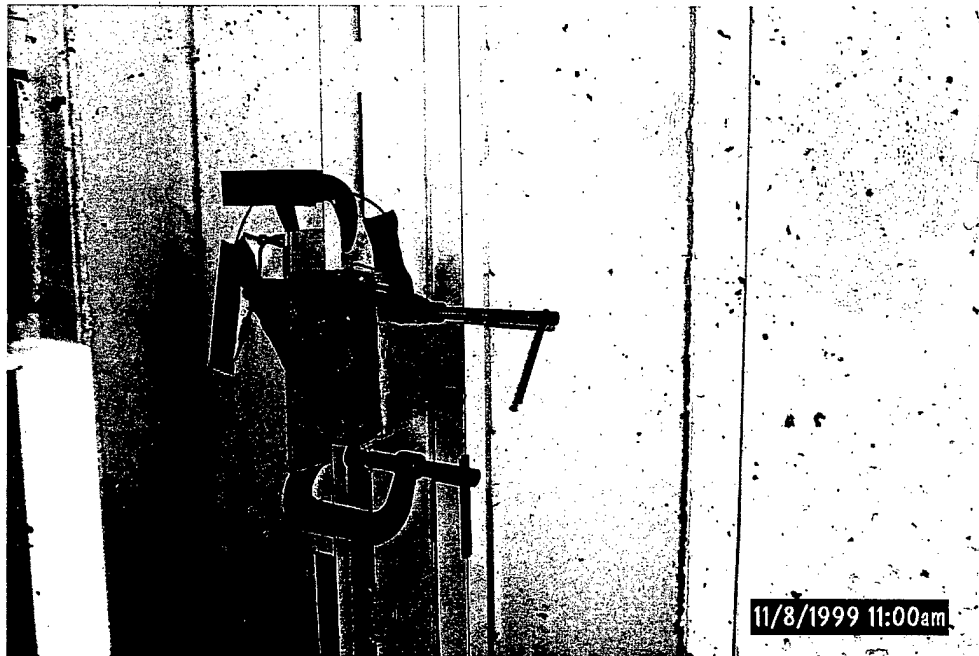
Figure 3. Photograph of pressure gauge and mount clamped to entrance door.

Hand-formed Detasheet spheres were detonated on top of a target table 57 in away from the entrance door of the chamber. Again, it should be noted that the Detasheet spheres used were handpacked and not cast, but they were considered adequate for the purpose of this study. An RP 87 detonator was used to detonate the explosive. The detonator was placed in the center of the explosive and was positioned facing toward the door of the chamber. This was done to ensure that the maximum pressure obtained by the detonation was aimed at the door and that the majority of the fragments from the detonator were propelled away from the pressure gauge mounted on the door. The door to the chamber is made of 1/2-in steel and has a 1/2-in bar stock locking pin, which is shown in Figures 1 and 2. Figure 3 shows a PCB 102M230 pressure gauge mounted into a lead "pig" pressure mount, which is attached to the chamber door facing the inside of the chamber. This pressure gauge was mounted so that it was in the direct line of sight of the explosive. The distance between the center of initiation and the pressure gauge was 72 in. (Figure A-1 in the Appendix shows a schematic of this pressure transducer. Figure A-2 lists the operating specifications of this transducer model. Figure A-3 is an engineering drawing of the lead pig pressure transducer mount.) A second PCB 102M230 pressure gauge in a lead pig mount was placed at the opening of a vent located on the sidewall of the chamber. This location was selected because the walls of the vent are constructed out of sheet metal. It was feared that this duct would be ruptured or severely damaged from the blast waves. The vent has a 1-ft² opening. Figure 4 shows the pressure gauge and lead pig mount at the entrance of the vent. (Calibration curves for both

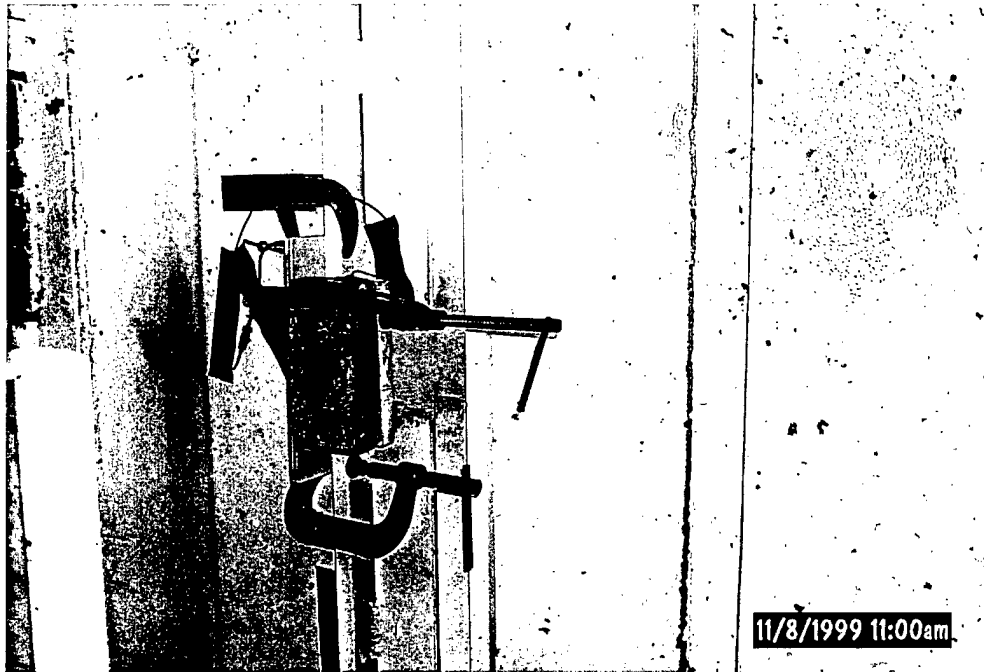
Figure 4. Photograph of pressure gauge and mount at entrance to vent.

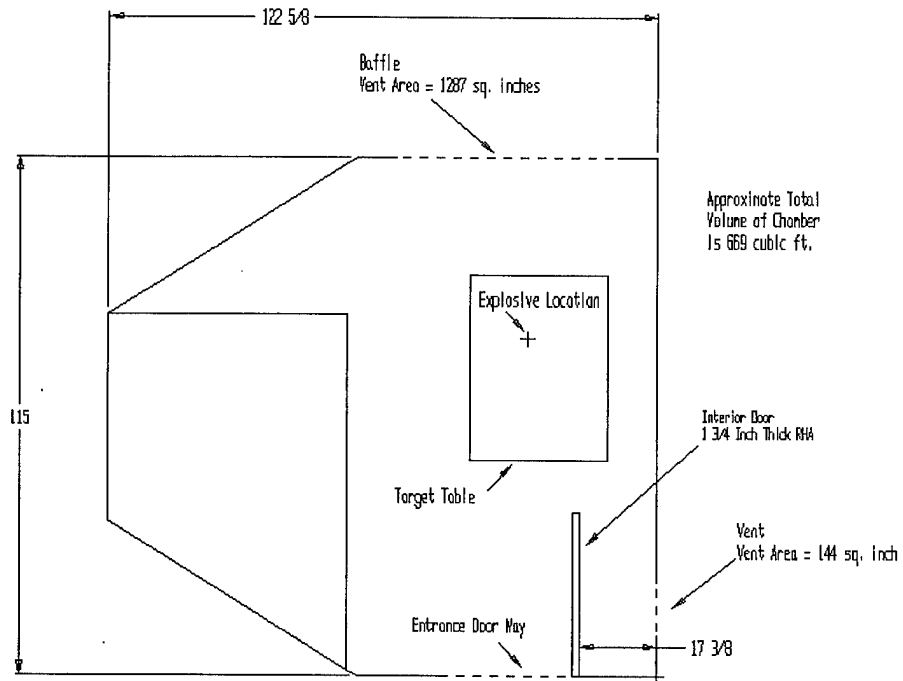
Simplified Schematic of
Experimental Facility 108 A/B
Chamber

Figure 5. Schematic of Experimental Facility 108 A/B chamber.

Figure 5 shows the position of this door relative to the vent and explosive. No damage was seen in the vent during any of the tests but the vent was protected somewhat by the lead pig pressure mount and the interior door. Assuming this door is kept in the position shown in Figure 5, during most tests, the vent should be safe. However, it would be advisable to examine this vent to ensure that repeated use does not have a cumulative damage effect on its structural integrity. Once again, Table 1 summarizes all of the peak pressures and impulses measured in these tests.

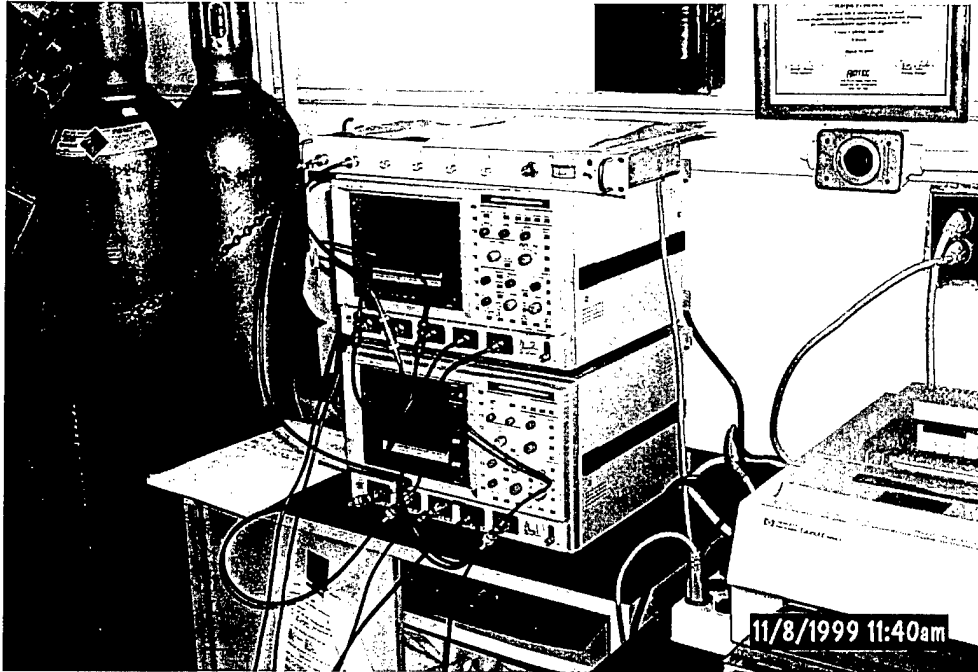
Figure 7. Photograph of data acquisition equipment.

Two Lecroy LT344 500-MHz oscilloscopes were used to capture the data obtained in these tests (Figure 7). Data were sampled at 1 μ s per point for a duration of 190 ms. The 190-ms duration was used to enable the signal to return to baseline as much as possible, which gives us an idea of the venting rate for the chamber. Two plots for each signal are given in section 3. The first time history is a full-duration plot to show how the pressure levels change with time. The second time history plot is a short-duration plot of the initial pressure wave measured and the initial reflected waves that were seen shortly after. It should be noted that all of the measurements shown herein are reflected pressure. The impulse of the pressure measurements obtained on the door were calculated for the first blast wave that struck the door. Impulses from secondary reflections were not considered. In all, four blast tests were conducted.

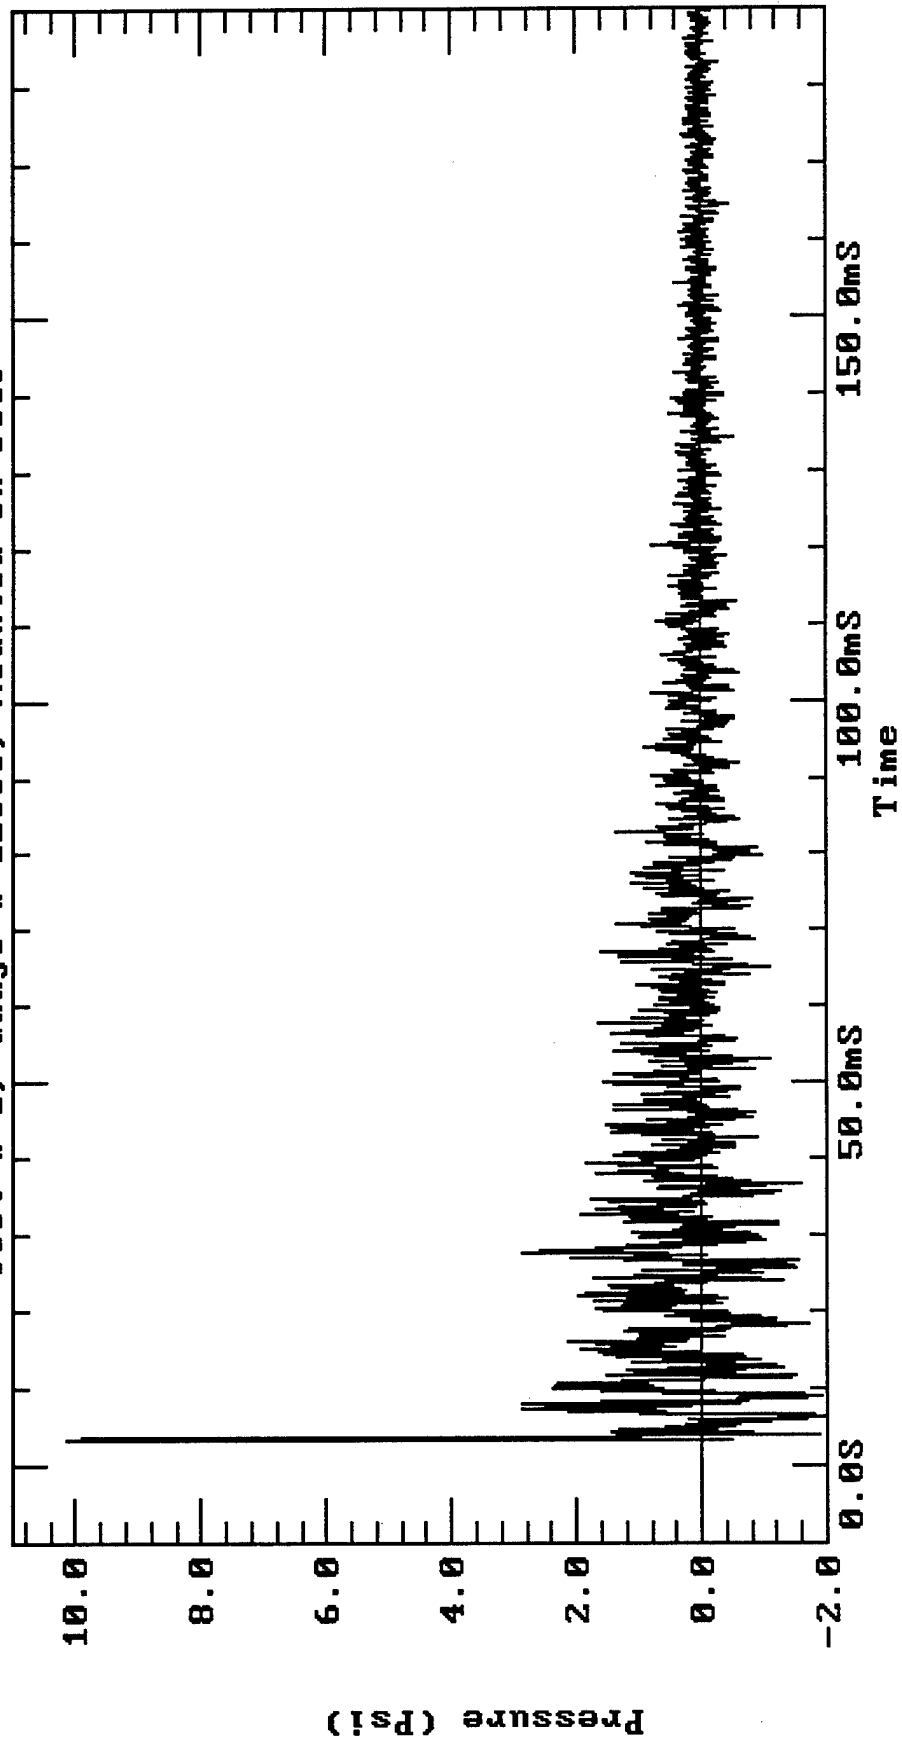
Experimental Facility 108 A/B Blast Tests, 11/8/99
Test # 1, Gauge # 12636, Mounted on Door

Figure 8. Test 1 long duration time history of pressure gauge mounted on door.

In test no. 1, a 10-g sphere of Detasheet was detonated. The 107-ft² steel baffle door was closed, which is shown in Figure 6. Time histories from the gauges are shown in Figures 8–11. Table 1 summarizes the peak pressures obtained in all of the tests. A maximum pressure of 10.1 psi was measured on the door with an impulse of 2.2E-3 psi · s. Figure 12 shows the impulse of the initial pressure wave striking the door of the chamber. A maximum pressure of 2.1 psi was measured at the entrance to the vent. No damage was done to the chamber.

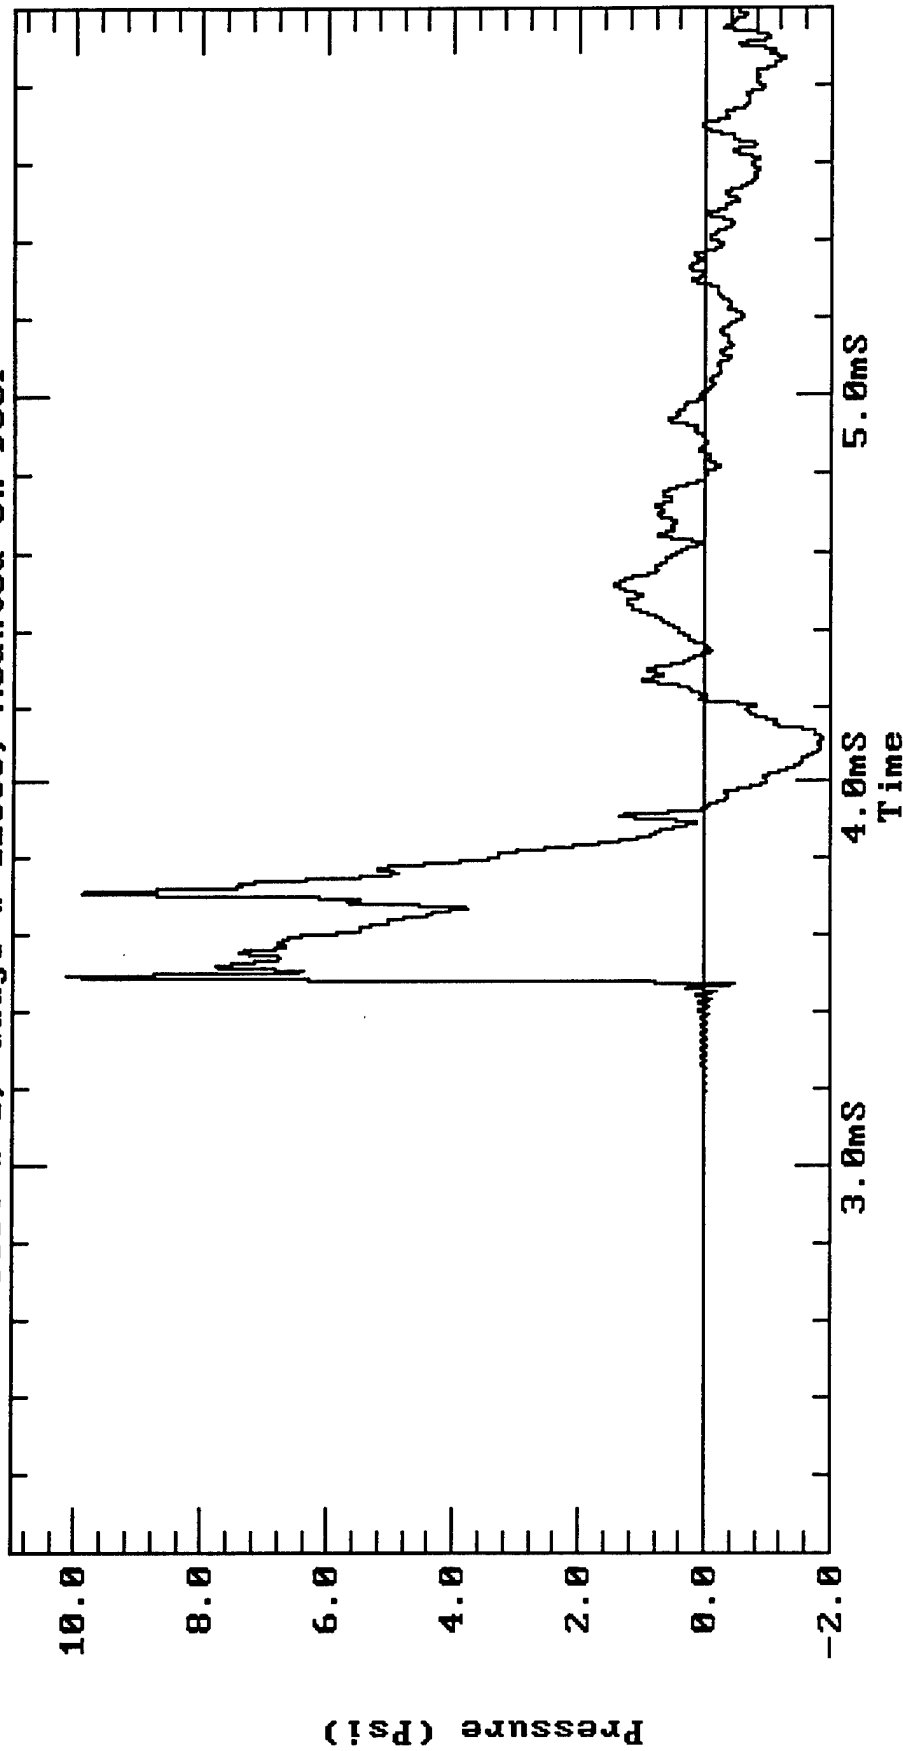
Experimental Facility 108 A/B Blast Tests, 11/8/99
Test # 1, Gauge # 12636, Mounted on Door

Figure 9. Test 1 short duration time history of pressure gauge mounted on door.

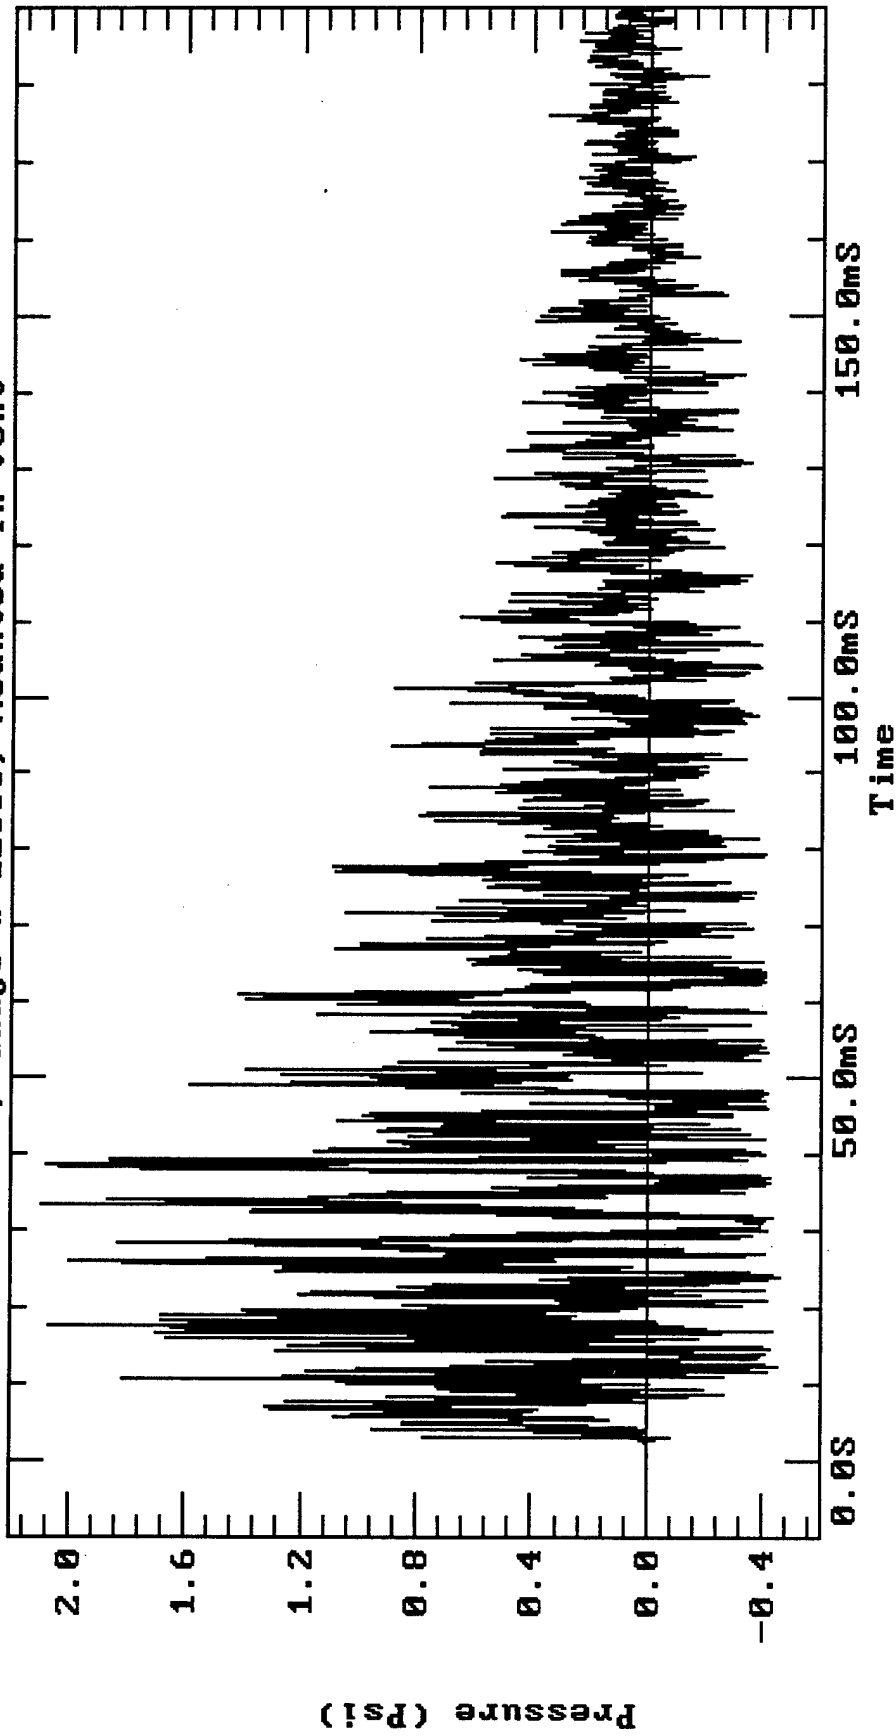
Experimental Facility 108 A/B Blast Tests, 11/8/99
Test 1, Gauge # 12638, Mounted in Vent

Figure 10. Test 1 long duration time history of pressure gauge mounted in vent.

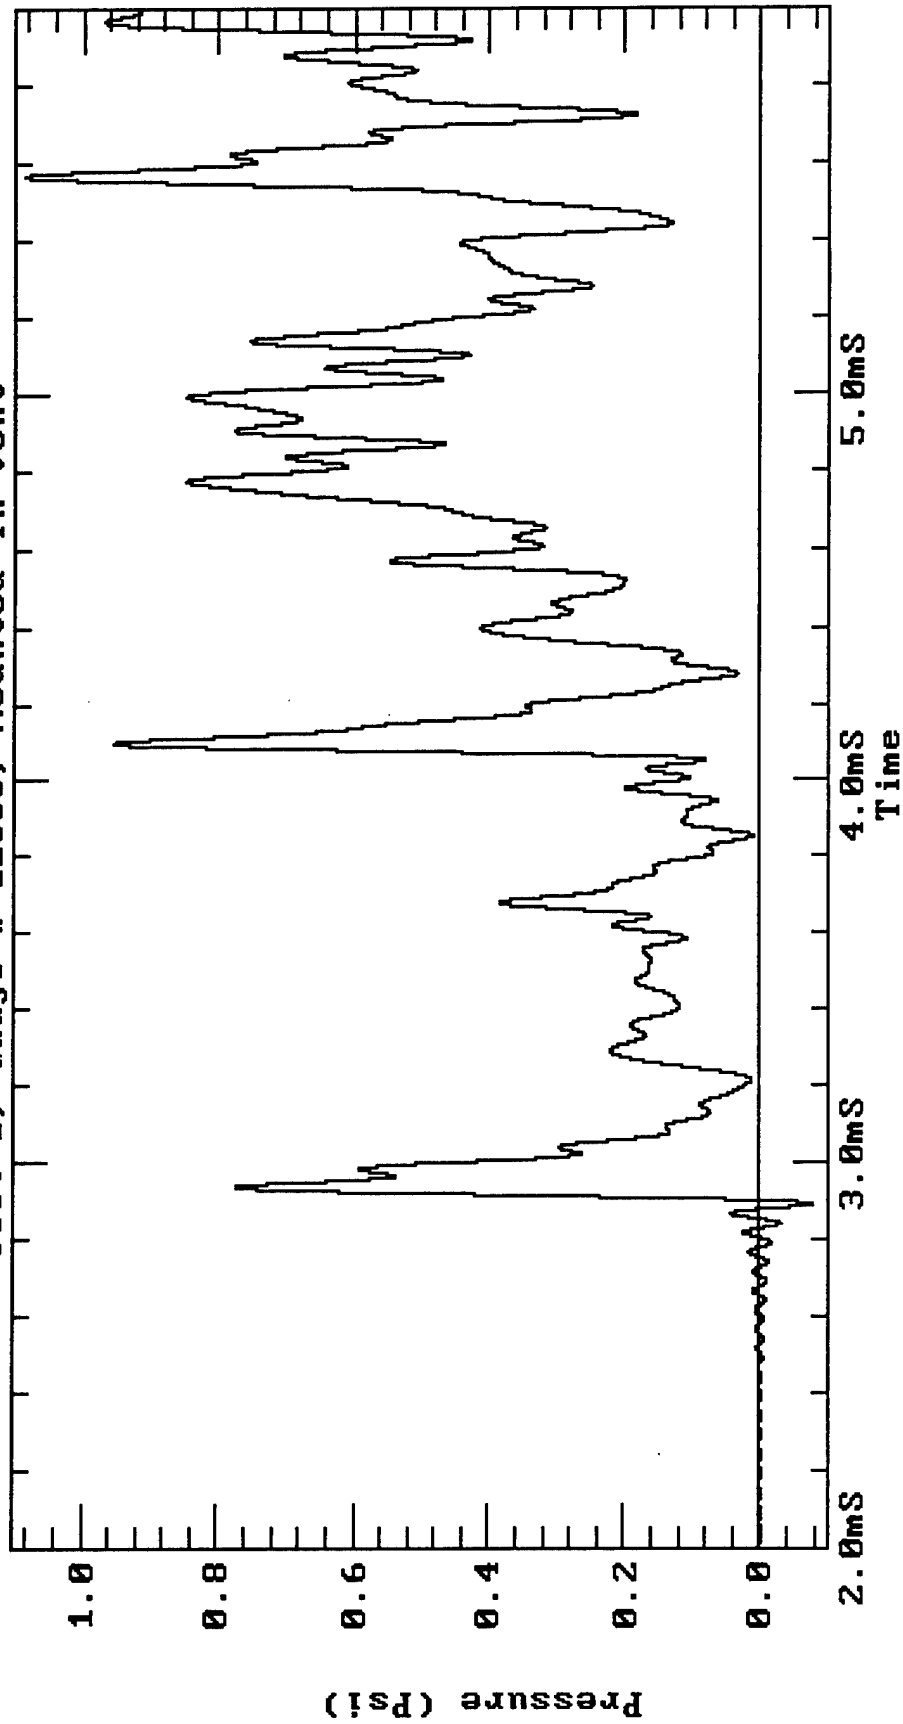
Experimental Facility 108 A/B Blast Tests, 11/8/99
Test 1, Gauge # 12638, Mounted in Vent

Figure 11. Test 1 short duration time history of pressure gauge mounted in vent.

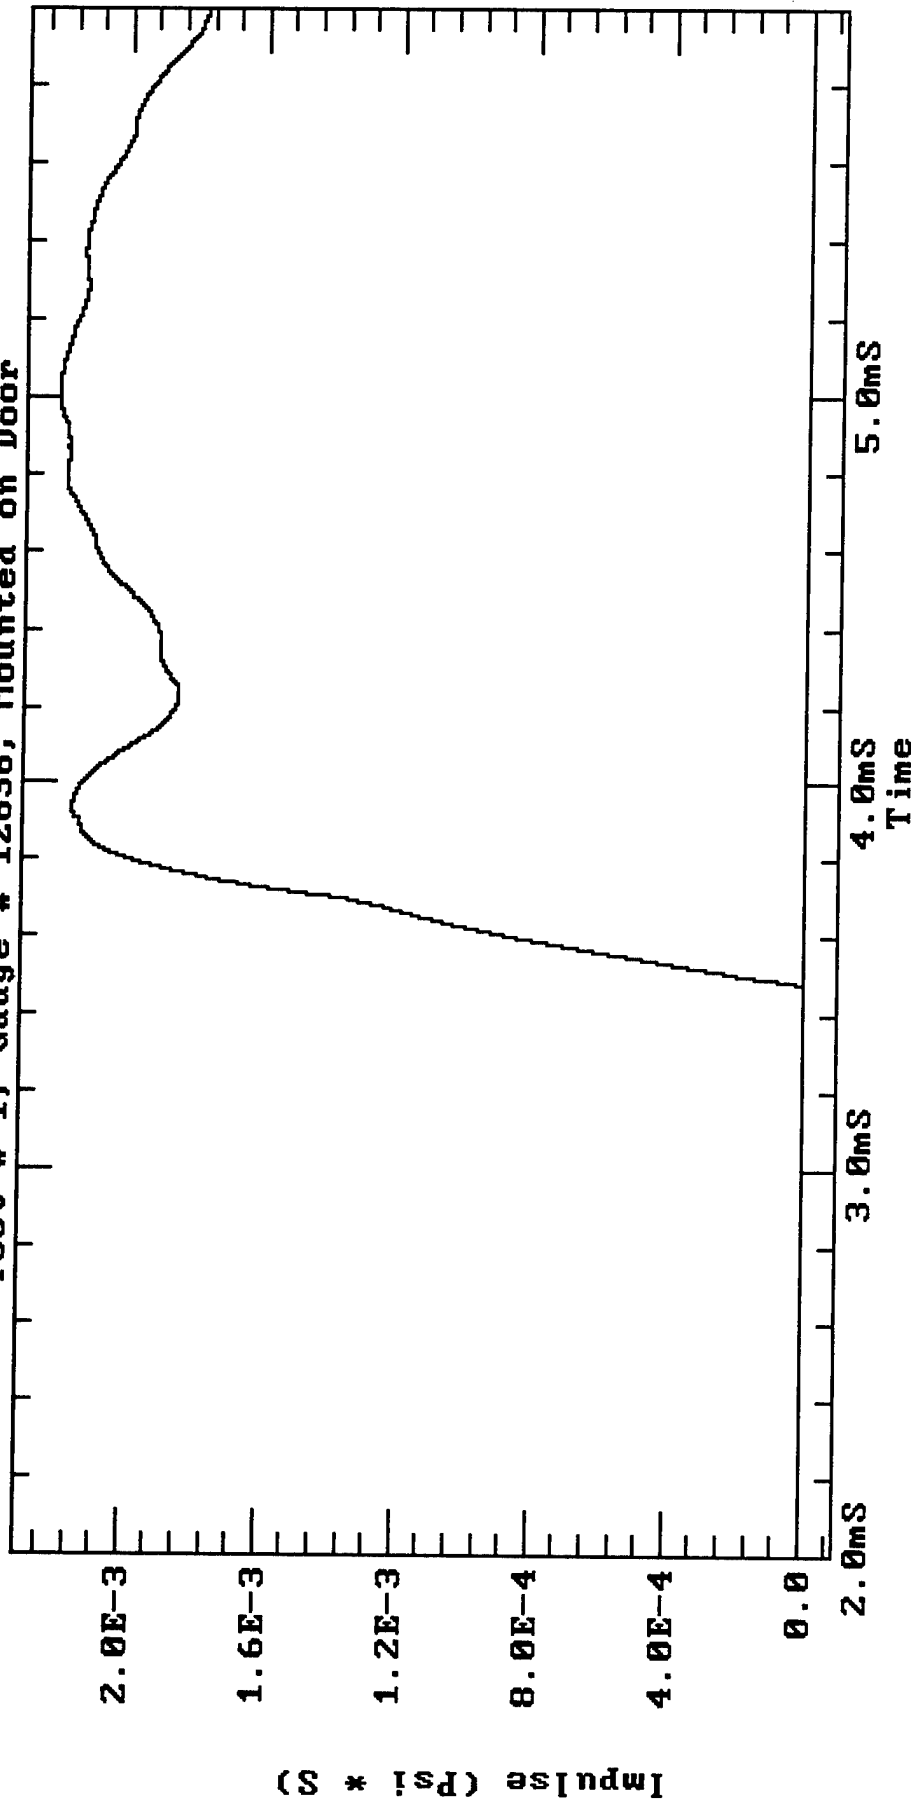
Experimental Facility 108 A/B Blast Tests, 11/8/99
Test # 1, Gauge # 12636, Mounted on Door

Figure 12. Test 1 impulse measured at the door.

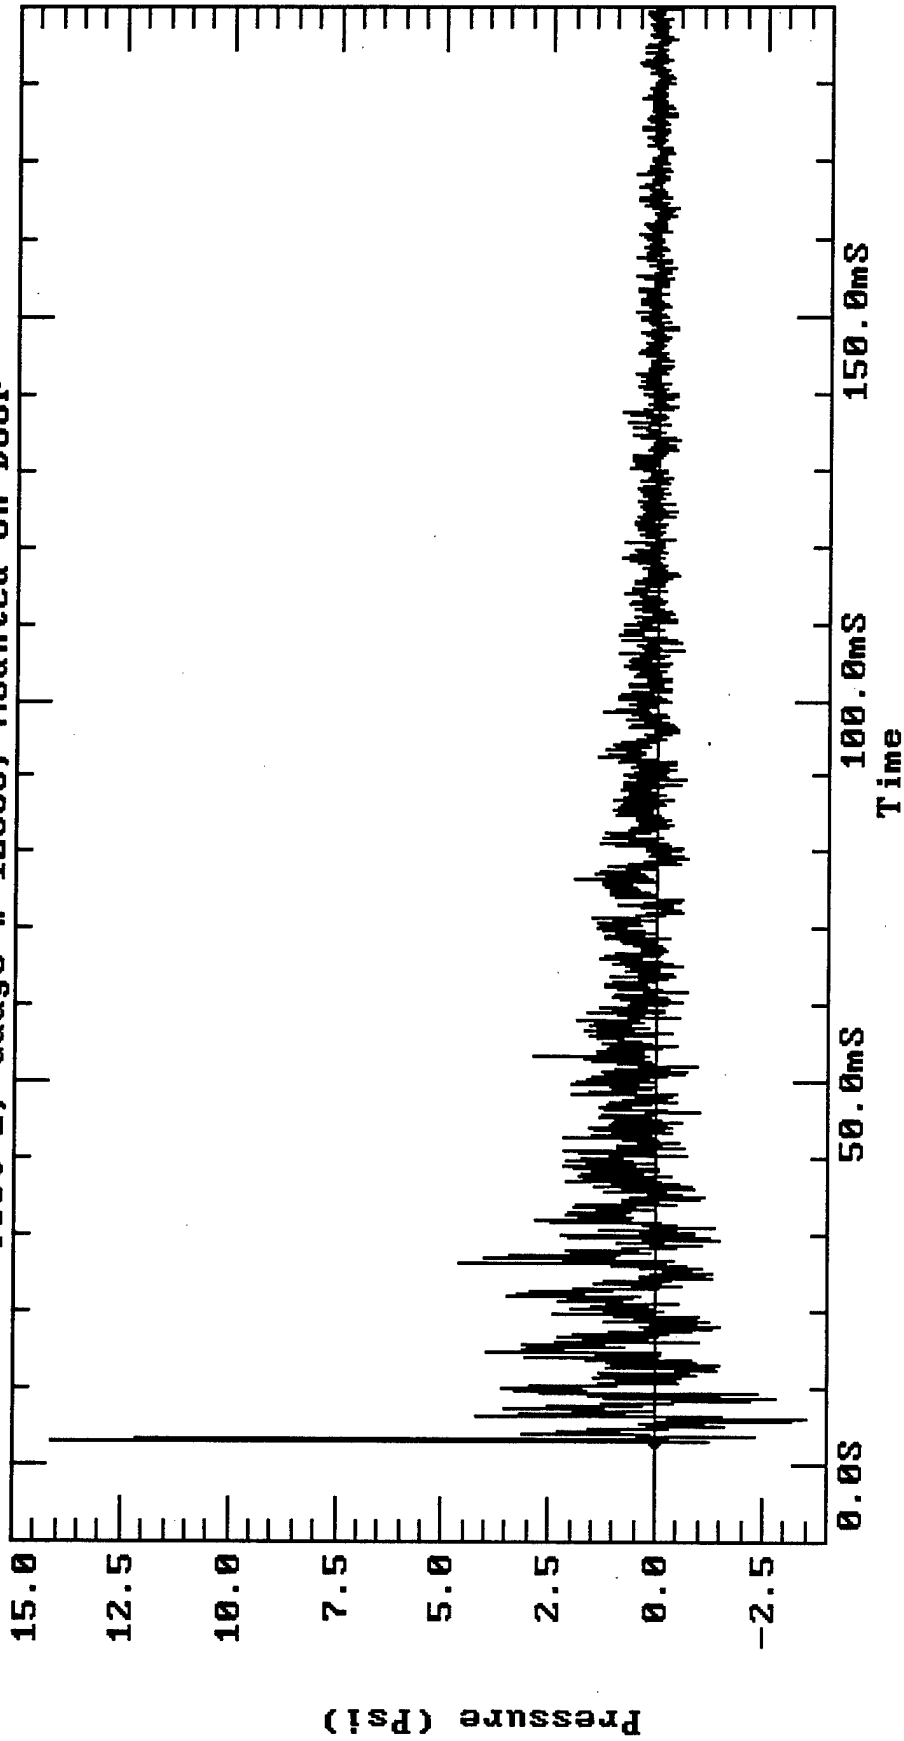
Experimental Facility 108 A/B Blast Tests, 11/8/99
Test 2, Gauge # 12636, Mounted on Door

Figure 13. Test 2 long duration time history of pressure gauge mounted on door.

In test no. 2, a 20-g sphere of Detasheet was detonated. Again, the baffle door was closed for this test. Time histories from the gauges are shown in Figures 13–16.

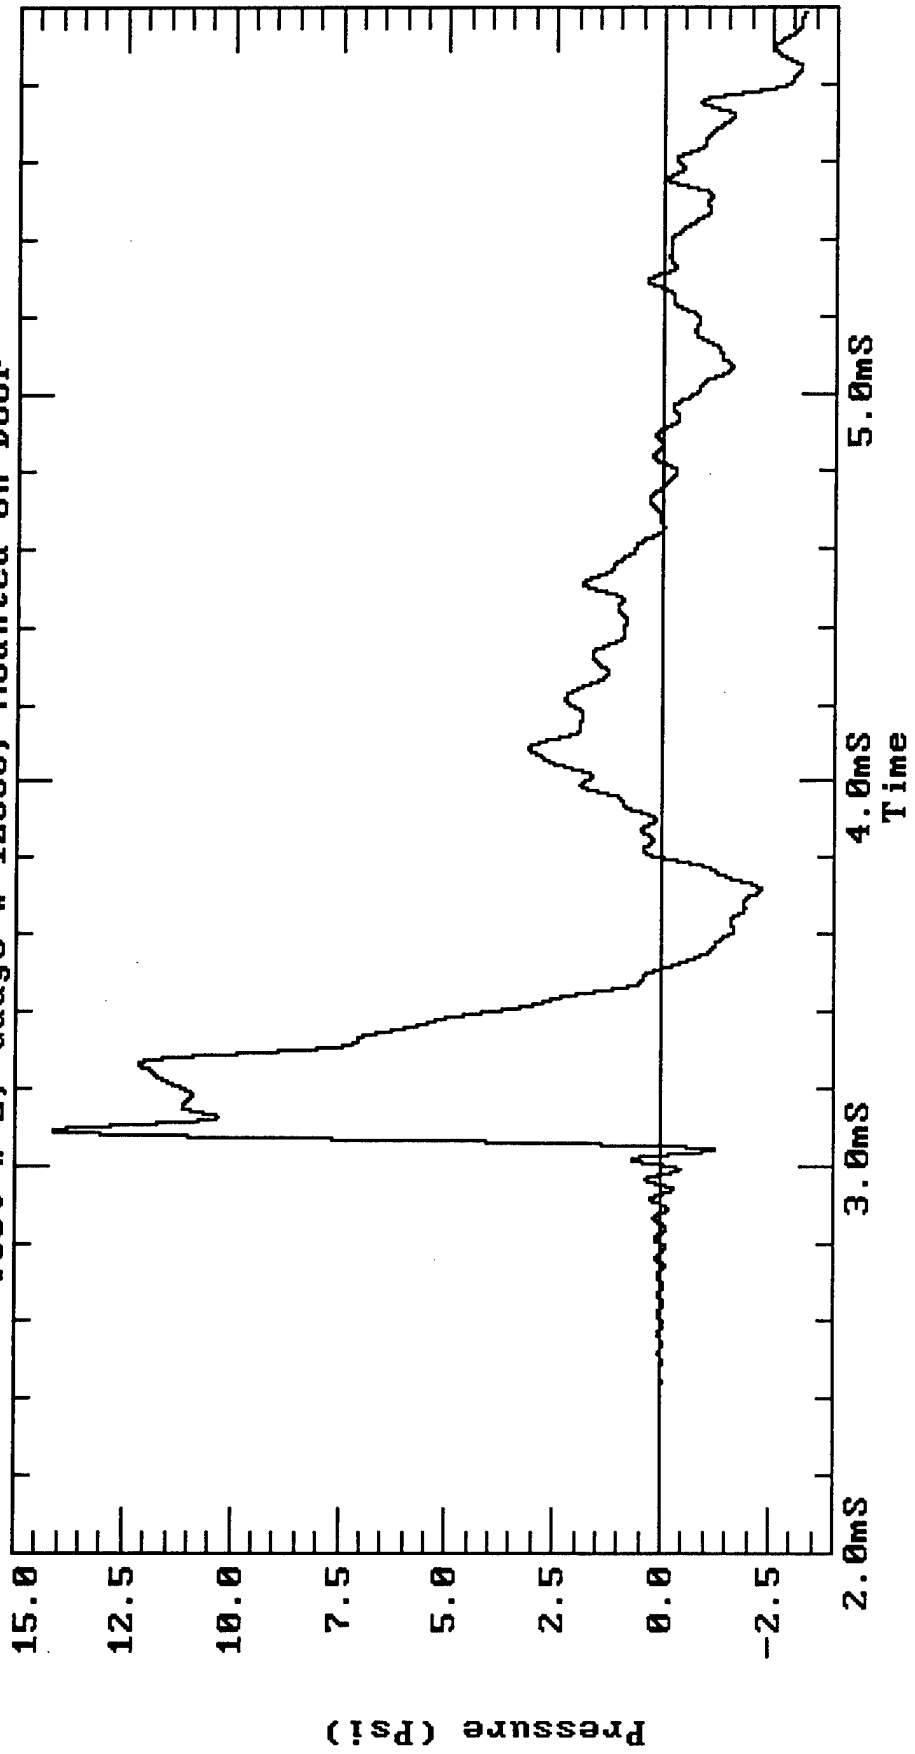
Experimental Facility 108 A/B Blast Tests, 11/8/99
Test # 2, Gauge # 12636, Mounted on Door

Figure 14. Test 2 short duration time history of pressure gauge mounted on door.

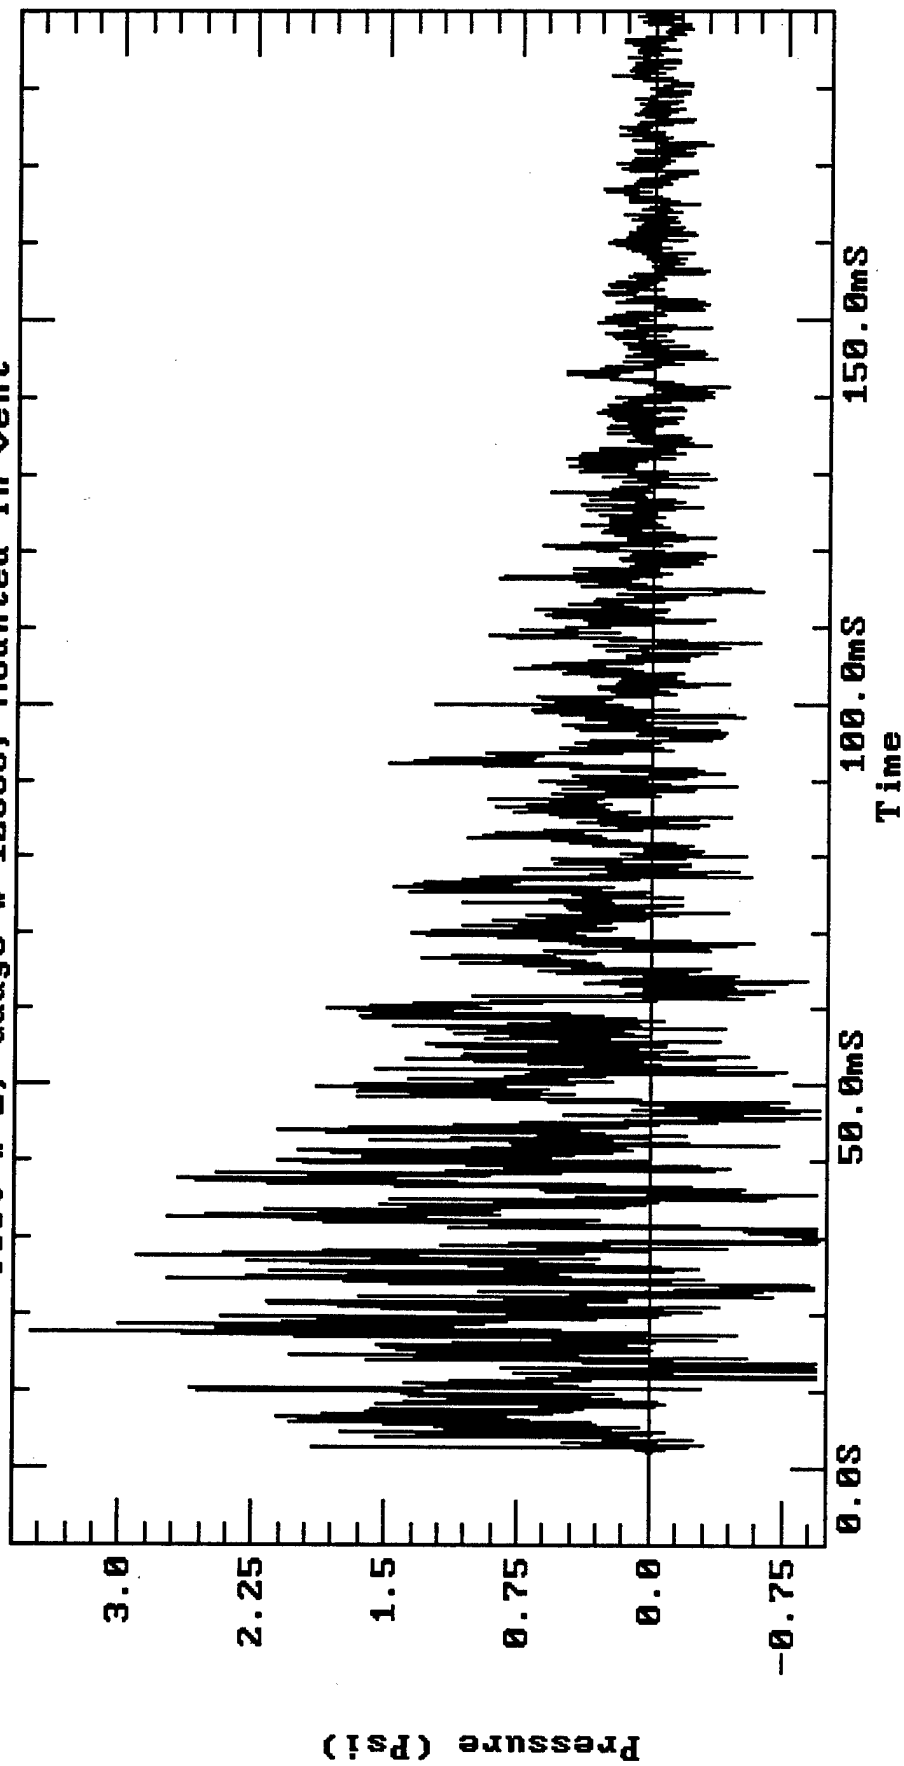
Experimental Facility 108 A/B Blast Tests, 11/8/99
Test # 2, Gauge # 12638, Mounted in Vent

Figure 15. Test 2 long duration time history of pressure gauge mounted in vent.

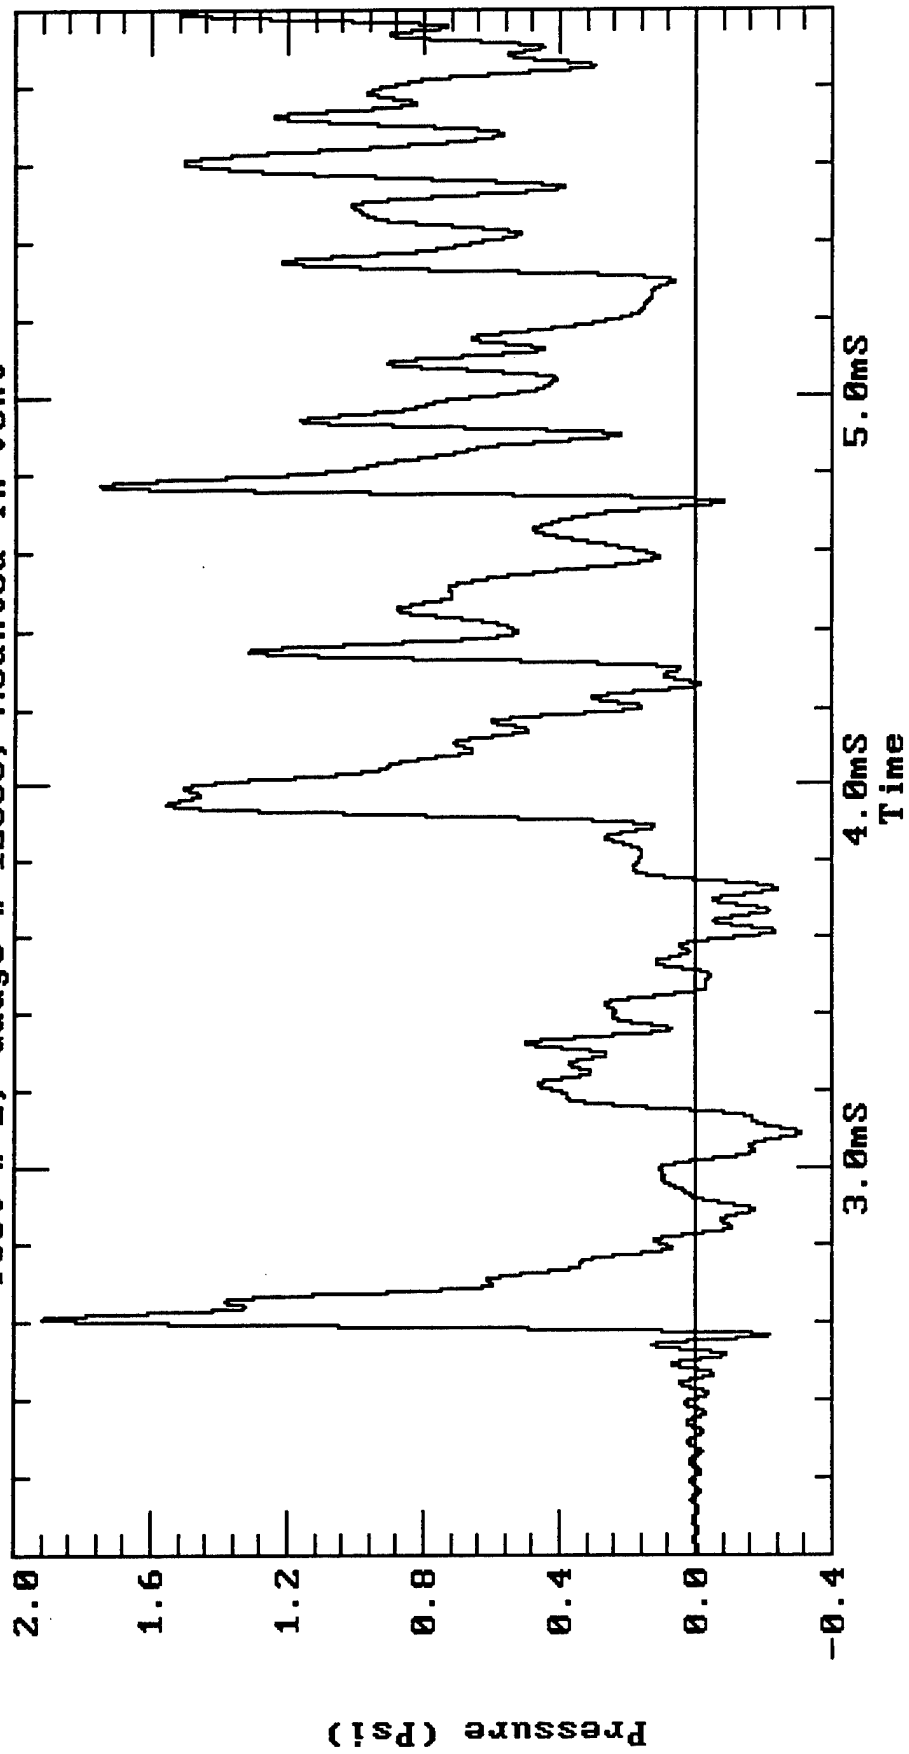
Experimental Facility 108 A/B Blast Tests, 11/8/99
Test # 2, Gauge # 12638, Mounted in Vent

Figure 16. Test 2 short duration time history of pressure gauge mounted in vent.

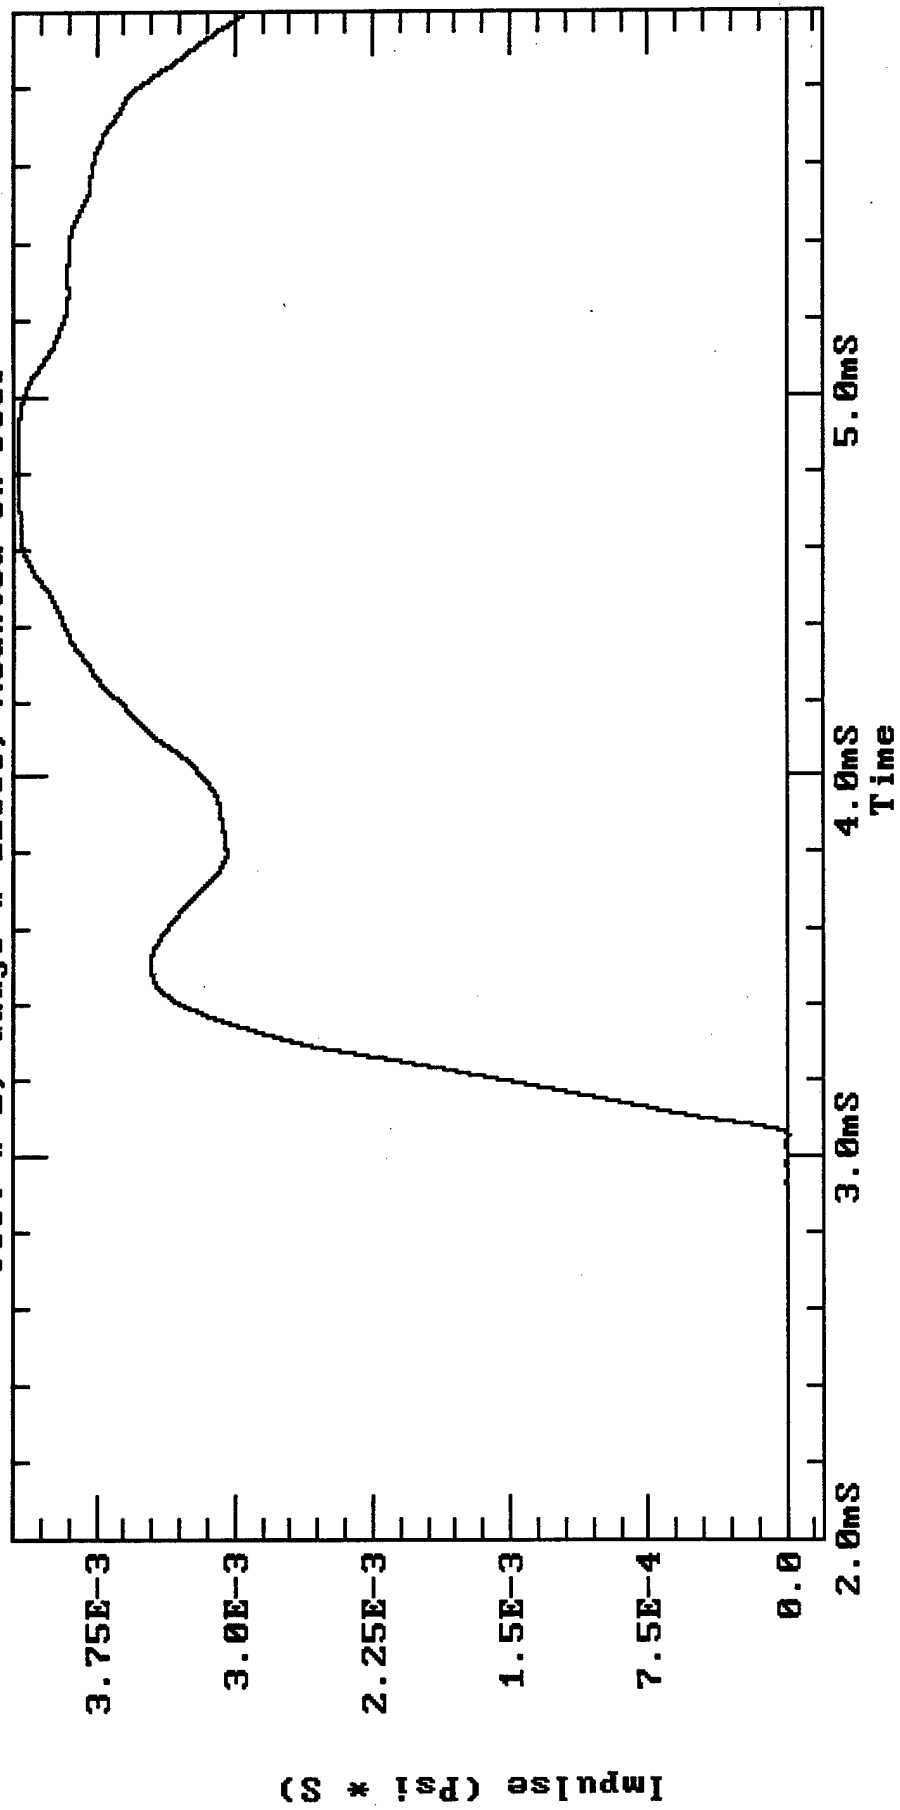
Experimental Facility 108 A/B Blast Tests, 11/8/99
Test # 2, Gauge # 12636, Mounted on Door

Figure 17. Test 2 impulse measured at the door.

A maximum pressure of 14.1 psi was measured on the door with an impulse of 3.4E-3 psi · s. Figure 17 shows the impulse of the initial pressure wave striking the door of the chamber. A maximum pressure of 3.5 psi was measured at the entrance to the vent. No damage was done to the chamber.
