ARL Experimental Facility 108 A/B Blast Tests - Summary Report

ARL-MR-511

April 2001

Weapons and Materials Research Directorate, ARL

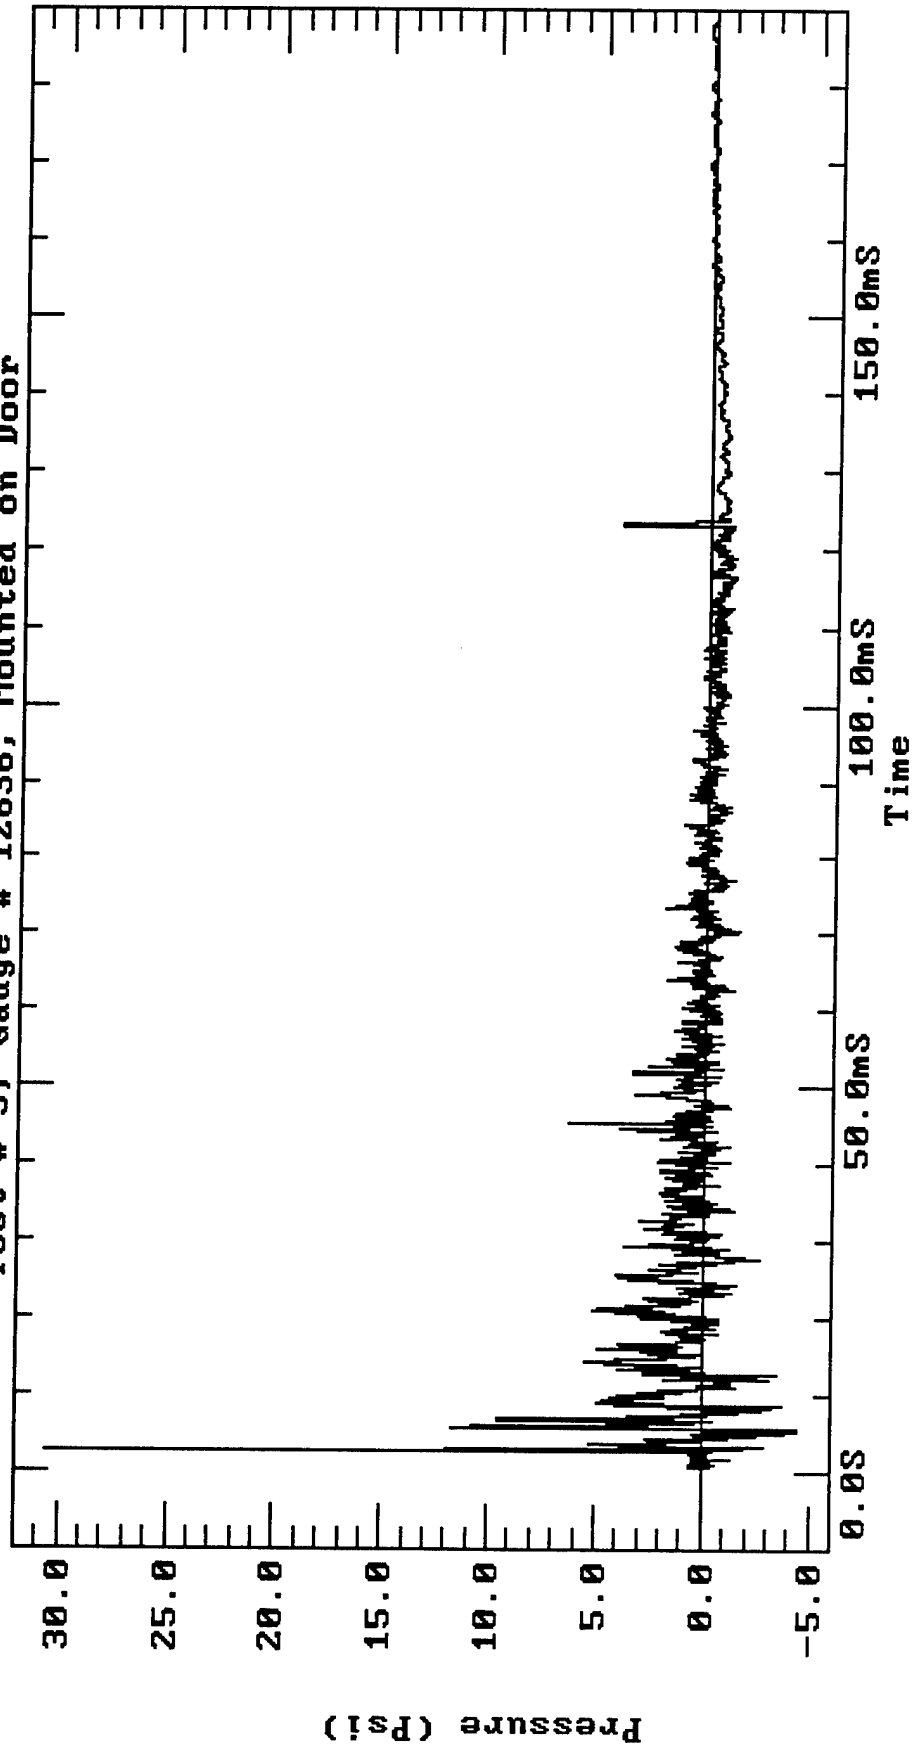
Experimental Facility 108 A/B Blast Tests, 11/8/99
Test # 3, Gauge # 12636, Mounted on Door

Figure 18. Test 3 long duration time history of pressure gauge mounted on door.

In test no. 3, a 50-g sphere of Detasheet was detonated. The baffle door was open for this test. Time histories from the gauges are shown in Figures 18–21.

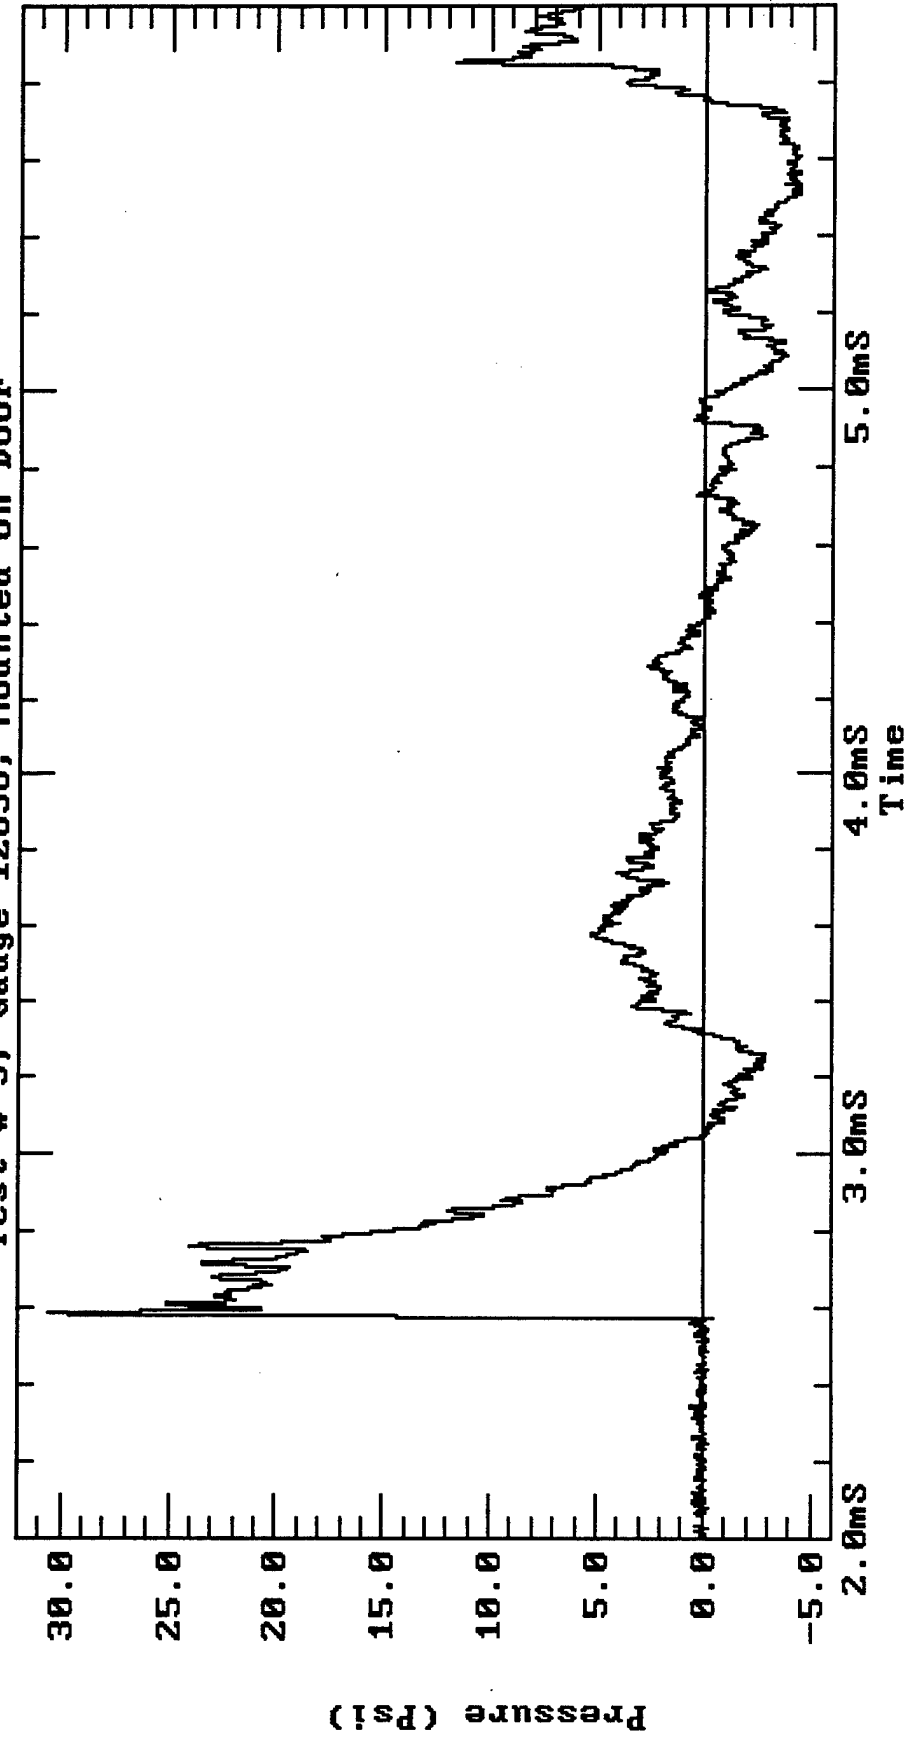
Experimental Facility 108 A/B Blast Tests, 11/8/99
Test # 3, Gauge 12636, Mounted on Door

Figure 19. Test 3 short duration time history of pressure gauge mounted on door.

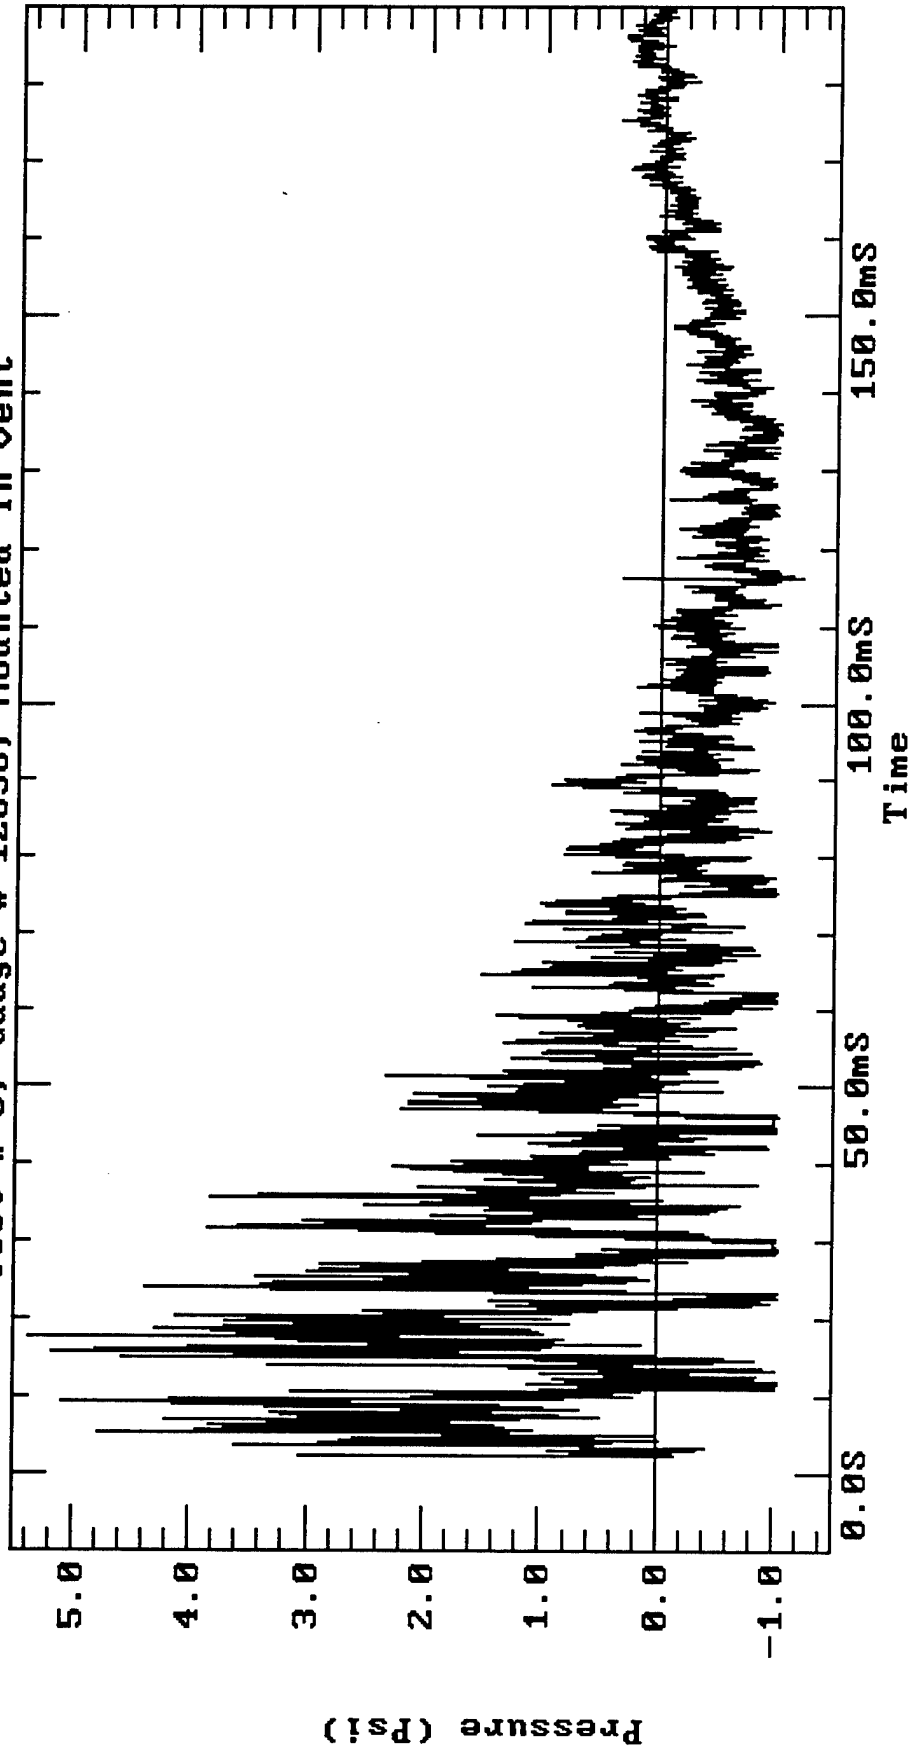
**Experimental Facility 108 A/B Blast Tests, 11/8/99
Test # 3, Gauge # 12638, Mounted in Vent**

Figure 20. Test 3 long duration time history of pressure gauge mounted in vent.

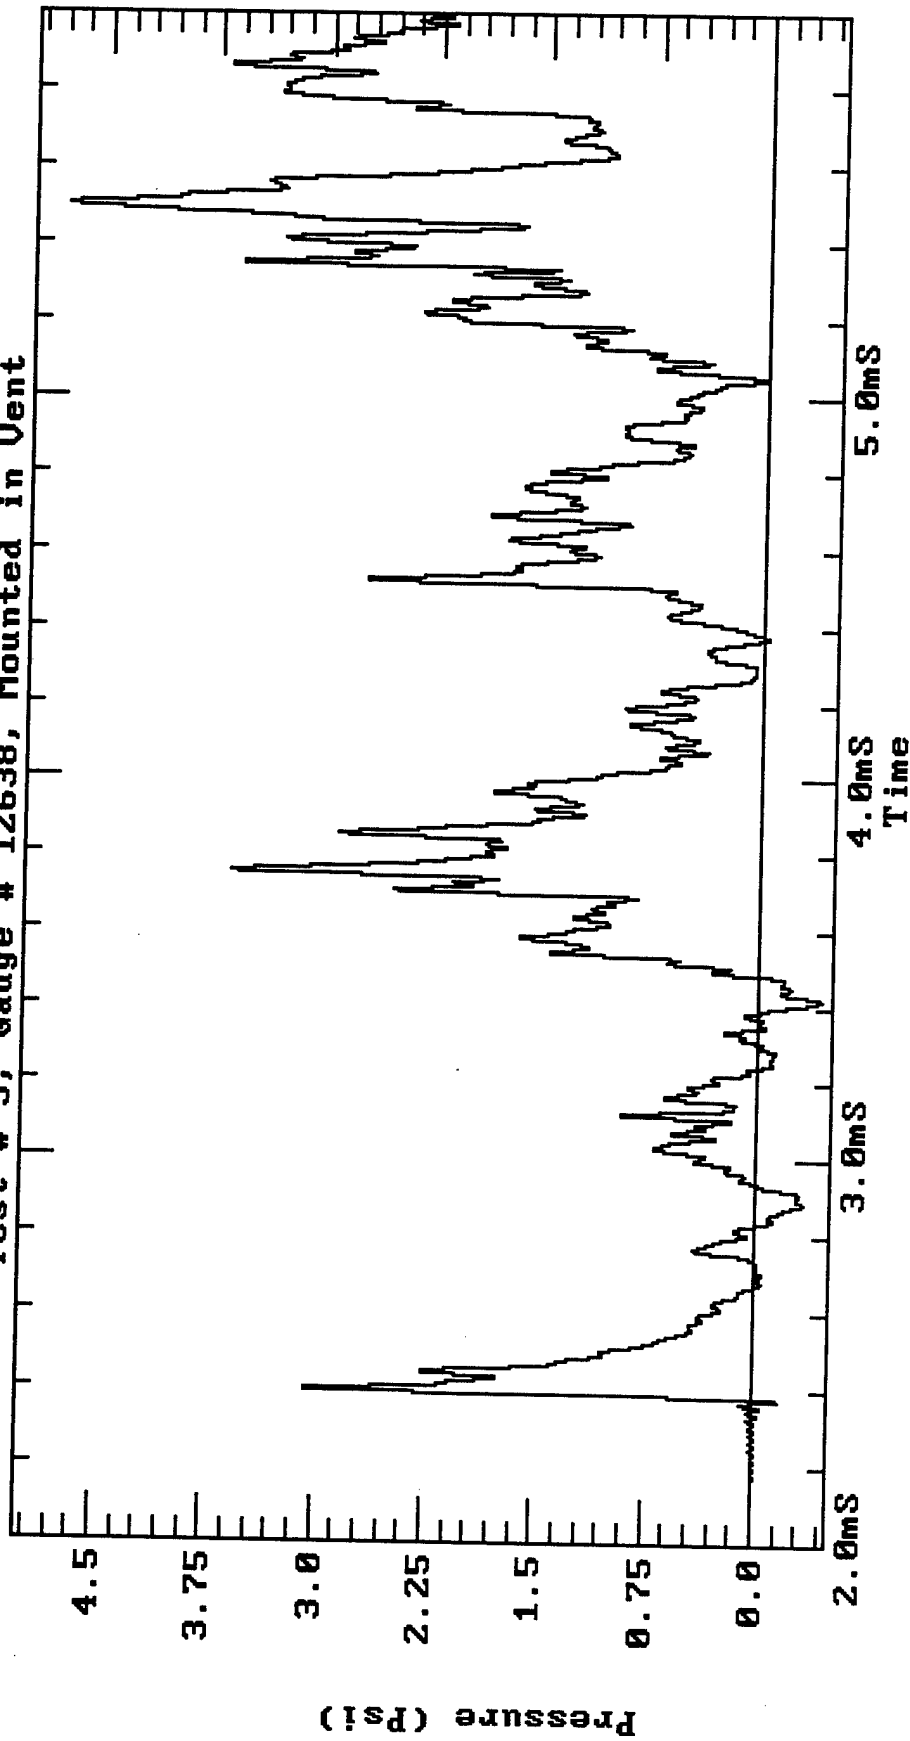
**Experimental Facility 108 A/B Blast Tests, 11/8/99
Test # 3, Gauge # 12638, Mounted in Vent**

Figure 21. Test 3 short duration time history of pressure gauge mounted in vent.

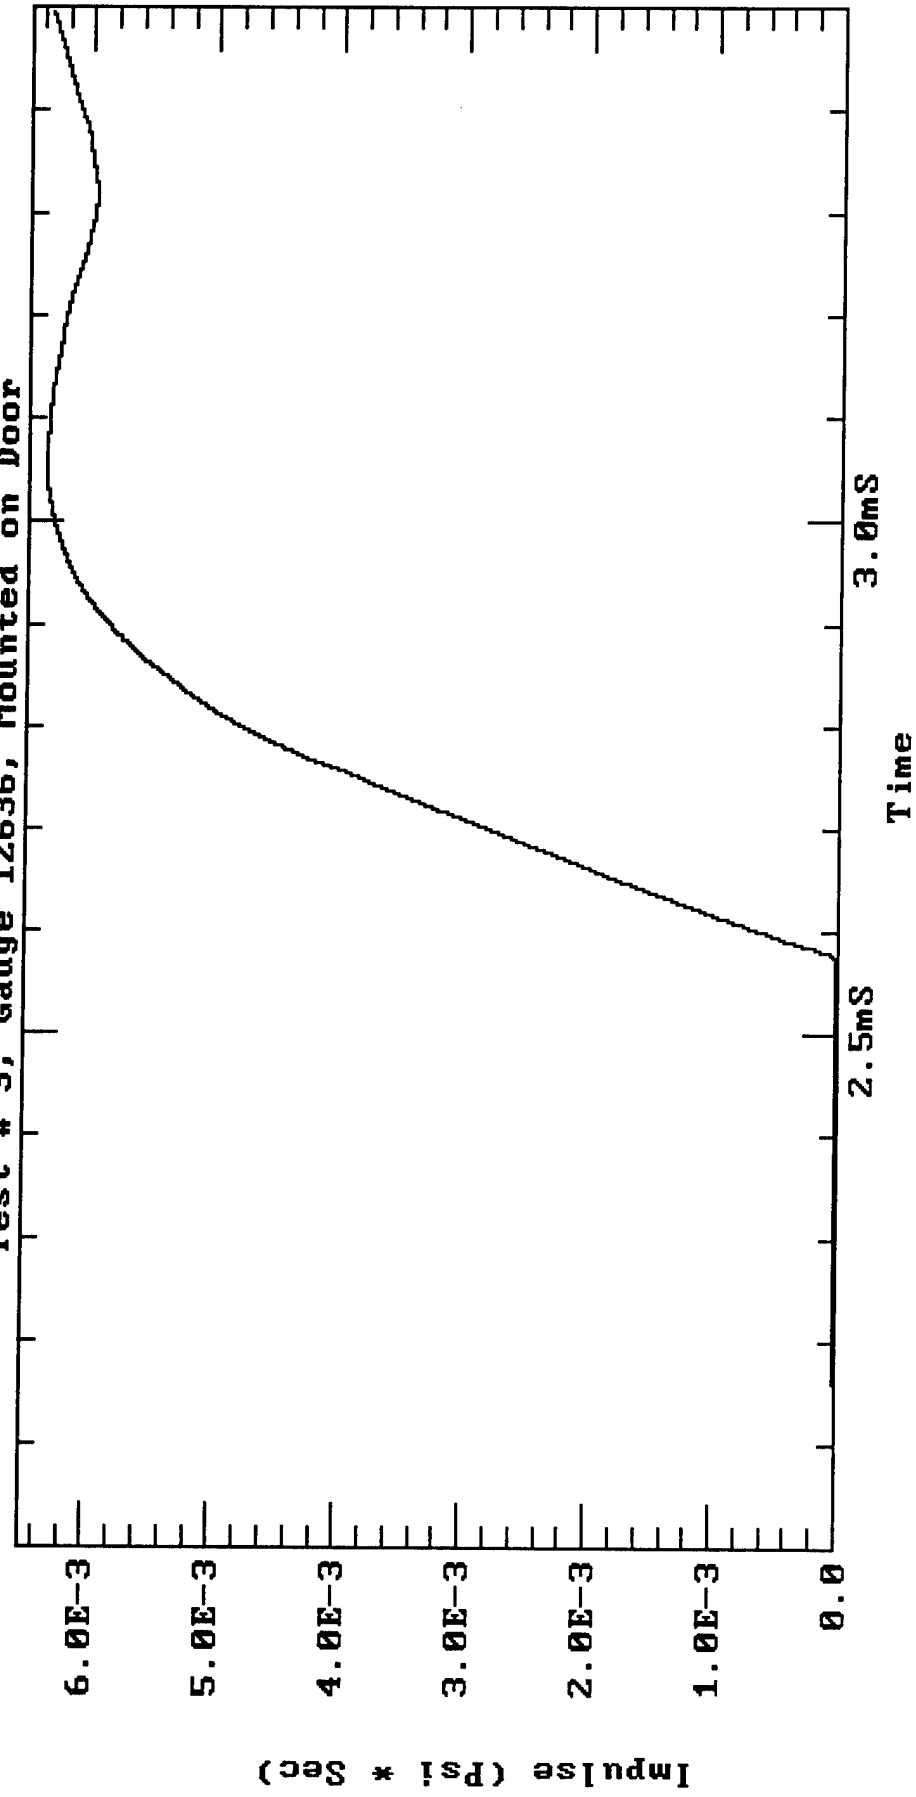
Experimental Facility 108 A/B Blast Tests, 11/8/99
Test # 3, Gauge 12636, Mounted on Door

Figure 22. Test 3 impulse measured at the door.

A maximum pressure of 30.5 psi was measured on the door with an impulse of 6.4E-3 psi · s. Figure 22 shows the impulse of the initial pressure wave striking the door of the chamber. A maximum pressure of 5.4 psi was measured at the entrance to the vent. In this test, the pin locking mechanism for the chamber door was severely bent as shown in Figures 23 and 24.

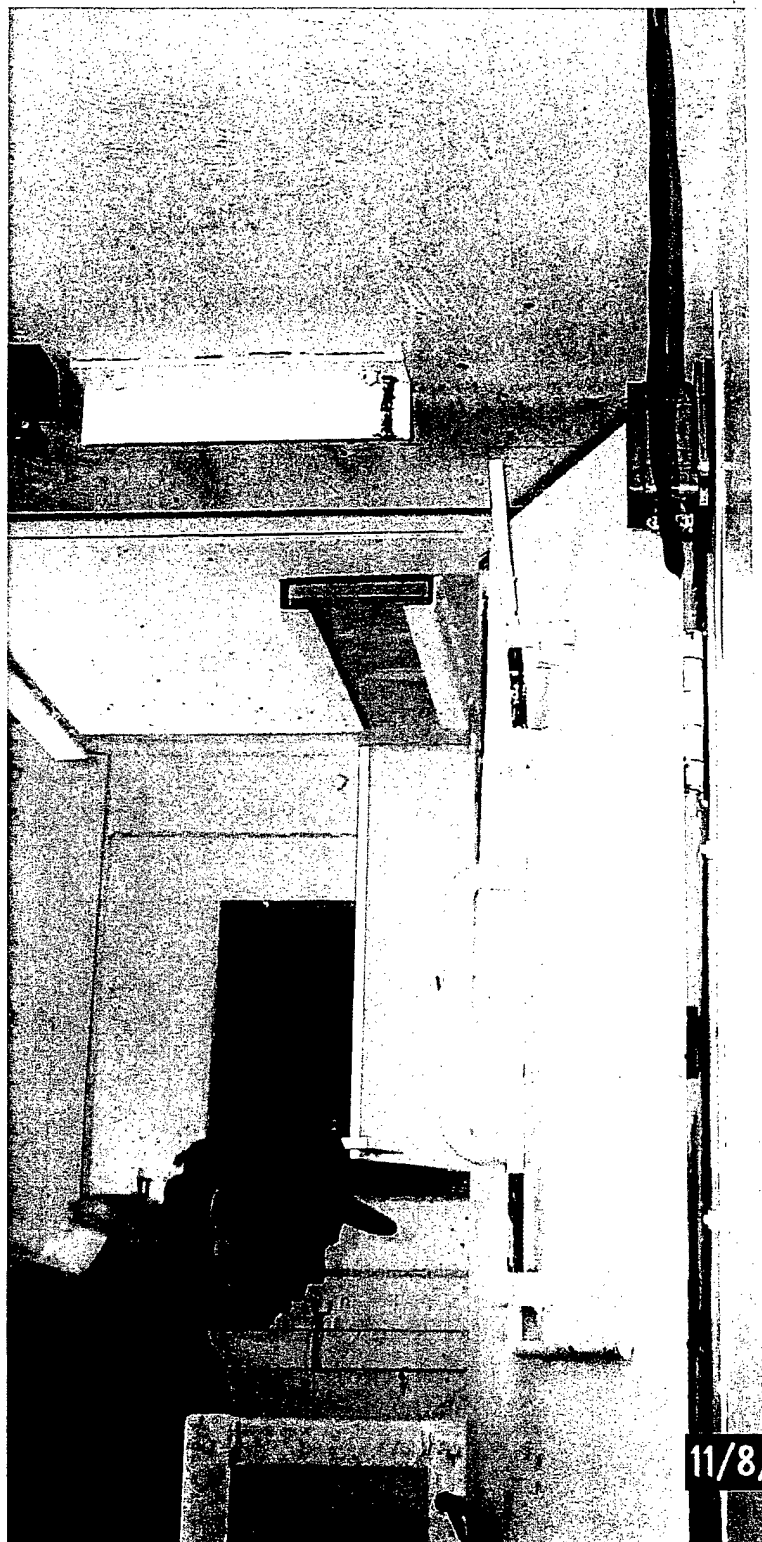
Figure 23. Photograph of door with damaged locking mechanism.

A maximum allowable explosive weight for this chamber should be less than 50 g of explosive unless modifications are made to the chamber door locking mechanism and other critical areas. No damage was seen at 35 g of explosive with the baffle open. The door should be secured with the locking mechanism instead of a c-clamp. Peak pressures at the vent were relatively low—especially the initial blast wave that was seen at the entrance to the vent. Over time, the peak pressure ramped up due to multiple reflections and the establishment of a quasi-static over pressure. The maximum pressure at the vent was 5.4 psi, but it should be noted that the vent is partially blocked by a steel interior door.

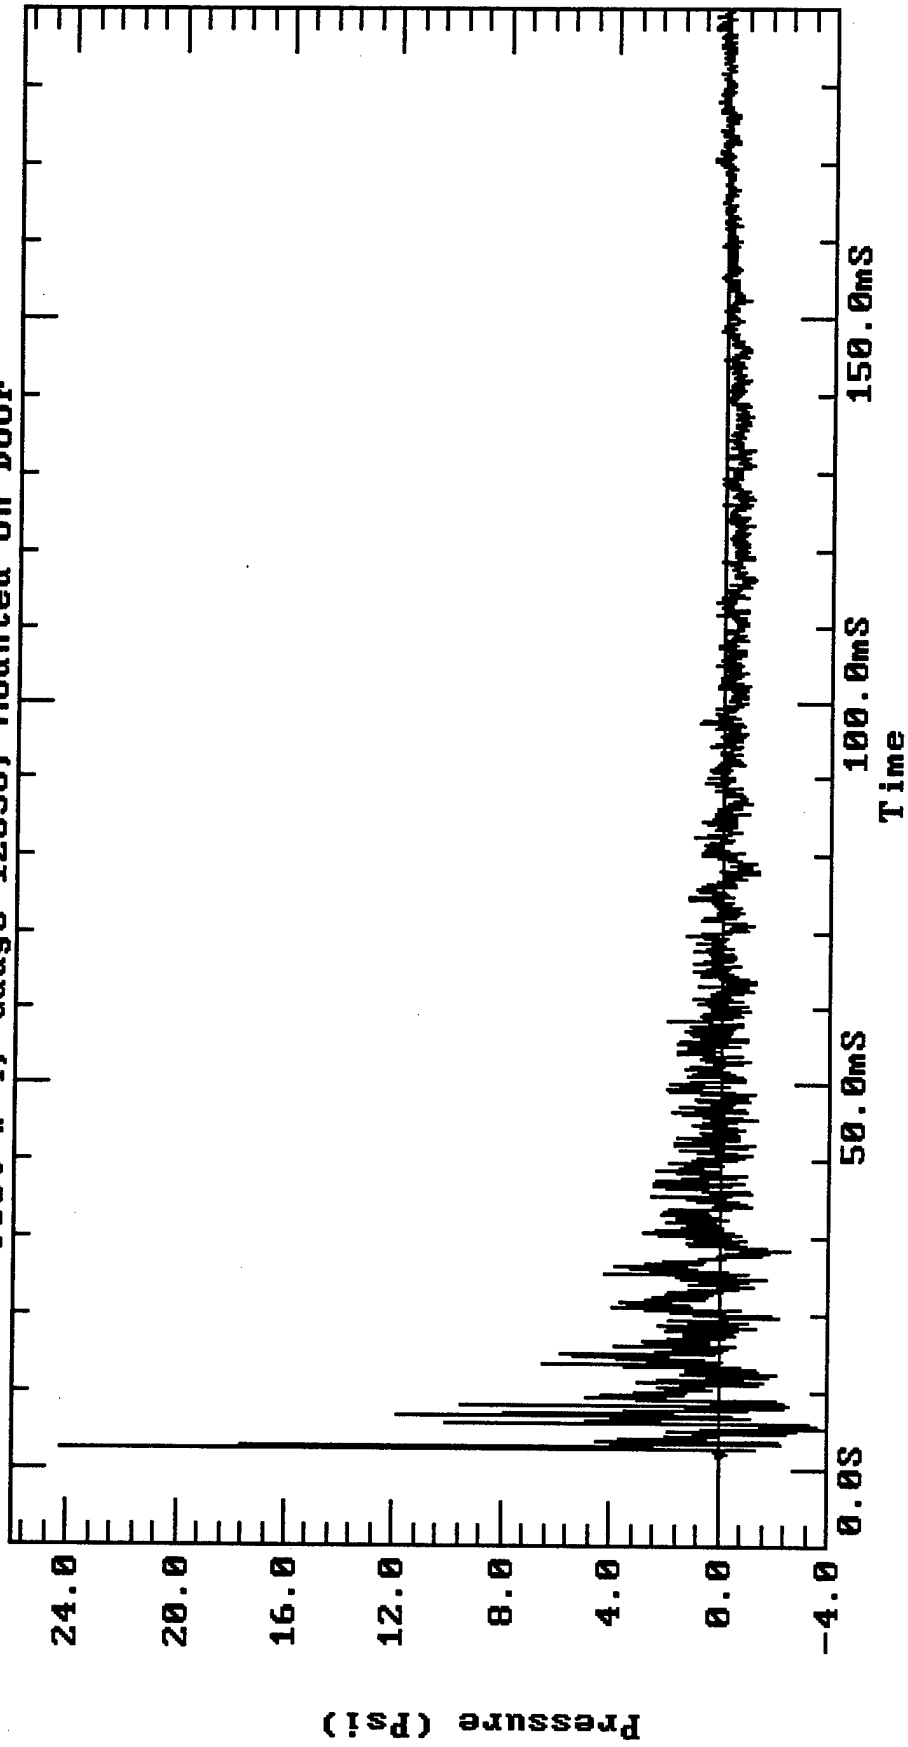
**Experimental Facility 108 A/B Blast Tests, 11/8/99
Test # 4, Gauge 12636, Mounted on Door**

Figure 25. Test 4 long duration time history of pressure gauge mounted on door.

In test no. 4, a 35-g sphere of Detasheet was detonated. Again, the baffle door was open for this test. Time histories from the gauges are shown in Figures 25–28.

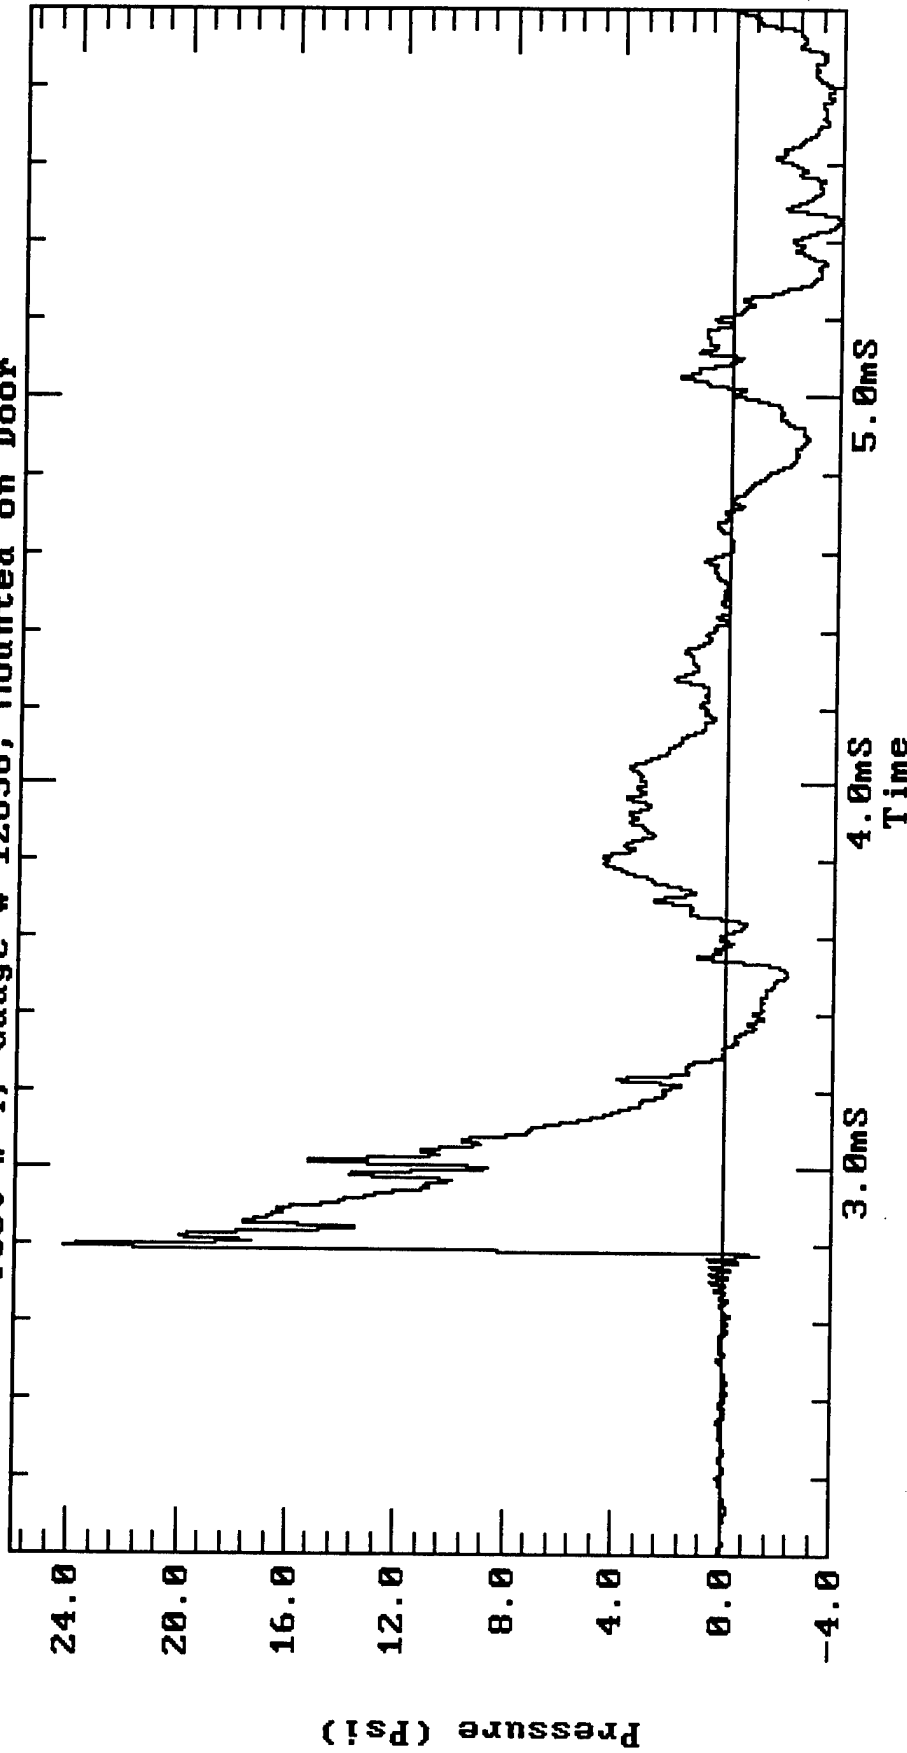
**Experimental Facility 108 A/B Blast Tests, 11/8/99
Test # 4, Gauge # 12636, Mounted on Door**

Figure 26. Test 4 short duration time history of pressure gauge mounted on door.

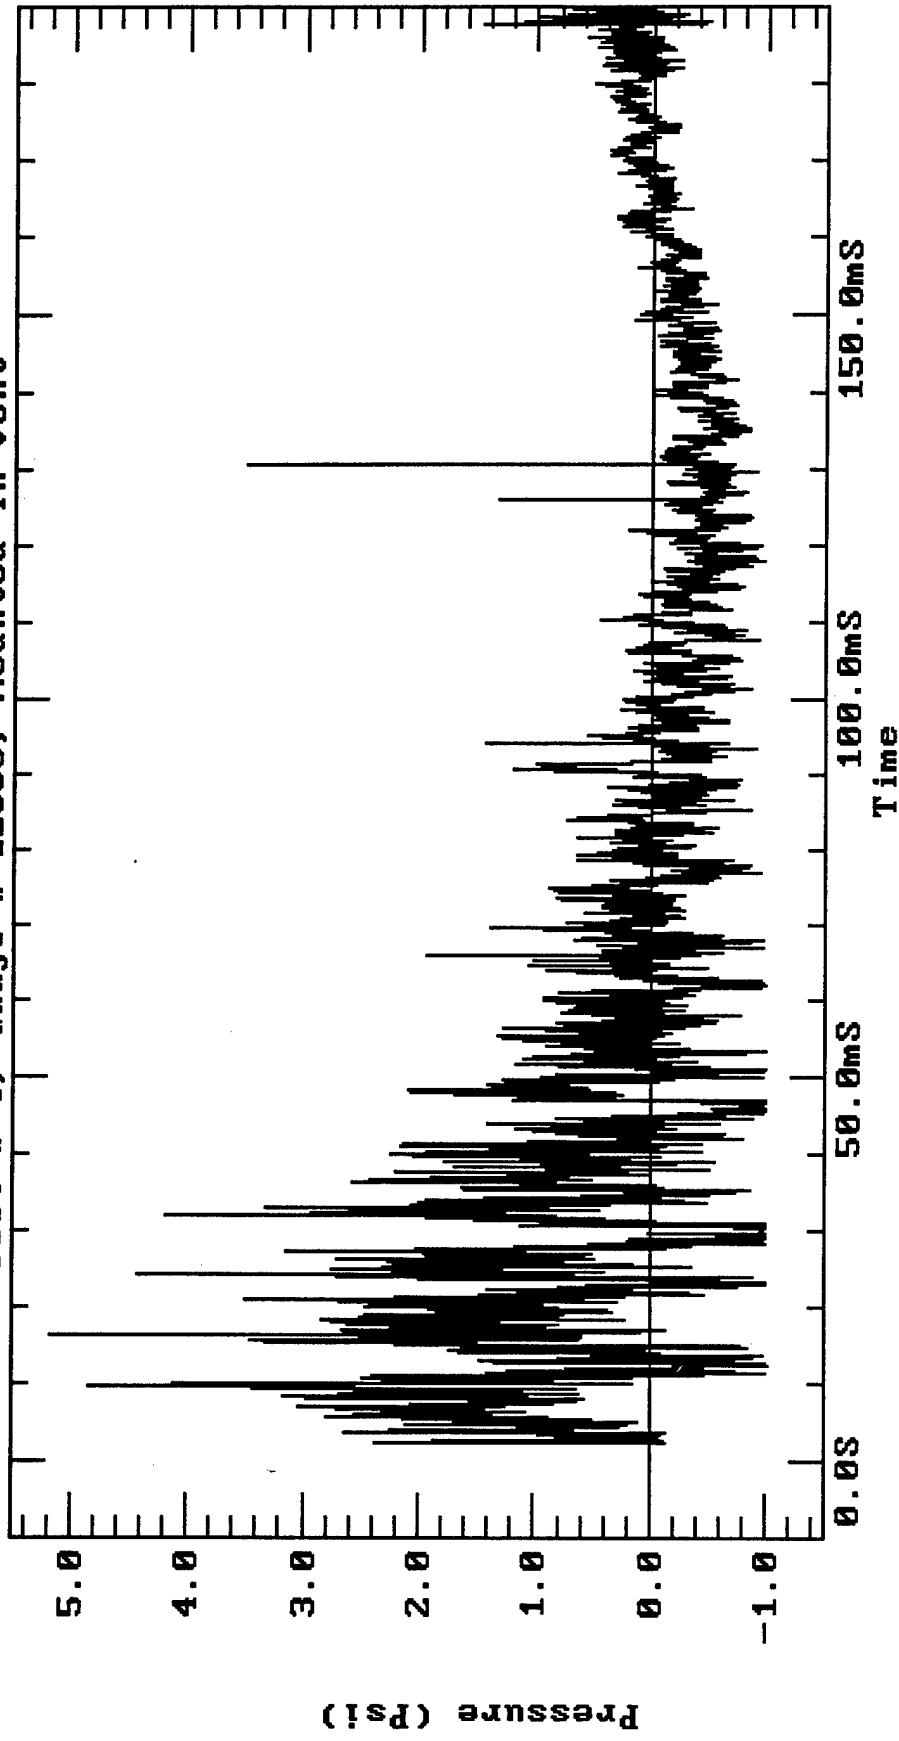
**Experimental Facility 108 A/B Blast Tests, 11/8/99
Test # 4, Gauge # 12638, Mounted in Vent**

Figure 27. Test 4 long duration time history of pressure gauge mounted in vent.

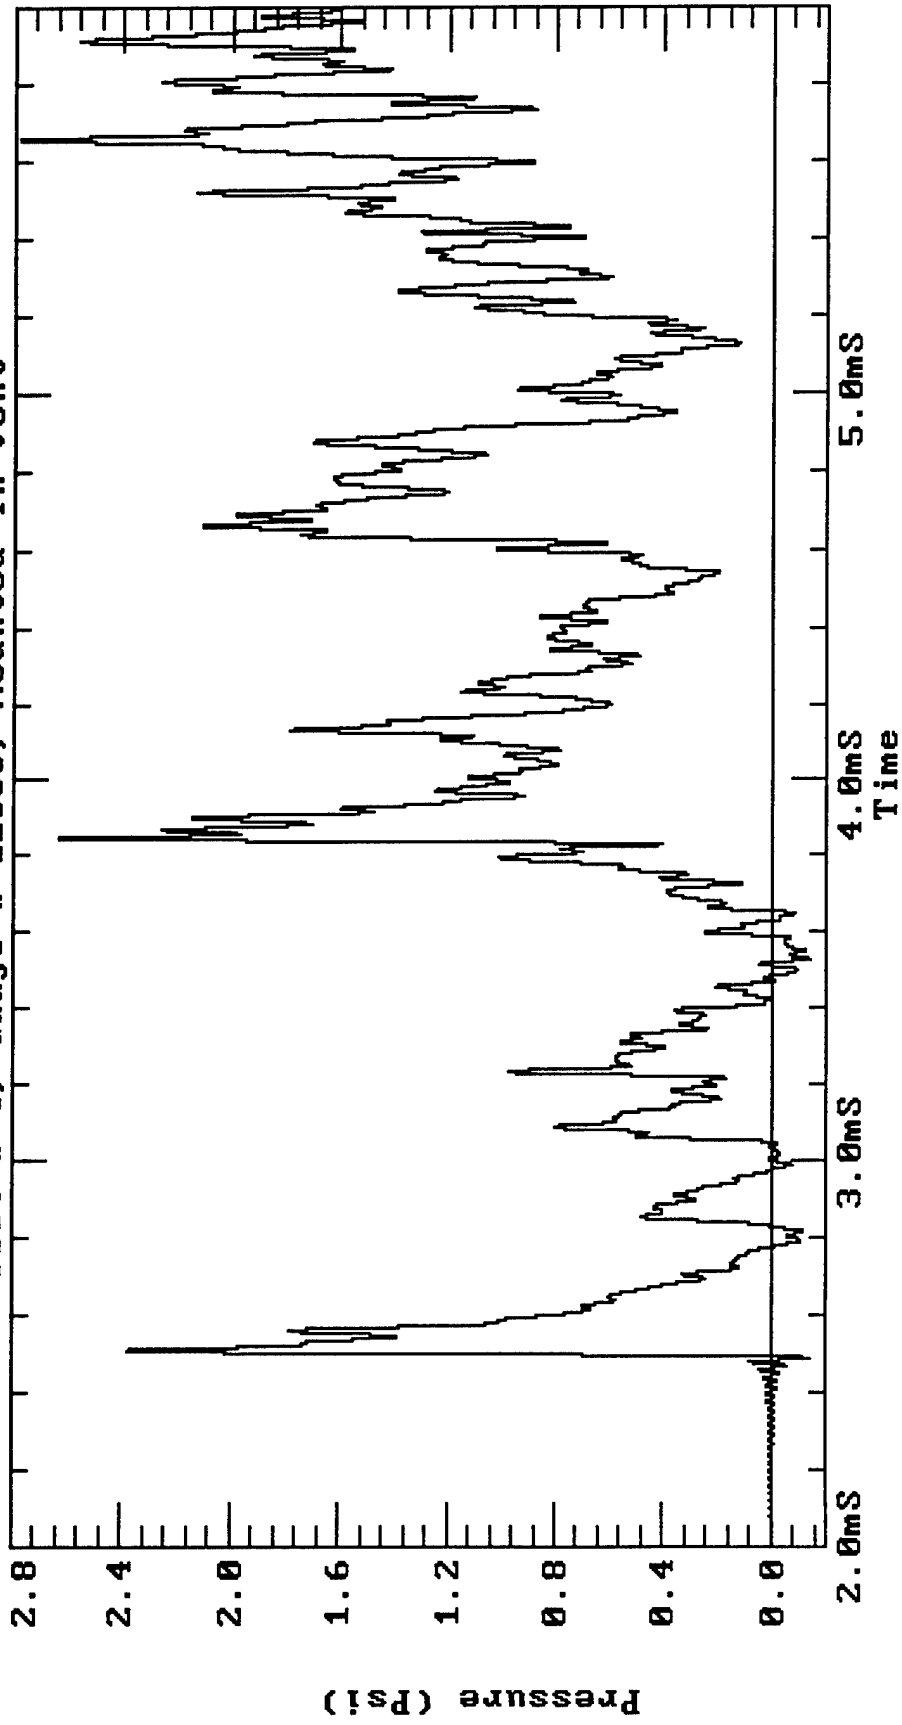
Experimental Facility 108 A/B Blast Tests, 11/8/99
Test # 4, Gauge # 12638, Mounted in Vent

Figure 28. Test 4 short duration time history of pressure gauge mounted in vent.

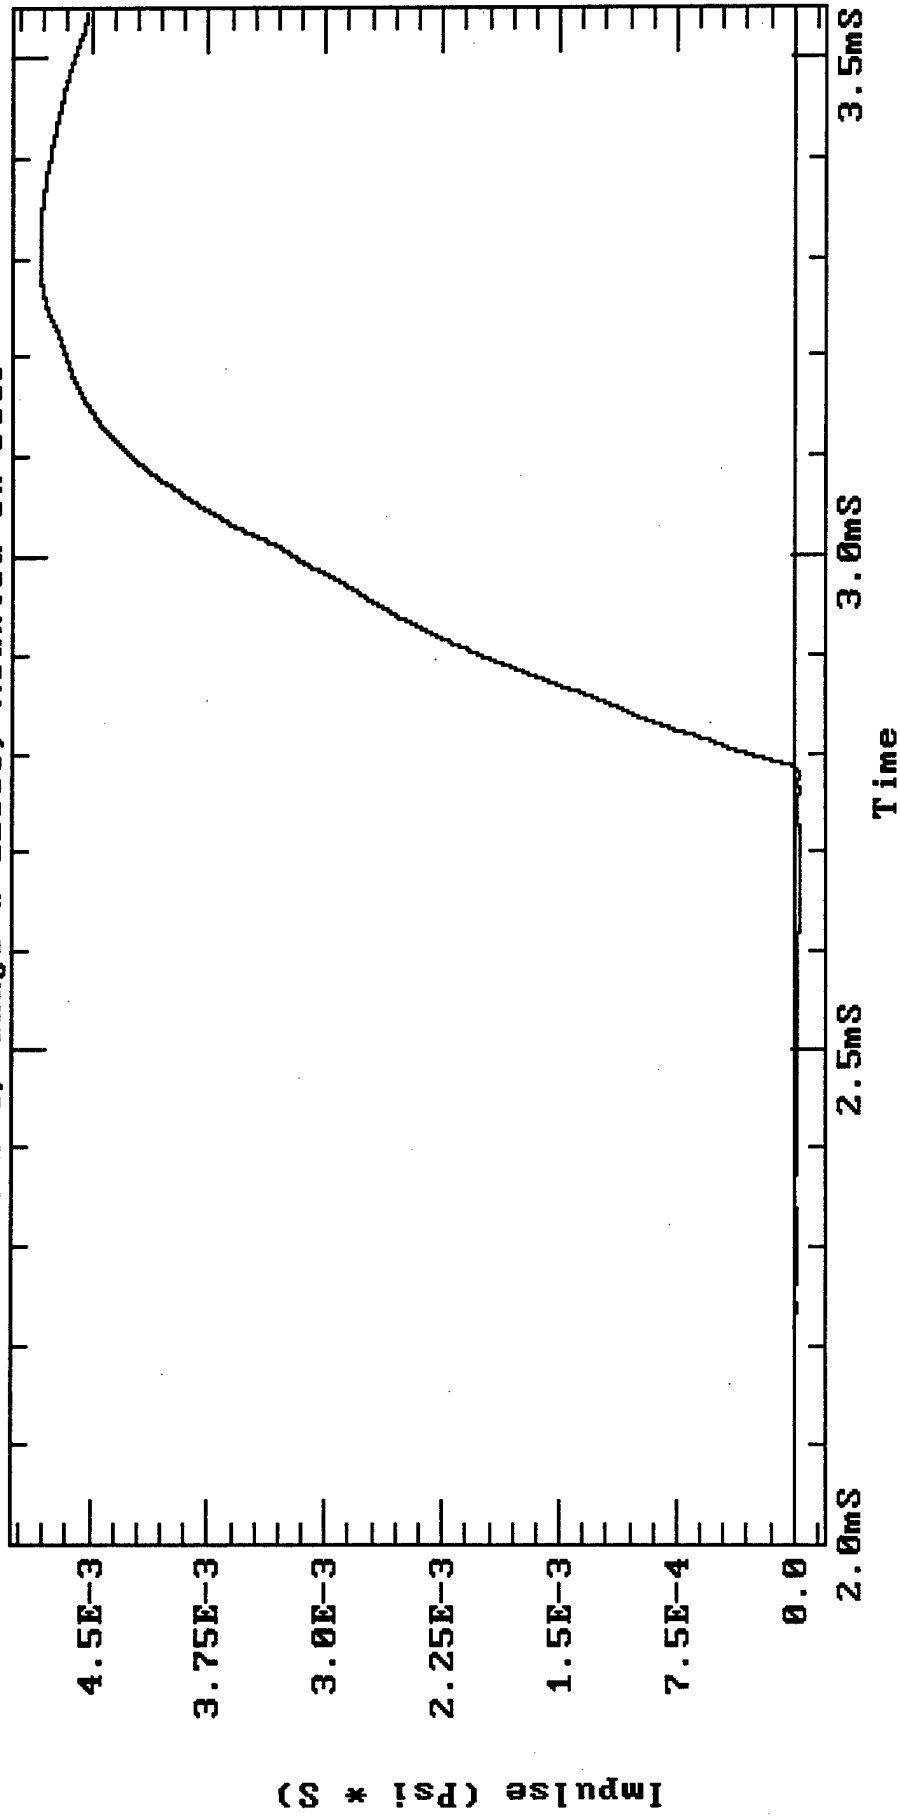
Experimental Facility 108 A/B Blast Tests, 11/8/99
Test # 4, Gauge # 12636, Mounted on Door

Figure 29. Test 4 impulse measured at the door.

A maximum pressure of 14.1 psi was measured on the door with an impulse of 3.4E-3 psi · s. Figure 29 shows the impulse of the initial pressure wave striking the door of the chamber. A maximum pressure of 3.5 psi was measured at the entrance to the vent. In this test, a c-clamp was used to temporarily secure the chamber door. The c-clamp was knocked loose during the detonation, but no other damage was found in the chamber.

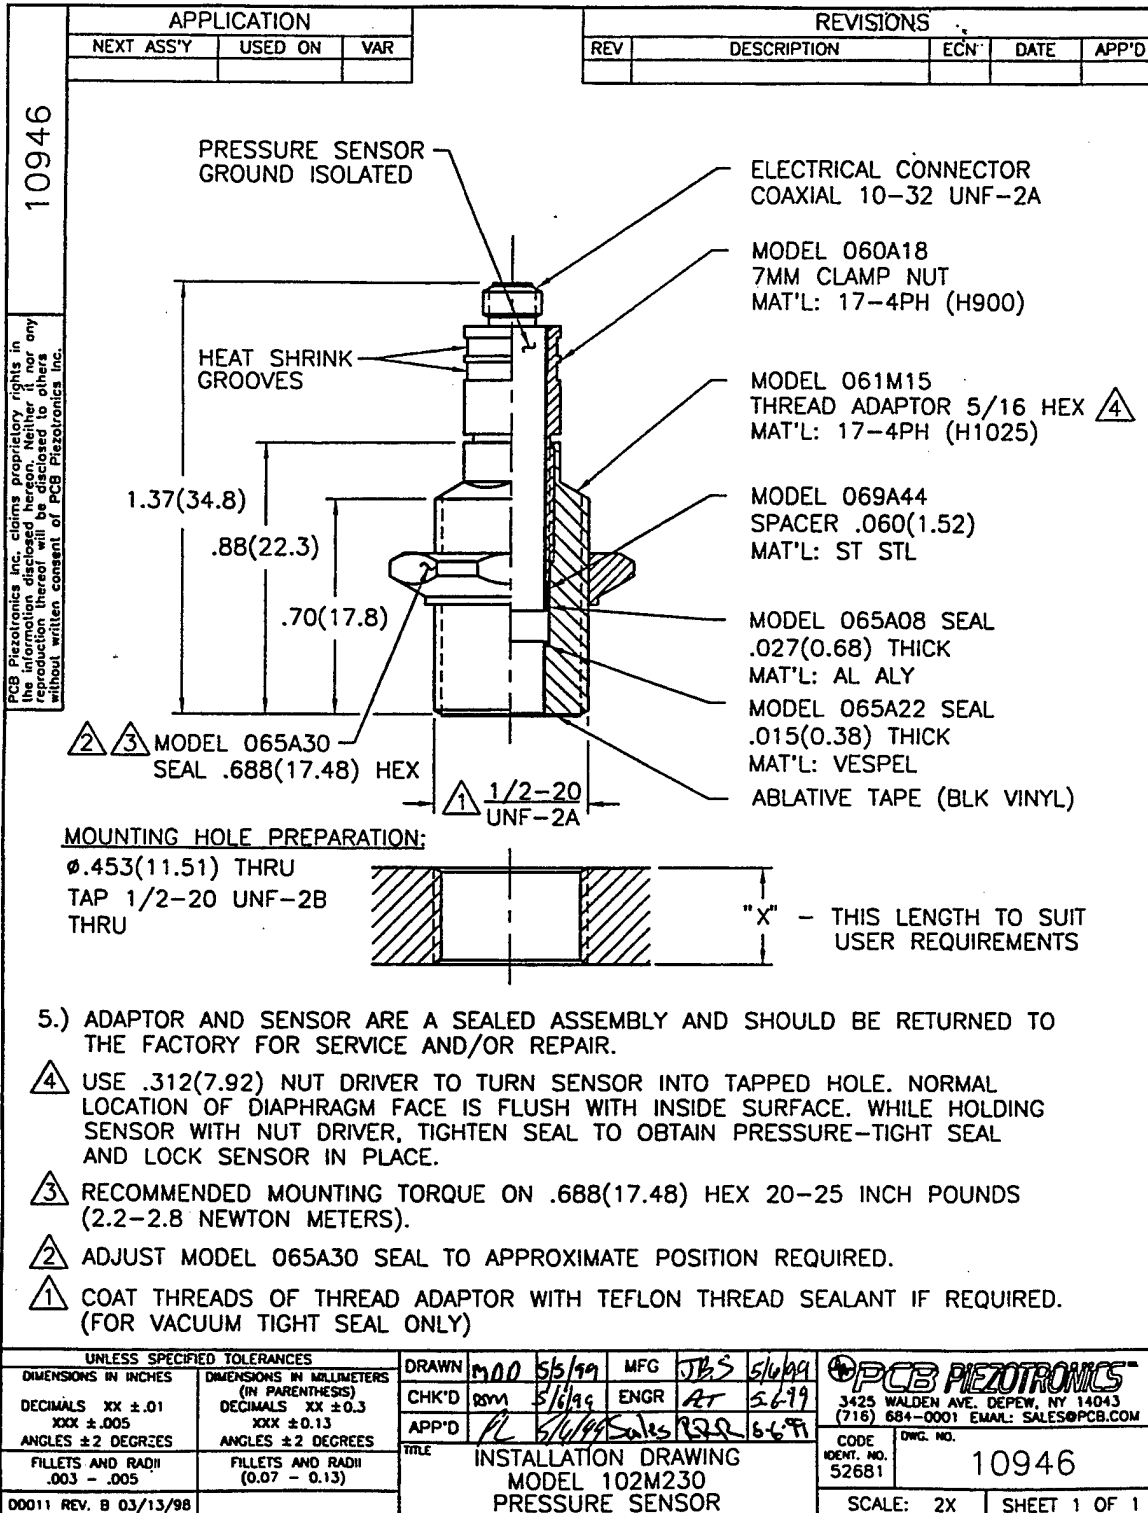
Figure A-1. Engineering drawing of PCB 102M230 pressure gauge.

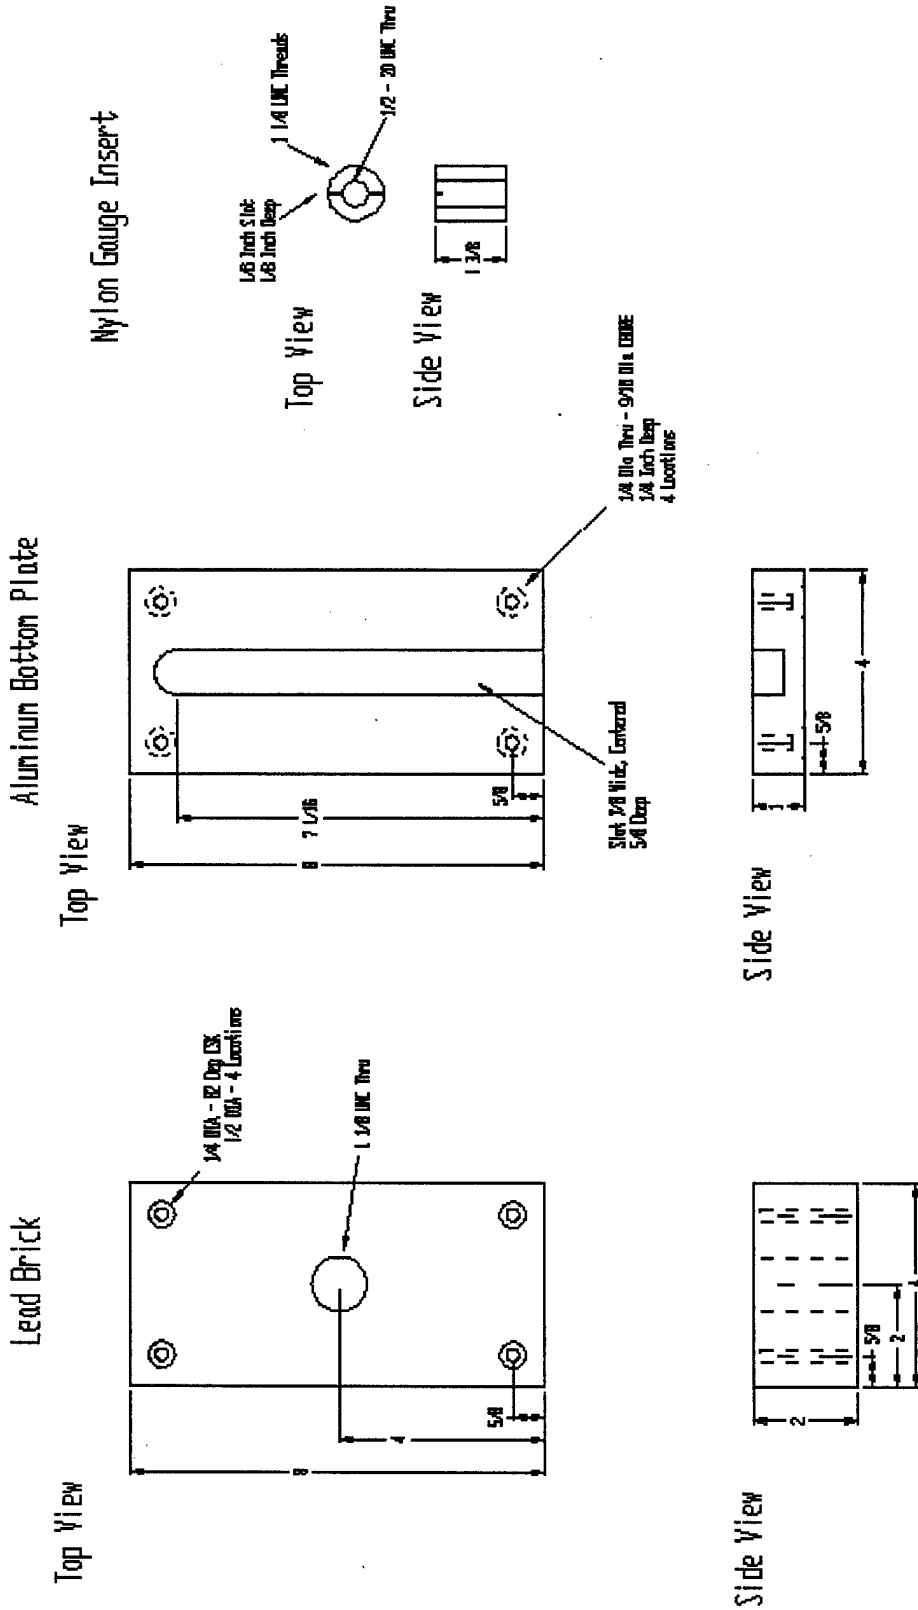
Figure A-3. Engineering drawing of lead "pig" pressure transducer mount.

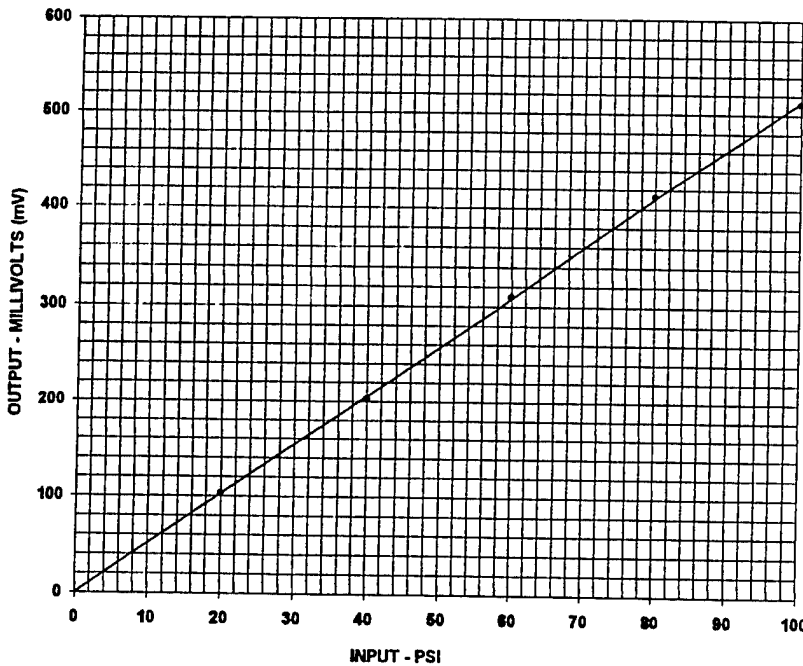
Model: 102M230
 Serial #: 12636
 Description: Pressure Sensor
 Type: ICP

Sensitivity*: 5.133 mV/PSI
 Linearity*: 0.46% FS

INPUT (PSI)	OUTPUT (mV)
20	103
40	203
60	310
80	413
100	511

Figure A-4. Calibration sheet for pressure transducer mounted on door.

pressure transducers can be found in Figures A-4 and A-5.) Figure 5 shows the approximate layout of the chamber with dimensions. The approximate volume of the chamber is 669 ft³. The chamber has an additional baffle that can be opened. This baffle has a 107-ft² opening and is shown in Figures 2 and 6.

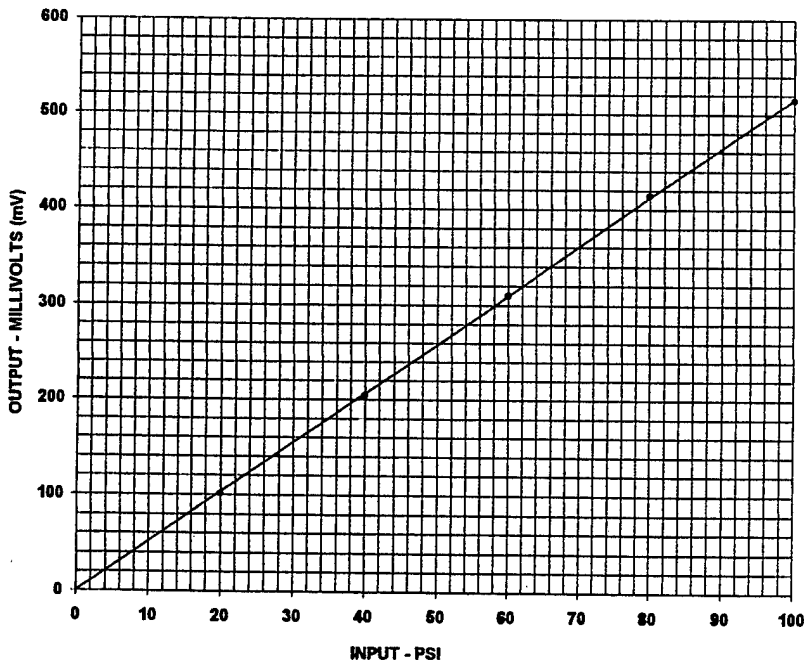
Model: 102M230
Serial #: 12638 Nat'l Freq: 550 kHz Date: 5/4/99
Description: Pressure Sensor By: Tom Johnston, Cal. Tech.
Type: ICP Station: Dead Weight #1

Sensitivity*: 5.158 mV/PSI
Linearity*: 0.45% FS

INPUT (PSI)	OUTPUT (mV)
20	101
40	204
60	310
80	415
100	515

Figure A-5. Calibration sheet for pressure transducer mounted in vent.
