<b>1. REPORT DATE (DD-MM-YYYY)</b> 22/02/2001		<b>2. REPORT TYPE</b> Final technical report		<b>3. DATES COVERED (From - To)</b> 6/1/97-5/31/00	
<b>4. TITLE AND SUBTITLE</b> AASERT - Fabrication and Characterization of Photoconductive AlGa <sub>N</sub> Detectors / Structural Characterization of SiC Wafers				<b>5a. CONTRACT NUMBER</b> F49620-97-1-0452	
				<b>5b. GRANT NUMBER</b>	
				<b>5c. PROGRAM ELEMENT NUMBER</b>	
<b>6. AUTHOR(S)</b> Marek Skowronski				<b>5d. PROJECT NUMBER</b>	
				<b>5e. TASK NUMBER</b>	
				<b>5f. WORK UNIT NUMBER</b>	
<b>7. PERFORMING ORGANIZATION NAME(S) AND ADDRESS(ES)</b> Carnegie Mellon University Schenley Park Pittsburgh, PA 15213				<b>8. PERFORMING ORGANIZATION REPORT NUMBER</b>	
<b>9. SPONSORING / MONITORING AGENCY NAME(S) AND ADDRESS(ES)</b> AFOSR/NE, 801 North Randolph Street, Arlington VA 22203 Contract monitor: Maj. D. K. Johnstone				<b>10. SPONSOR/MONITOR'S ACRONYM(S)</b> AFOSR

**Final Technical Report**  
**AFOSR Grant F49620-97-1-0452**  
**June 1, 1997 –May 1, 2000**

**Marek Skowronski**  
**Department of Materials Science and Engineering**  
**Carnegie Mellon University**  
**Pittsburgh, PA 15213**

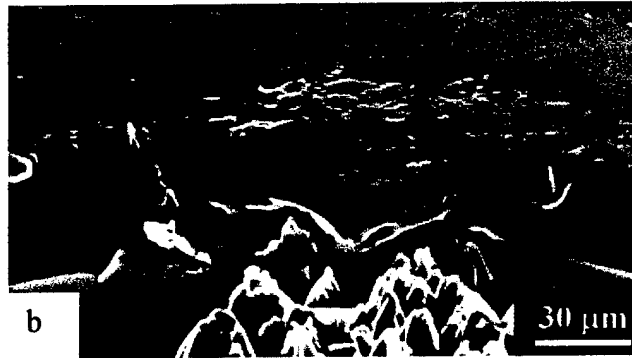
Fig. 9. Optical (a) and SEM (b) micrographs of void formation at the seed / crucible interface. Regions (N) are overhangs that protrude into the void interior.

Fig. 9 shows images of the early stages of hexagonal void formation in a short growth experiment. A Lely seed was attached to a graphite crucible cap using sucrose as an attachment layer. The crucible bottom and top temperatures were 2200 °C and 2090 °C, respectively. The argon growth pressure was 2 torr, yielding a growth rate of approximately 0.5 mm/hr. The growth was interrupted after 8 hours in order to see the formation of hexagonal voids. After growth, the crystal was removed from the cap by grinding away most of the graphite and oxidizing the remaining material. The interface between the seed and crucible cap is shown in Fig. 9. Fig. 9(a) is an optical image in reflection of a hexagonal depression with dimensions similar to that of a hexagonal void that can be found in crystals grown for a long time. The depression has an out of focus region in the center that corresponds to the top of the void, and black features that are areas of incomplete evaporation, as can be seen in Fig. 9(b). The void takes on a hexagonal shape immediately at the seed / lid interface with edges perpendicular to  $\langle 1\bar{1}00 \rangle$  directions. It is apparent that the void formed because of an imperfection or cavity in the attachment layer, and that transport occurred across the cavity in a manner similar to the transport during PVT growth. At the left and right edges of the void are regions (N) that protrude sideways into the void interior. Fig. 9(b) is a SEM micrograph showing a close-up of an (N) region seen on the left side of Fig. 9(a). The protrusion is an overhang that is not directly connected to the top of the void, and is most likely the initial stage of formation of the void bottom. The overhang has the same orientation as the surrounding crystal, as determined by orientation imaging microscopy. Sidewall nucleation and growth is supported by the lack of significant misorientation. If nucleation and growth had occurred on the crucible cap, then it would be expected that the volume beneath the void would be highly misoriented.

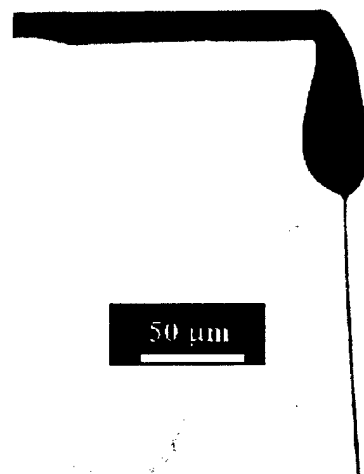
Fig. 12 Micropipe extended below the trench formed at the bottom of hexagonal void. This is the dominant formation mechanism for micropipes.

In order for screw dislocations to combine and micropipes to form, the dislocations must be forced together. The depressions that occur at the corner of the void, formed by the last closing regions of the growth front in the trench, provide the location for screw

dislocations to combine. If screw dislocations are in the region of the depression when it begins to close, then it is energetically more stable for the dislocation core to remain open because the surface energy of the open core is less than that of the strain energy of the closed core. The image forces associated with the large growth steps can push additional screw dislocations lined up in the trench along the edge of the void closer to the depressions at the void corners. According to Pirouz, once a dislocation is close enough (~5 nm) to a hole already containing a dislocation of the same sign (effectively a micropipe), then the force between the closed-core screw dislocation and open-core screw dislocation becomes attractive. Same-sign dislocations can combine in the hole, thus forming a micropipe at the bottom of a trench extending below the void.

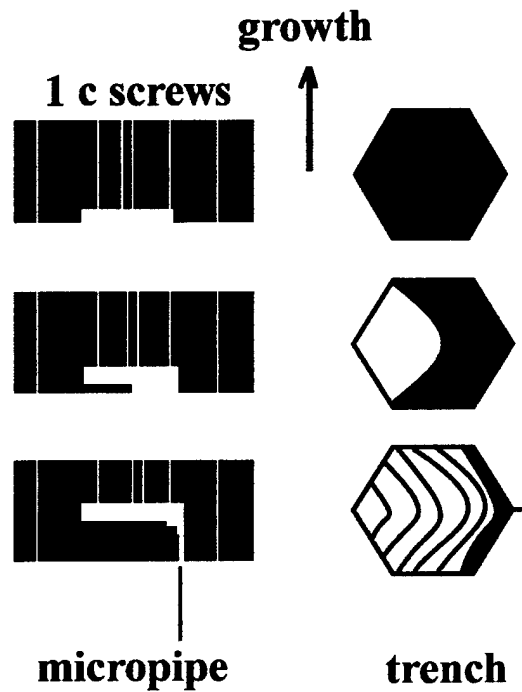
Fig. 13 Schematic diagram showing void formation and movement. The void begins as a cavity in the seed attachment layer, growth within the void occurs by lateral attachment and step flow, and the trench closes at the corners of the void, forming micropipes that extend beneath the void.

Fig. 13 is a schematic representation of the void and micropipe formation process. The PVT-grown wafers used as seeds typically contain  $10^4 \text{ cm}^{-2}$  threading edge dislocations and  $10^3$ - $10^4 \text{ cm}^{-2}$  elementary screw dislocations. The void moves into the crystal and immediately intersects dislocations, which now terminate at the top of the void still open to the back of the crystal. Nucleation occurs at the sidewall of the void, as can be seen in Fig. 8, and the void begins to close as it moves into the crystal. It is well known that dislocation lines cannot end inside a crystal; they must terminate at a <sup>b</sup> r dislocation or a free surface. Although the interior of a void may be considered a free surface, an enclosed cavity must have a net Burger's vector of zero. If the cavity surface divides in two (in our case the top and bottom void facets), then the net Burger's vector of each half must be equal. Consequently, if the net Burger's vector of dislocations terminating at the top of the void is not zero, then dislocations must be created in the recrystallized material beneath the void. This conserves the net Burgers vector between the top and bottom of

the void. Dislocations will likely form in the last closed regions of the void bottom where the convex growth front makes a hole with the angled corners of the void walls. Only basal plane dislocations should propagate into the growth homogeneously nucleated at a void sidewall; stresses, foreign material, and high supersaturations that normally result in dislocation formation are not present. In addition, the growth front of the closing void bottom does not initially have any support from either above or below. The cantilevered growth front could flex up or down under the influence of small forces, which in turn would cause the formation of additional dislocations not already present in the seed. Similarly, this effect was observed in the pendeo-epitaxy of GaN, where cantilevered lateral growth fronts contact to produce rows of dislocations. The strain associated with a dislocation increases the bond energy near the dislocation core, which in turn can lower the probability of adatom attachment. The growth rate near a dislocation is therefore expected to be slower. This leads to the formation of a trench opposite to the nucleation site. As the trench gets deeper, the temperature at its bottom will be colder than the rest of the void. Local supersaturation will eventually cause the trench to close, as discussed by Benema. The formation of a trench is also seen in GaN pendeo-epitaxy where the mating growth fronts do not completely close beneath the elevated GaN seeds.
