ERDC/EL SR-01-2

**Biological Assessment of Streams
Associated with the Northern Training
Complex at Fort Knox, Kentucky,
August 2000**

February 2001

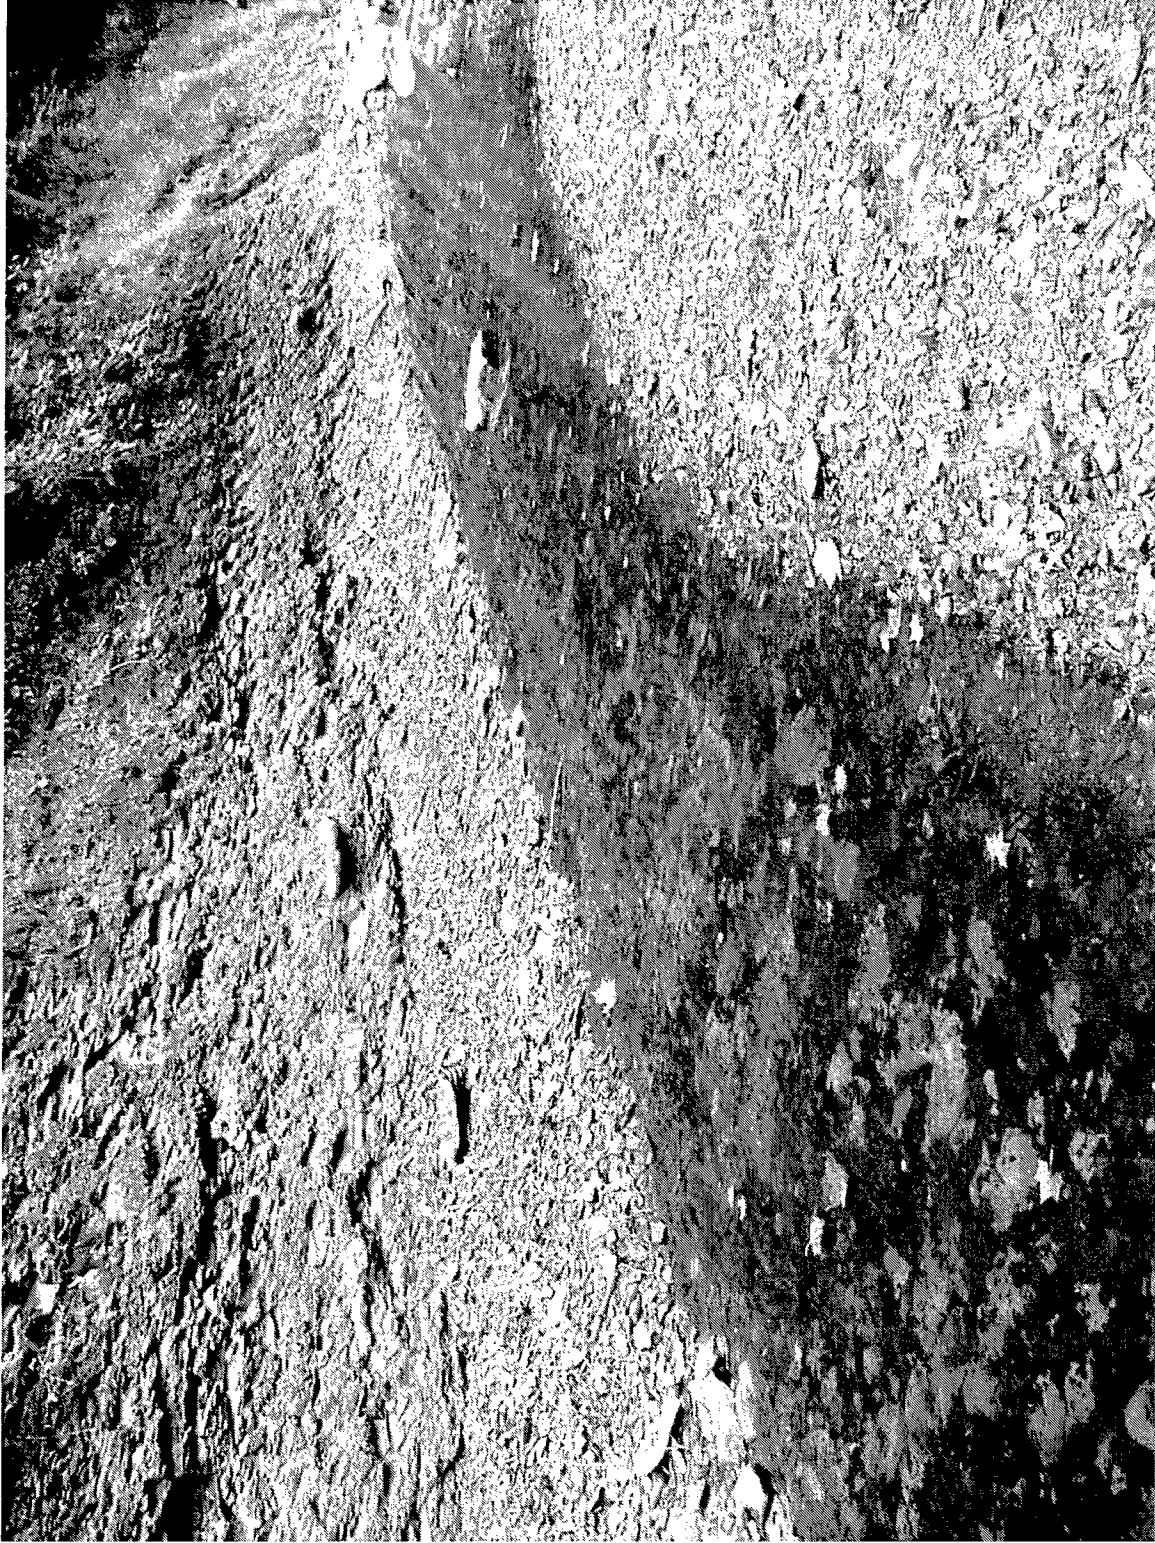
Site 2 was approximately 300 feet downstream of Site 1 and was a long (150 ft), shallow (0.5 ft), wide (10 ft) pool along the left descending bank (Photograph 3). The left bank was a vertical cliff of clay and substratum was "bedrock" of scoured, hard clay. Sand, gravel, and cobble were present along the right margin and both ends of this pool. Extensive FPOM littered the hard clay (Photograph 4). CPOM was abundant in a relatively deep pool (2.5 ft) at the upstream end of the entire pool. Water velocity was 0 ft/sec.

Photograph 3. Downstream view of Site 2 in Cedar Point Branch, a wide and shallow pool along the base of the vertical cliff that forms the left descending bank.

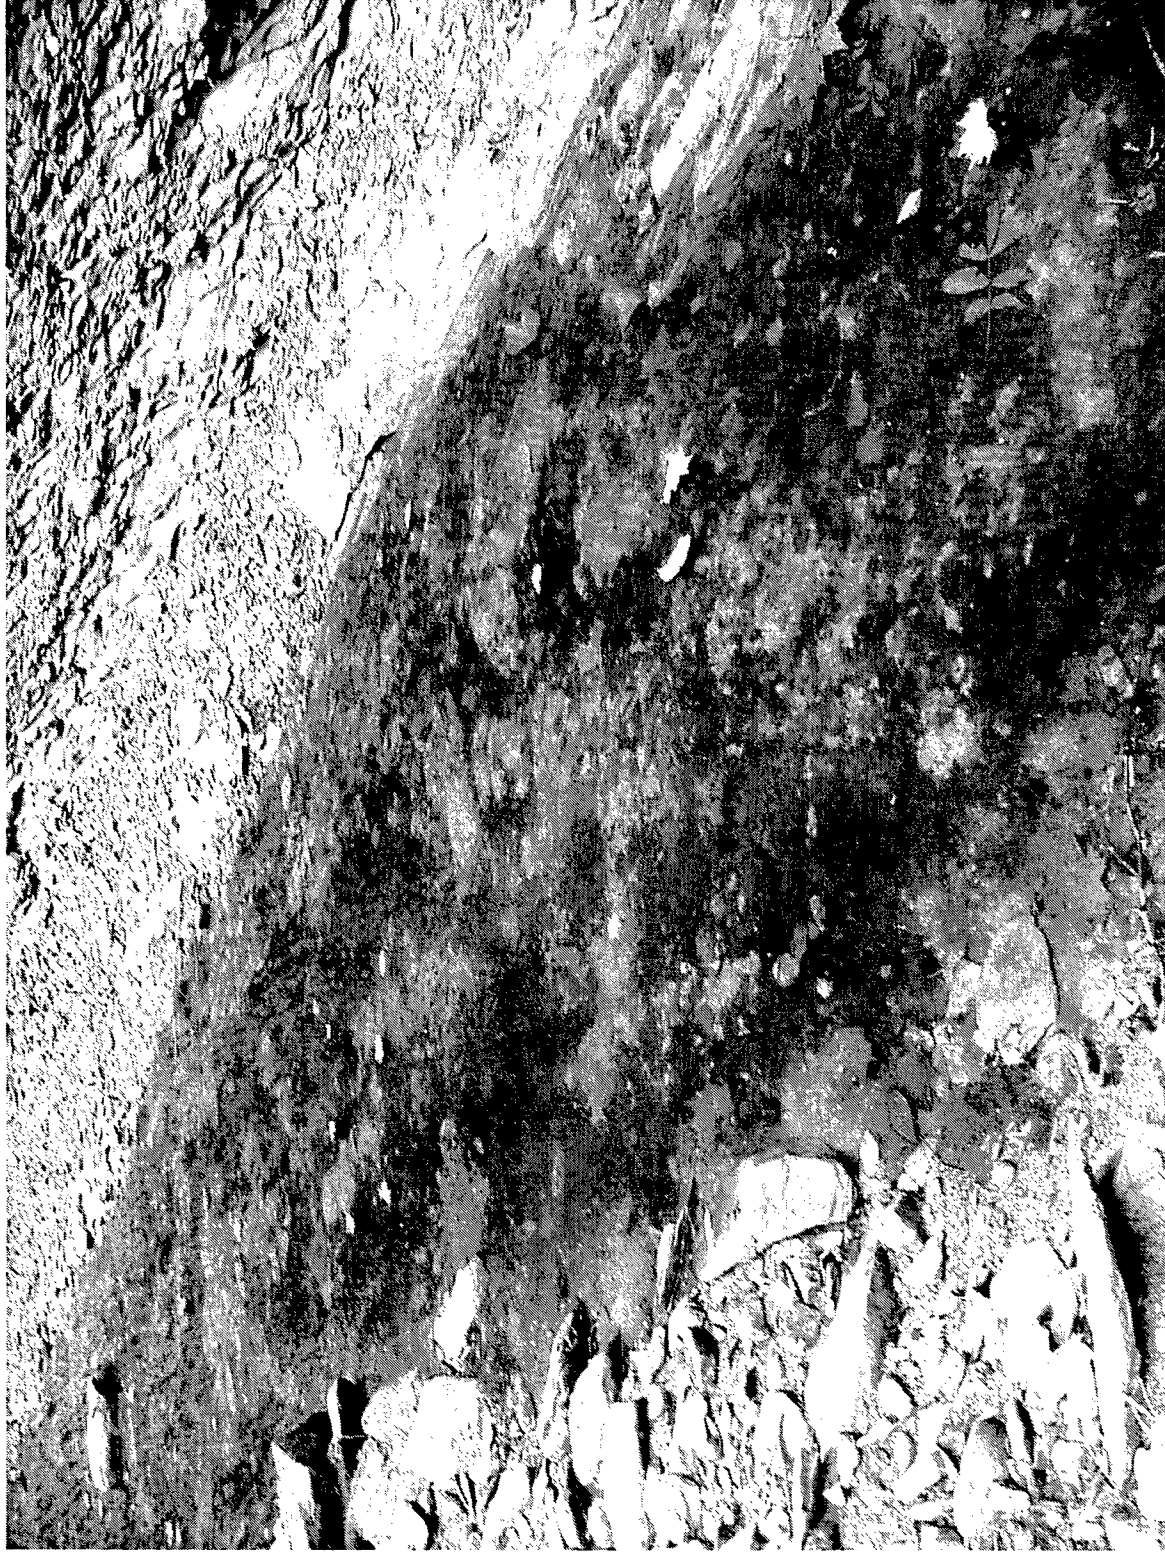
Photograph 4. Fine Particulate organic matter (FPOM) accumulated in Site 2 in Cedar Point Branch.

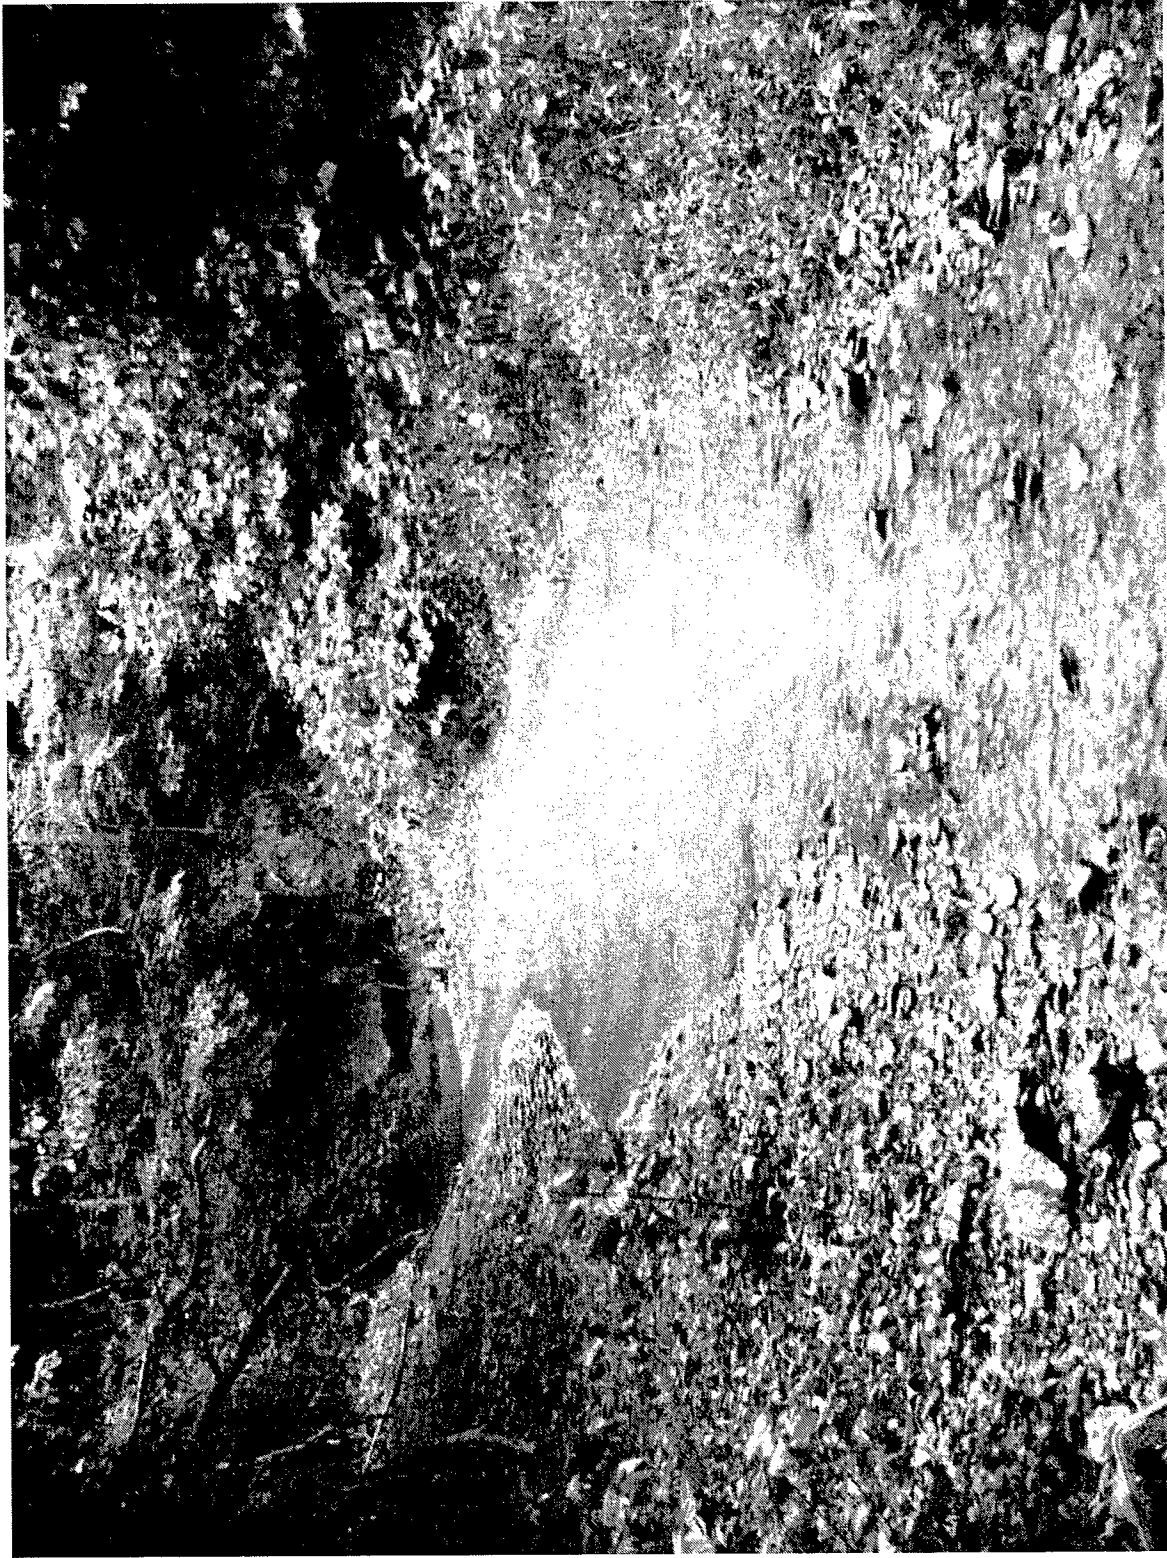
Photograph 6. Upstream view of Site 2 in Castleman Creek.

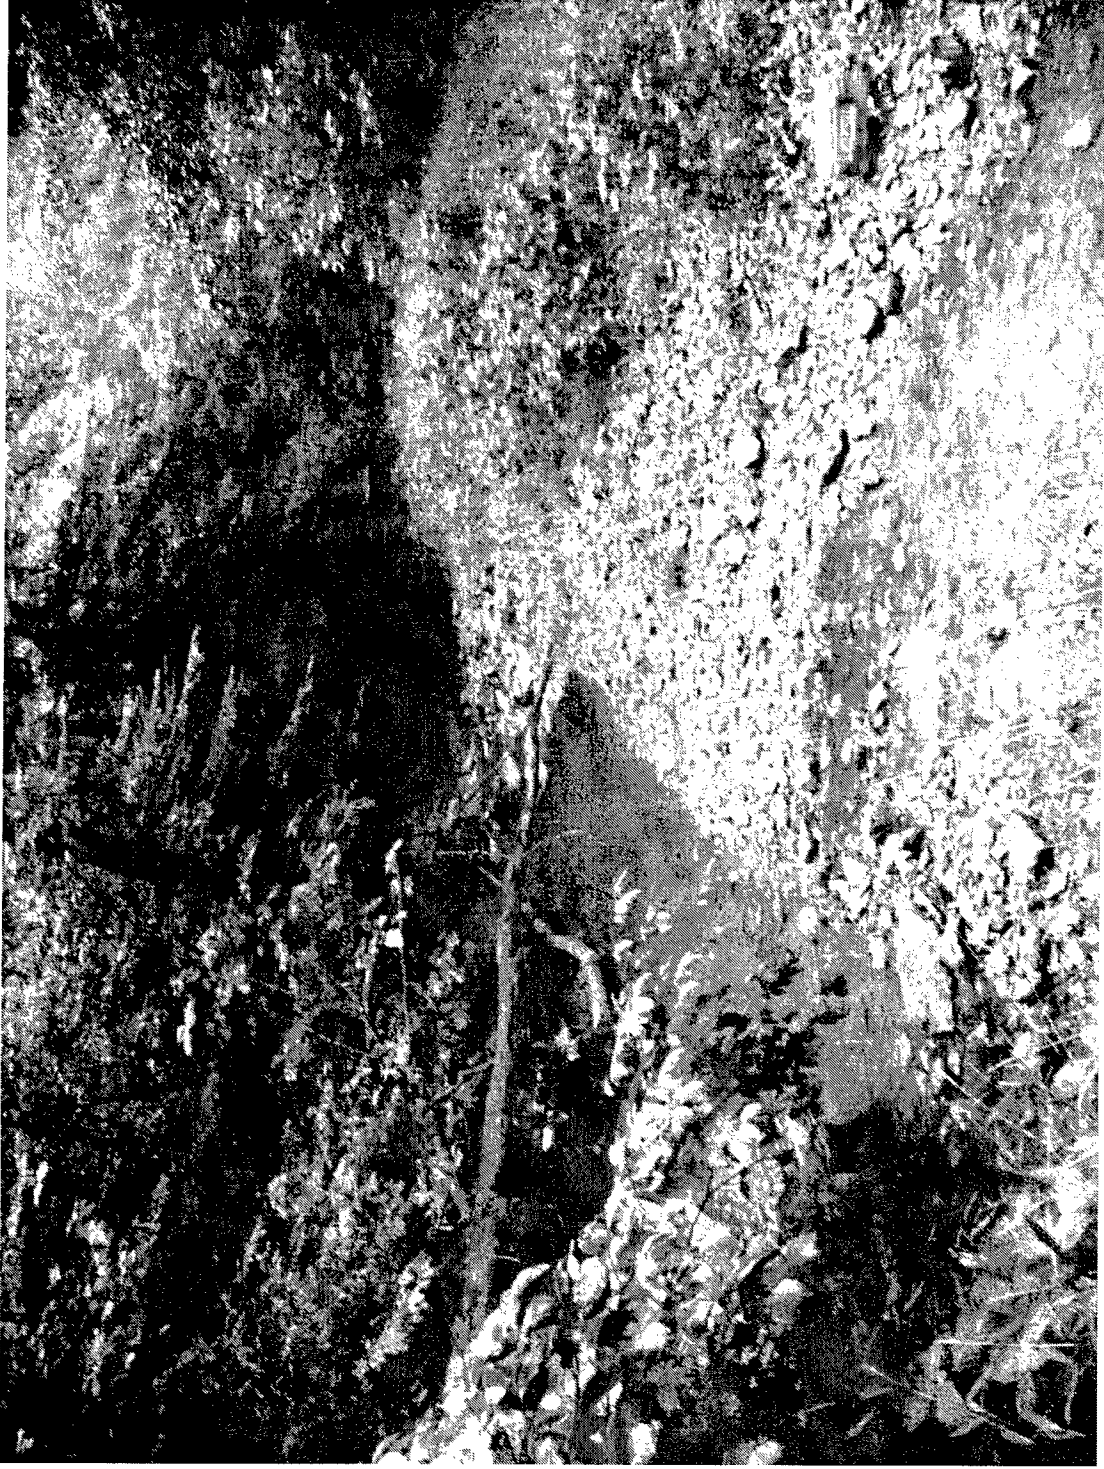
Photograph 7. Downstream view of Site 3 in Castleman Creek showing herbaceous and young woody vegetation growing in dry cobble streambed.

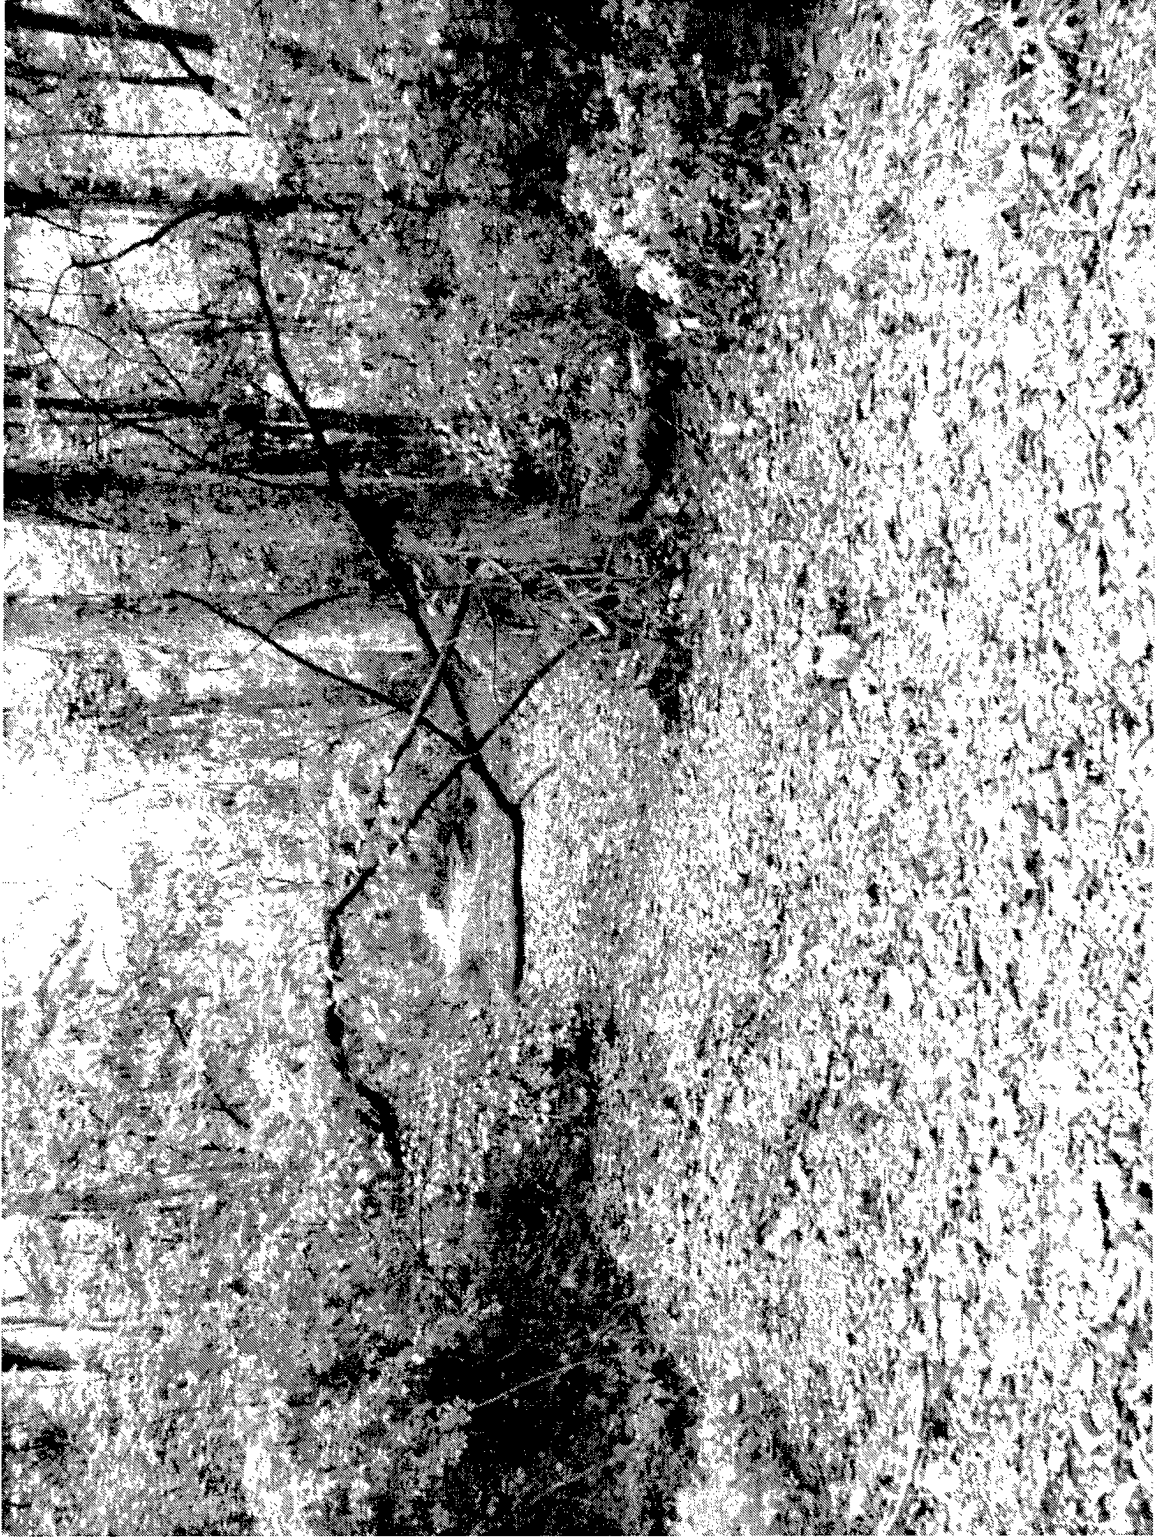
Two sites were investigated in this drainage. Both were dry. The upstream site was a 30 ft wide channel of large and medium cobble with some gravel and sand (Photograph 9). Bank height was approximately 2 to 3 feet. Scour holes below large trees at the edge of the channel provide the only pool habitat in an otherwise continuous riffle. No water was found even in these scour holes. The downstream site (Site 2; Photograph 10) was near Pitts Point Road in the same general area as the downstream site in the closely adjacent Castleman Creek. The channel was very similar to that at Site 1. One scour hole held a few gallons of water; however, the near total lack of permanent water precluded sampling of Woodland Creek. The cobble streambed was evidence that this creek occasionally conveys swift scouring flow despite being dry during low flow seasons.

Photograph 9. Upstream view of Site 1 in Woodland Creek showing the dry gravel and cobble streambed and a small scoured depression at the base of a large tree on the left descending bank.

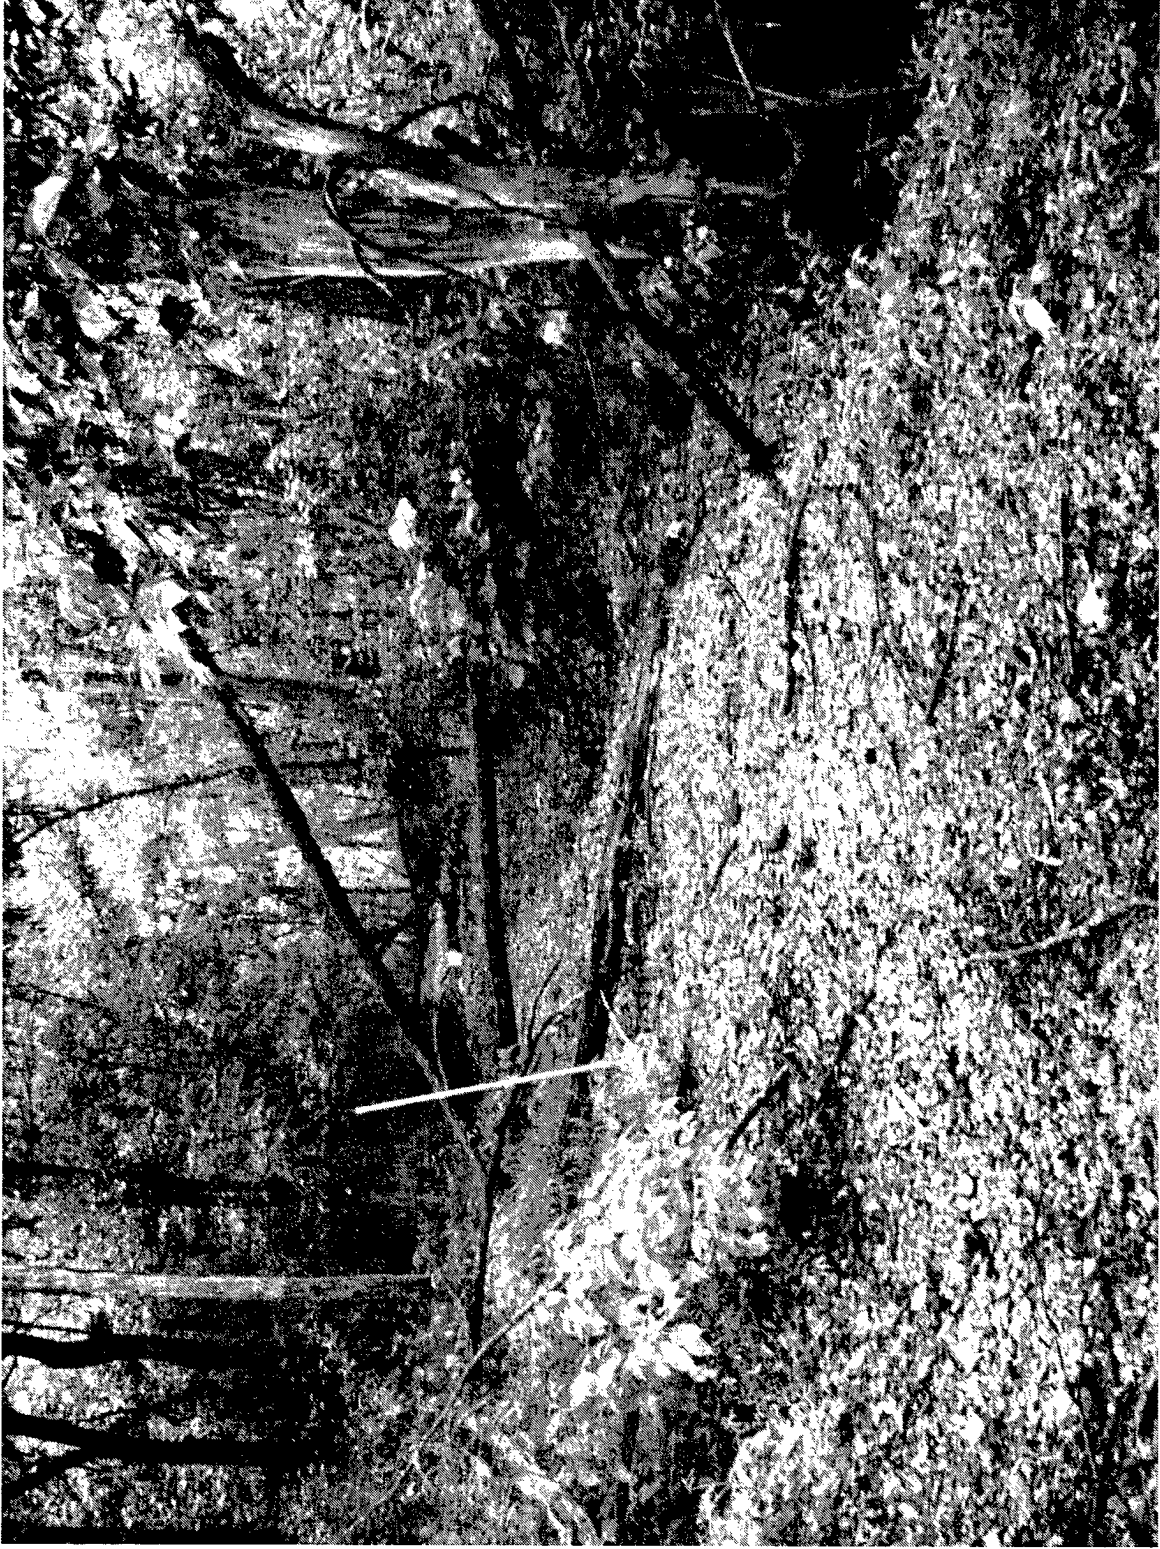
Photograph 10. Downstream view of Site 2 in Woodland Creek showing dry gravel and cobble streambed.

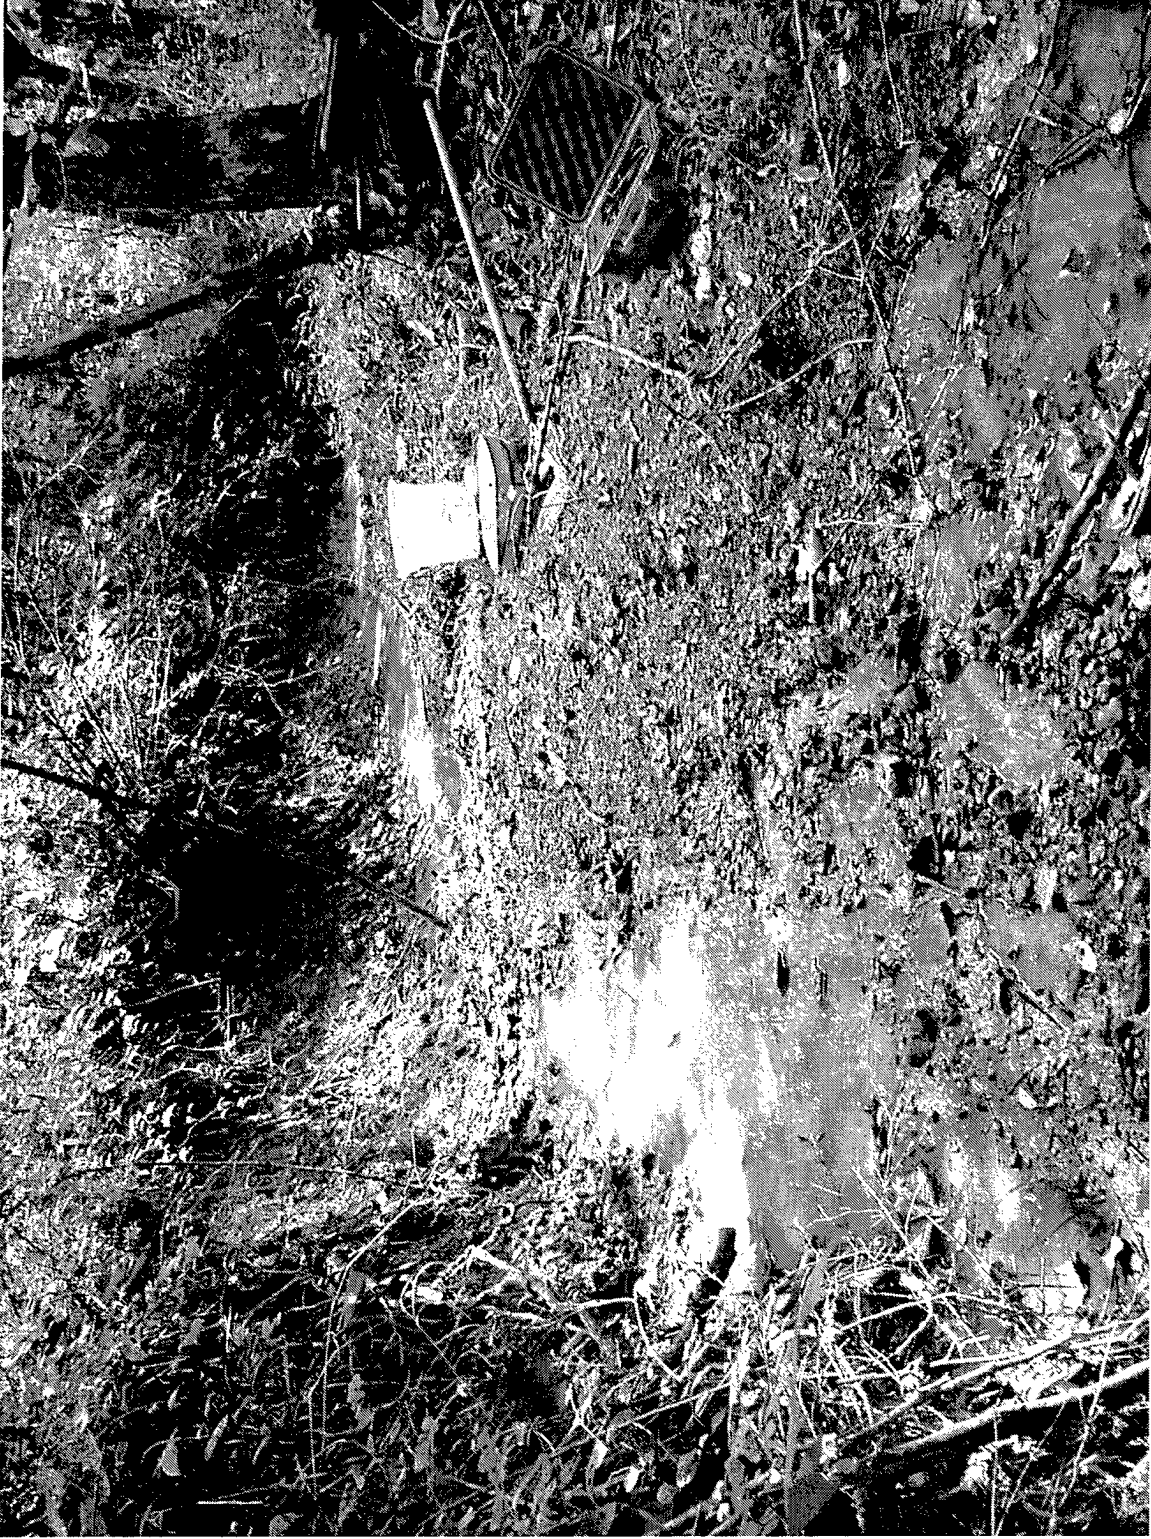
Site 1 was a narrow pool along the left descending bank, approximately 120 ft long, 3 ft wide, and 6.5 feet deep (Photograph 11). The stream channel was only 10 to 15 ft wide; bank height was 3 to 4 feet. Channel substratum was a mix of some cobble with much gravel, silt, and soft clay (Table 2). Clay and leaf litter deposits smelled of hydrogen sulfide when disturbed. There was no evidence of organic pollution. Surrounding woodlands were second growth on abandoned farmlands (old barbed wire fencing ran along the left descending bank).

Photograph 11. Downstream view of Site 1 in Mud Creek tributary showing slightly turbid pooled water mainly along the left descending bank.

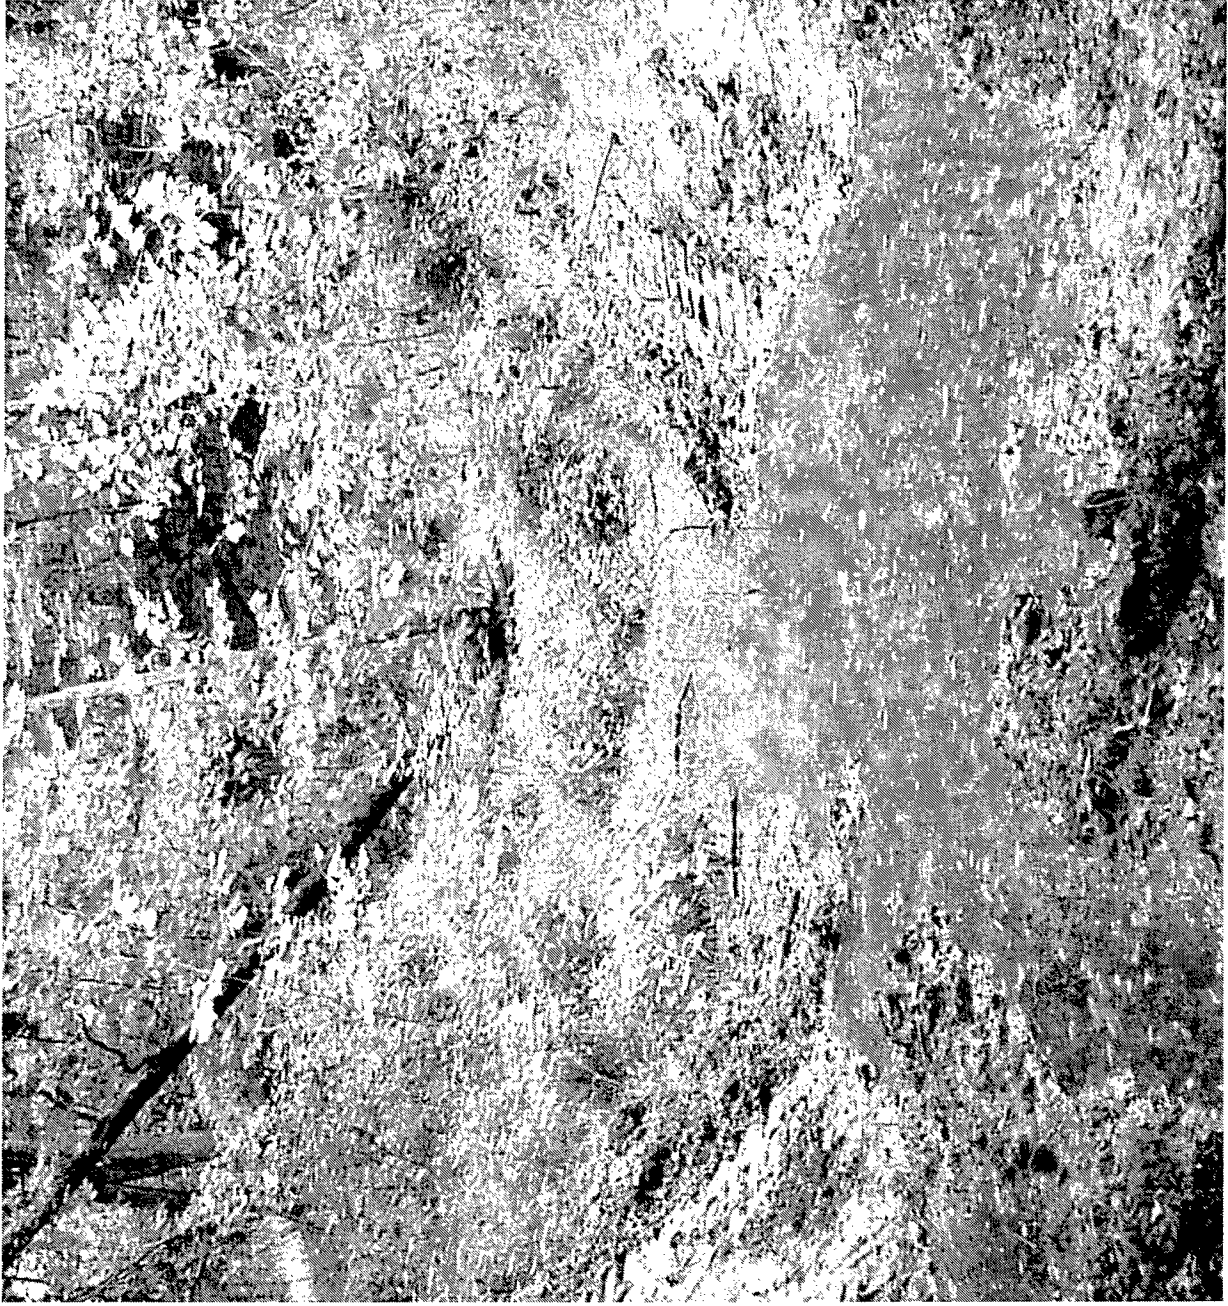
Site 3 was a shallow muddy pool in a depression along the lower stream channel (Photograph 13) that meanders through the broad alluvial and forested floodplain of the creek as it approaches Pearl Pond (Photograph 14). Oligochaetes, decapods (the same *Orconectes* sp. observed at all sites), gastropods (pulmonate snails of the genus *Helisoma*), and chironomids were all common but not abundant (Table 7). A single sphaeriid bivalve was also found. Laboratory processing of a subsample of the soft sediment and leaf litter at this location revealed several very small (recently released young) sphaeriid bivalves, indicating that this taxon is common at this site (Table 5). Many small chironomids (Chironominae) were also found. Isopoda, Hemiptera, Coleoptera, Odonata, and Megaloptera were orders that were rare but present in the sample analyzed in the laboratory.

Photograph 13. Downstream view of Site 3 in Mud Creek, a pooled depression in the meandering streambed through a forested alluvial floodplain upstream of Pearl Pond.

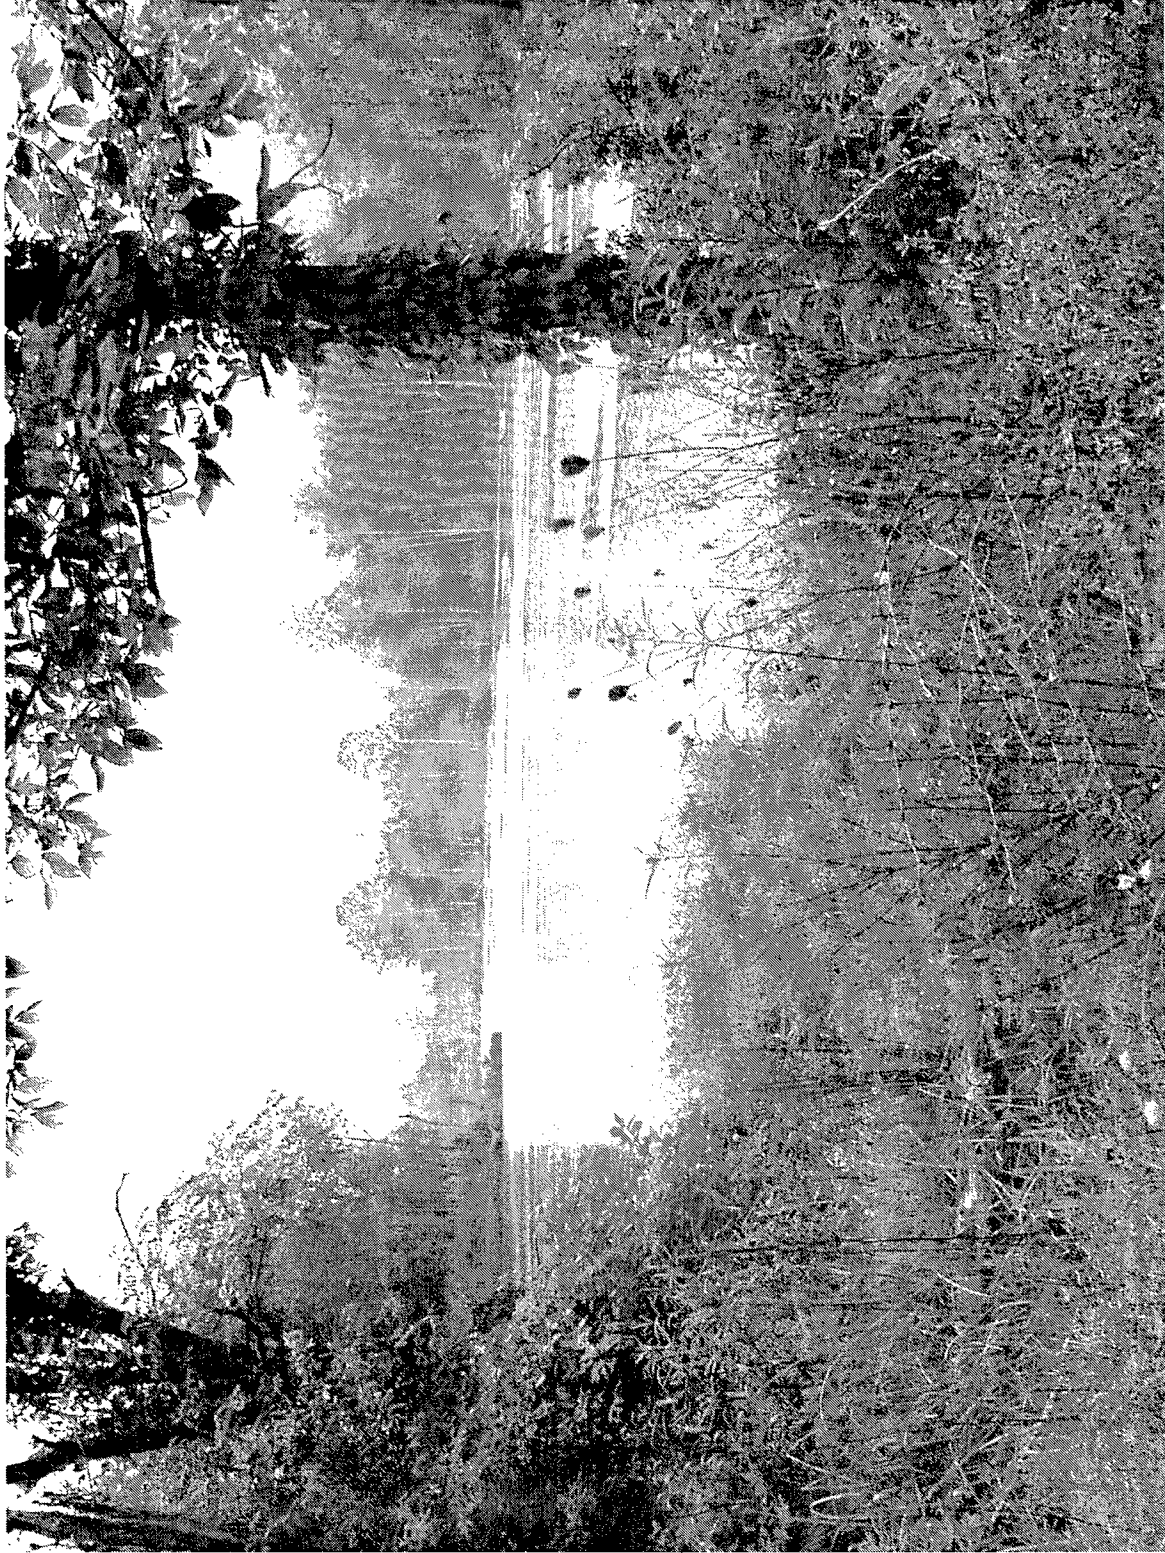
Photograph 16. Upstream view of Wilcox Lake # 3.
