NAWCWD TM8330

**ENGINEERING INVESTIGATION OF FAILURES OF CABLE USED
TO TOW THE TDU-32A BANNER TARGET FROM T2C AIRCRAFT**

by Brent Meeker
6 DEC 2000

NAVAL AIR WARFARE CENTER, WEAPONS DIVISION
CODE 531100E

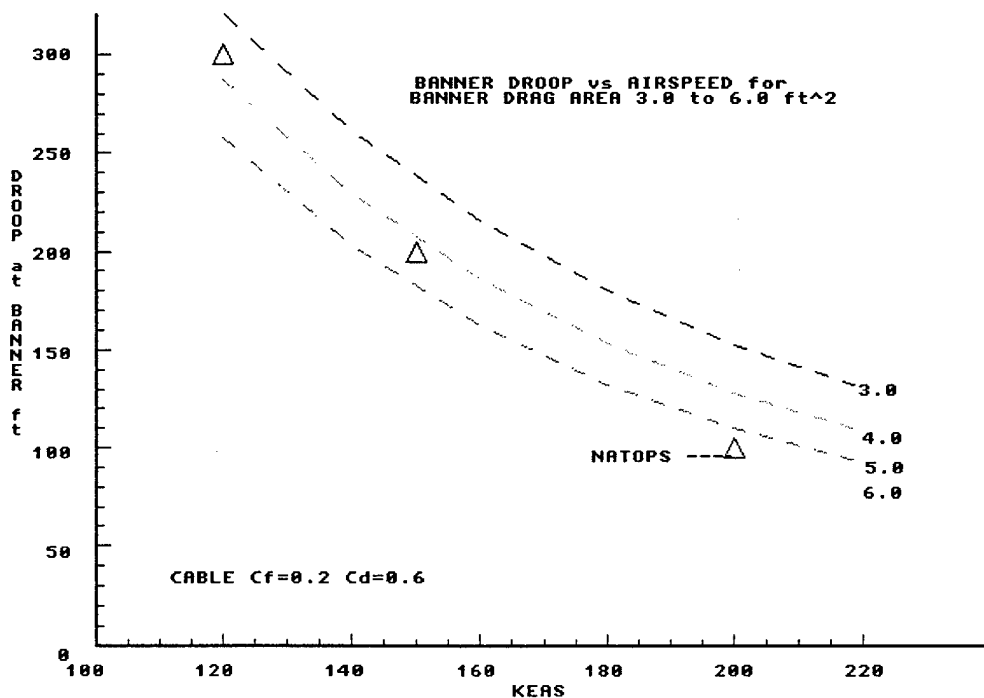
Figure 8. Comparison of droop predicted by steady-state analysis and tabulated NATOPS values.

The simpler of these two determined only the steady-state, equilibrium shape of the cable for straight and level flight or for a level turn at a constant rate. As shown in Appendix B the assumption of steady-state reduces the problem of determining the cables towed shape to the integration of a set of ordinary differential equations. The greatest uncertainty in application of these equations is the drag of the banner. This was estimated by matching the droop tabulated in the NATOPS as shown in figure 8. No realistic combination of banner and cable aerodynamic parameters could be found to match all three NATOPS data points, but a banner drag area of 4.0ft^2 matched at 150KIAS and was close at the other two speeds.

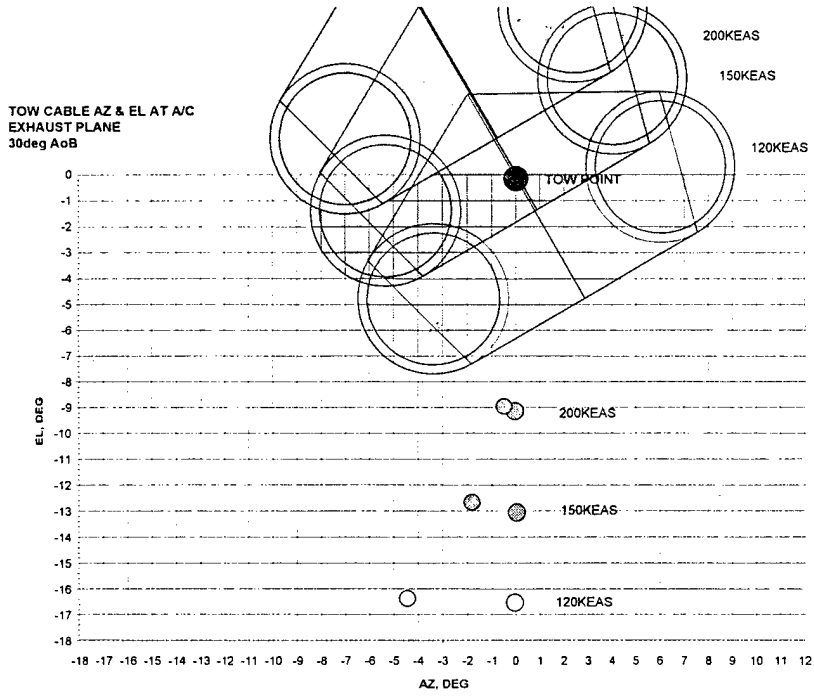
Figure 10. Steady-state position of the cable in the exhaust plane for level 30⁰ AoB turns.

The greater tension due to the centripetal acceleration also causes the banner to droop less so the cable is higher at the exhaust plane. The predicted cable steady state position is shown for 30° AoB in figure 10 and 60° AoB in figure 11. The straight and level cable position is also shown for reference.

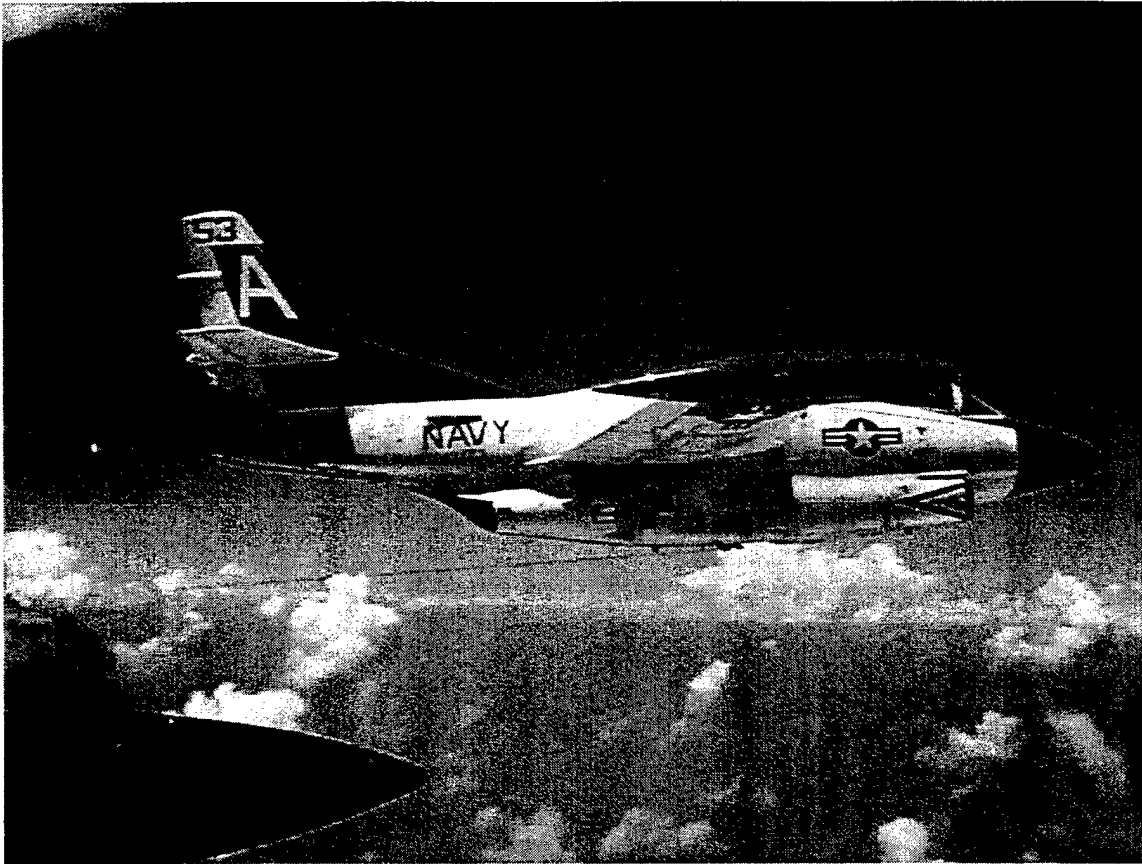
Scaling from figure 2, the tow point is 13.3ft forward of the exhaust on the center-line of the belly. This photograph was taken a 200KEAS in straight and level flight. At this flight condition, the bottom of the exhaust opening is seen to be 0.58ft above the tow point.
