**GEOMORPHOLOGICAL  
CHANNEL AND BANK ASSESSMENT OF  
THE MISSOURI RIVER -  
FORT PECK DAM TO PONCA STATE PARK**

**Final Technical Report**

Chris Bromley, Colin Thorne, and Chester Watson

September 2000

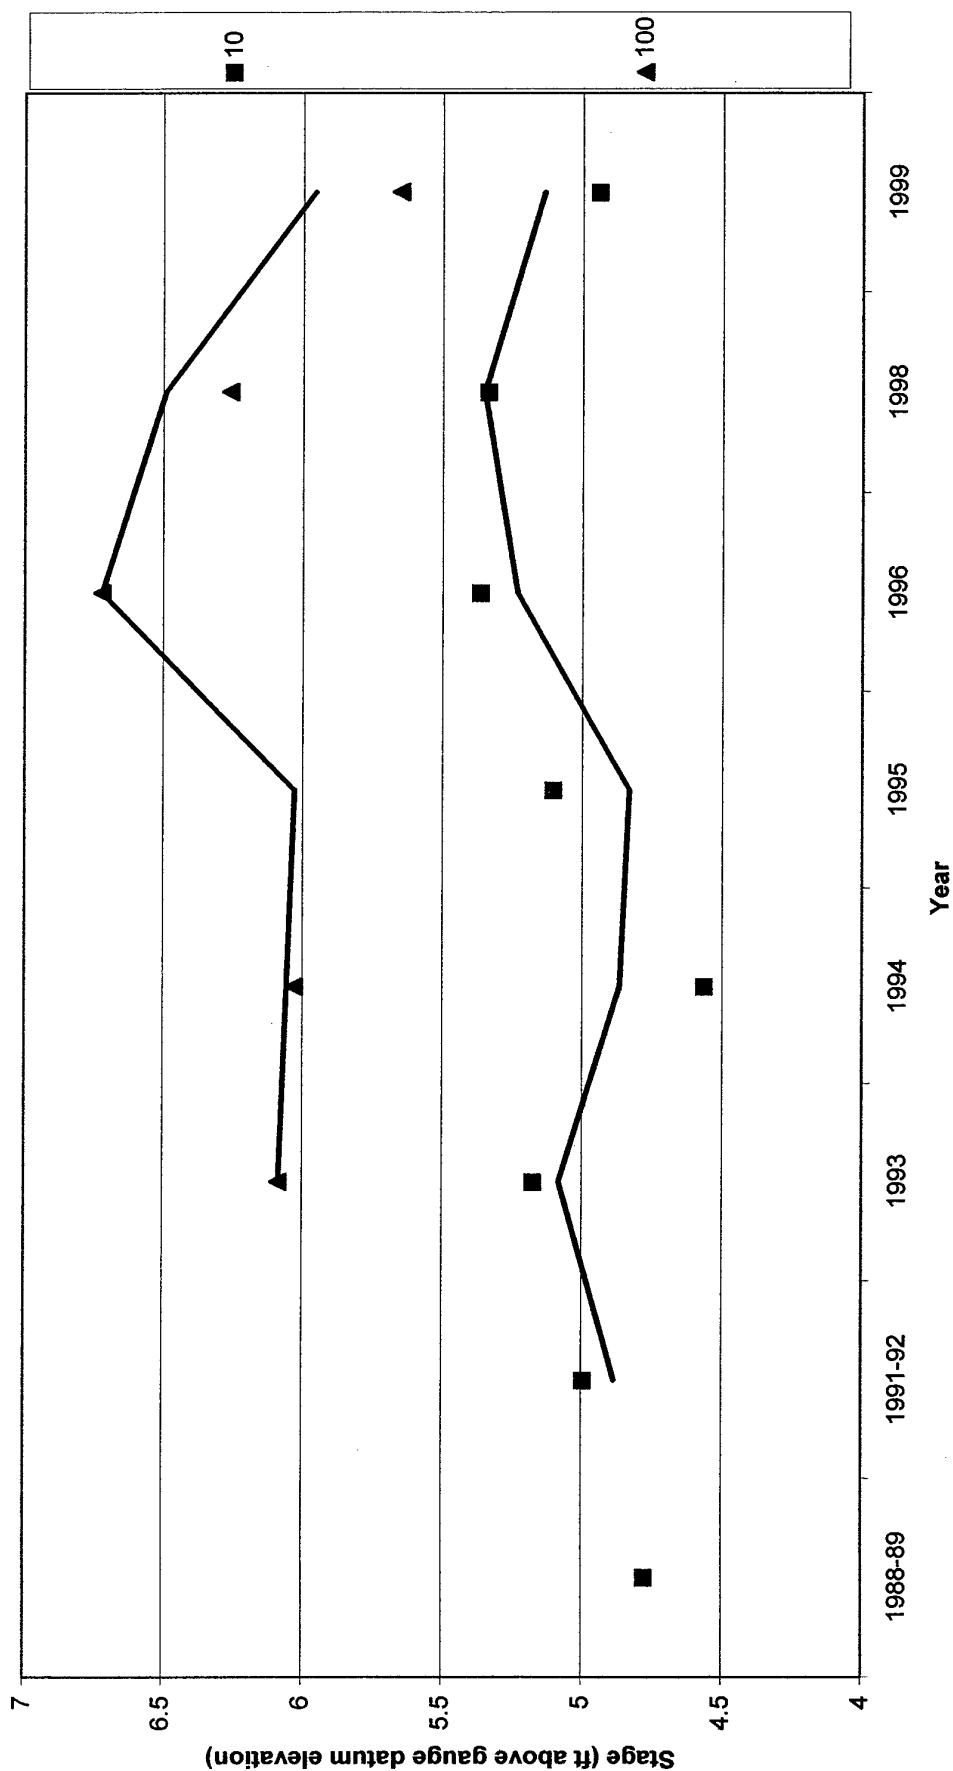
Figure B18: Garrison Reach: Specific Gauge Record for Burnt Creek near Bismarck, ND - RM 1316.2

Data availability is also severely limited for Burnt Creek (Fig. B18). The short records for 10 cfs and 100 cfs are consistent with each other in suggesting that stage changes have produced no clear trend during the 1990s. However, the period of record is simply too short to support firm conclusions.
