1. REPORT DATE		2. REPORT TYPE Viewgraphs	3. DATES COVERED	
4. TITLE AND SUBTITLE P-3C SLAP Emerging Technology Evaluations			5a. CONTRACT NUMBER	
			5b. GRANT NUMBER	
			5c. PROGRAM ELEMENT NUMBER

P-3C SLAP

Emerging Technology Evaluations

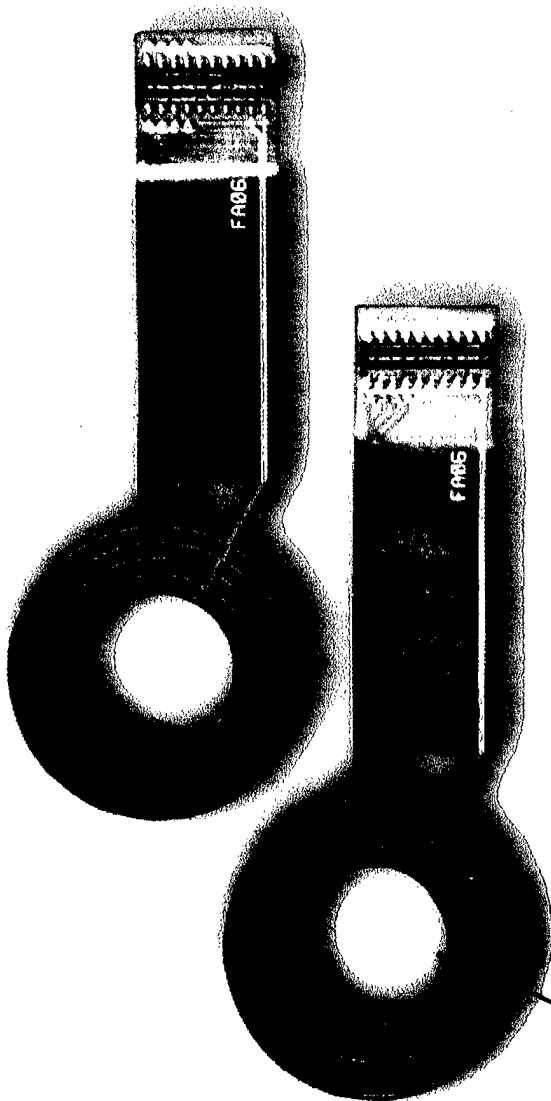
JENTEK's MWM-Rosette for Monitoring Crack Initiation and Growth

- Crack Detection
- 4 Sensing Element Array
- Mountable on Surfaces and Between Layers (e.g. Aircraft Skins)

- Demonstration was successful
 - Surface breaking cracks of ~0.050” past the fastener head were easily detectable and could be tracked as they grew
- System Configuration
 - MC-ERIM
 - 18 surface mountable sensors delivered for use on the component and FSFT

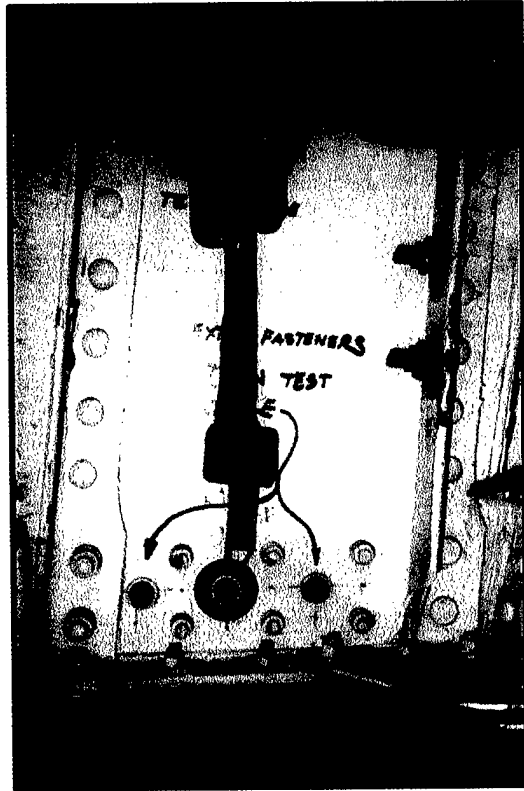
Using sensor as a scanning probe

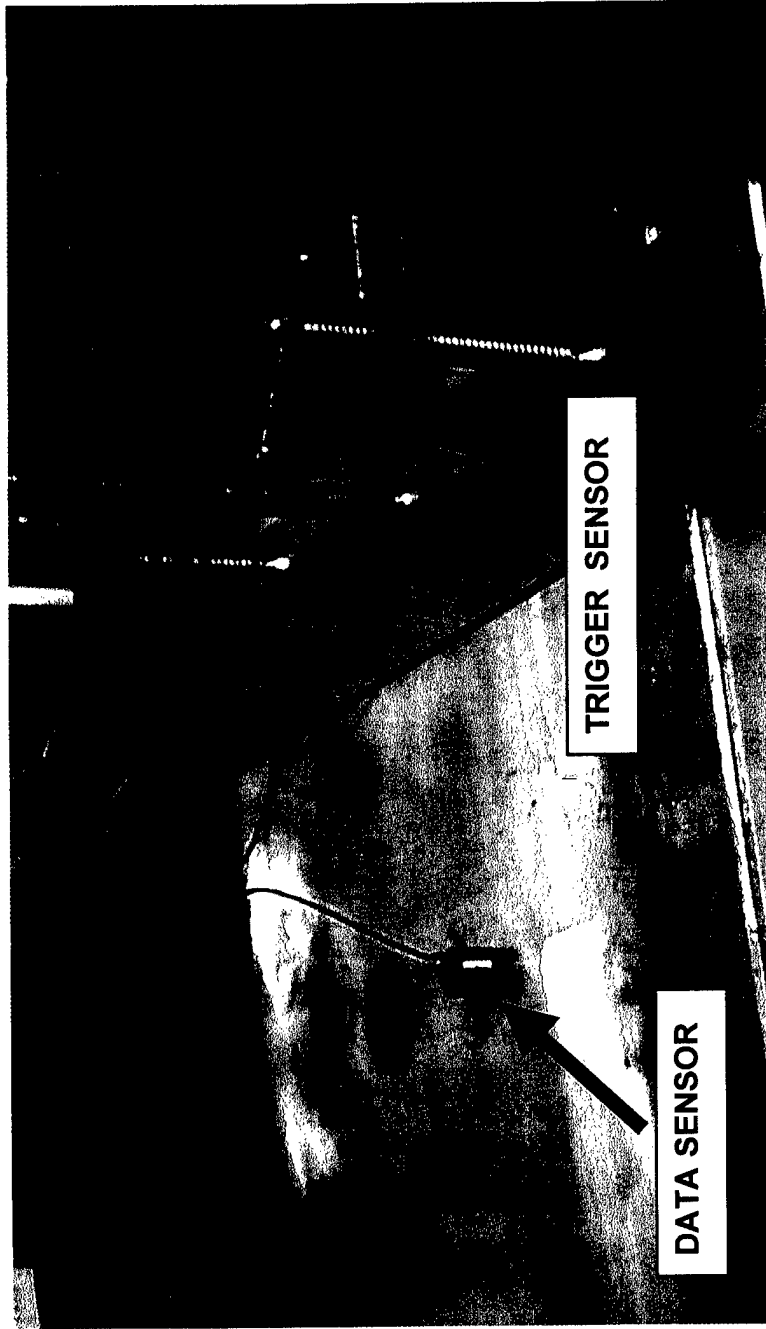
- Sample Test based on BL 65 area

- **Selected Acoustic Emission Technique**
 - **Dunegan Engineering Consultants**
 - **AESmart 2000 Fixed Asset System with 2 lines of 12 sensors each**
 - **Low cost system**
 - **Simple discrimination of noise and cracking**
 - **Successful demonstraton on skewed panel component test**
 - **Will be applied on the BL 65 lower front spar joint component test to refine final sensor placement**

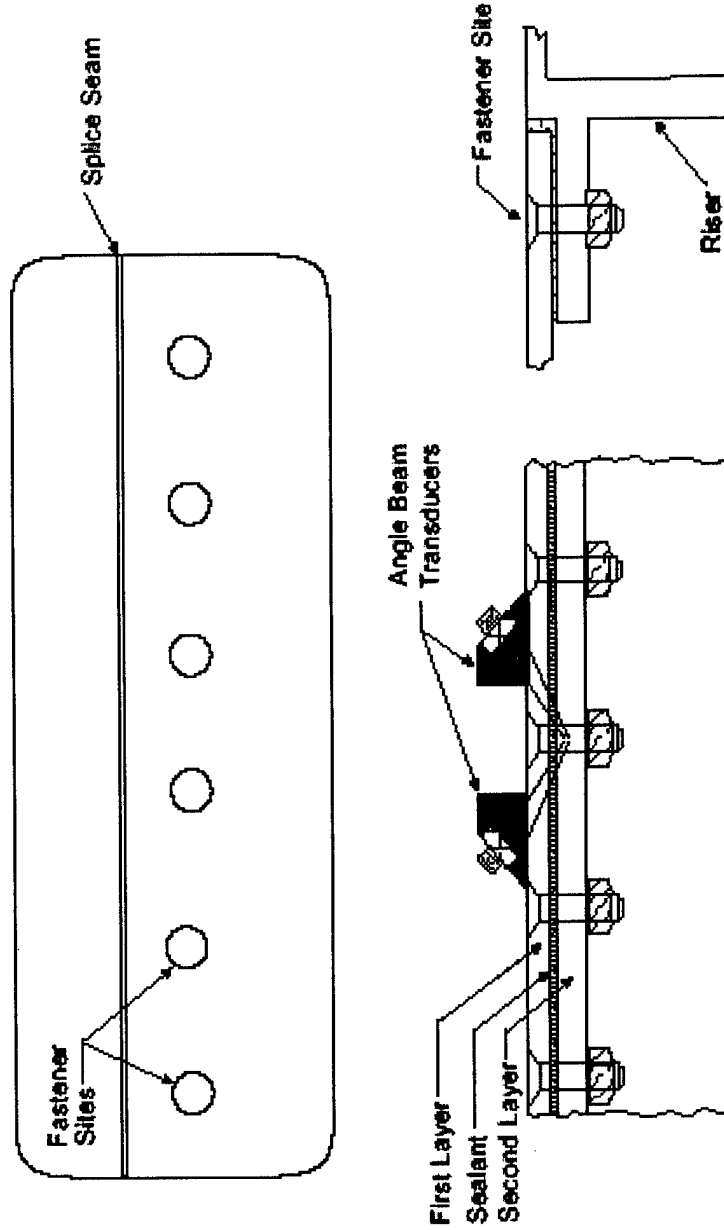
Ultrasonic Scan Set-up

- Ultra Image UT System (SAIC)
 - Scanning system for wing panel splice through sealant for 1st & 2nd layer crack detection
 - Baseline Scan completed in December

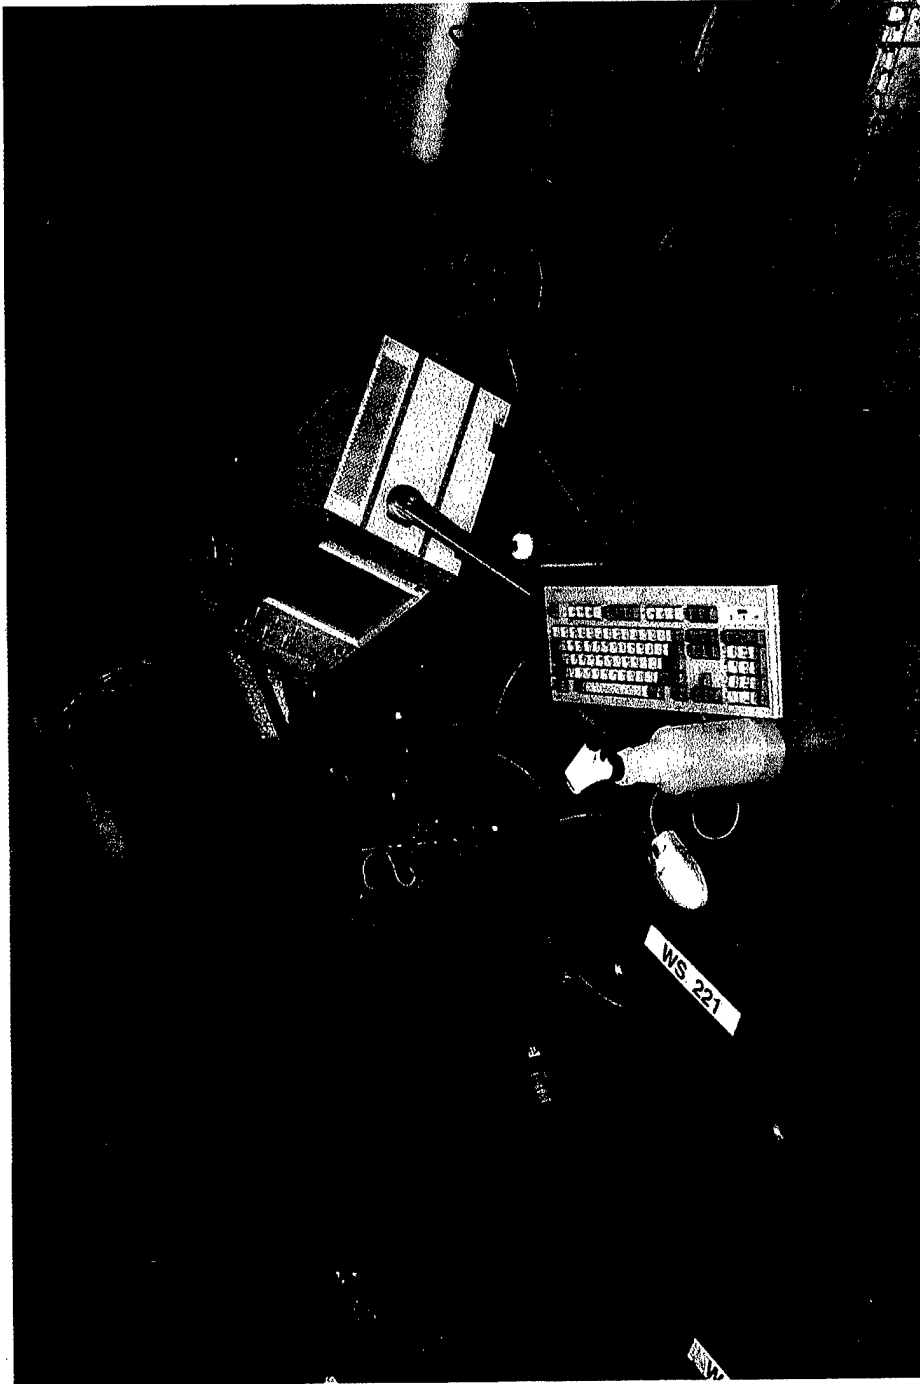
Application to the P-3C SLAP Aircraft

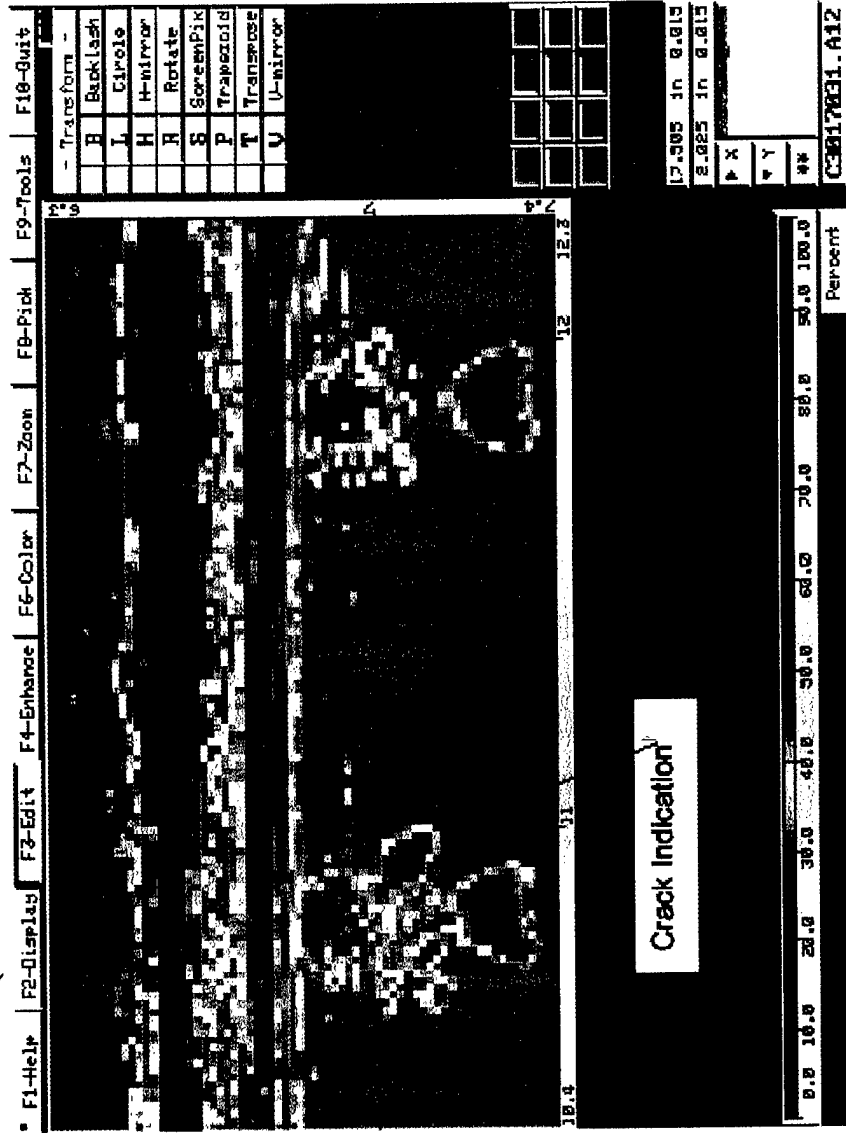
C-Scan Image of Two Fasteners

(one with and one without a crack indication)

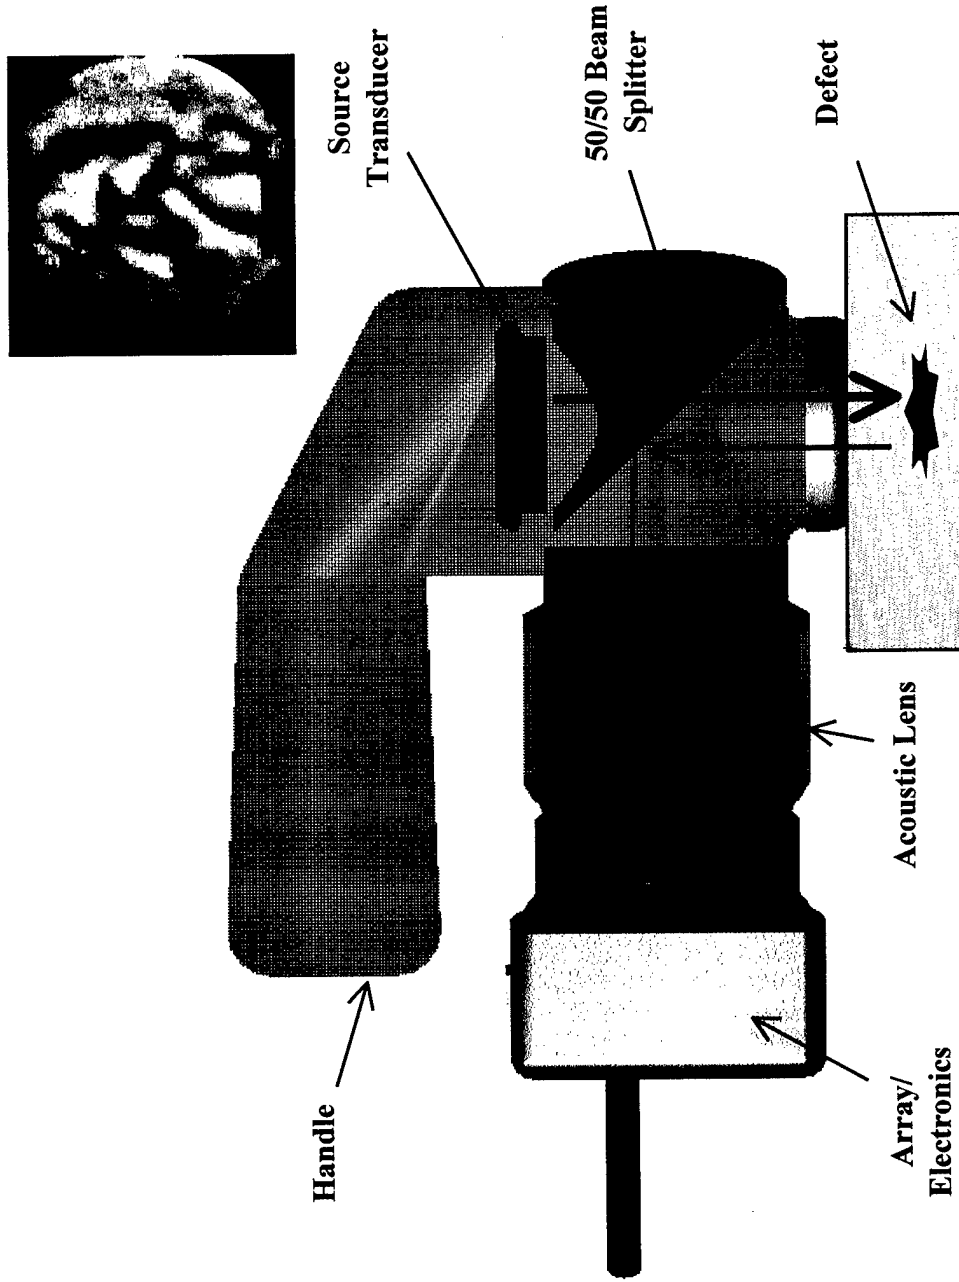
Reflection Imaging - Beamsplitter

(Imperium, Inc.)

- **High sensitivity, resolution, & dynamic range**
- **Range gating**
- **Small, portable (under 8 lbs.)**
- **Low power, battery operation**
- **PC based**
- **Minimum sensitivity 70 times I**
- **60 - 70 dB instantaneous dynamic range**
- **Up to 60 frames per second**
- **Range gate to 500 nanoseconds**

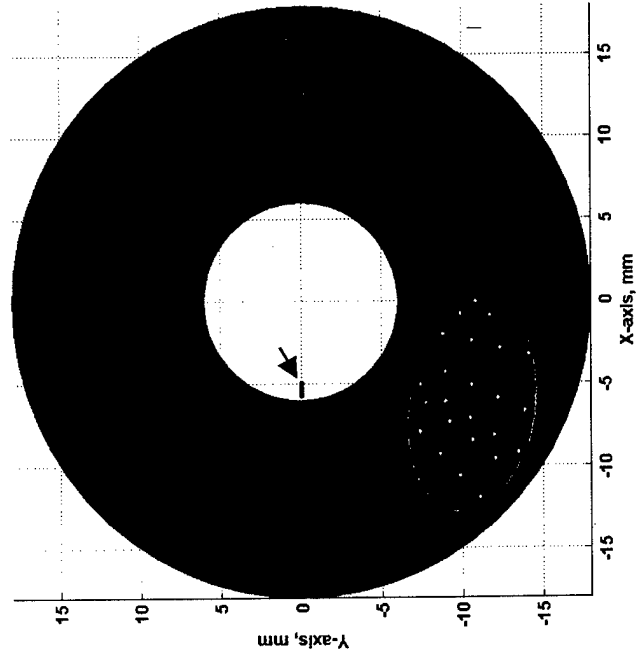
Top View

Operating Principle - Conical Matrix Array

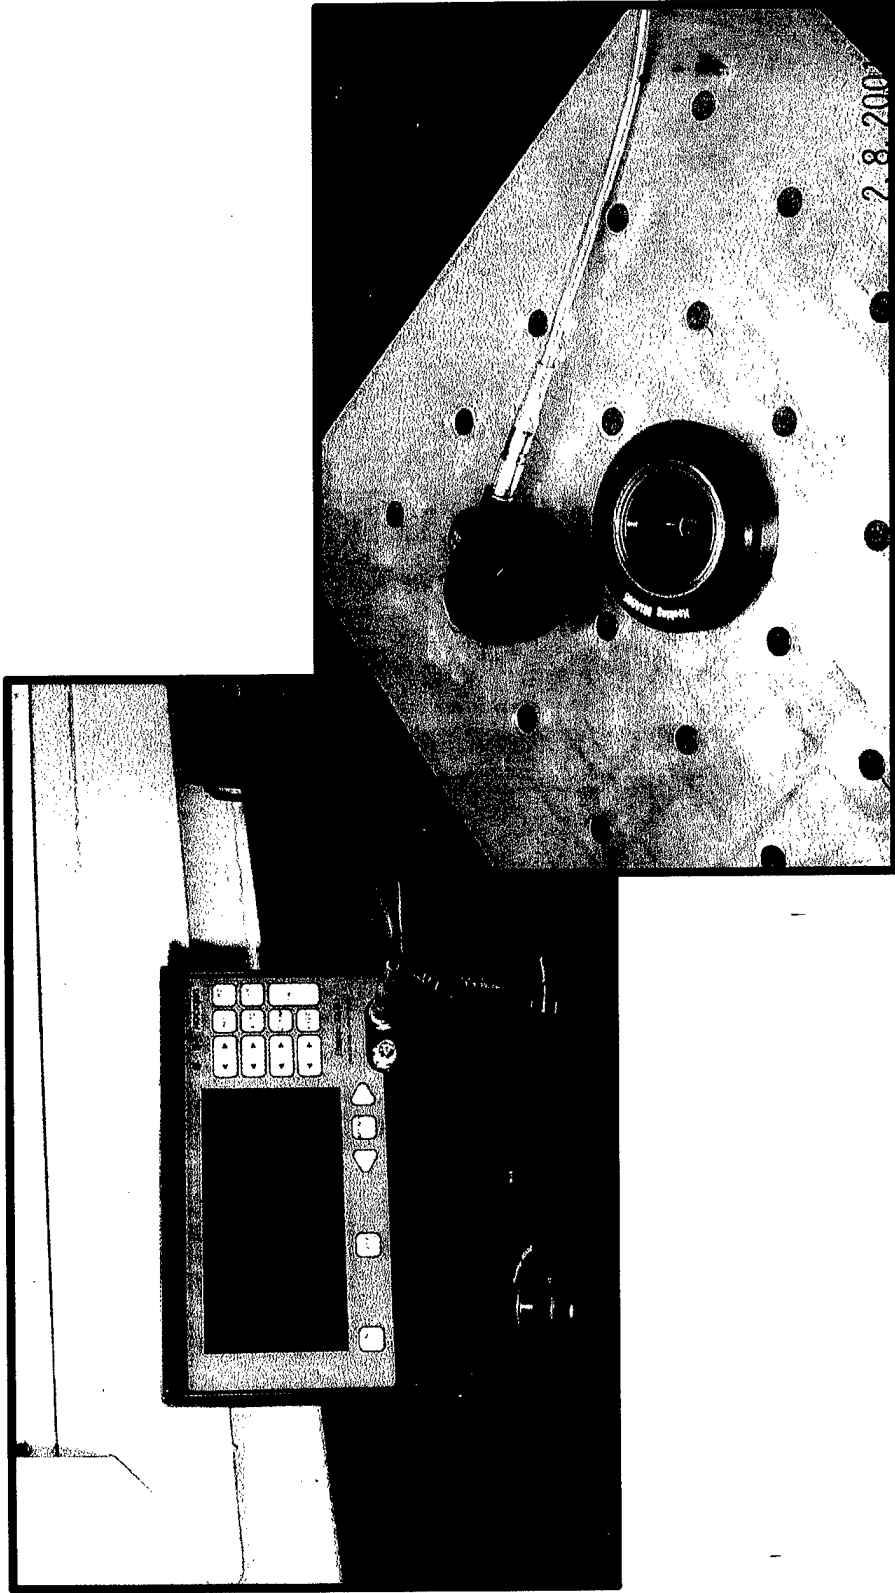
Hocking FastScan

(Eddy Current for Cracks under Fasteners)

- **Hocking FastScan EC System procured for crack detection under fasteners**
- **0.060 crack detection capability in first layer (under fastener)**
- **Preliminary tests showed system to be limited to applications with fastener to fastener or fastener to edge spacing > 1 inch**
- **Design of custom dual frequency probe in work to minimize edge effects**

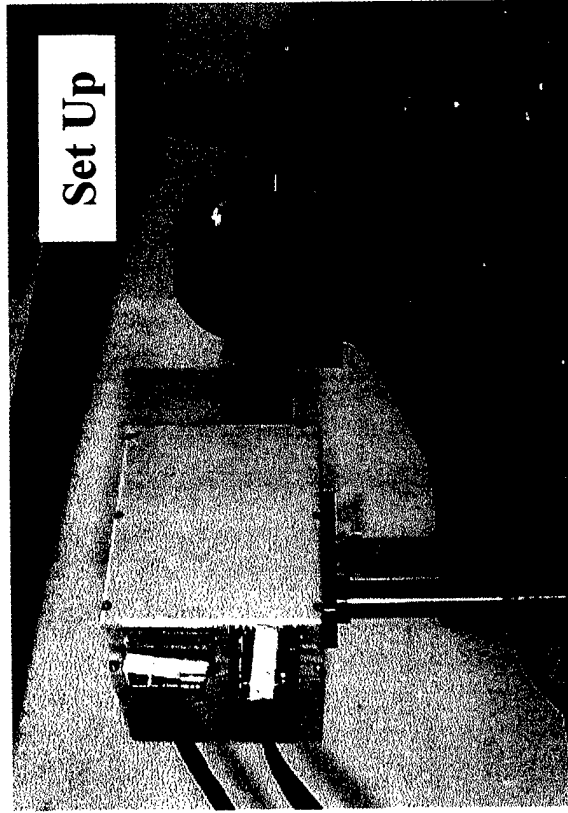
Inspection of Compressor Disk Section at Patuxent River NAS

- Utilizes high-energy ultrasonic energy induces rubbing at crack faces which generates enough heat to be detected by the infrared camera.
- Technology is extremely promising but not ready for transition.
- The US Navy has partnered with Boeing/Thermal Wave Imaging and Wayne State University in a Total Ownership Cost Program to transition this technology within 4 years.
- Application of acoustic-thermography is planned during the teardown inspections, which will be conducted in 2002.
