# Fabrication and Evaluation of Welded Ti-6Al-4V Test Sections

by Scott Grendahl, Daniel Snoha,  
and Brijmohan Roopchand

ARL-TR-2533

## Fabrication and Evaluation of Welded Ti-6Al-4V Test Sections

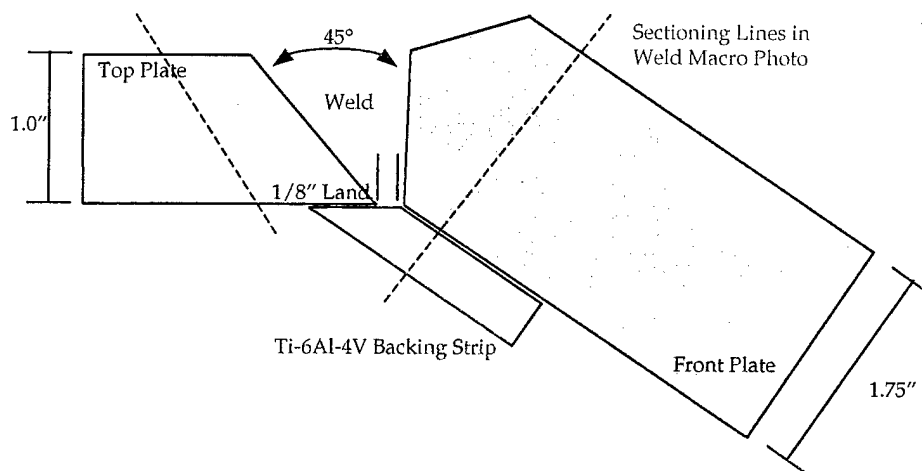
Figure 1. Schematic of the front plate to top plate weld joint.

The ARL-WMRD joint designs incorporated 60° openings (when feasible) and backing strips to prevent arc blow through. Lands of 1/8 in were specified at the roots of the welds. Figures 1–6 present the schematics of the joint designs of the ARL-WMRD test section. The schematics are not drawn to scale. The weld joints between the sides and the base were fillet welds.

Figures 17–21 depict the cross sections of the front plate to top plate weld joint, as shown schematically in Figure 1. Figures 22–26 depict the front to side plate weld cross sections, as shown schematically in Figure 2.

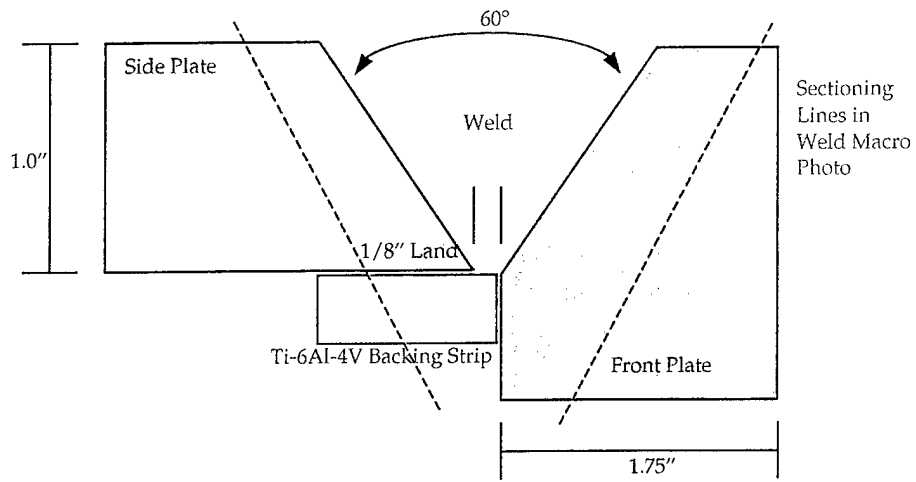
Figure 2. Schematic of the front plate to side plate weld joint.

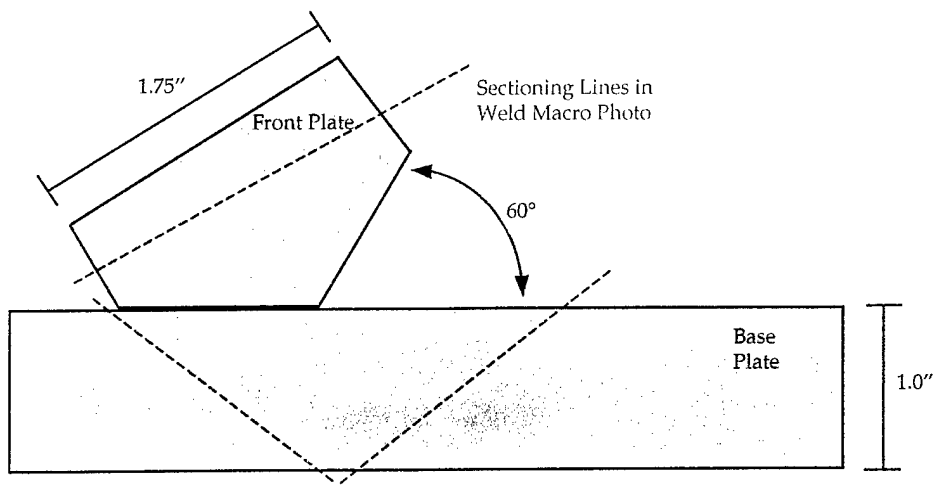
Figure 3. Schematic of the front plate to base plate weld joint.

Figures 27–31 depict the front to base plate weld cross sections, as shown schematically in Figure 3, while Figures 32–36 depict the base to top plate weld cross sections, as shown schematically in Figure 4.

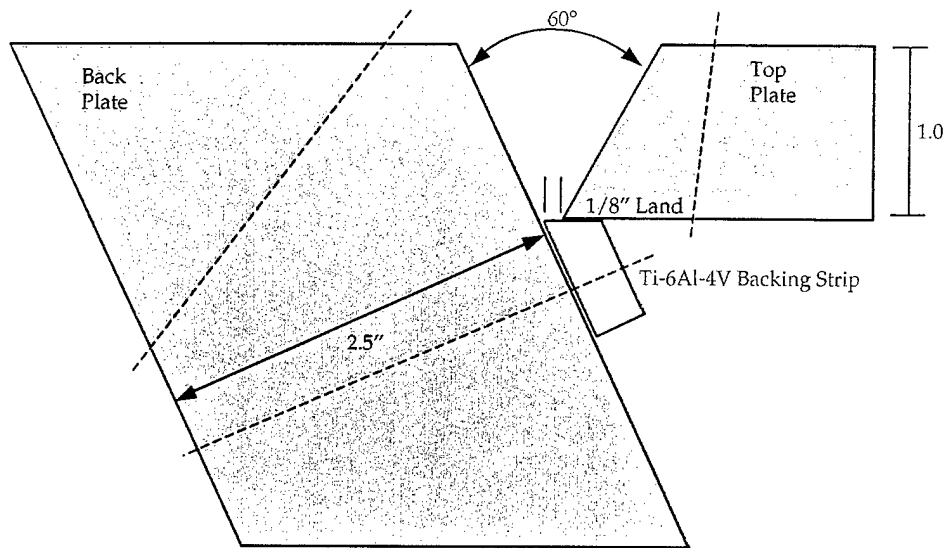
Figure 4. Schematic of back plate to top plate weld joint.

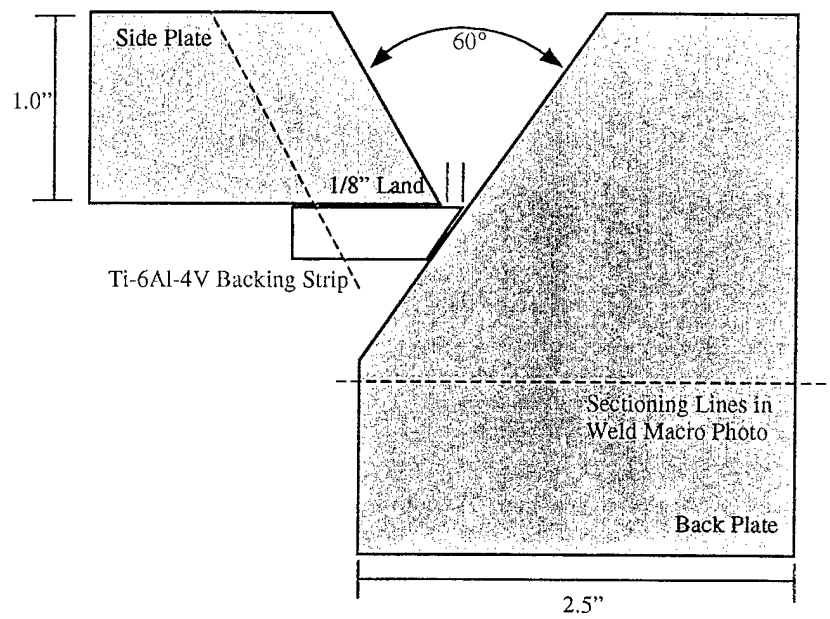
Figure 5. Schematic of back plate to side plate weld joint.

Figures 37–41 depict the base to side plate weld cross sections, as shown schematically in Figure 5.

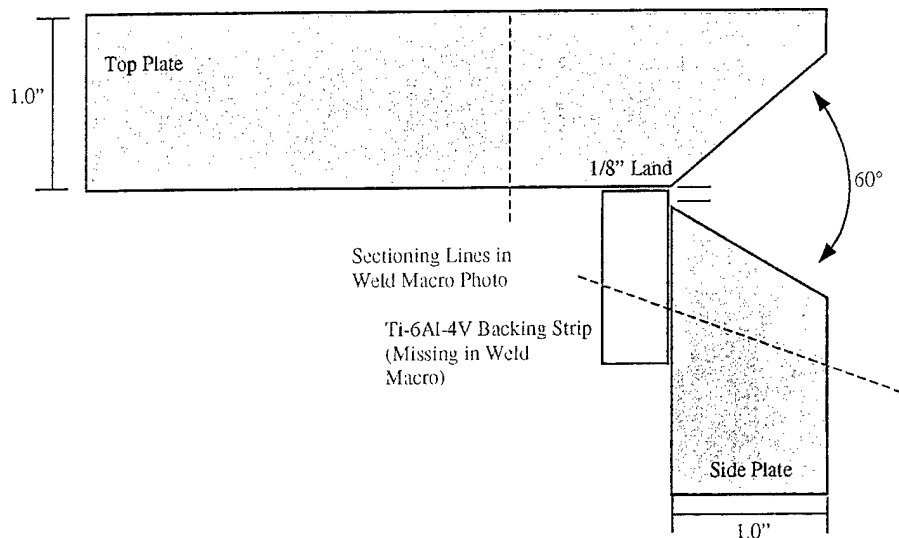
Figure 6. Schematic of the top plate to side plate weld joint.

Similarly, Figures 42–46 depict the top to side plate weld cross sections, as shown schematically in Figure 6.

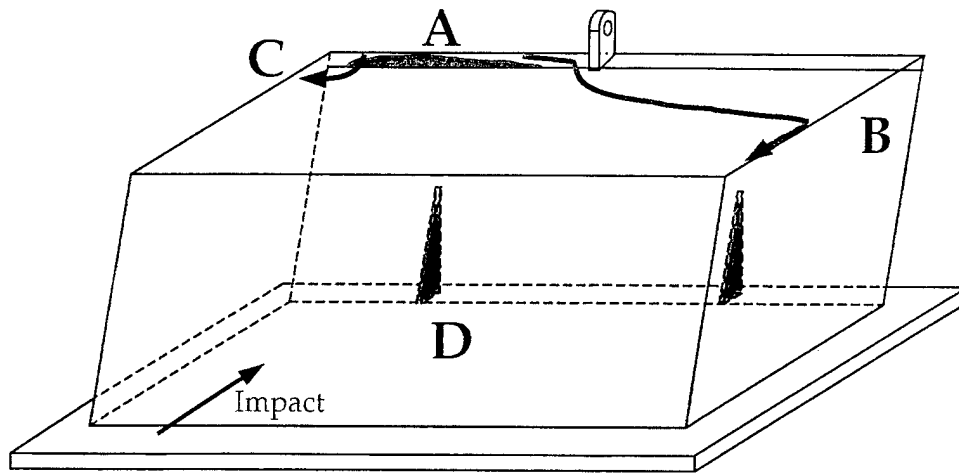
Figure 7. ARL overview, schematic 1.

but was still considered a penetration. The third and final round was a shock round to test the weld toughness, the result of which was considerable cracking. The ARL section had its primary fracture from this round at the top back left hand side (LHS) of the box, point A in Figure 7. Inspection revealed that the inside surface of the top plate in that area had taken an impact load from the armor package during the ballistic event (See GDLS Test Section Ballistic Results). Consequently, the top plate to back plate joint failed from overpressure down a 23-in span, point A, along the weld. The top 1/4-1/2 in of this weld zone failed in shear. Beyond this region, cracking advanced out of the weld joint and proceeded into the base material of the top plate, most likely as a result of the lifting hook being welded across the plate interface in this area (see schematic). Cracking progressed through the top plate, until the right hand side (RHS) of the top to side plate joint was reached at the approximate halfway point (Figure 7, point B). The crack then turned and followed the top to side plate joint approximately 6 in before arresting. The other end of the crack, emanating from the primary fracture, met (at the top back LHS corner, point C) with a crack from a secondary fracture that initiated at the base of the LHS gusset support (Figures 7 and 8, point D). In all likelihood, cracking originated from this area due to the fact that several weld beads converge here. This area was almost directly behind the point of collision of the round as it impacted the back plate (or impacted the armor package that, in turn, impacted the back plate). Failure most likely occurred here because the weld beads were discontinuous in this area.

The primary fracture occurred as a result of overpressure. This indicates that the weld was not tough (a measure of both strength and ductility) enough to stop cracking from initiating. Preventing crack initiation can eliminate crack progression. The results of the other welds on both the ARL and GDLS test section (in the case of the back plate to bottom plate interface discussed previously) indicate a nearly functional weld process. However, the stresses on the top plate to back plate interface still need to be lowered. In the opinion of ARL, the top plate should be increased in thickness to approximately 1.5 in to allow for a larger weld area to reduce the stress at this interface. It should be noted that the RHA box also had significant cracking (10–15 in) in this area.

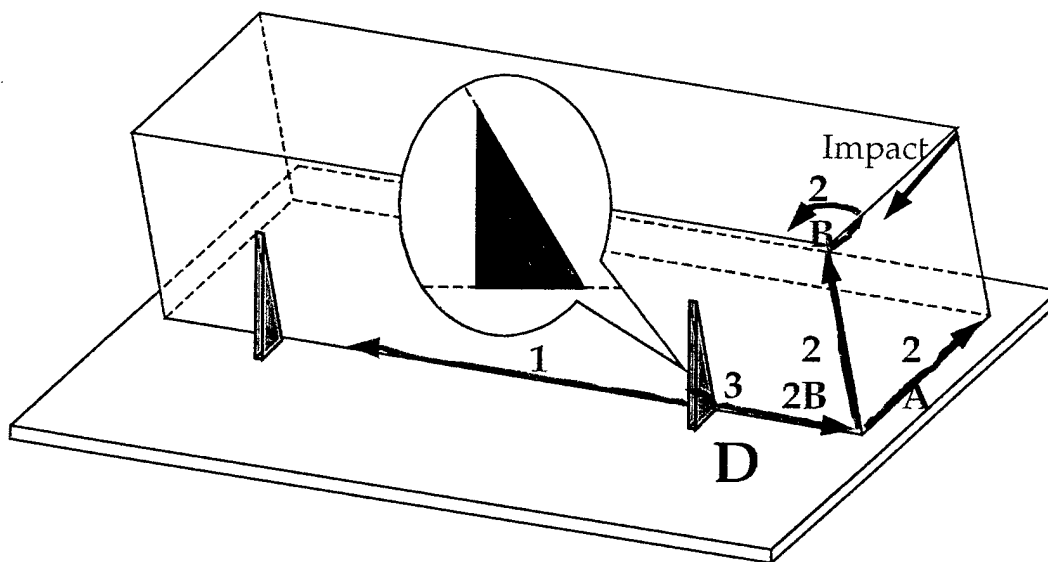
Figure 8. ARL overview, schematic 2.

The secondary fracture, crack no. 1 in Figure 8, ran along the back to bottom plate interface and continued approximately 30 in until it arrested. Crack no. 2 proceeded to the LHS (from front orientation) bottom back corner and wrapped

around the edge of the box. It then split in two, cracks 2A and 2B. Crack 2A proceeded along the LHS to the bottom weld interface approximately 15 in where it arrested. Crack 2B ran along the LHS back to the side weld interface and curled around the top of the plate where it met with the crack from the primary fracture and arrested. Crack no. 3 proceeded directly into the base material of the LHS gusset and ran entirely through the support; Figure 8 shows the details.

The secondary fracture most likely occurred from a combination of a lack of weld material along the back to base plate interface and the stop/start point of six weld root passes being in the corner of the gusset. A redesign of the welding in this area would result in the entire back plate to base plate interface being welded before the addition of the gusset supports. The fact that the GDLS test section had more weld metal in this area, a very similar weld design, continuous weld beads, and minimal cracking in this area substantiates this (See GDLS Test Section Ballistic Results). The main point here is that ARL believes the cracking originated from a fault in the welding procedure (discontinuous weld beads), not from a fault in the weld design.

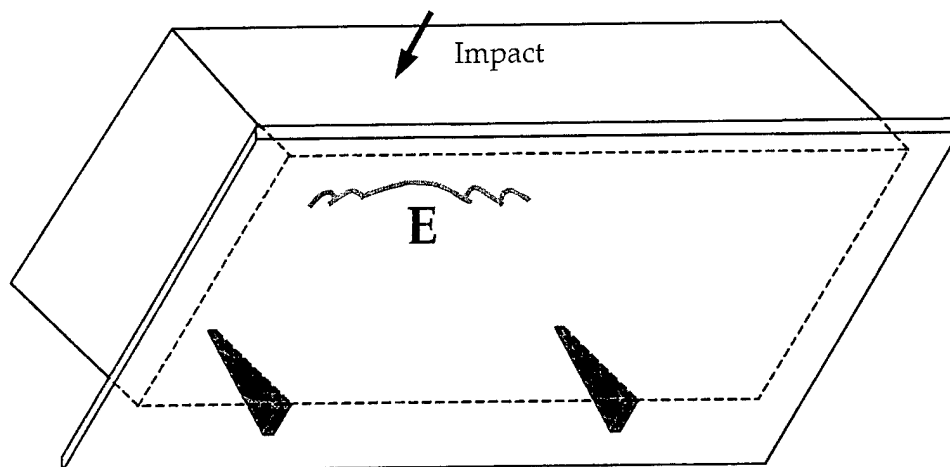
Figure 9. ARL overview, schematic 3.

Tertiary fracture occurred entirely within the base plate material from the entry of the shock round in the front plate. The 1-in-thick base plate failed along a 14-in section due to the bending moment and stresses from the impacting projectile. This can be observed in Figure 9, point E, and in Figure 10. This crack can most likely be eliminated from a simple redesign of the front to base plate weld and would not occur on a vehicle due to the joint design differences.

The tertiary fracture occurred first, but is of the least significance. It was ARL's understanding that during the construction of the test section, the base plate needed a lip around the box so it could be held in place on the test stand. A tank turret would not need this lip nor incorporate it in its design. Figure 11 depicts a simple redesign of the front to bottom weld interface that would change the stress configuration, drastically reducing the likelihood of cracking in this area.

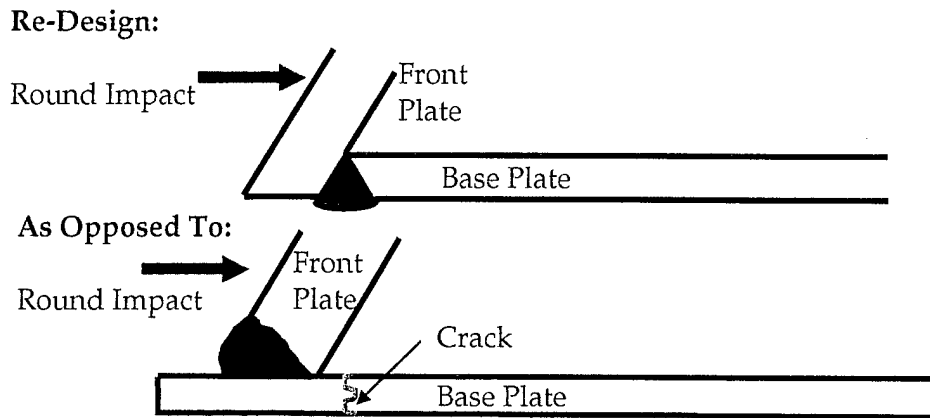
Figure 11. Schematic of the redesigned front to base plate weld joint.

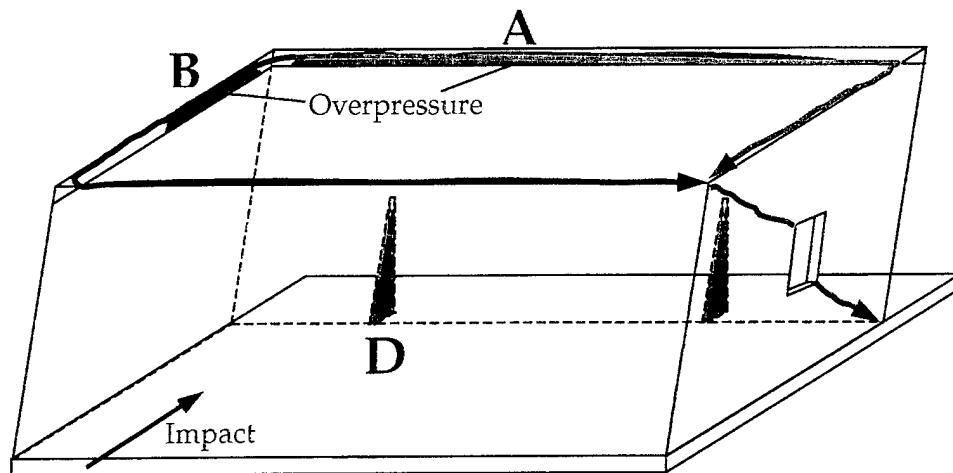
Figure 12. GDLS overview, schematic 1.

The GDLS test section had its primary fracture originate at the top back LHS of the box, point A in Figure 12.

It was apparent that the inside surface of the top plate in that area had taken an impact from the armor package. There were linear deformation marks on the inside surface of the top plate that matched the configuration of the armor package. Additionally, the GDLS box weld interface did not match the proposed design of the region, as observed in the picture of the weld failure (see Figures 13 and 14). The top to back plate interface was designed as shown in Figure 13, however; the test section also had an extra step shown.

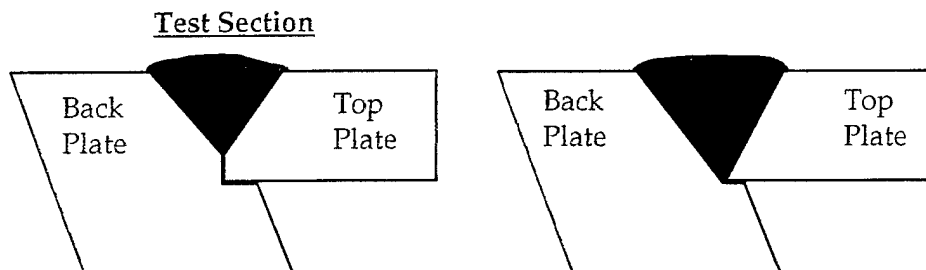
Figure 13. Design of GDLS back to top plate weld vs. test section.

This extra step was detrimental to the strength of the weld. As a result, the top plate to back plate weld failed from overpressure along a 46-in span along the weld (2/3 of the welded length). The top 1/4–1/2 in of this weld zone failed in shear. There also existed overpressure failure along a 10-in span on the back LHS of the top to side plate interface (see Figure 12, point B). Beyond these regions, the crack paths continued along the top plate welds until both crack fronts met at the top front RHS of the box and the top plate was entirely removed in one piece. A crack then proceeded into the RHS side plate base material, diagonally through the air vent in the RHS side plate, and arrested at the back bottom RHS corner of the test section.

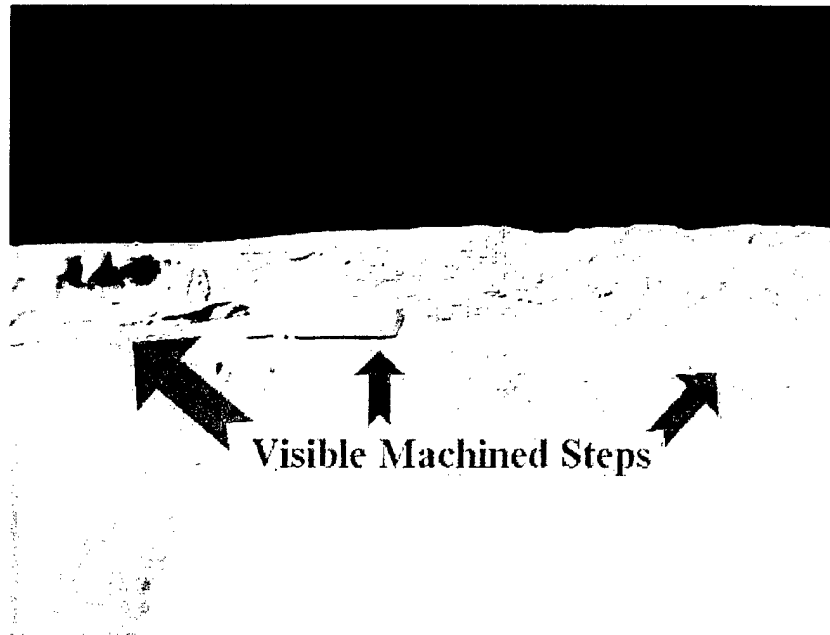
Figure 14. Photograph of the GDLS test section back to top and back to side weld designs.

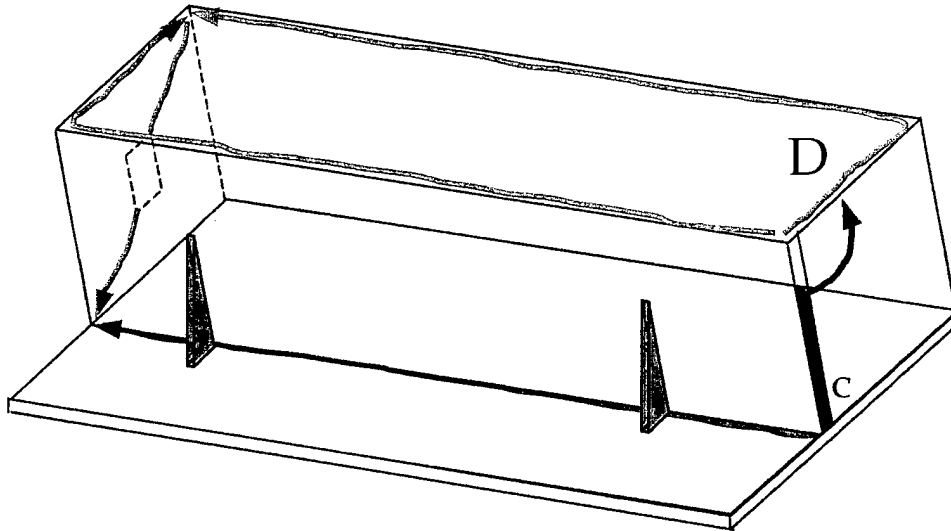
Figure 15. GDLS overview, schematic 2.

The secondary fracture occurred along the inside back to LHS side plate and back to base plate interfaces. The back to side plate failure originated from overpressure along a 17-in section toward the bottom of that interface (see Figure 15, point C). Cracks progressed along the back to bottom plate weld interface. From the other end of the overpressure zone, cracking advanced into the base material of the LHS side plate until it met the crack path of the top plate from the primary failure (see Figure 15, point D).

Several separate areas of overpressure existed after the shock testing. Some of these areas were also of significant size. The areas where the overpressure mode of failure existed need improvement in the weld toughness and strength. Redesigning the welds, changing the weld material, and/or optimizing the welding process and parameters can accomplish this.

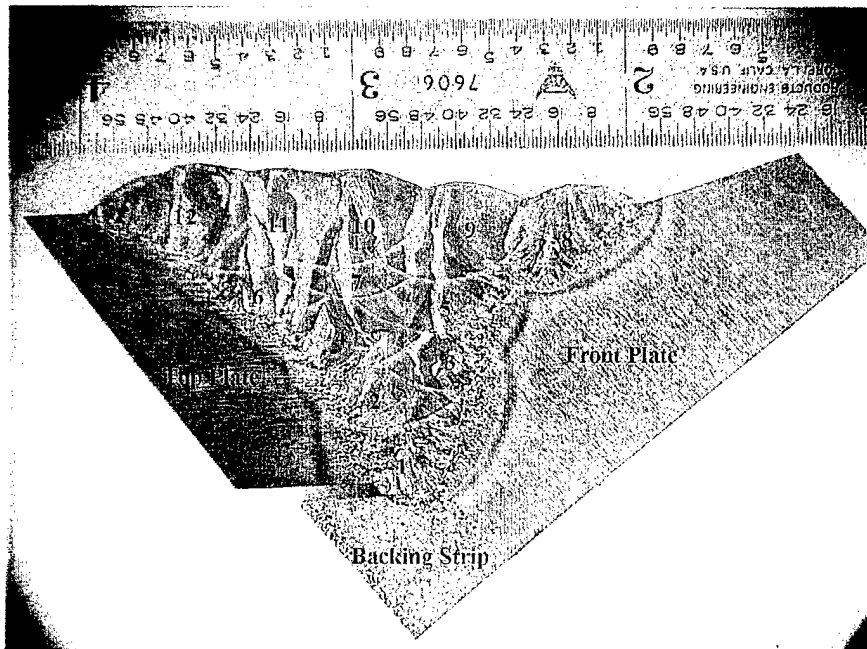
Figure 17. Macro cross section of the front plate to top plate weldment.

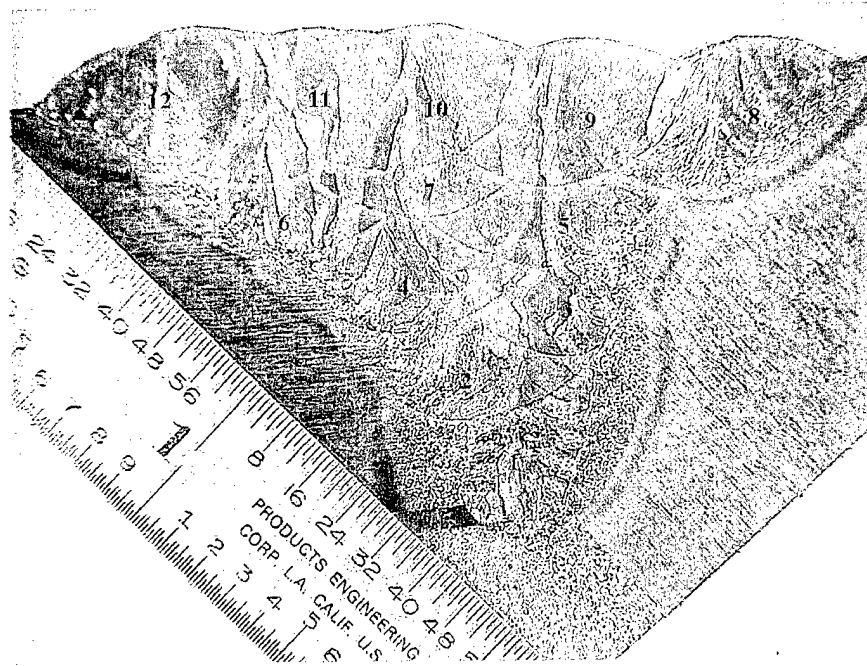
Figure 18. Cross section of the front plate to top plate weld bead.

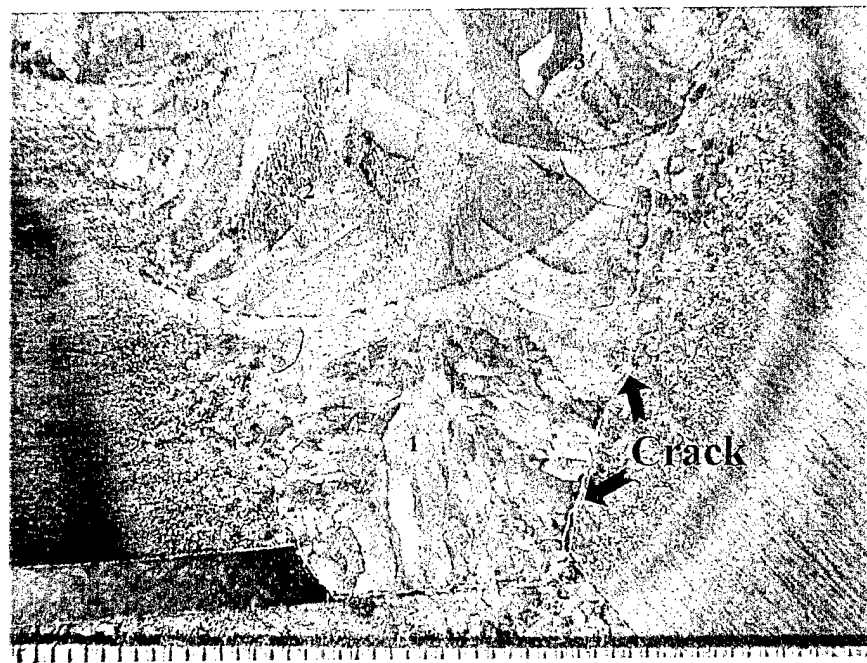
Figure 19. Cross section showing a fine crack in the front plate to top plate weldment.

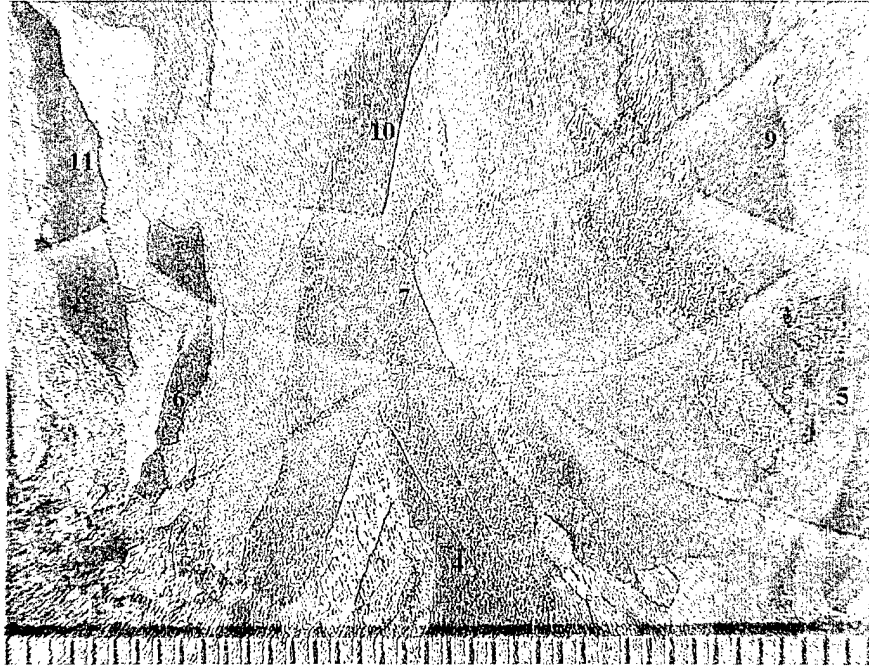
Figure 20. Front to top plate fusion zone with grain growth across weld pass boundaries.

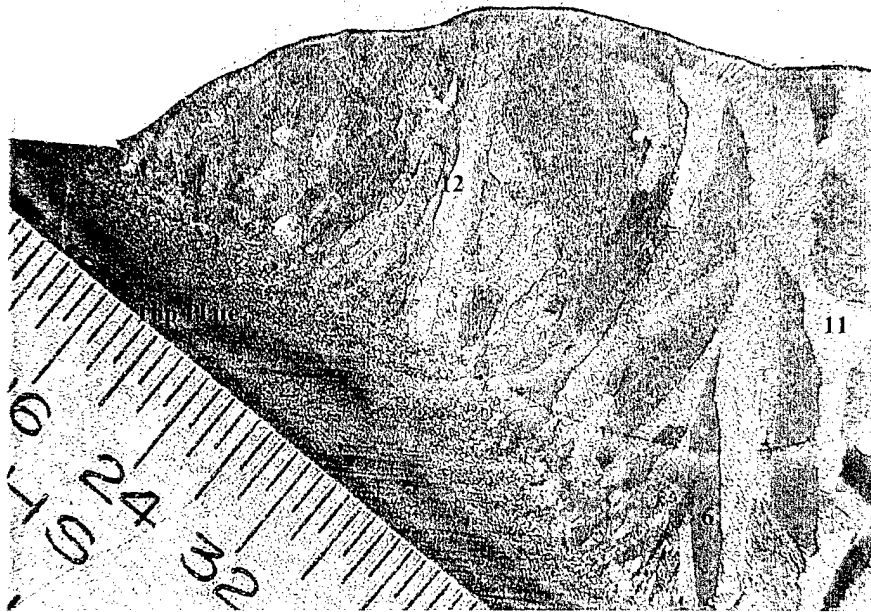
Figure 21. Front plate to top plate weldment showing approximately 1/8-in HAZ.

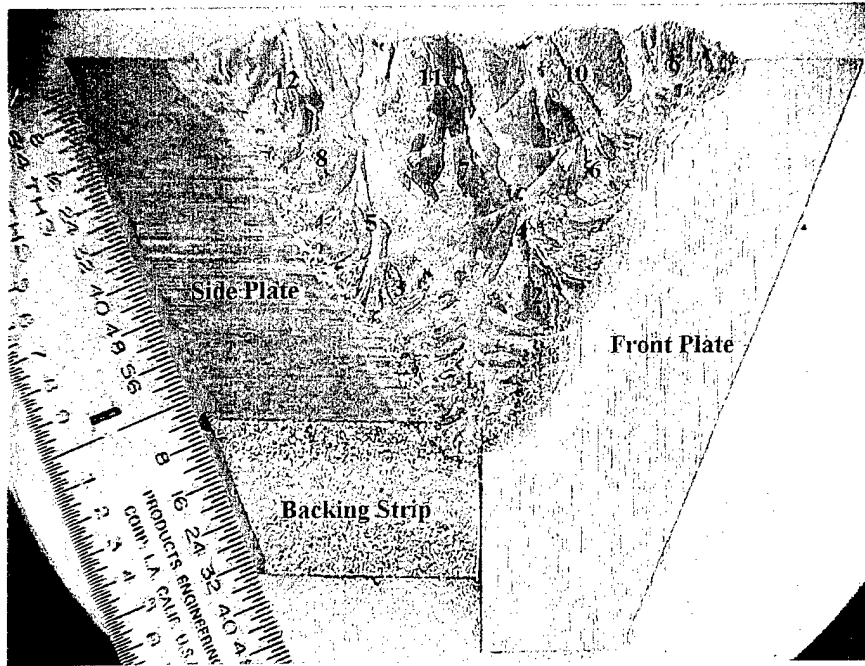
Figure 22. Macro cross section of the front to side plate weldment.

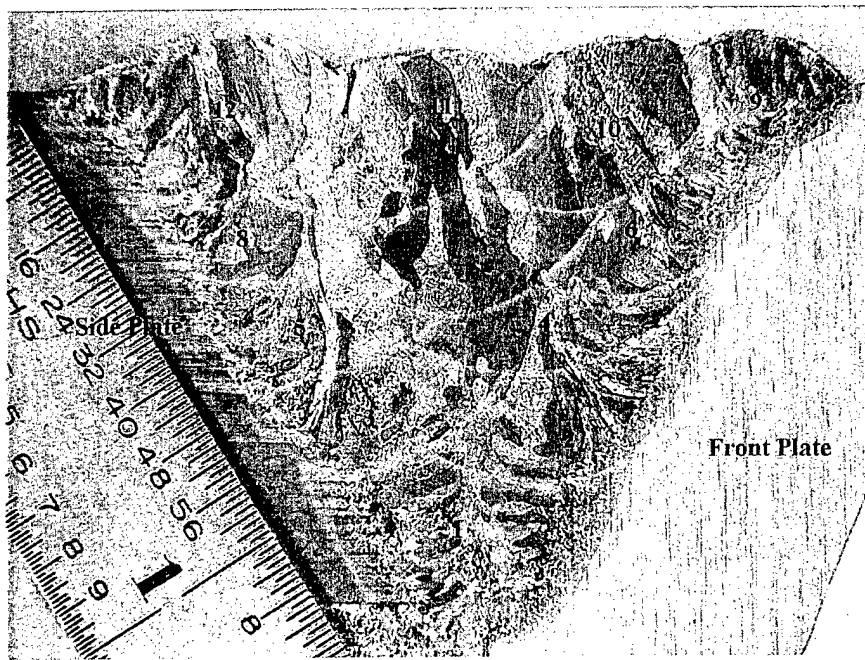
Figure 23. Cross section depicting the front to side plate fusion zone.

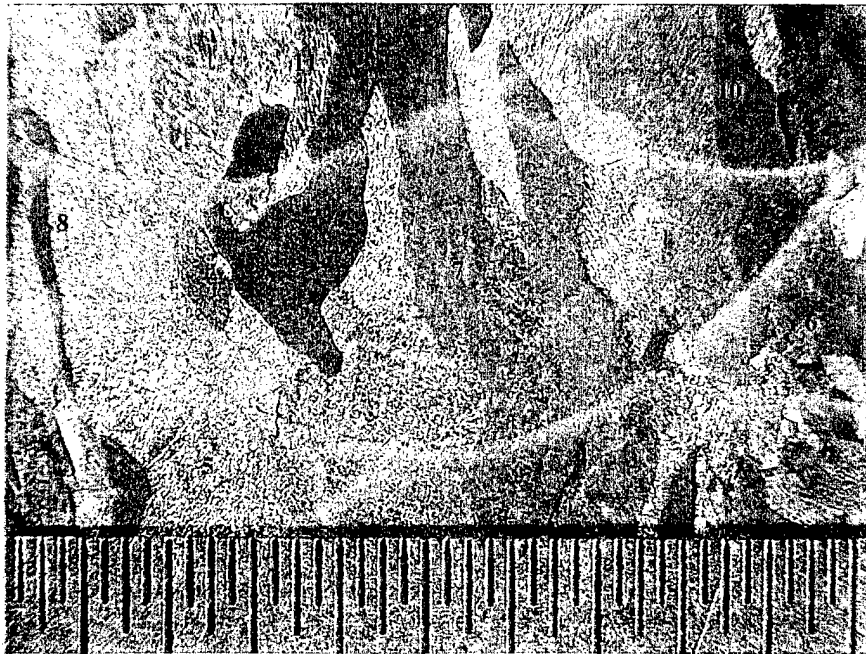
Figure 25. Front to side plate middle of the fusion zone.

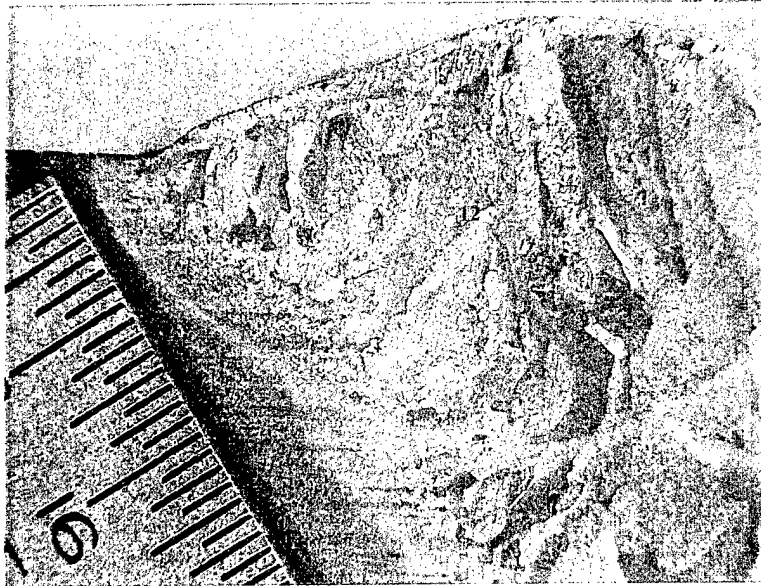
Figure 26. Front to side plate weld cap.

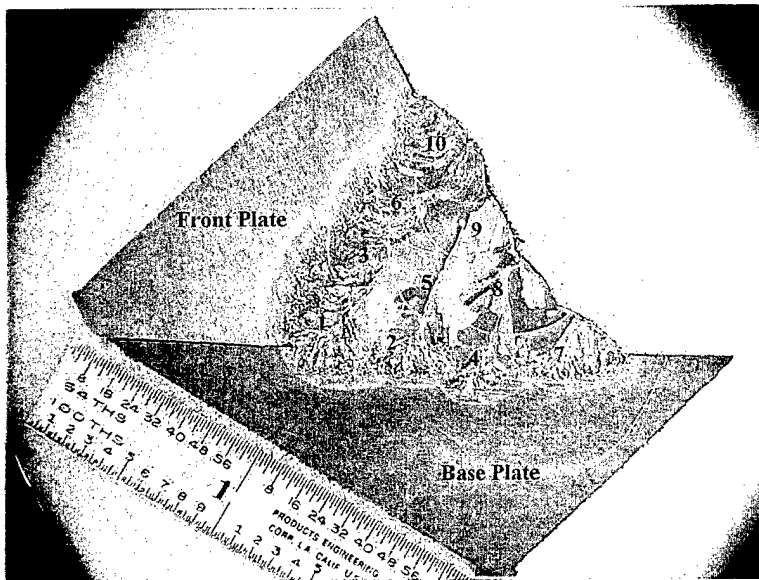
Figure 27. Macro cross section of the front to base plate.

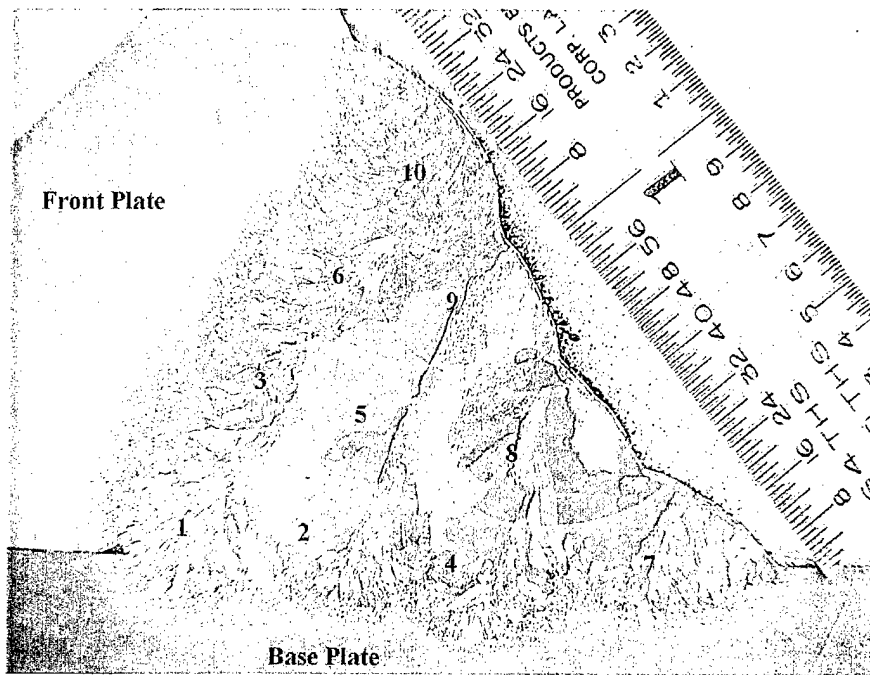
Figure 28. Cross section of the front to base plate fusion zone.

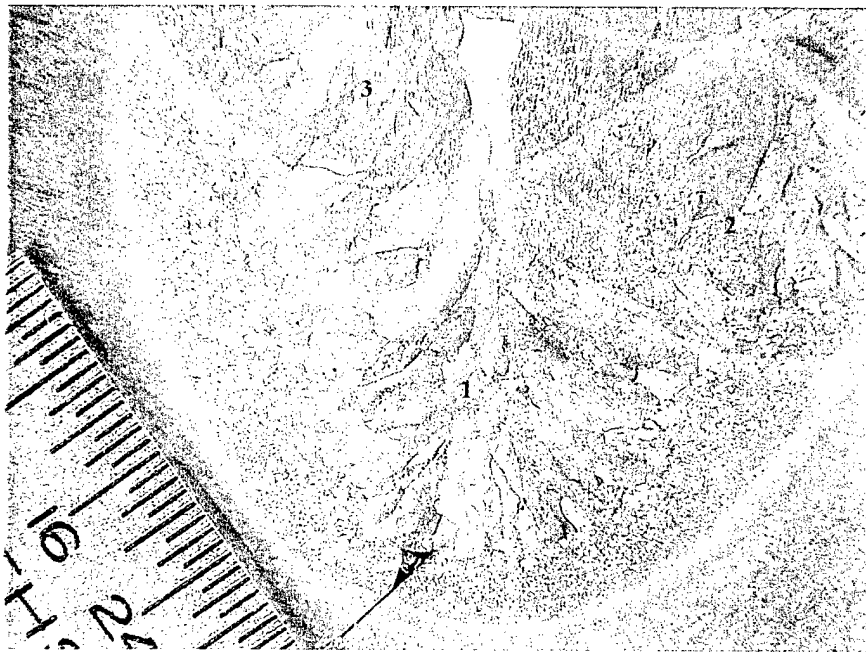
Figure 29. Cross section of the front to base plate weld root.

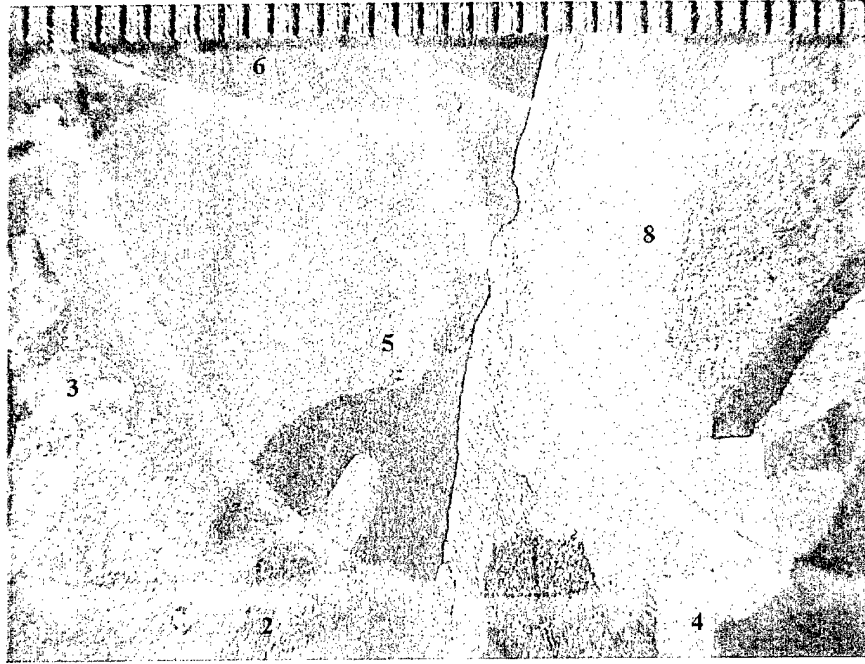
Figure 30. Cross section of the middle of the fusion zone of the front to base plate weld.

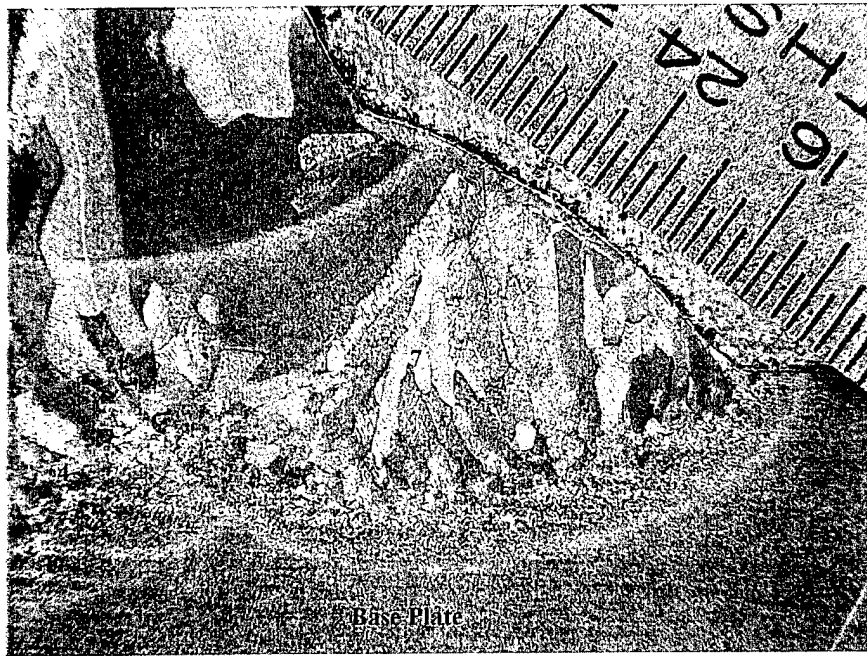
Figure 31. Cross section of the front to base plate weld cap.

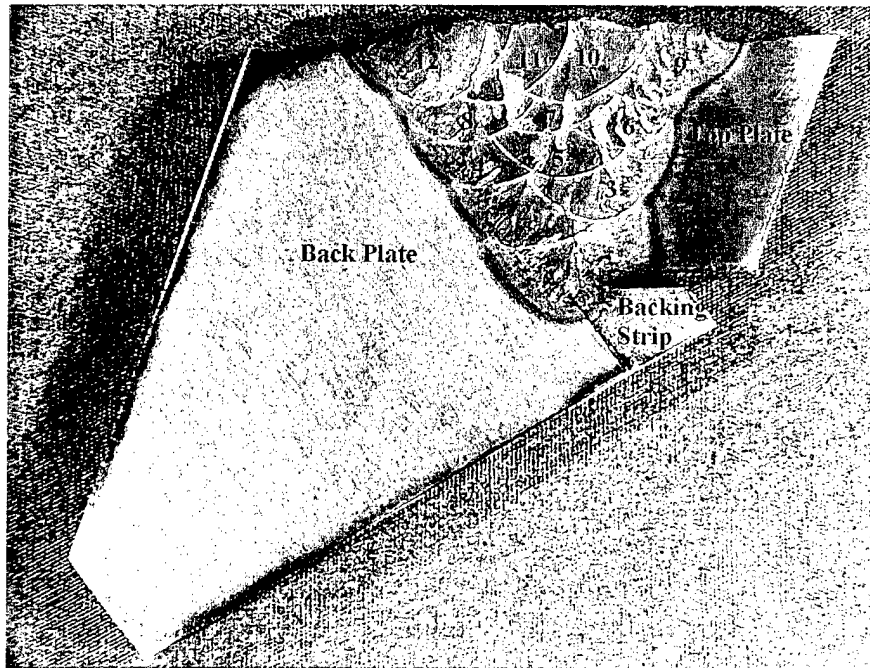
Figure 32. Macro cross section of the back to top plate.

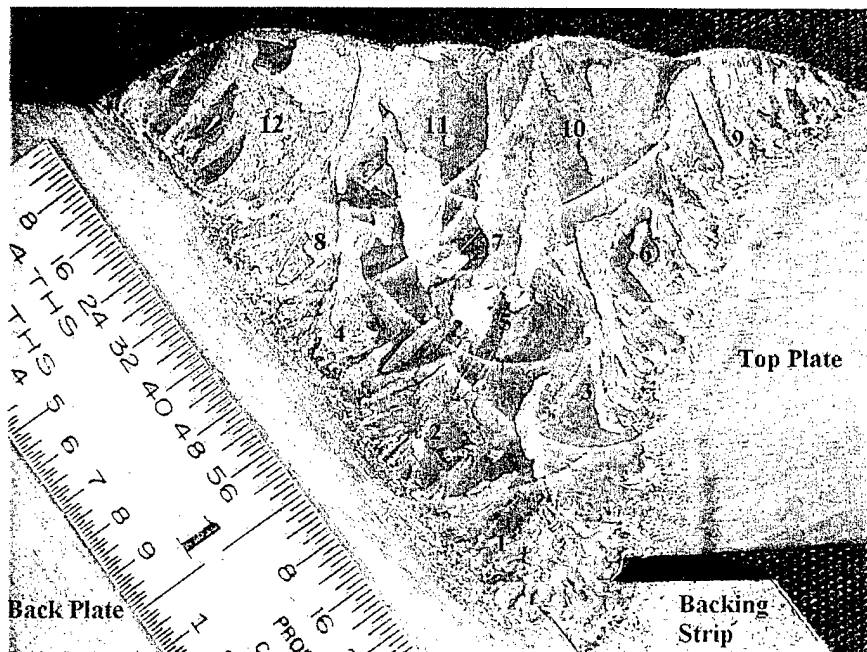
Figure 33. Cross section of the back to top plate weld fusion zone.

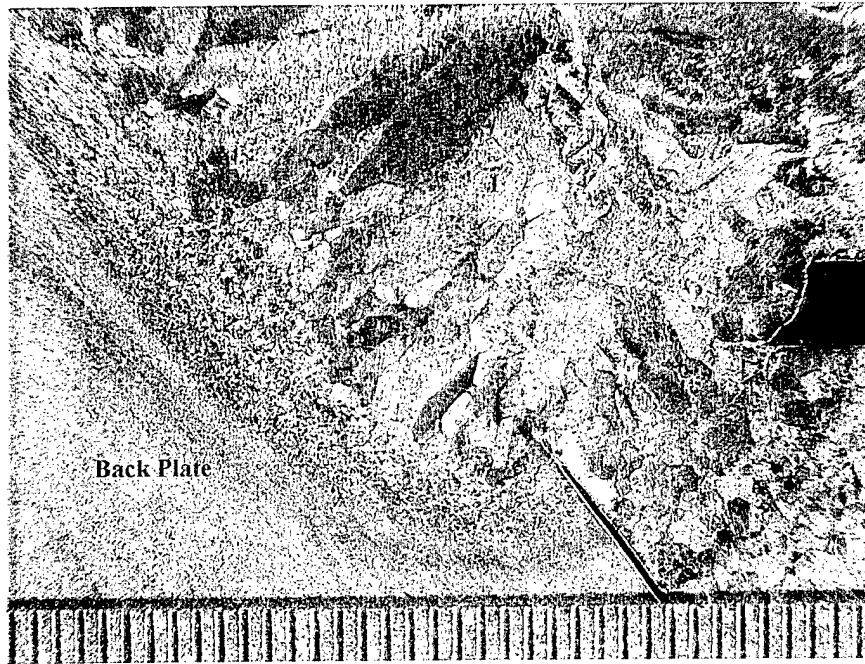
Figure 34. Cross section of the root of the back to top plate weldment.

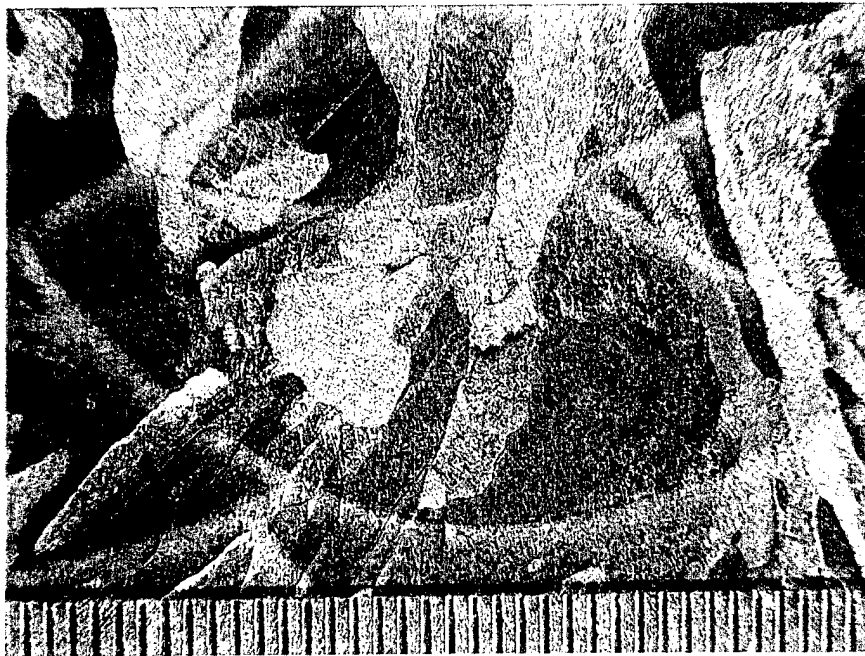
Figure 35. Cross section of the middle of the fusion zone of the back to top plate weldment.

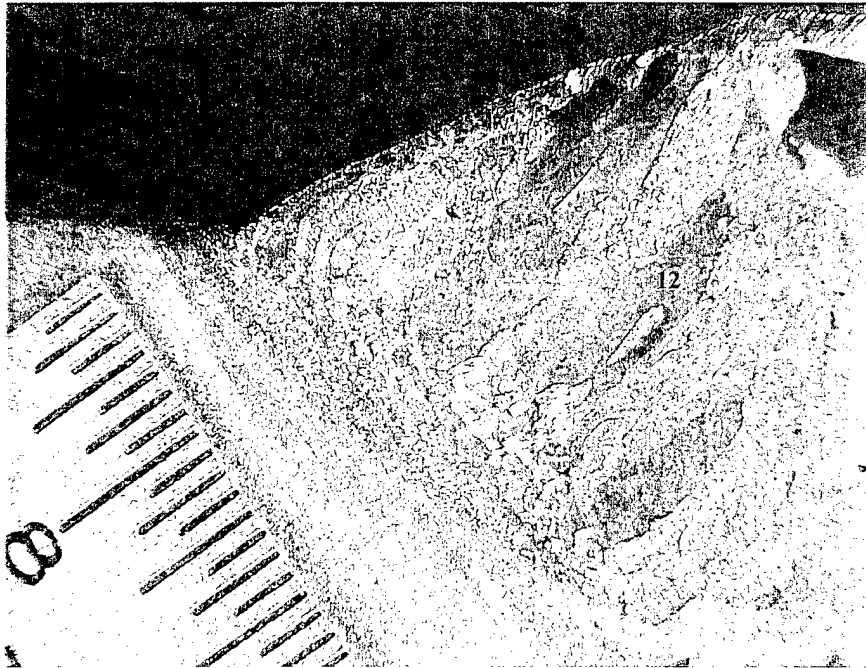
Figure 36. Cross section of the cap of the back to top plate weldment.

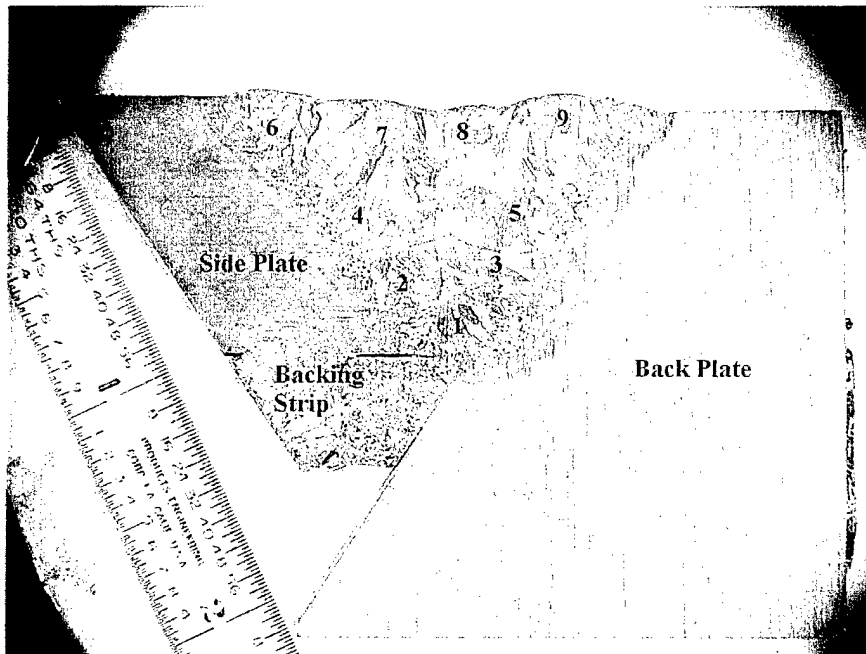
Figure 37. Macro cross section of the base to side plate weldment.

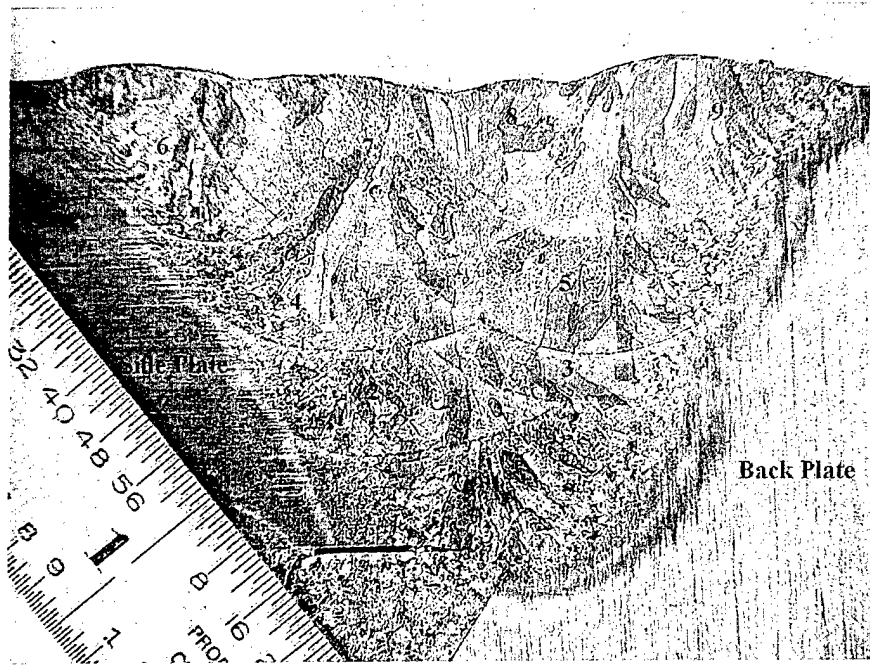
Figure 38. Cross section of the back to side plate weld fusion zone.

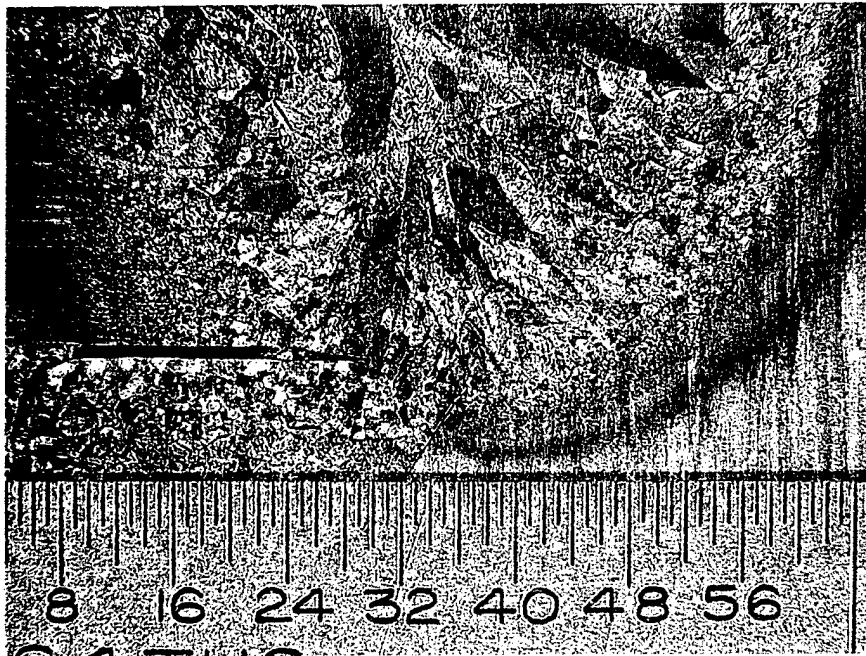
Figure 39. Cross section of the root of the back to side plate weldment.

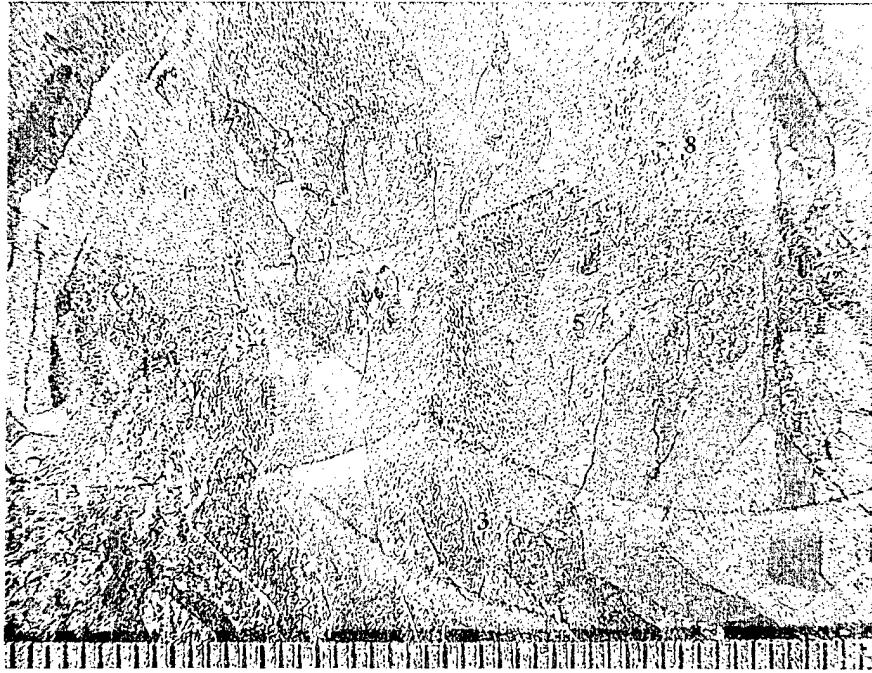
Figure 40. Cross section of the middle of the back to side plate weld fusion zone.

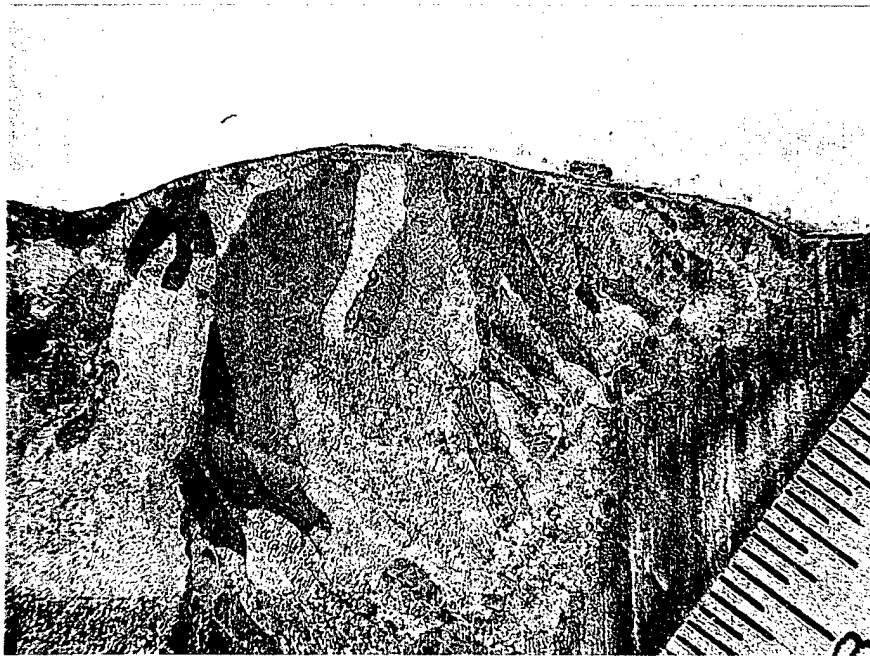
Figure 41. Cross section of the back to side plate weld cap.
