# Fabrication and Evaluation of Welded Ti-6Al-4V Test Sections

by Scott Grendahl, Daniel Snoha,  
and Brijmohan Roopchand

ARL-TR-2533

## Fabrication and Evaluation of Welded Ti-6Al-4V Test Sections

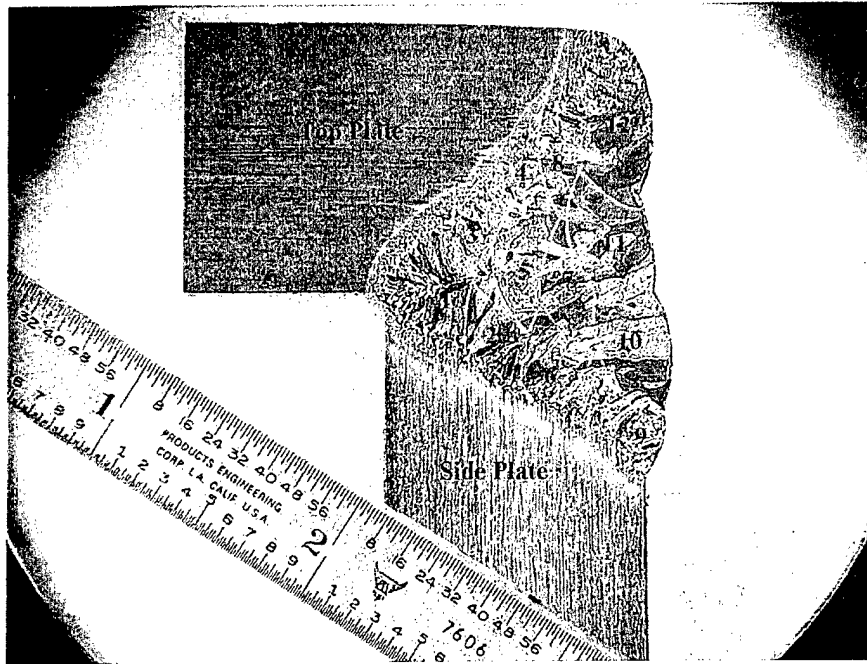
Figure 42. Macro cross section of the top to side plate weldment.

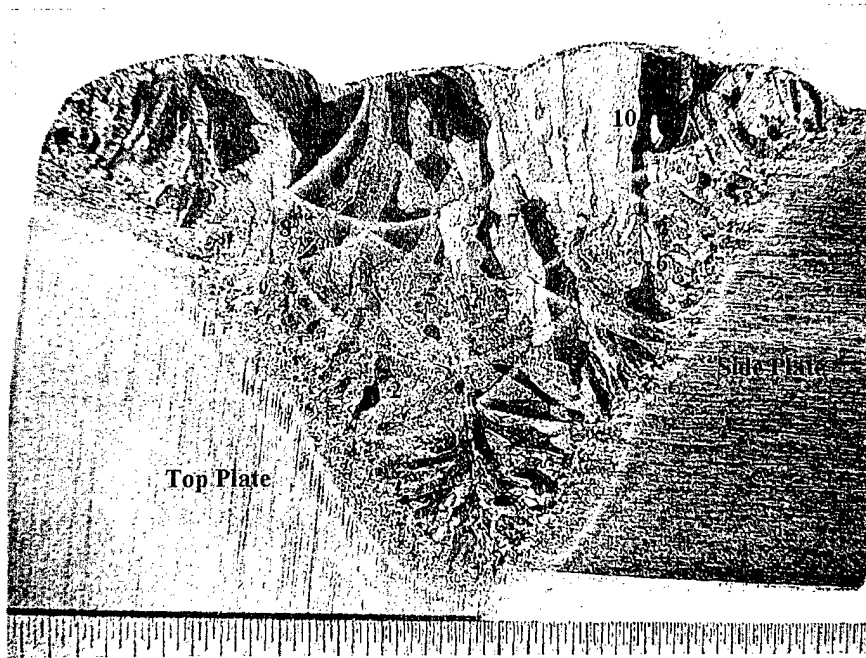
Figure 43. Cross section of the top to side plate weld fusion zone.

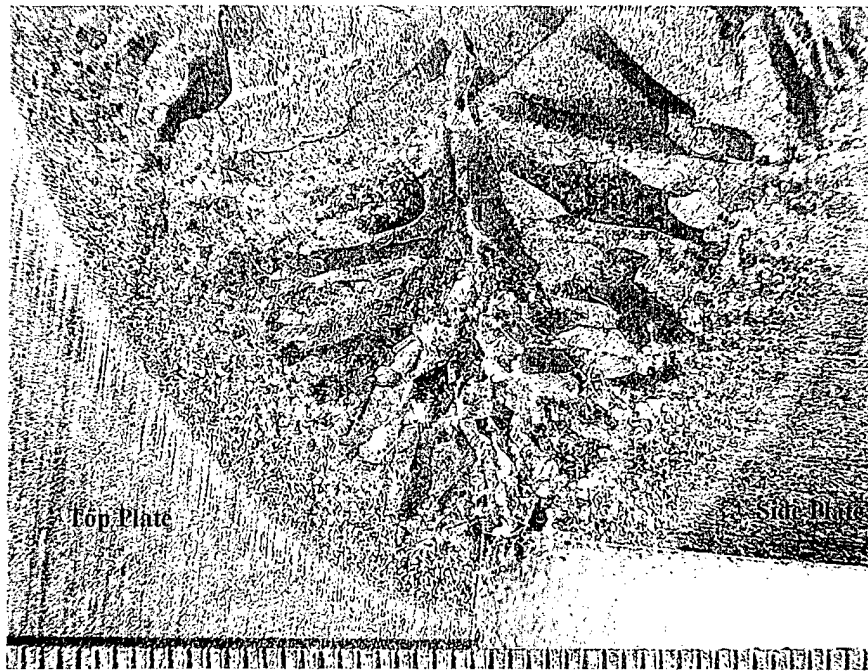
Figure 44. Cross section of the root of the top to side plate weldment.

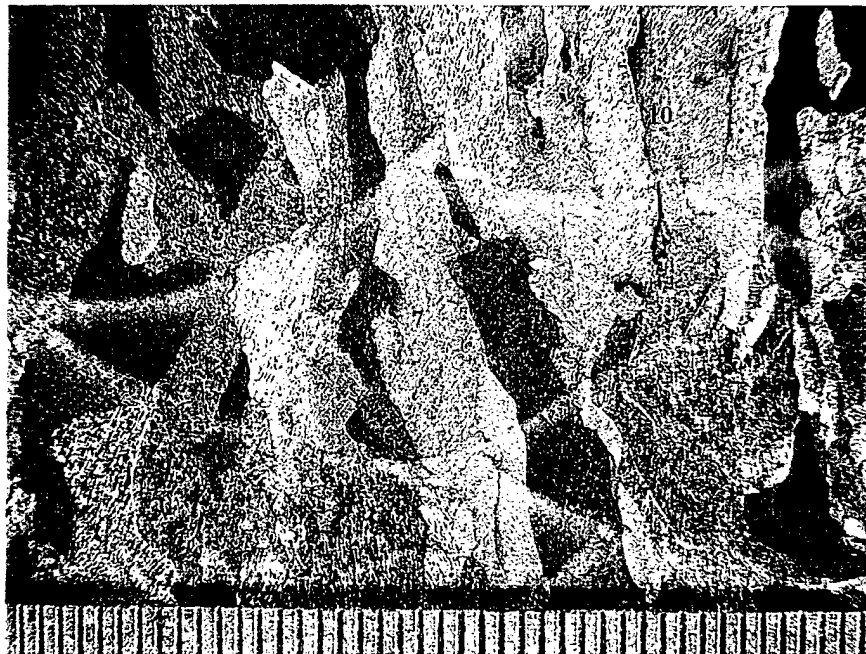
Figure 45. Cross section of the middle of the top to side plate weld fusion zone.
