**FINAL REPORT
JUNE 2001**

REPORT NO. 01-14

**PALLET, STANDARD SIZE 44 x 40, SHEET METAL,
MANUFACTURED BY
ARMOR METAL FABRICATION, INC.,
MIL-STD-1660, FIRST ARTICLE TEST (FAT)**

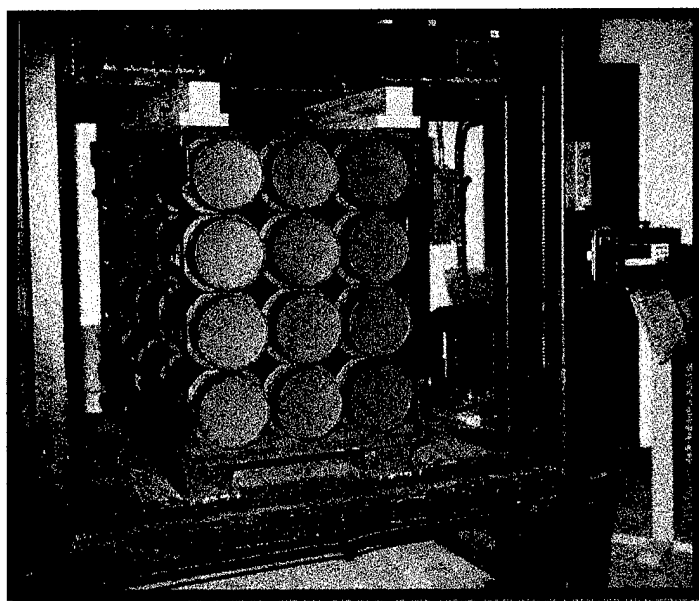
**Figure 1. Example of Compression Tester.
(2.75-inch Hydra 70, PA151 Rocket Pallet in the compression tester.)**

A. STACKING TEST. The unit load was tested to simulate a stack of identical unit loads stacked 16 feet high, for a period of one hour. This stacking load was simulated by subjecting the unit load to a compression weight equal to an equivalent 16-foot stacking height. The compression load was calculated in the following manner. The unit load weight was divided by the unit load height in inches and multiplied by 192 less the weight of one pallet load. The resulting number was the equivalent compressive force of a 16-foot-high load. Figure 1 below shows an example of a unit load in the compression tester.

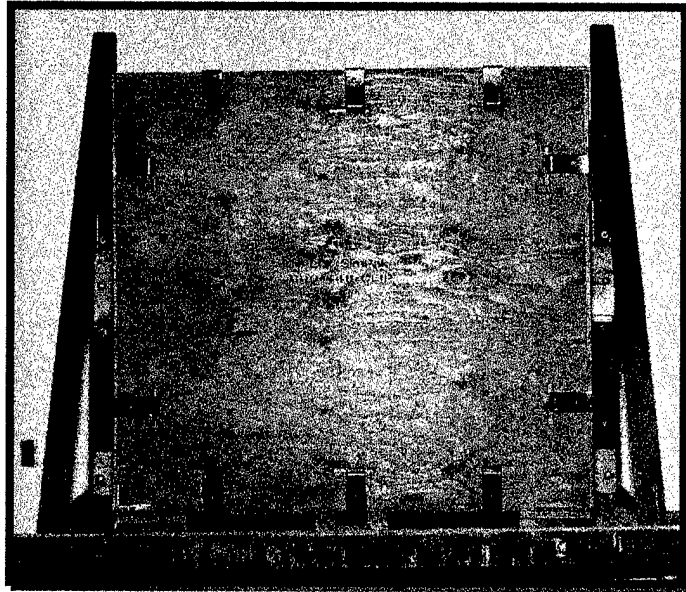
**Figure 2. Example of the Repetitive Shock Test.
("Clip-Lok" pallet on the vibration table.)**

B. REPETITIVE SHOCK TEST. The repetitive shock test was conducted IAW Method 5019, Federal Standard 101. The test procedure is as follows: The test specimen was placed on (not fastened to) the platform. With the specimen in one position, the platform was vibrated at 1/2-inch amplitude (1-inch double amplitude) starting at a frequency of approximately 3 cycles-per-second. The frequency was steadily increased until the package left the platform. The resonant frequency was achieved when a 1/16-inch-thick feeler gage momentarily slid freely between every point on the specimen in contact with the platform at some instance during the cycle. Midway into the testing period, the specimen was rotated 90 degrees, and the test continued for the duration. Unless failure occurred, the total time of vibration was three hours. Figure 2 shows an example of the repetitive shock test.

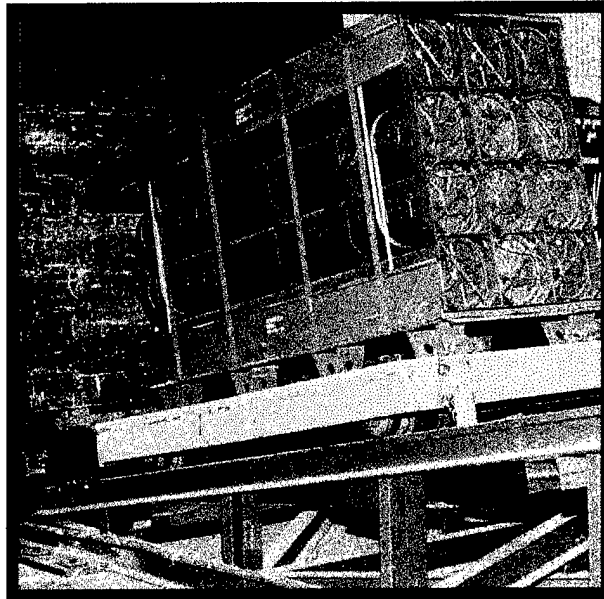
**Figure 4. Example of the Incline-Impact Test.
(2.75-Inch, Hydra 70, PA151 Rocket Pallet on incline-impact tester.)**

D. INCLINE-IMPACT TEST. This test was conducted by using the procedure of Method 5023, Incline-Impact Test of Federal Standard 101. The procedure for the incline-impact test is as follows: The specimen was placed on the carriage with the surface or edge to be impacted projecting at least 2 inches beyond the front end of the carriage. The carriage was brought to a predetermined position on the incline and released. If it were desired to concentrate the impact on any particular position on the container, a 4- x 4-inch timber would be attached to the bumper in the desired position before the test. The carriage struck no part of the timber. The position of the container on the carriage and the sequence in which surfaces and edges were subjected to impacts was at the option of the testing activity and depended upon the objective of the test. This test was to determine satisfactory requirements for a container or pack, and, unless otherwise specified, the specimen was subjected to one impact on each surface that has a dimension of less than 9.5 feet. Unless otherwise specified, the velocity at the

time of the impact was 7 feet-per-second. Figure 4 shows an example of this test.

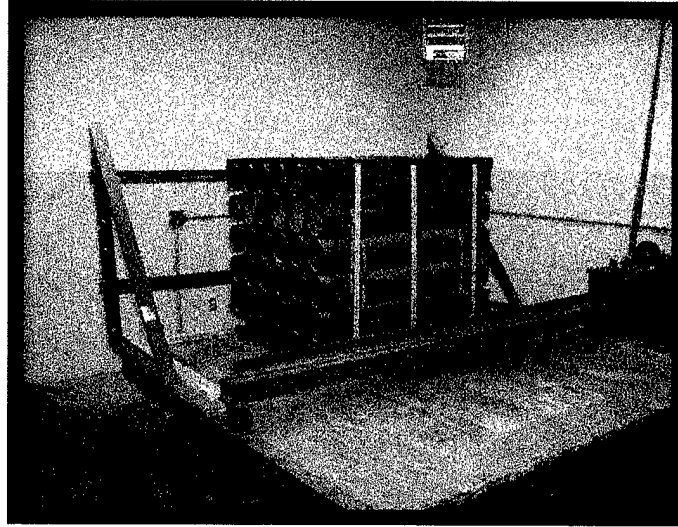
Figure 6. Test setup of Repetitive Shock Test.

2. **Repetitive Shock Test.** Test Pallet 2A was vibrated 90 minutes at 171 RPM in the longitudinal orientation and 90 minutes at 180 RPM in the lateral orientation. There was no damage to the pallet as a result of this test. See figure 6 for test setup.

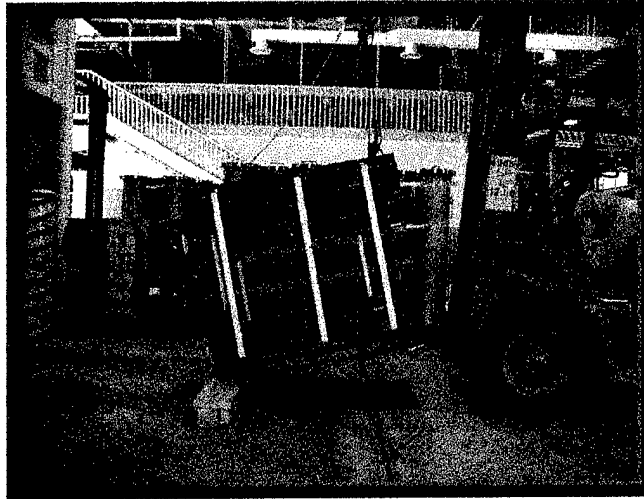
Figure 7. Test setup of Edgewise Rotational Drop Test.

3. **Edgewise Rotational Drop Test.** Test Pallet 2A was edgewise rotationally dropped from a height of 15 inches on the longitudinal and 15 inches on the lateral drops. The post skid welds broke in several places, but it should be noted that there were no post deck welds broken. The damage was deemed to be minor with further inspection to be done during disassembly of the pallet. See Figure 7 for test setup.

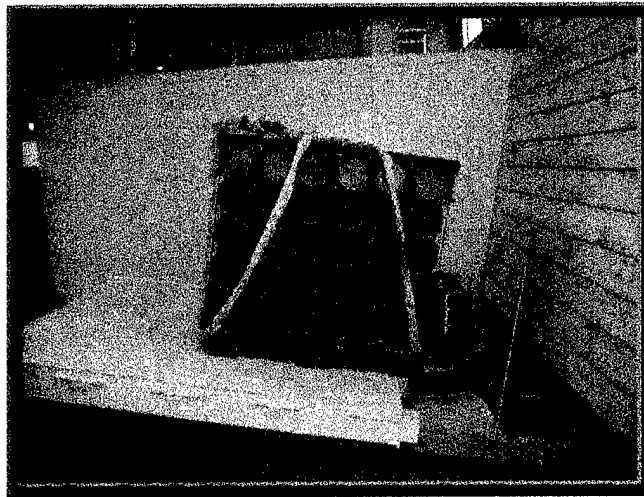
Figure 8. Test setup of Incline-Impact Test.

4. **Incline-Impact Test.** Test Pallet 2A was incline-impacted on all four sides with the pallet impacting the stationary wall from a distance of 8 feet. Again, no additional problems were encountered. See figure 8 for test setup.

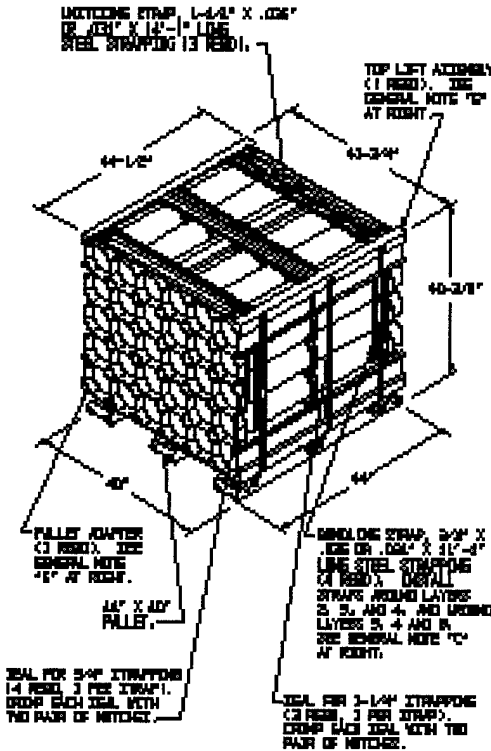
The following drawing represents the load configuration that was subjected to the test criteria. The final load drawing is AMC Drawing # 19-48-4231/45-20PM1006. This drawing may be located at:

CARTRIDGE, 105MM. PACKED 1 PER PA117
CYLINDRICAL METAL CONTAINER, UNITIZED 30
PER 44" X 40" PALLET; APPROX CONTAINER
SIZE 44-1/2" L X 6-7/8" W X 6-7/8" H
