NASA TM X-1048

PRELIMINARY INVESTIGATION
OF EFFECT OF ENVIRONMENTAL
FACTORS ON SALT STRESS CORROSION
CRACKING OF Ti-8Al-1Mo-1V
AT ELEVATED TEMPERATURES

by David N. Braski

Langley Research Center

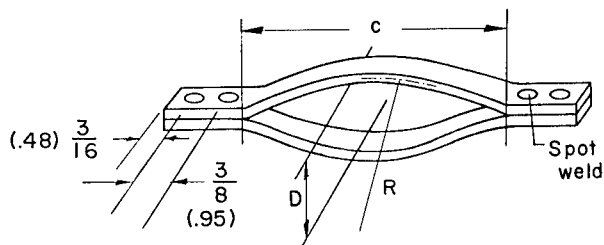
(a) Machined strip.

(b) Strip with ends bent.

(c) Completed specimen.

Figure 1.- Construction of self-stressed specimen. Dimensions are given in inches and parenthetically in centimeters.

- (1) Cut and machine 4- by 1/4-inch (10.16- by 0.64-cm) strips (fig. 1(a))
- (2) Bend ends of each strip to bend angle of approximately 12° (fig. 1(b))
- (3) Clean the strips chemically (see section entitled "PROCEDURE")
- (4) Place two cleaned strips together, clamp the ends, and spotweld (fig. 1(c)). Handle all specimens carefully with clean white gloves throughout this operation to prevent any contamination.

The magnitude of the outer fiber stresses depends upon the radius of curvature, the thickness of the sheet strip, and Young's modulus for the material at the exposure temperature. As long as the strips are stressed below the elastic limit, the distance D (see fig. 1(c)) between the inner faces of the

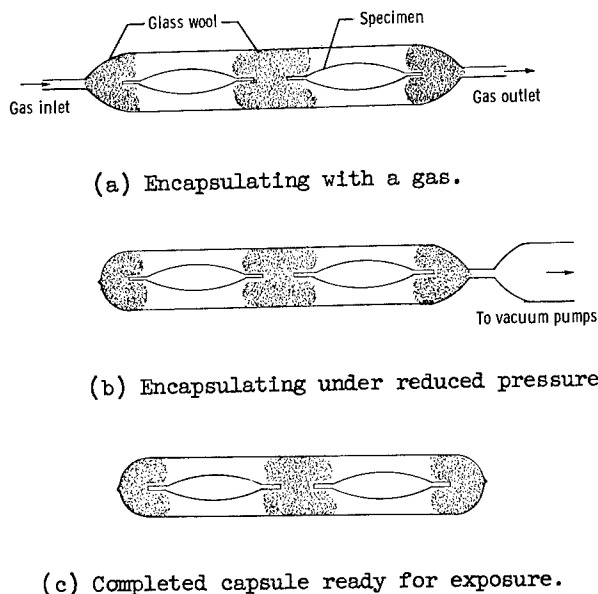
Figure 2.- Encapsulation of specimens.

In order to study the effects of different amounts of oxygen and moisture on the stress corrosion of Ti-8Al-1Mo-1V, salt-coated specimens were encapsulated in glass tubes with oxygen, nitrogen, and air with dewpoints of -40° F (233° K) and 60° F (289° K). A group of uncoated specimens was also encapsulated in moist chlorine gas to determine the manner in which this gas reacts with Ti-8Al-1Mo-1V and the resultant corrosion products. Figure 2(a) is a sketch of the type of capsule used for encapsulation with a gas. Other

salt-coated specimens were encapsulated under reduced pressures of 34 (4.55 kN/m^2) and $3 \times 10^{-5} \text{ mm Hg}$ (4.0 mN/m^2) to study the effects of pressure. (See fig. 2(b).) Figure 2(c) represents a sealed capsule ready for exposure. The detailed procedure used for encapsulating specimens is given in appendix C.

(3) Both ends of the tube were drawn down to approximately 1/8 inch (0.3 cm) by using a glass lathe and an oxypropane torch to provide an inlet and outlet for the desired gas. (See fig. 2(a).) To obtain a reduced pressure capsule, one end was sealed off and the other necked as shown in figure 2(b).

(4) The tubes were purged with the desired gas for at least 1/4 hour and then sealed quickly. The outlet was sealed first to prevent any entrance of outside air. The reduced-pressure capsules were pumped down to the desired pressure by use of a portable pumping system consisting of a mechanical pump and a 2-inch (5.08-cm) diffusion pump. A flexible, thick-walled plastic hose and clamps were used to connect the capsule to the pumping system. The capsule was placed in a small ceramic tube furnace when an encapsulation at elevated temperature was desired. A capsule, which has been sealed off and is ready for exposure, is shown in figure 2(c).

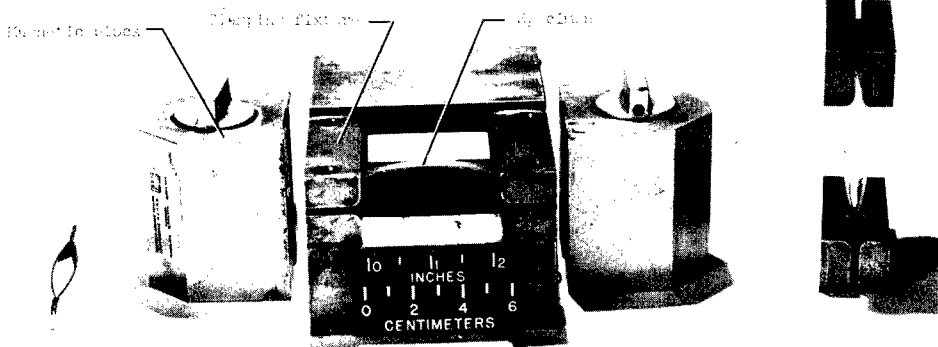
(a) Specimen.

(b) Alinement fixtures.

(c) Specimen with upper and lower clamping fixtures.

Figure 3.- Specimen, alinement fixtures, and clamping fixtures.

After exposure, the salt coatings were removed with a water rinse and specimens were tested in compression at room temperature by utilizing the fixtures shown in figure 3. A special fixture was used to aline the upper and

lower clamps with the specimen (fig. 3(b)). These clamping fixtures were used to support the specimen vertically in the hydraulic testing machine (fig. 3(c)). Load was applied at a rate of 200 pounds per minute (15 N/s) and recorded automatically against head displacement. The head displacement, which is equivalent to specimen shortening, was measured by a deflectometer consisting of an aluminum-alloy cantilever beam instrumented with strain gages at the base of the beam.

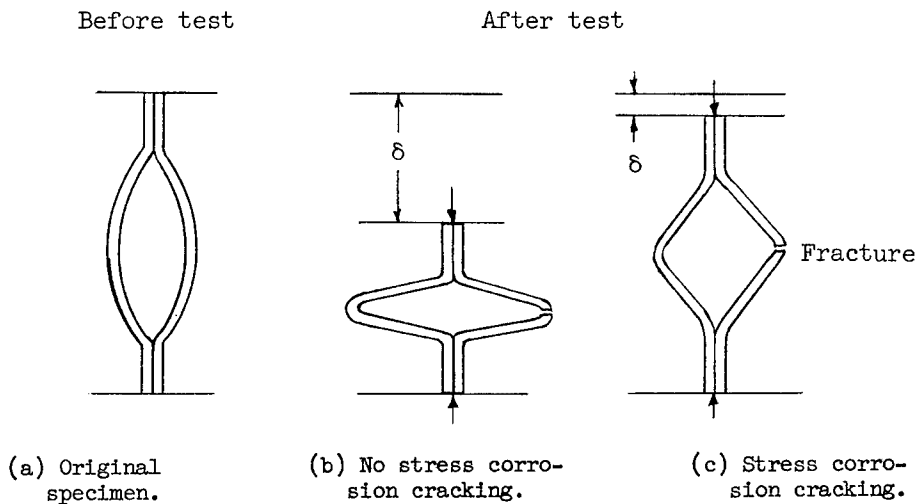
Figure 4.- Specimen configuration before and after room-temperature compression test. δ represents shortening.

The effects of the various environments on the stress corrosion cracking in Ti-8Al-1Mo-1V were evaluated by the compression tests. Typical specimen configurations before and after compression testing are illustrated in figure 4. Specimens with no stress corrosion cracks could be compressed approximately 1.6 inches (4.1 cm) before fracture occurred at the bend (fig. 4(b)). Specimens with stress corrosion cracks fractured after relatively small amounts of shortening (fig. 4(c)). It was shown in reference 2 that the greater the maximum crack penetration, the smaller the amount of shortening needed to produce fracture. The following paragraphs are a discussion of the effects of different variables and environments on the stress corrosion cracking of Ti-8Al-1Mo-1V specimens stressed at 100 ksi (689 MN/m²). The results are shown graphically with specimen shortening at fracture, determined from the compression tests,

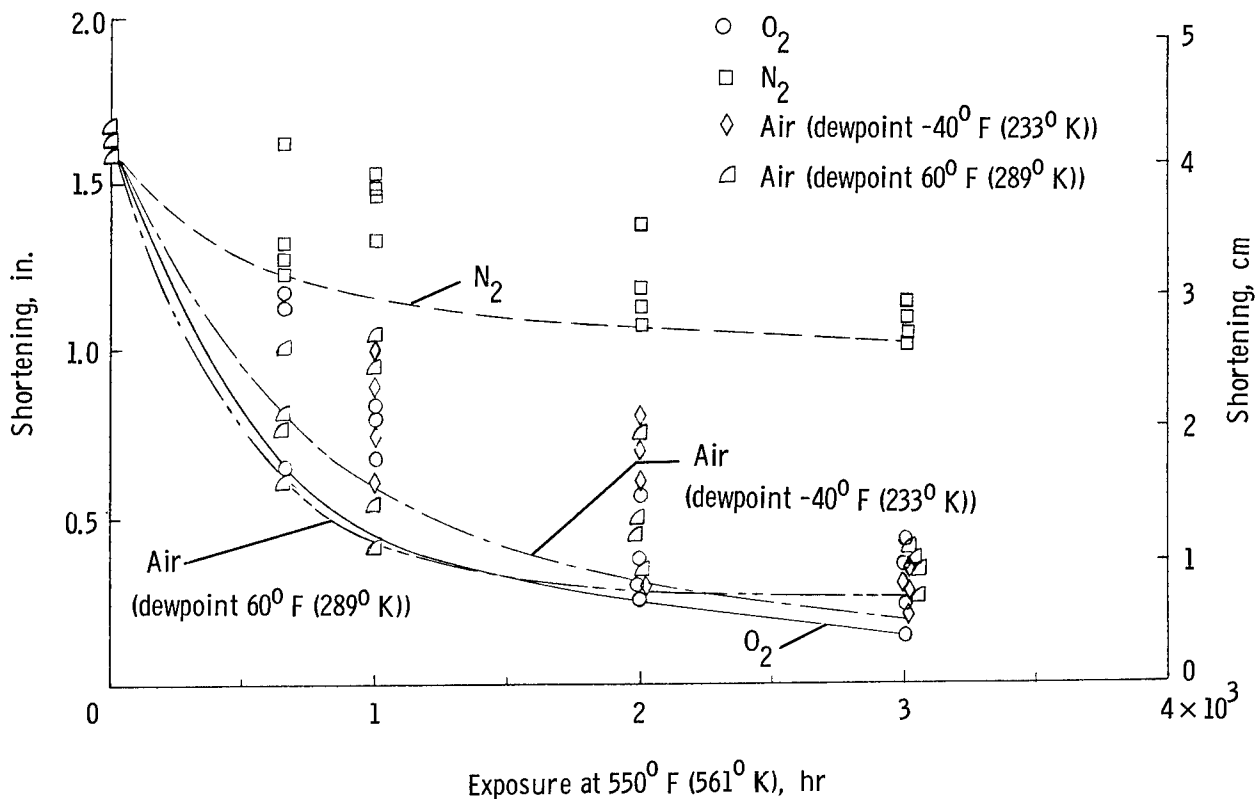
Figure 5.- Effect of oxygen, nitrogen, dry air, and moist air on shortening of Ti-8Al-1Mo-1V specimens after exposure at 550° F (561° K).

It is recognized that oxygen is an important factor in the stress corrosion mechanism in titanium alloys (see refs. 6, 7, and 8), but the effect of the amount and form of oxygen has not been established. The results of compression tests on specimens encapsulated in nitrogen, oxygen, moist air, and dry air (experiments 1, 2, 3, and 4 in table I), are shown in figure 5. These four environments contain three levels of gaseous oxygen: 0.002 percent (nitrogen), 100 percent, and 21 percent (air), by volume. The results show that the 100 percent oxygen, moist air, and dry air produced approximately the same amount of stress corrosion damage, whereas exposure in the nitrogen, with only 0.002 percent oxygen, produced less than one-half as much damage in the same time period.

Figure 5 shows that specimens encapsulated in air with dewpoints of -40° F (233° K) and 60° F (289° K) displayed almost the same values of shortening with exposures up to 3000 hours. Therefore, moisture in this dewpoint range had little effect on stress corrosion cracking.

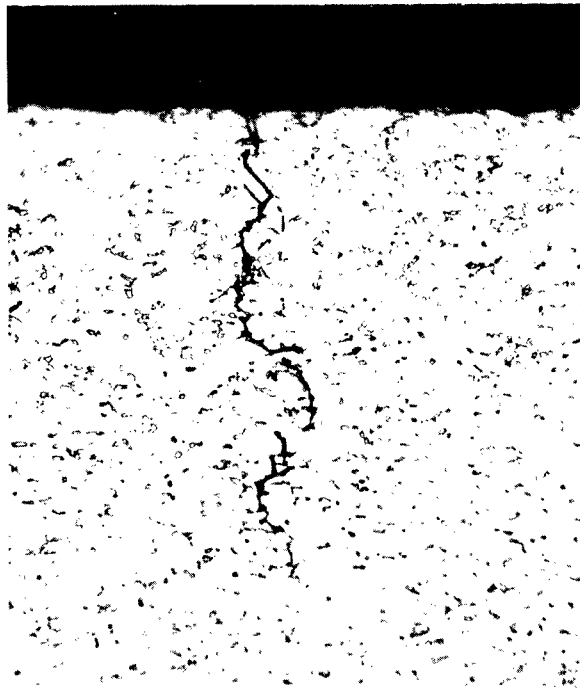
L-64-8381
Figure 6.- Stress corrosion crack in Ti-8Al-1Mo-1V specimen encapsulated in oxygen for 3000 hours at 550° F (561° K). $\times 500$.

Figures 6 and 7 show photomicrographs of intergranular stress corrosion cracks in salt-coated specimens encapsulated in oxygen and in nitrogen and exposed for 3000 hours at 550° F (561° K). The cracks produced in the oxygen environment were more numerous and penetrated deeper into the base material than those produced in nitrogen.

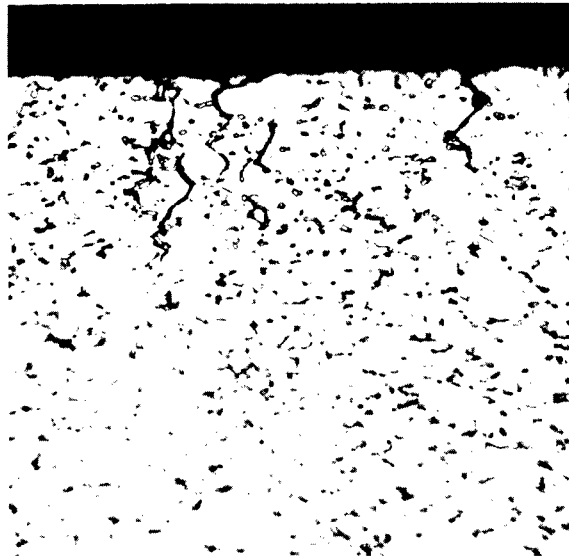
L-64-8382
Figure 7.- Stress corrosion cracks in Ti-8Al-1Mo-1V specimen encapsulated in nitrogen for 3000 hours at 550° F (561° K). $\times 500$.

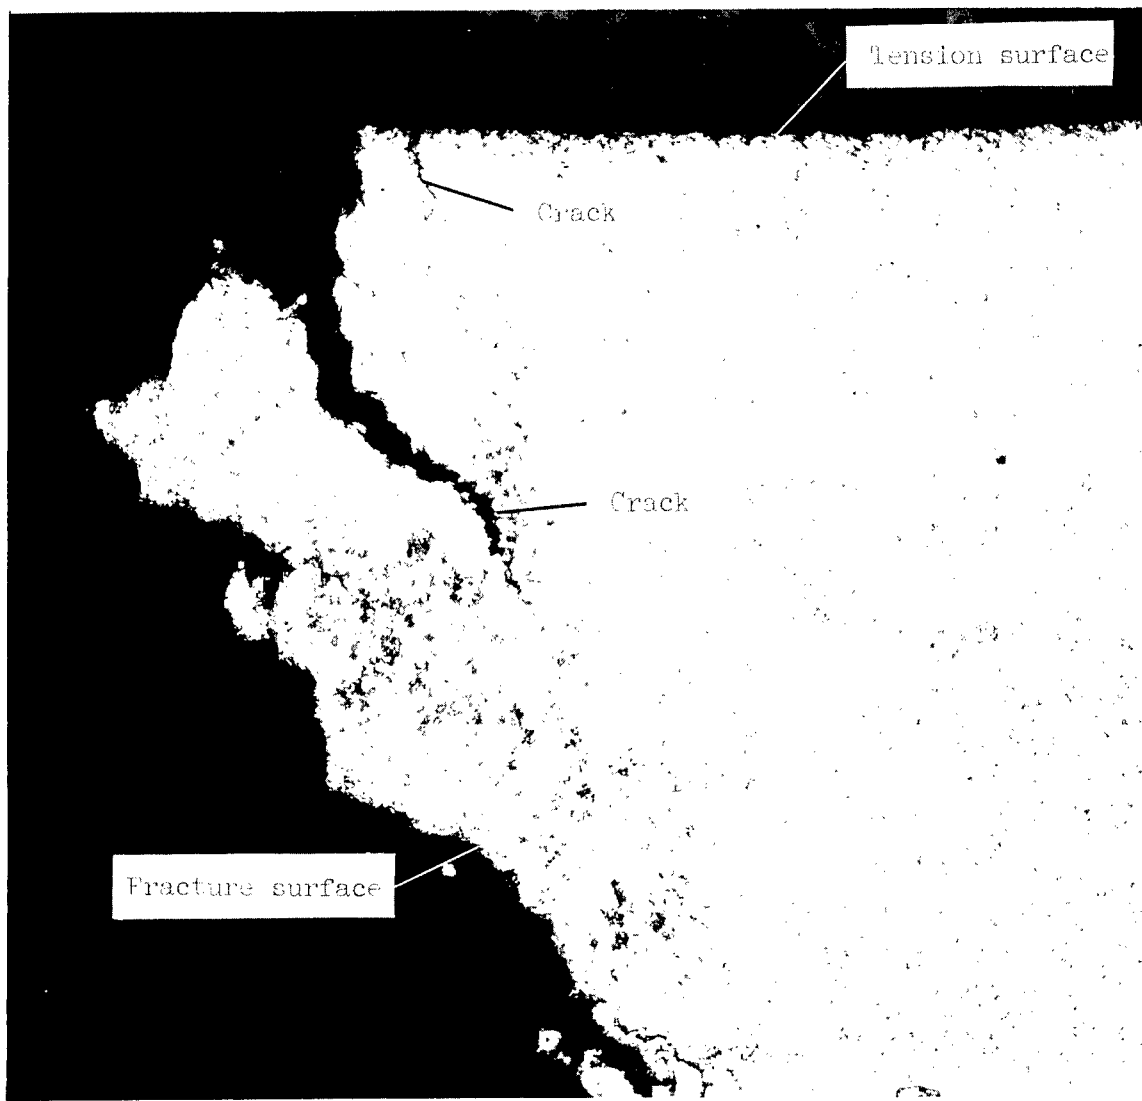
Figure 8.- Edge view of stress corrosion cracks in fracture zone of Ti-8Al-1Mo-1V specimen exposed in moist chlorine for 500 hours at 550° F (561° K). $\times 150$. L-64-8383

Moist chlorine gas was found to produce extremely severe stress corrosion in uncoated Ti-8Al-1Mo-1V at 550° F (561° K), (experiment 5 in table I). All of the specimens failed completely as a result of stress corrosion cracking before the 500-hour exposure time was reached. In every case, failure occurred at the intersection of the straight and bent portions of the specimens before removal from the oven. Figure 8 shows a photomicrograph of a stress corrosion failure area at one such intersection. Note the small intergranular cracks branching off of the main crack where failure occurred. The cracks were most numerous in

the vicinity of fracture and only a few were observed on the center portions of the specimen.

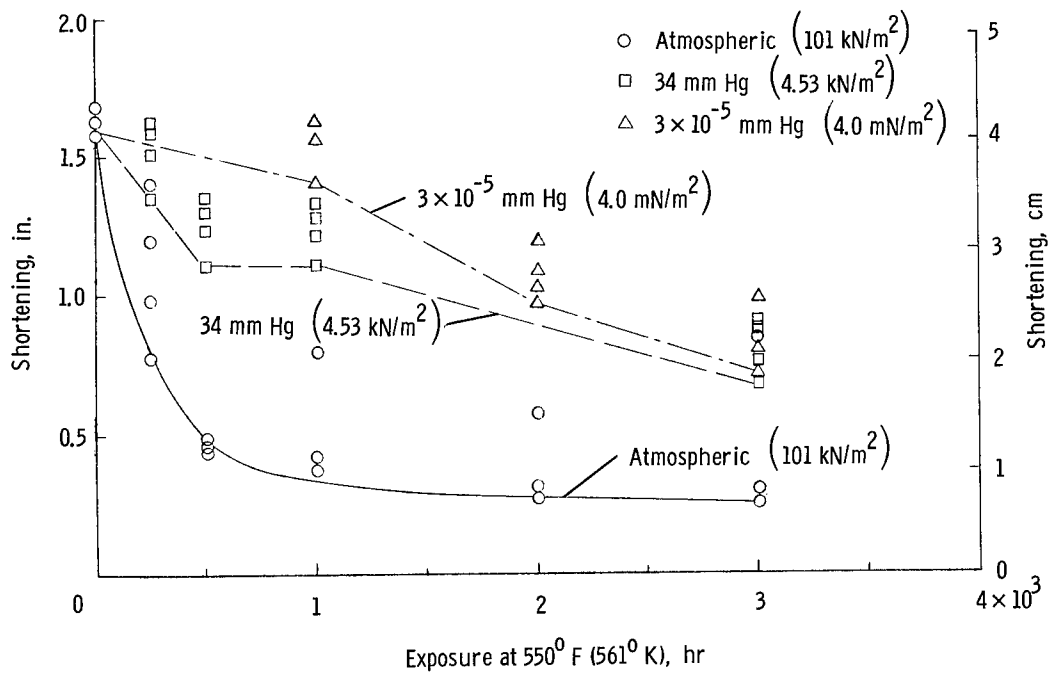
Figure 9.- Effect of pressure on shortening of salt-coated Ti-8Al-1Mo-1V specimens after exposure at 550° F (561° K).

The effect of atmospheric (101kN/m²), 34 mm Hg (4.53 kN/m²), and 3×10^{-5} (4.0 mN/m²) pressure on the salt stress corrosion cracking of Ti-8Al-1Mo-1V (experiments 6, 7, and 8 in table I) is shown in figure 9. (The pressure of 34 mm Hg simulates the static pressure at an altitude of 70,000 feet (about 21,000 m), the approximate cruising altitude for a supersonic transport.) Note that, as the pressure is reduced, the damage due to stress corrosion cracking is also reduced. This result generally agrees with tests reported in reference 8 on Ti-5Al-2.5Sn at various reduced pressures down to 1 micron (133 mN/m²) exposed at 800° F (700° K) for 1 hour. The reduction of stress corrosion cracking with lower pressure can be explained by the decreased amounts of oxygen available to the reaction.

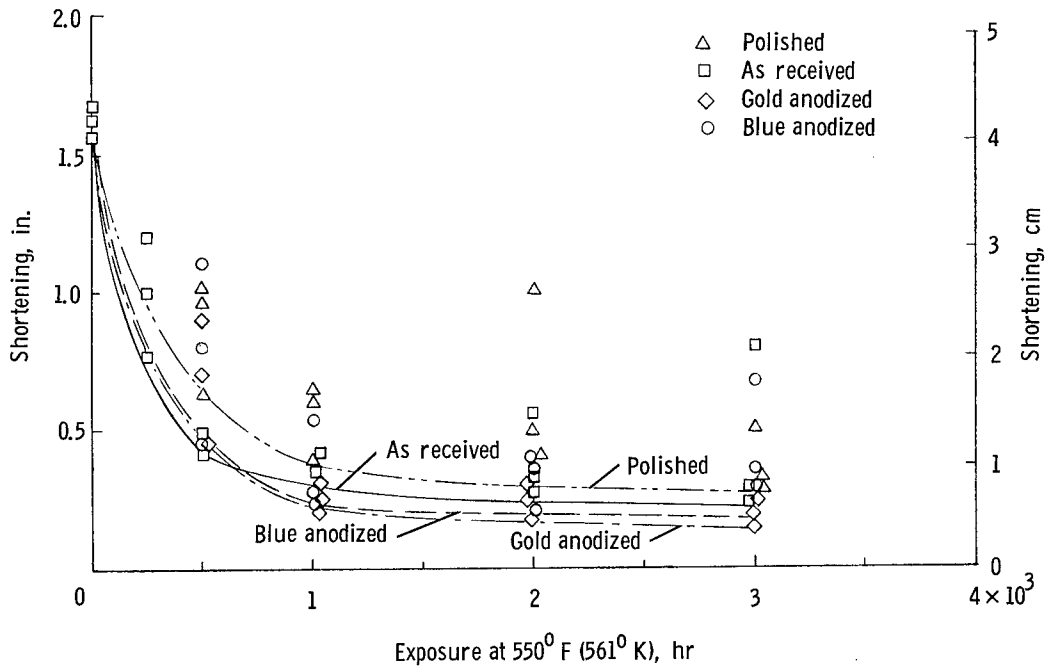
Figure 10.- Effect of different surface conditions on shortening of salt-coated Ti-8Al-1Mo-1V specimens after exposure at 550° F (561° K) in air.

The results in figure 10 indicate that [oxide films less than 600 angstroms do not noticeably affect stress corrosion cracking in Ti-8Al-1Mo-1V under the experimental conditions.] However, data in reference 7 showed that a thicker gray oxide film (estimated from ref. 5 to be greater than 1000 Å) offered some protection against salt stress corrosion in Ti-6Al-4V exposed at 750° F (672° K) and 800° F (700° K) up to 50 hours. $\rightarrow 15$

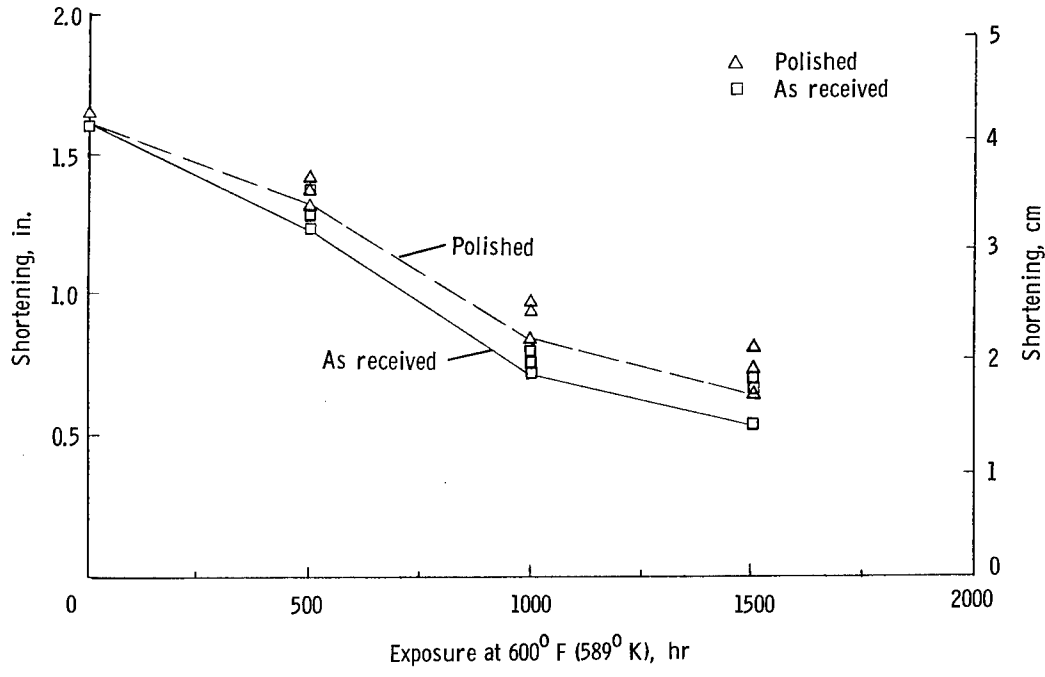
Figure 11.- Effect of surface condition at 3×10^{-5} mm Hg (4.0×10^{-3} mN/m²) on shortening of salt-coated Ti-8Al-1Mo-1V specimens after exposure at 600° F (589° K).

As a further check on the effect of surface conditions, salt-coated specimens with polished and as-received surfaces were encapsulated separately under a pressure of 3×10^{-5} mm Hg (4.0 mN/m^2) (experiments 12 and 13 in table I). Each capsule was heated to 600° F (589° K) while pumping down to insure the removal of moisture. The results in figure 11 indicate that polished specimens demonstrated slightly better resistance to stress corrosion cracking than did the as-received specimens. However, because of the limited number of specimens tested, it was difficult to draw any definite conclusions as to the relative effects of these two surface conditions. These tests do show that very little gaseous oxygen or surface oxide is necessary to produce stress corrosion cracks in Ti-8Al-1Mo-1V at 600° F (589° K).

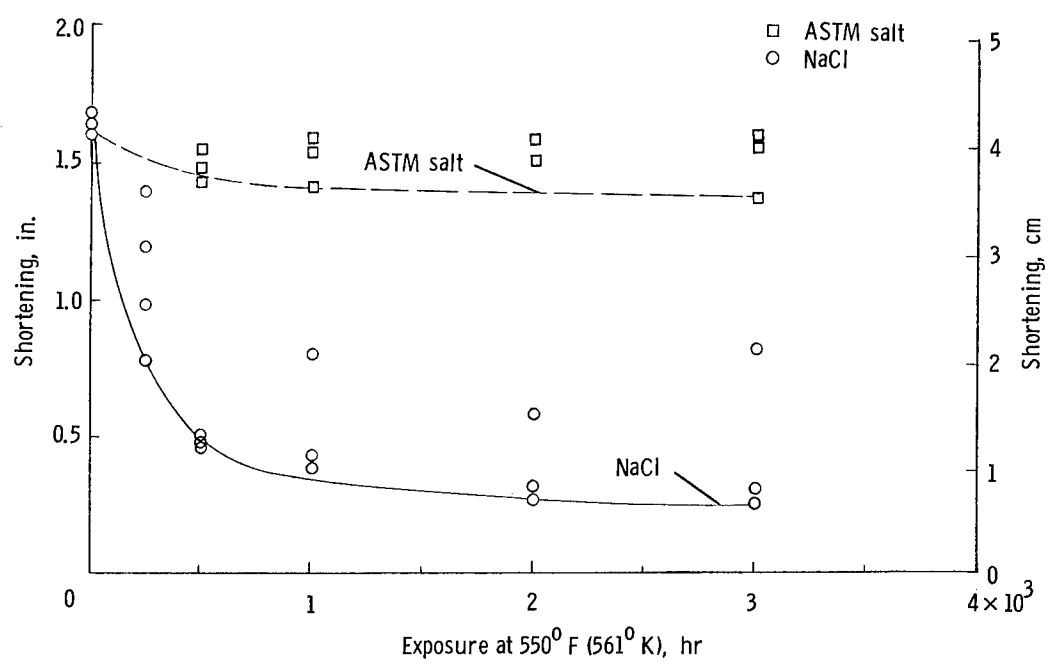
Figure 12.- Effect of salt composition on shortening of Ti-8Al-1Mo-1V specimens after exposure at 550° F (561° K).

The results for specimens with NaCl and ASTM salt coatings (experiments 6 and 14 in table I) are given in figure 12. For exposures up to 3000 hours at 550° F (561° K), the ASTM salt produced substantially less stress corrosion damage than the NaCl. This result was surprising since data from several investigations such as reference 1, indicated that the effect of ASTM salt is probably more severe than that of NaCl. There seems to be no obvious explanation for this apparent inconsistency at this time. Additional stress corrosion tests are underway to determine the relative effects of NaCl, ASTM salt, and natural sea salt.
