**UNITED STATES AIR FORCE  
RESEARCH LABORATORY**

**Cumulative Damage to Window Panes**

**Jerold M. Haber**

**Interim Report for the Period February 1991 to July 1995**

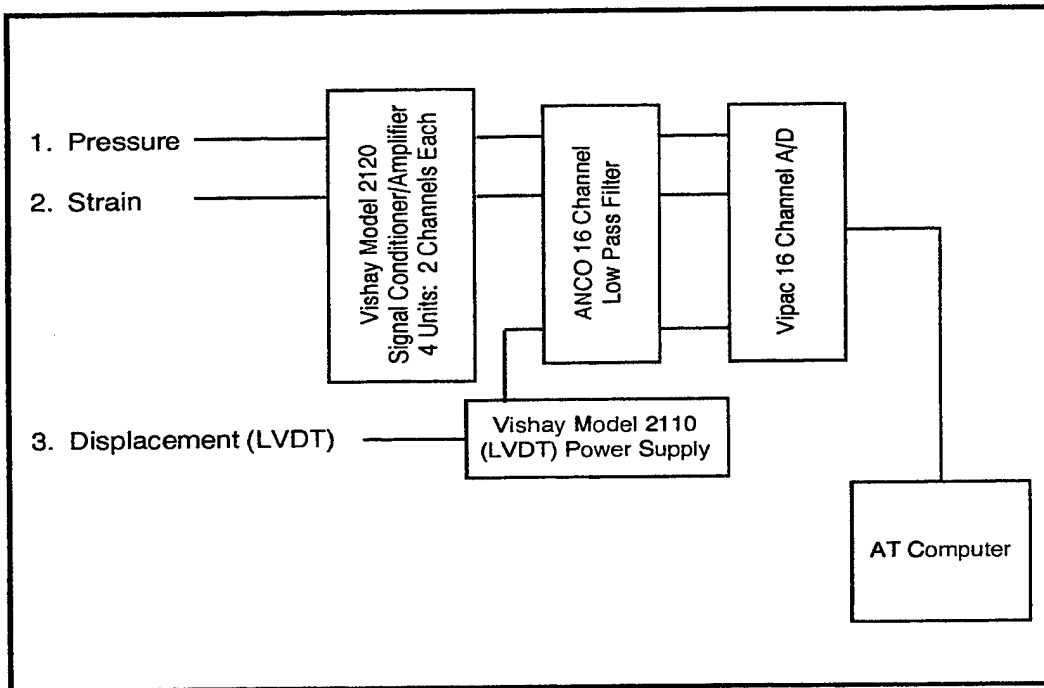
**Figure 2-6.** Block Diagram of Instrumentation for Static/Fatigue Tests.

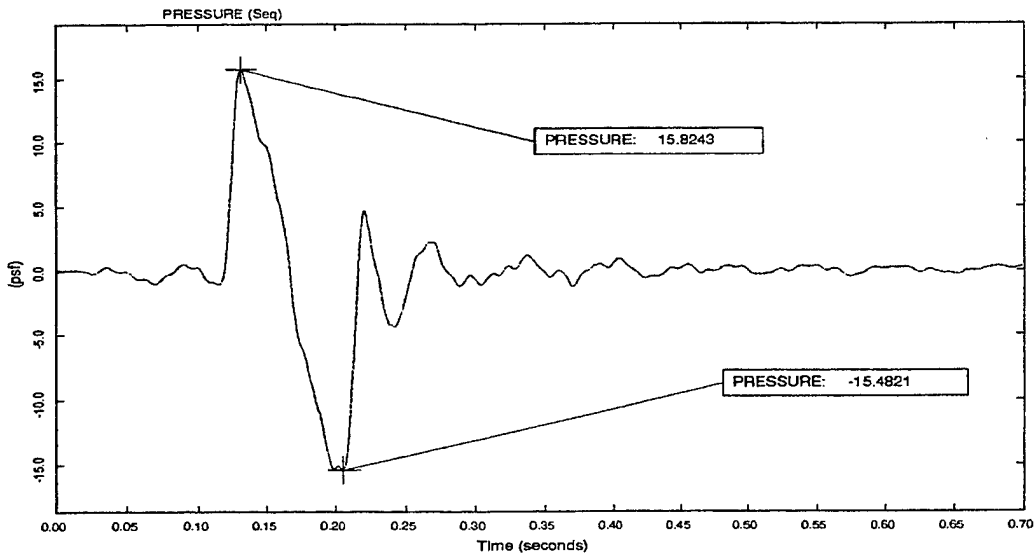
SBTF GLASS TEST EXPERIMENTS -  
PRESSURE TIME HISTORY FOR  
TEST GROUP 1 BOOM NUMBER 2

SBTF GLASS TEST EXPERIMENTS -  
PRESSURE TIME HISTORY FOR  
TEST GROUP 1 BOOM NUMBER 5000

Figure 2-15. Comparison of Test Pressures for Booms 2 and 5,000 from Test Group 1.

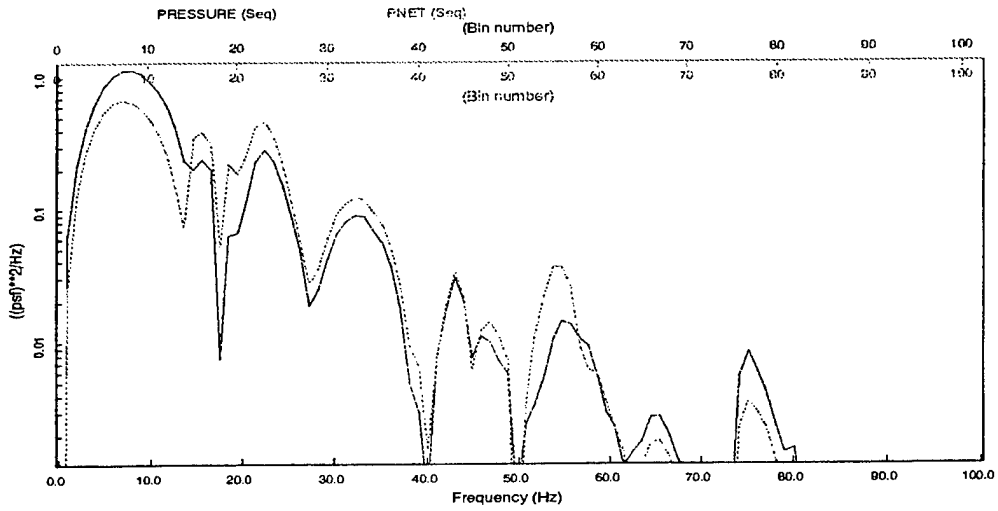
Figure 2-16. Comparison of Spectra of Test Pressures and Net Pressures for Booms 2 and 5,000 of Test Group 1.

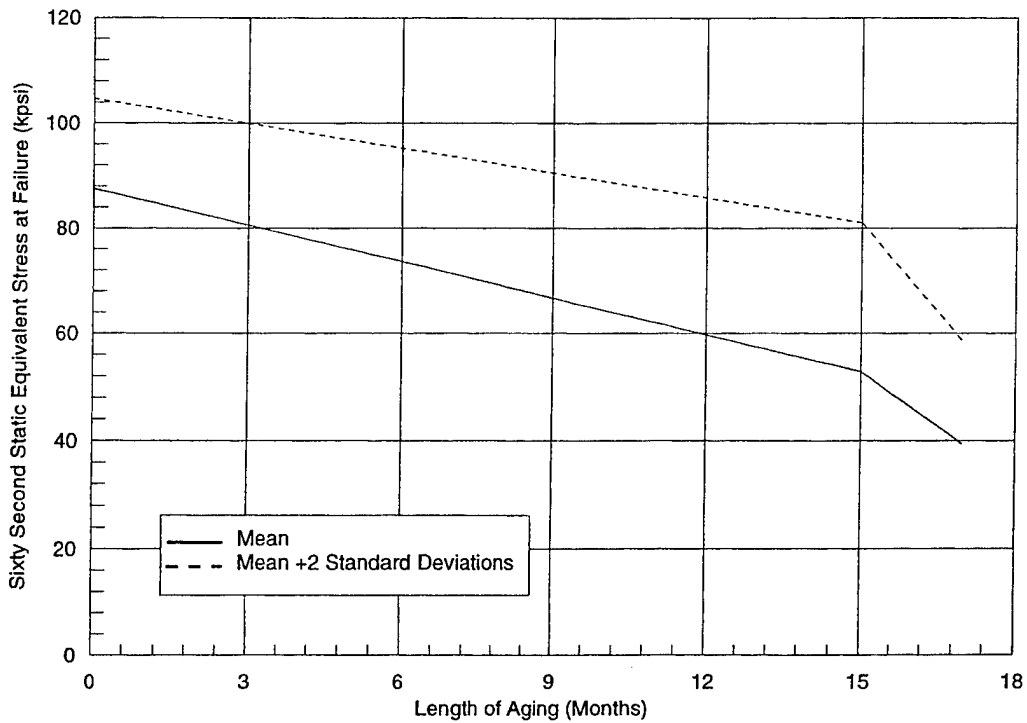
**Figure 3-3.** Glass Strength vs. Age.

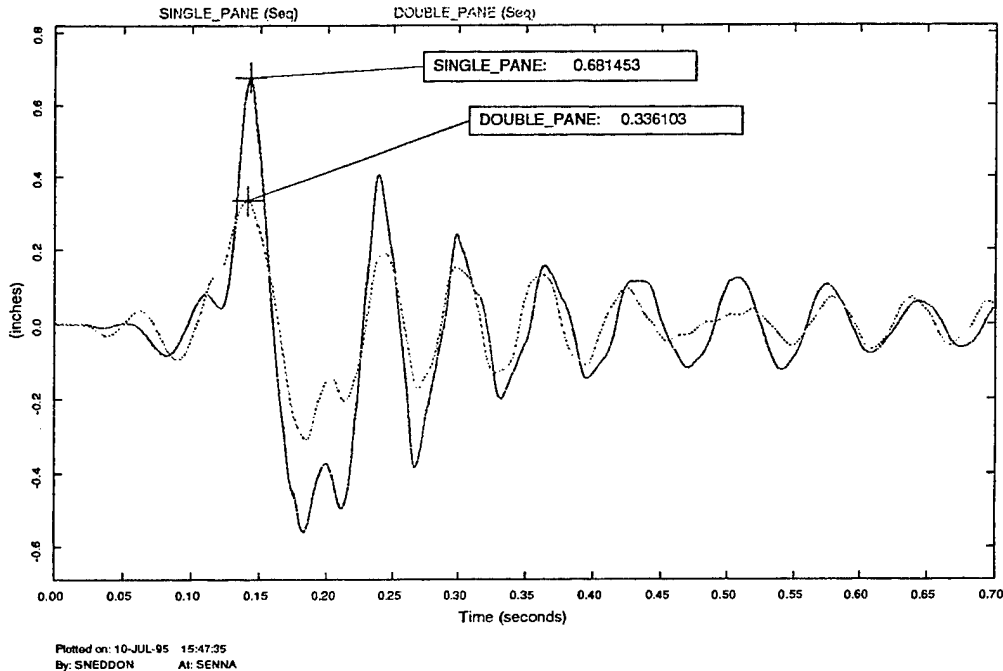
**Figure A-1.** Comparison of Peak Deflection of a Double Glazed Window and a Single Pane.

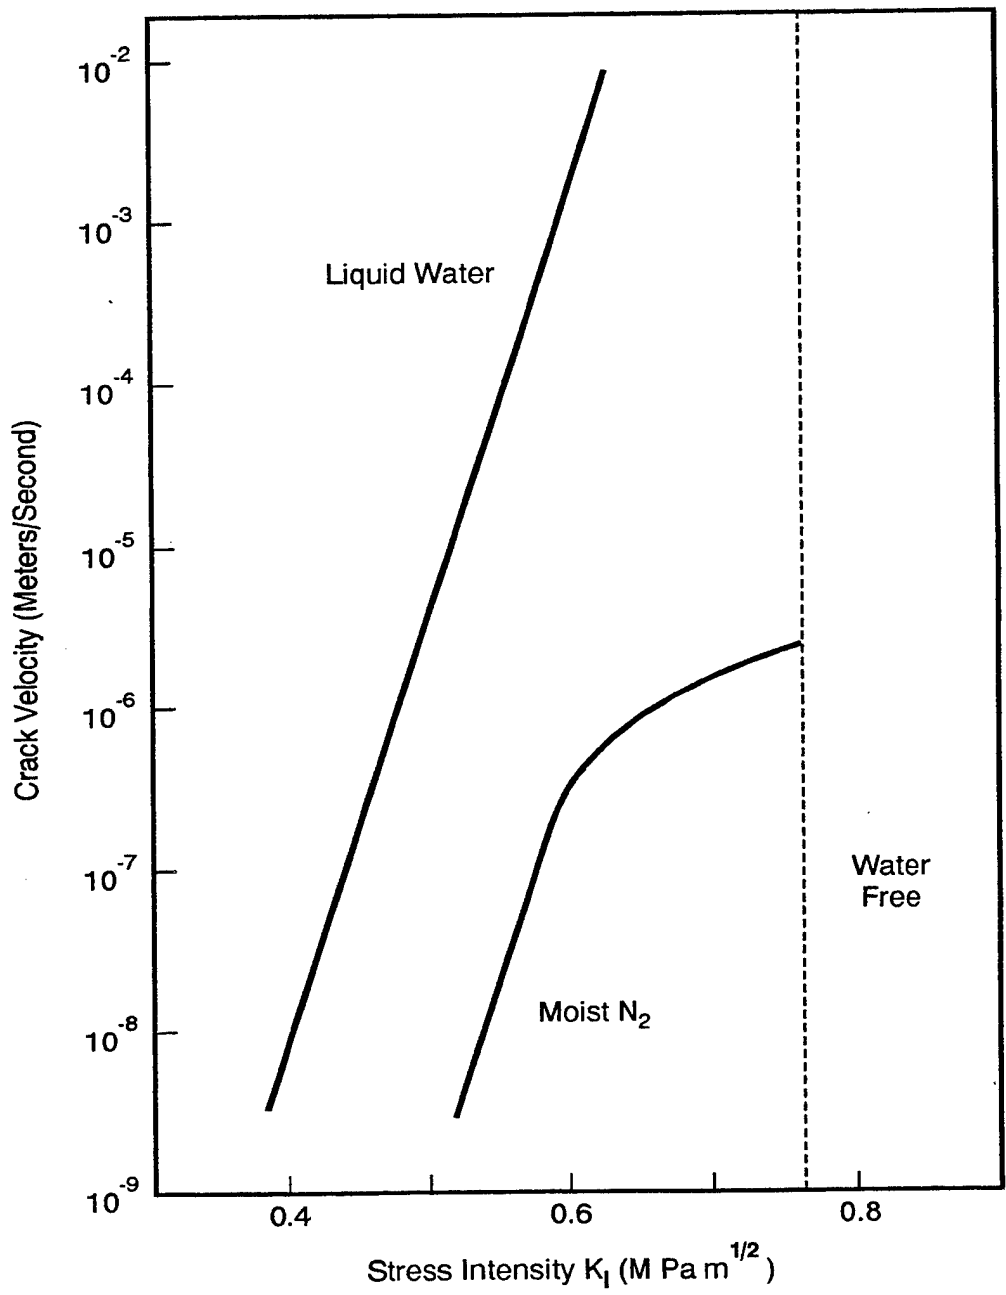
Figure A-4. Effect of Water on Crack Growth in Vitreous Silica (Michalske and Freiman, 1982).

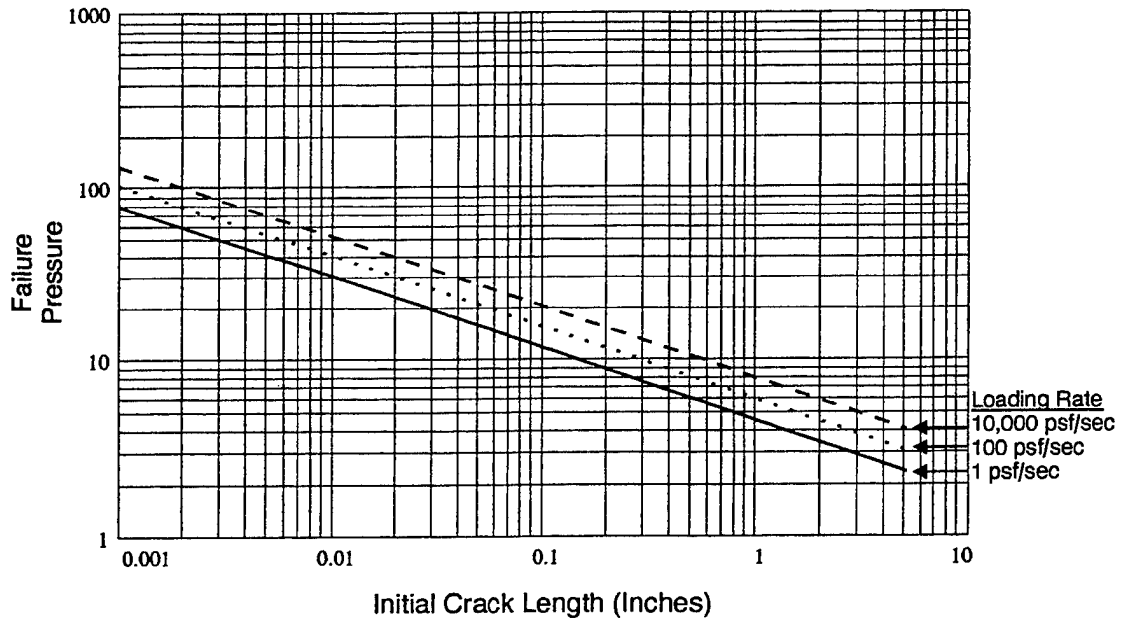
Figure B-3. Minimum Failure Pressure as a Function of Initial Crack Length: Corner - (1,1) Element.

- Susceptibility to crack propagation depends on crack length as indicated in Figures B-3 to B-5.
- Susceptibility to crack propagation depends on the orientation of the cracks with respect to the principal stresses. All calculations reported here are for the most susceptible orientation.
