NASA/CR-2001-211223  
ICASE Report No. 2001-27

## **Progressive Failure Studies of Composite Panels with and without Cutouts**

*Navin Jaunky  
ICASE, Hampton, Virginia*

September 2001

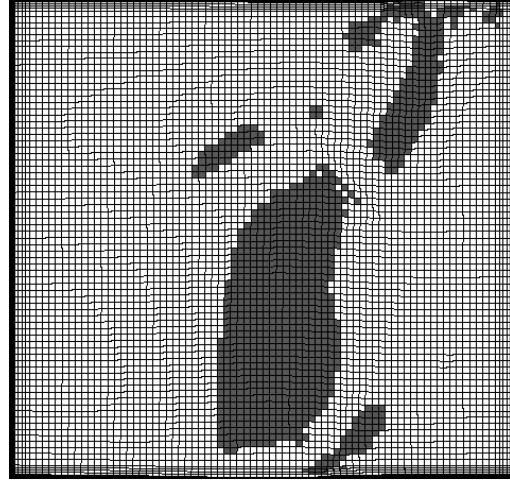
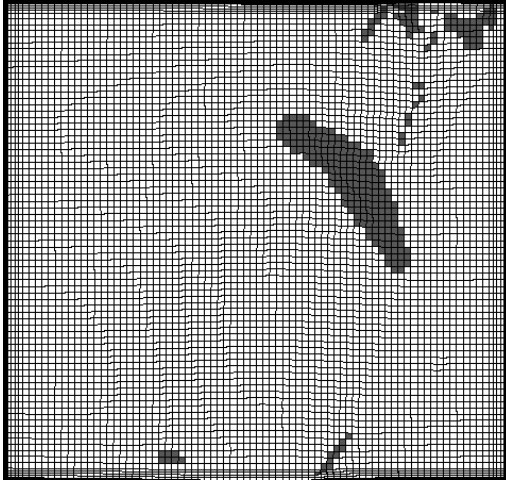
Figure 8: Axial compression response and damage modes in curved panel after final failure.

(a) Experimental out-of-plane displacement contour at failure

(b) Fringe plot of matrix cracking (FV1) in the bottom 45° ply

(c) Fringe plot of fiber-matrix shear failure (FV2) in the bottom 45° ply.

(d) Fringe plot of fiber failure (FV3) in the bottom 45° ply

Figure 8(a) through 8(d) show contour plots of out-of-plane displacement from moire interferometry, fringe plots of matrix cracking ( $FV1$ ) in the bottom ply, fiber-matrix shear ( $FV2$ ) in the bottom ply, and fiber failure ( $FV3$ ) in the bottom ply after final failure respectively. The moire contour plot is consistent with the deformed shape obtained from the progressive failure analysis where the half wavelength at the lower region of the panel has a larger displacement gradient. Analysis results indicates that damage initiated within the lower region of the deformed panel and propagated to the area shown in Figure 8(b) through 8(d). Damage also accumulated in part of the region supported by the knife edges of the fixture. These results are consistent with observations from the experiments which did not indicate delamination failure.
