**DOT/FAA/AR-01/27**

# **Engine Debris Fuselage Penetration Testing, Phase I**

Final Report

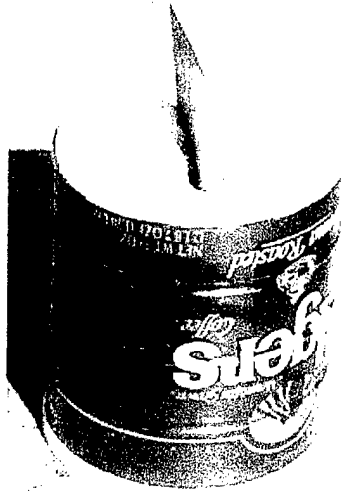
An example of the sabots can be seen in figure 8. A coffee can, Teflon, and Styrofoam to build the sabots were used. The Teflon was used as a backing plate to prevent the gas blast from destroying the foam. The coffee can had to be made slightly smaller in diameter to fit the gun, but worked wonderfully. The previous tests' sabot designs were very heavy and outweighed the projectile by many times. Stopping those sabots at the energies of this test was going to be expensive. Three sabot stopper plates of 3 in. Society of Automotive Engineers (SAE) 4140 steel were broken during the pretest experiments.

FIGURE 8. FINAL SABOT DESIGN WITH LOADED FRAGMENT

It should be noted that roll angles are approximate due to the muzzle loading nature of the gun. The sabot/fragment unit usually is loaded straight down the muzzle but on occasion it rotated slightly. The table values are estimated to be within 5 deg. of actual angles. The obliquity angles could not be selected for each shot. They were dictated by the shot location.
